19	BERGEN COUNTY STONE INDIVIDUAL STRUCTURE SURVEY FORM	HC	DUSE SURVEY
GENERAL	COMMON NAME: LOCATION: WUNICIPALITY: OWNERSHIP: Demarest OWNER/ADDRESS: John, Meyerhoff House St. Joseph's Rectory 279 County Read (Block 19, Lot 5) Demarest OWNERSHIP: Public Private OWNER/ADDRESS: St. Joseph's R.C. Church (same)	REFERENCE	MAP REFERENCES: Erskine (1778-80) Majr.Goetschius? Hopkins-Corey (1861) Jno.Myerhoff Walker's Atlas (1876) Jon.Myerhoff Bromley (1912) D.R.Ketcham Other RECOGNITION: National Register BCHS Marker HABS Bailey Other
MENT	HOUSE ORIENTATION: S 50° E IMPORTANT RELATED STRUCTURES:	USE	ORIGINAL: Residence PRESENT: Residence and office
ENVIRONMENT	SURROUNDING ENVIRONMENT: Residential Commercial Agricultural Open Space Other COMMENTS:	THREATS	THREATS TO STRUCTURE: Roads Development Zoning Deterioration Other No Threat, COMMENTS:
CONDITION	CONDITION: Excellent Good Fair Deteriorated STATUS: Cocupied Work in Progress ACCESSIBLE: Yes, Restricted No Little remains of what this house was originally. All signs of the fireplace are gone. The stonework has been redone around two French doors which are set into the front. The open beamed ceiling remains, but the beams have been painted

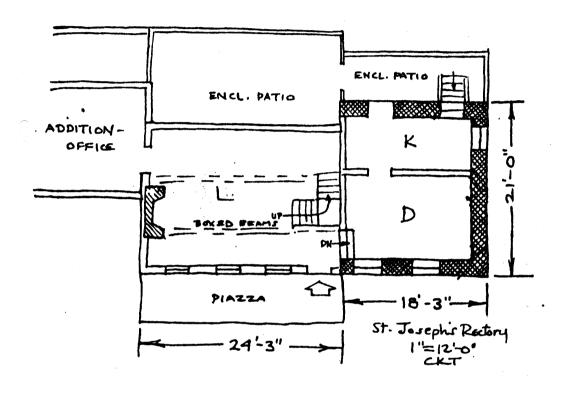
The contemporary description described this house as being 45' x 21'. It is 21'0" on the north end but the foundation is "L"-shaped and measures 42'6" overall. There might have been an oven or shed that was included in the early figure, or the stove part may have been an out-building that was later added to. The original house, said to have burned, was to the south on the knoll. Plotting from Watkins places "Maj. R. Goetchius" about 250 feet south of this building. However, the burned house was said to have been rebuilt.
