KENTUCKY HISTORIC RESOURCES
Individual Inventory Form

Resource # 155
Shelby County

1. Name of Resource: Harbison House

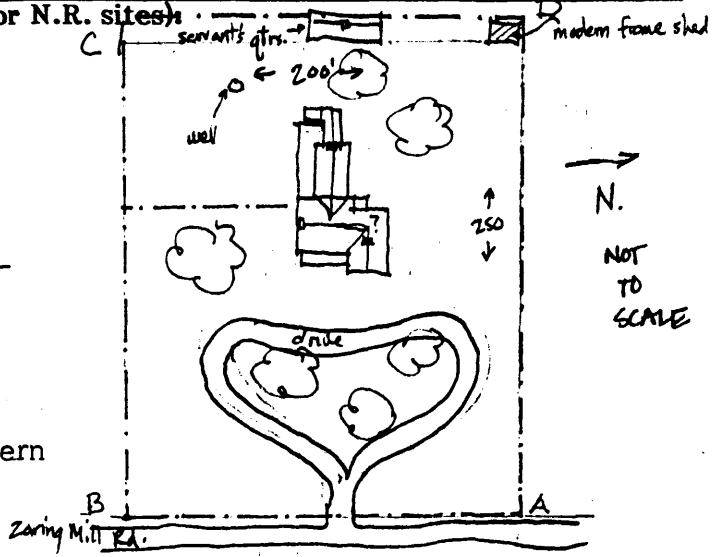
44. Site Plan (and boundary description and justification for N.R. sites)

Beginning at A, south along the west side of Zaring Mill Rd. 200' to B, thence west 250' along a fence to C, thence north along a fence 200' to D, thence east 250' along a fence to the point of origin. The boundaries were chosen to encompass the house, domestic-related space, and one outbuilding as defined by fences and the road from the surrounding fields. The outbuilding appears to have been built originally as quarters for servants. Also within the boundaries is a non-contributing modern frame shed.

Point A is located at the intersection of a fence with the western edge of Zaring Mill Road and is 125 feet northeast of the northeastern corner of the dwelling.

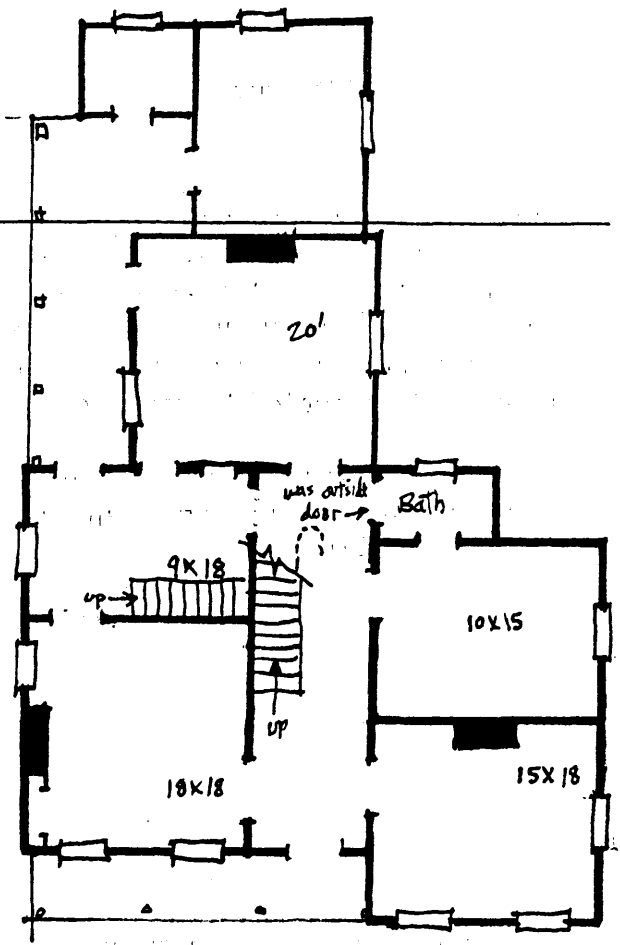
45. Description and House Plan:

2-story, brick, double-pile T-plan with passage, handsome 1-story iron porch on principal (east) facade, cast iron hood molds on front and sides of eastern portion of house, segmental arches over windows of ell and kitchen wing, stone sills, 2/2 sash windows, cut stone foundation with projecting ashlar water table, gabled, standing seam metal roof, gabled pediment with iron ventilator over center of recessed portion of facade, deep cornice with brackets, projecting eaves, corbelled brick chimneys, running bond with pencilled grapevine joints, kitchen wing has 6/6 sash, 2-story wooden porch on south side of ell with bracketed posts and jig-sawn railing on second level, 1-story brick pantry (?) off south side of kitchen wing opens

onto side porch, brick veneer bathroom added in angle of ell on north side of house.

Original woodwork consisting of eared door and window surrounds, panelled aprons beneath windows, high molded baseboards; secondary stair in southeast room of main portion of house.
