**NATIONAL REGISTER OF HISTORIC PLACES  
REGISTRATION FORM**

**historic name** Historic Trail and Cave Entrance

Historic Trail and Cave Entrance, Jewel Cave National Monument, Custer County, SD

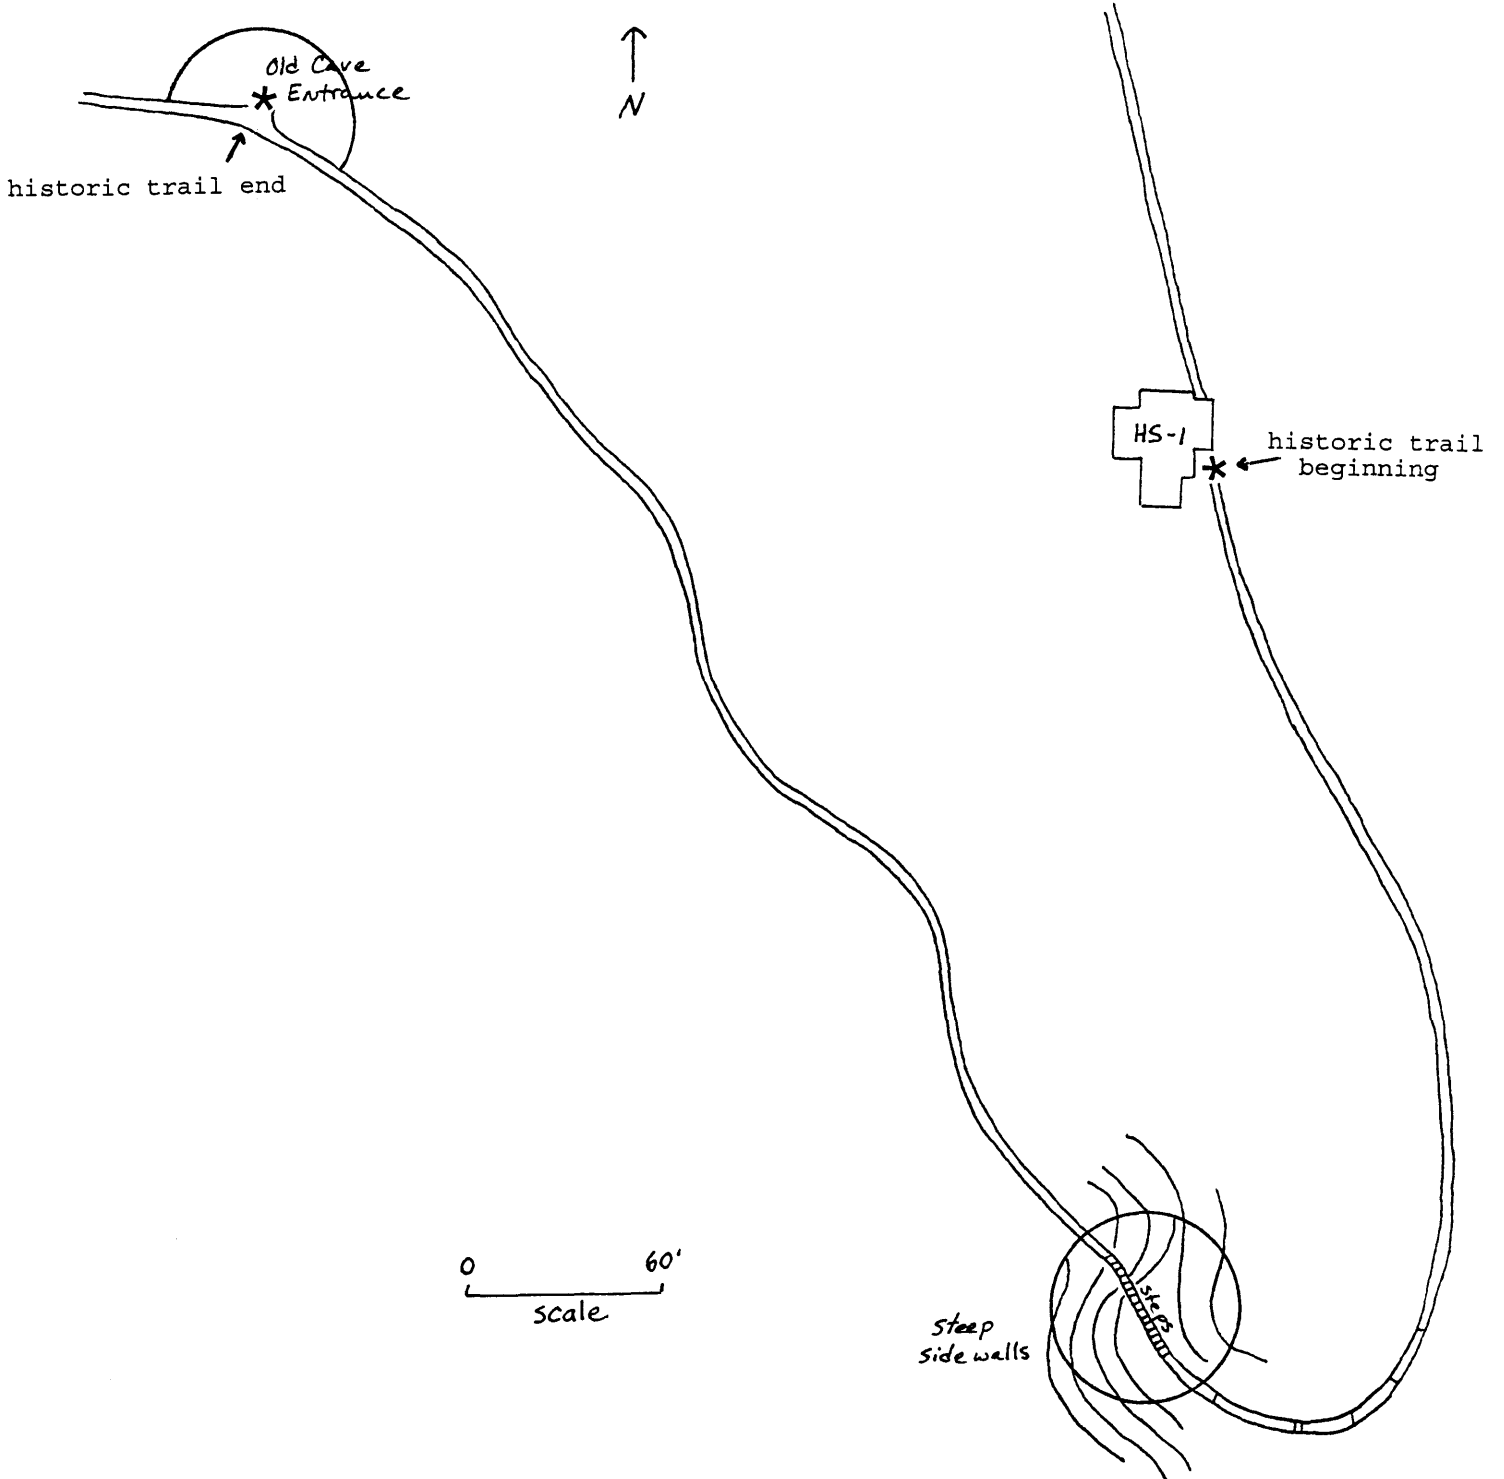
Property: Historic Trail and Cave Entrance, Jewel Cave National Monument, sketch map

project. The relationship of all three features are shown on the accompanying site map. The Ranger Station and the Historic Trail and Cave Entrance are associated with the following historic contexts: "Tourism in the Black Hills, 1890-1944"; "Creation and Development of Jewel Cave National Monument, 1905-1944"; and "National Park Service Rustic Architecture and Public Works Construction, 1933-1942." These contexts are discussed in Item E of the multiple property submission.

This parcel is primarily linear, measuring approximately three feet in width and 1,430 feet in length and includes a circular area (60' in diameter) at the stairway near UTM reference point #2 and a half-circle (60' in diameter) north of the trail at the cave entrance near UTM reference point #3. The trail begins southeast of the ranger's cabin, curves in a south southwesterly direction, over the crest of the ridge, through a rock outcropping and proceeds in a northwesterly direction to the historic cave entrance. The centerpoint of the circle lies on the centerline of the trail at the midpoint of the stairway; the centerpoint of the half-circle lies at the midpoint of the cave opening.

The boundary corresponds to UTM reference points 1, the starting point of the trail, located at the Ranger Station (HS-1); 2, the point where the trail goes through the rock outcrop; and 3, the location of the entrance of the cave. It includes the historic trail and the natural rock formations which the steps pass through and which form the cave entrance. The trail beyond the cave entrance (interior trail) has not yet been evaluated, and thus is not included in this nomination.
