KENTUCKY HISTORIC RESOURCES
Individual Inventory Form

Resource # 18
Shelby County

1. Name of Resource: Harbison House

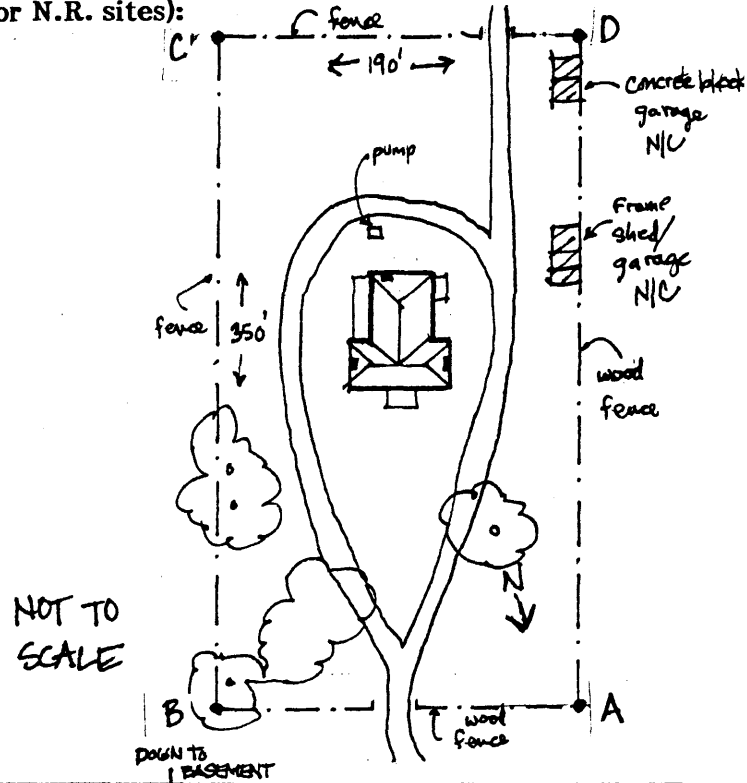
44. Site Plan (and boundary description and justification for N.R. sites):

Beginning at A, a point where two wooden fences meet at the north corner of the yard, approximately 80 feet northwest of the northwestern edge of the drive, 190 feet southeastward along wooden fence to intersection with another fence; then 350 feet southwestward along fence to intersection with another fence; then 190 feet northwestward along fence, crossing drive to intersection with wooden fence; then 350 feet northeastward along fence which extends behind garage and shed to point of origin.

The boundaries were chosen to include the house and its domestic space as enclosed by fences which separate it from the surrounding fields. Within the nominated area are the dwelling (contributing) and two non-contributing outbuildings.

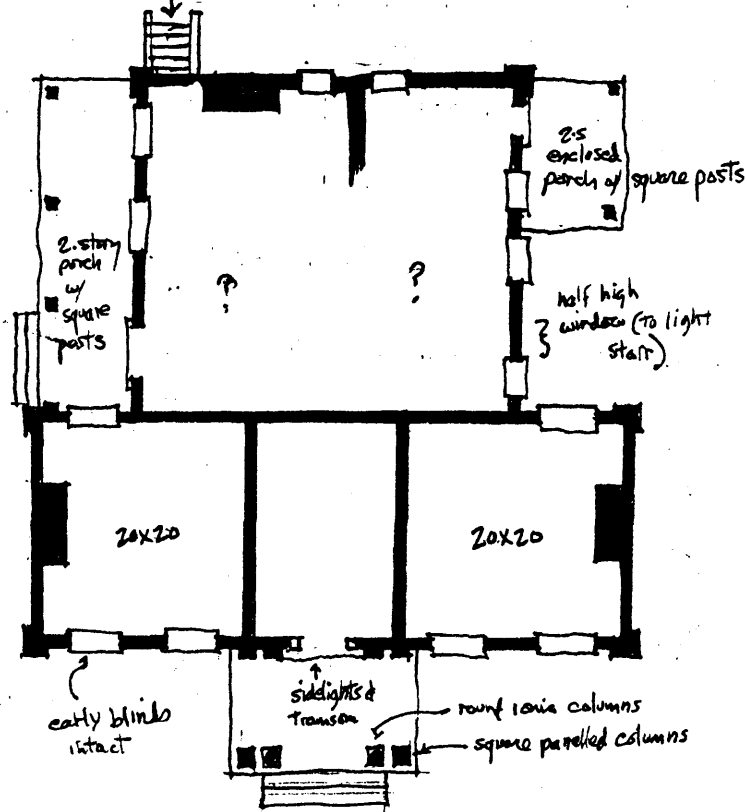
45. Description and House Plan:

Exterior:

2-story, 5-bay, brick, center-passage, single-pile plan, 2-story offset ell, pilasters divide bays, common bond brick work with pencilled grapevine joints, stone lintels and sills, 6/6 sash, hipped roof with deep frieze on cornice, interior end chimneys, unusually handsome ashlar foundation of long blocks with projecting water table, 1-story Greek Revival portico supported on panelled square posts and fluted Ionic columns, entrance framed by plain pilasters, 4-pane transom, narrow 3-pane sidelights flanked by plain pilasters, 2-story portico on east side of ell appears original, enclosed 2-story porch on west side of ell is later addition.
