National Register of Historic Places Registration Form

Historic name: Loleta Recreation Area

City or town: Millstone Township State: PA County: Elk

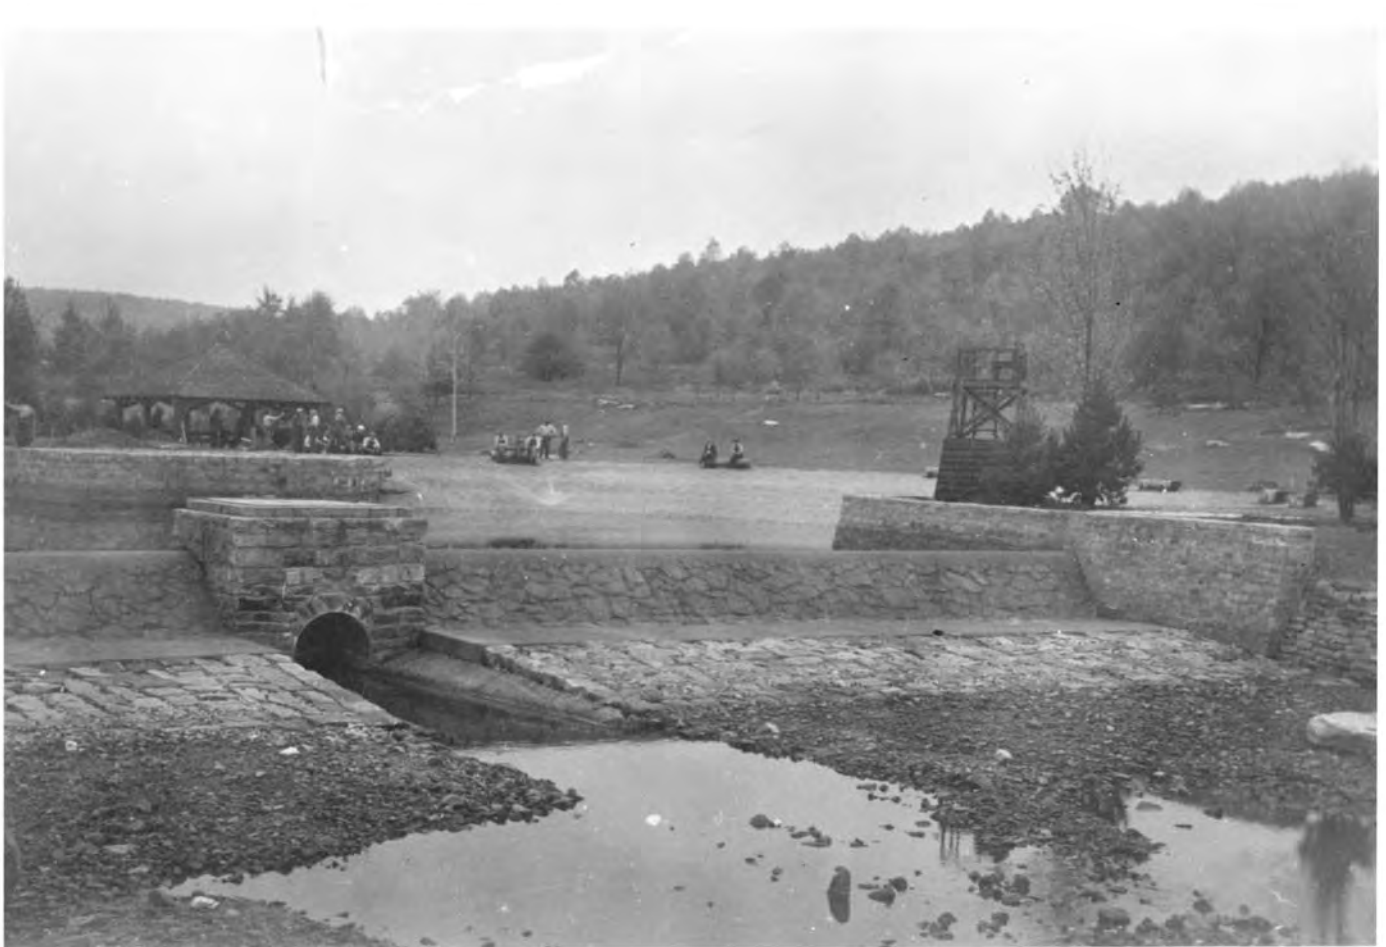
Figure 4: 1933 view of lower dam at Loleta Recreation Area. From HABS PA 5963, online, <http://www.loc.gov/pictures/resource/hhh.pa2801.photos.357189p/>, accessed April 1, 2015.

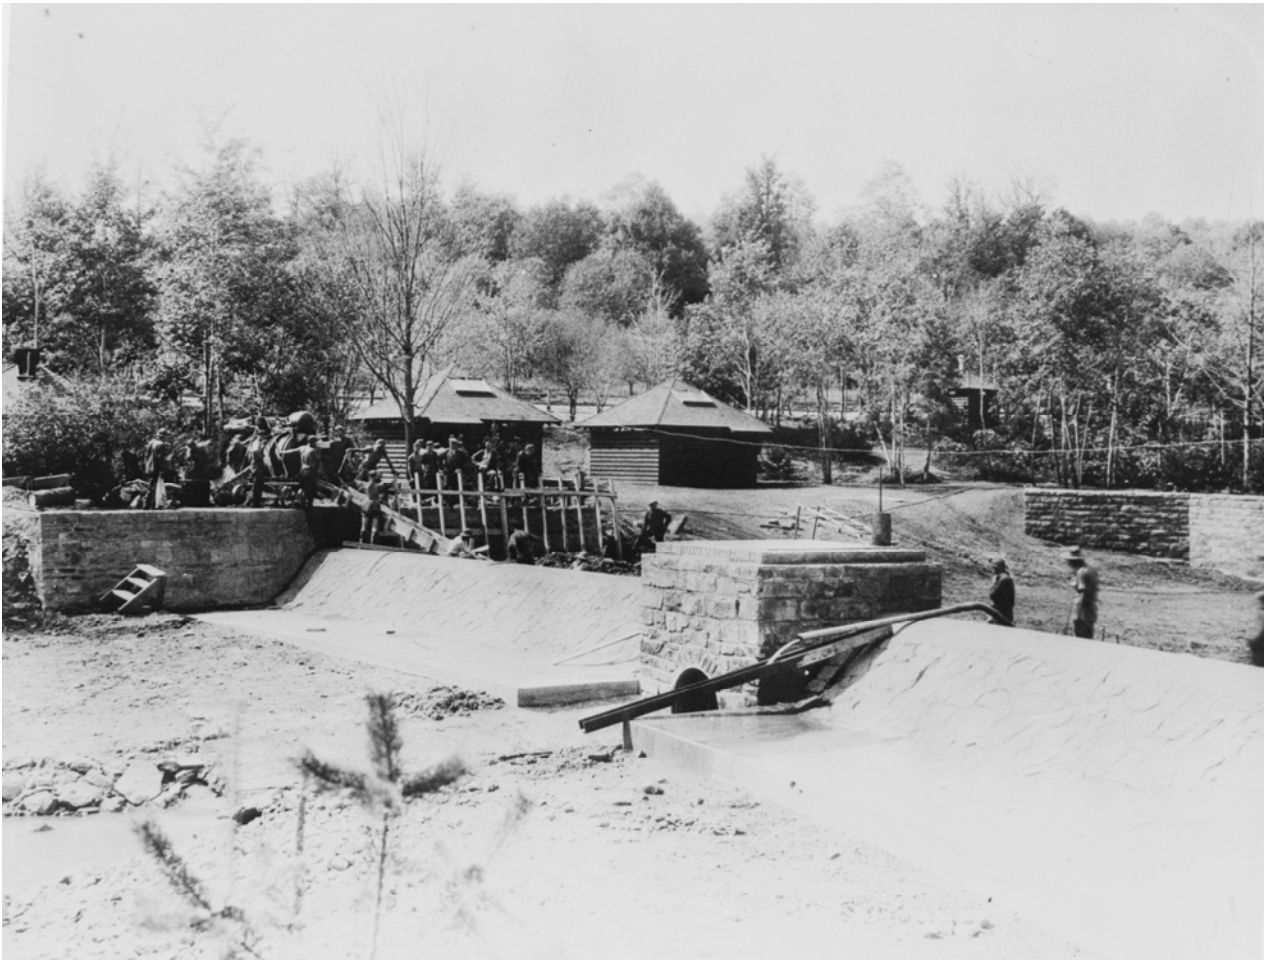
Figure 5: Ca. 1933 view of original men's and women's bathhouses at Loleta Recreation Area. From HABS PA 5963, online, <http://www.loc.gov/pictures/item/pa2801.photos.357186p/>, accessed April 1, 2015.

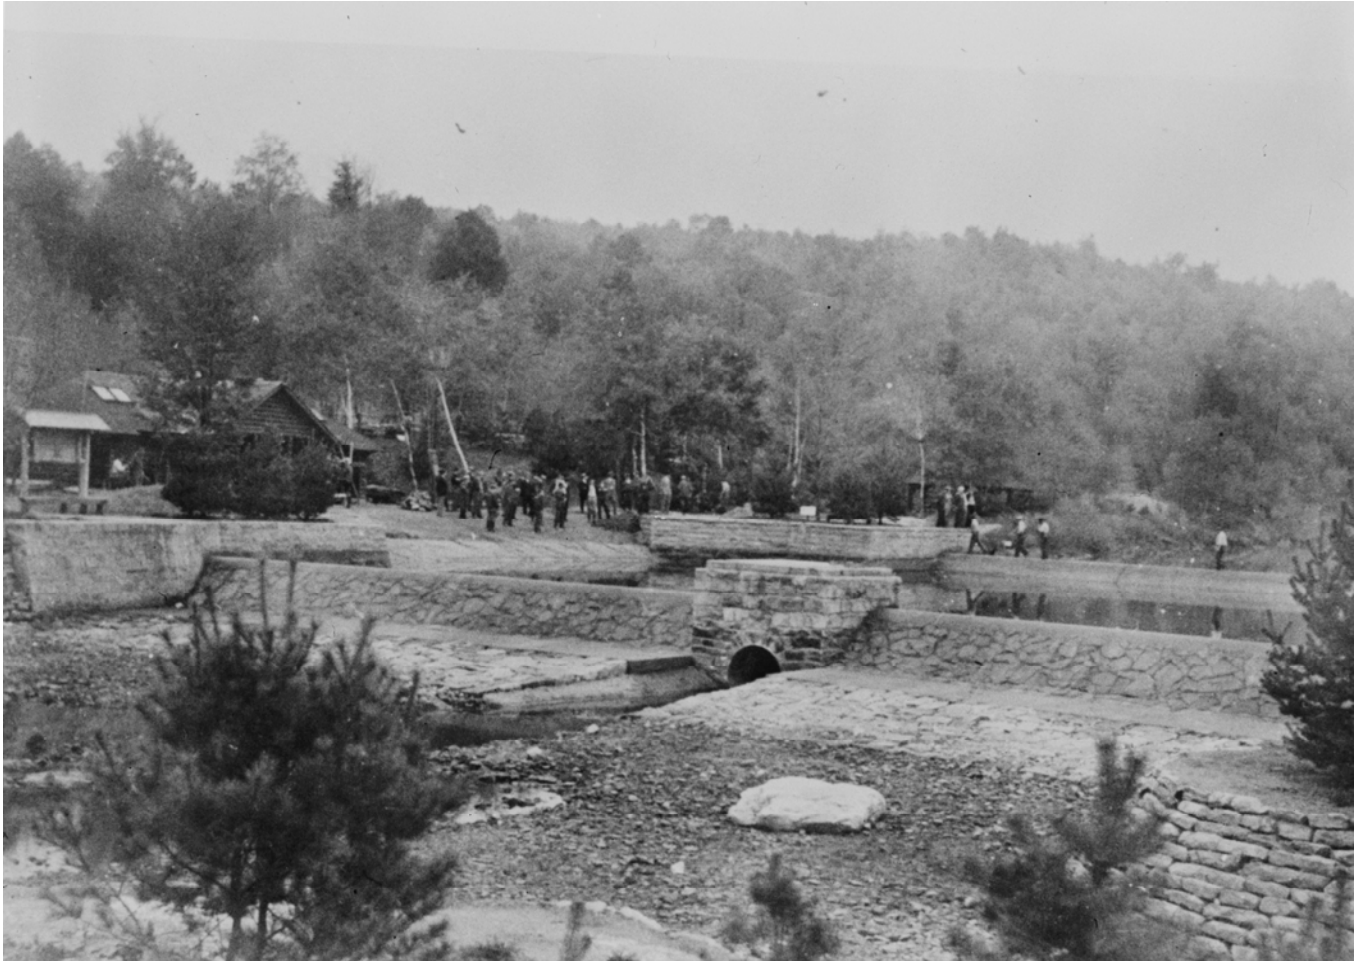
Figure 6: Ca. 1936 view of joined men's and women's bathhouses at Loleta Recreation Area. From HABS PA 5963, online, <http://www.loc.gov/pictures/item/pa2801.photos.357188p/>, accessed April 1, 2015.

The CCC-built bathhouse is an excellent example of the high quality construction of the CCC (Photos 1, 5, 11, and 17). The building sits on a concrete base and measures forty-eight feet, ten inches by fifteen feet, eleven inches. It consists of half-logs of uniform shape and sizing set in a horizontal pattern to form the exterior of the structure. The roof, which is covered in asphalt shingles over original cedar shingles, is hipped with a projecting center cross-gable supported by four log columns. The original fenestration and wane-edged siding of the bathhouse are all present today. Originally the east and west portions of the bathhouse were two separate changing facilities for men and women (Figure 5). In 1936, however, a center section was added to combine the two buildings (Figure 6 and 7). This middle section housed toilets and sinks.

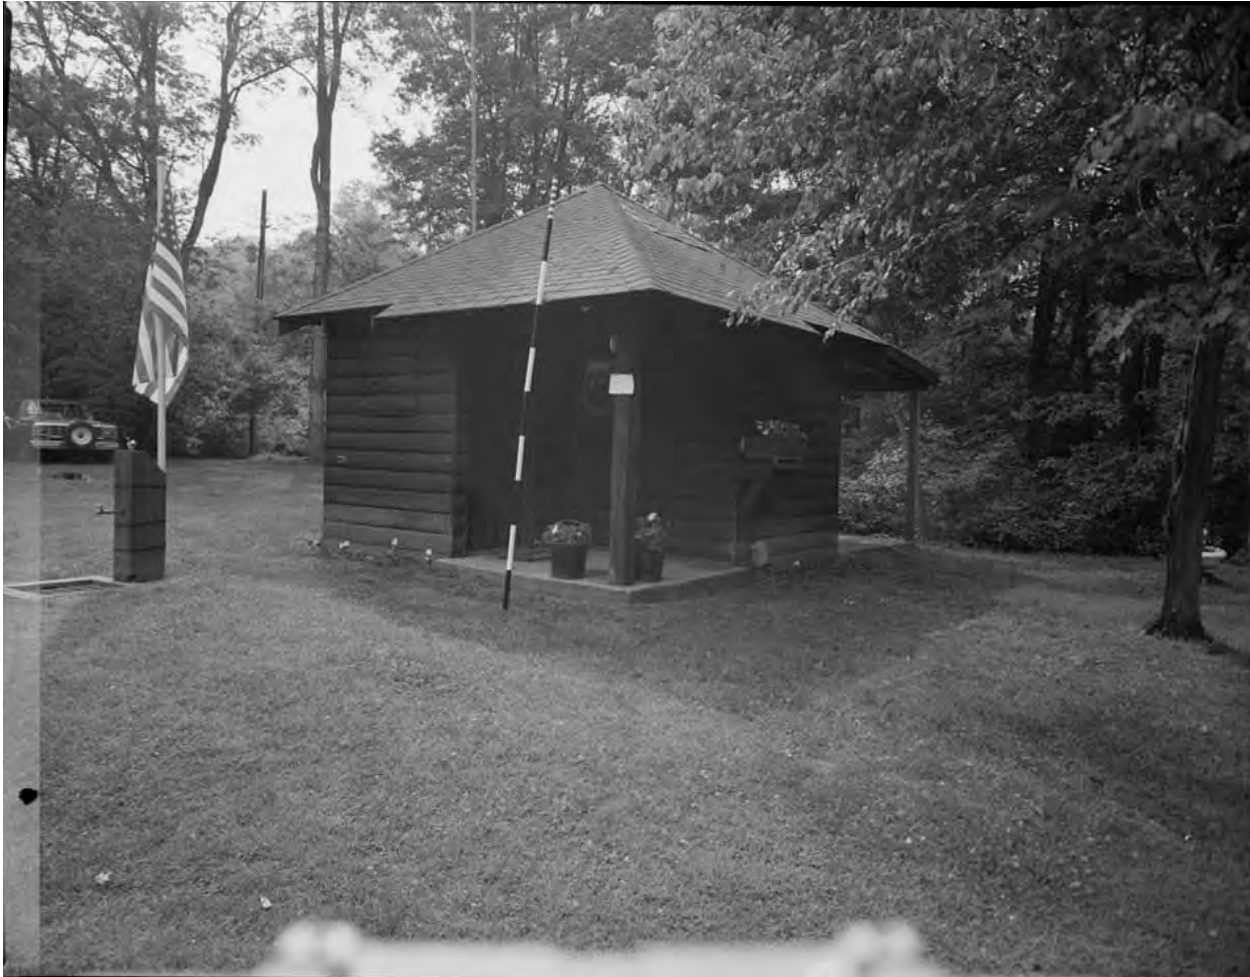
Figure 10: 1993 photo of the office/tool shed. From HABS PA 5963, online, <http://www.loc.gov/pictures/item/pa2804.photos.357223p/resource/>, accessed April 1, 2015.

The office/tool shed (Figure 10) was removed in 1994 due to deterioration of the structure.⁷ It was originally designed to hold construction tools, but was later converted into an office building. Its loss does not greatly impact integrity because it was a small-scale resource built to house workers' tools, and it was not strongly associated with recreation. In addition, when it was converted to an office, it was used only to hold maps and house a person to provide assistance to

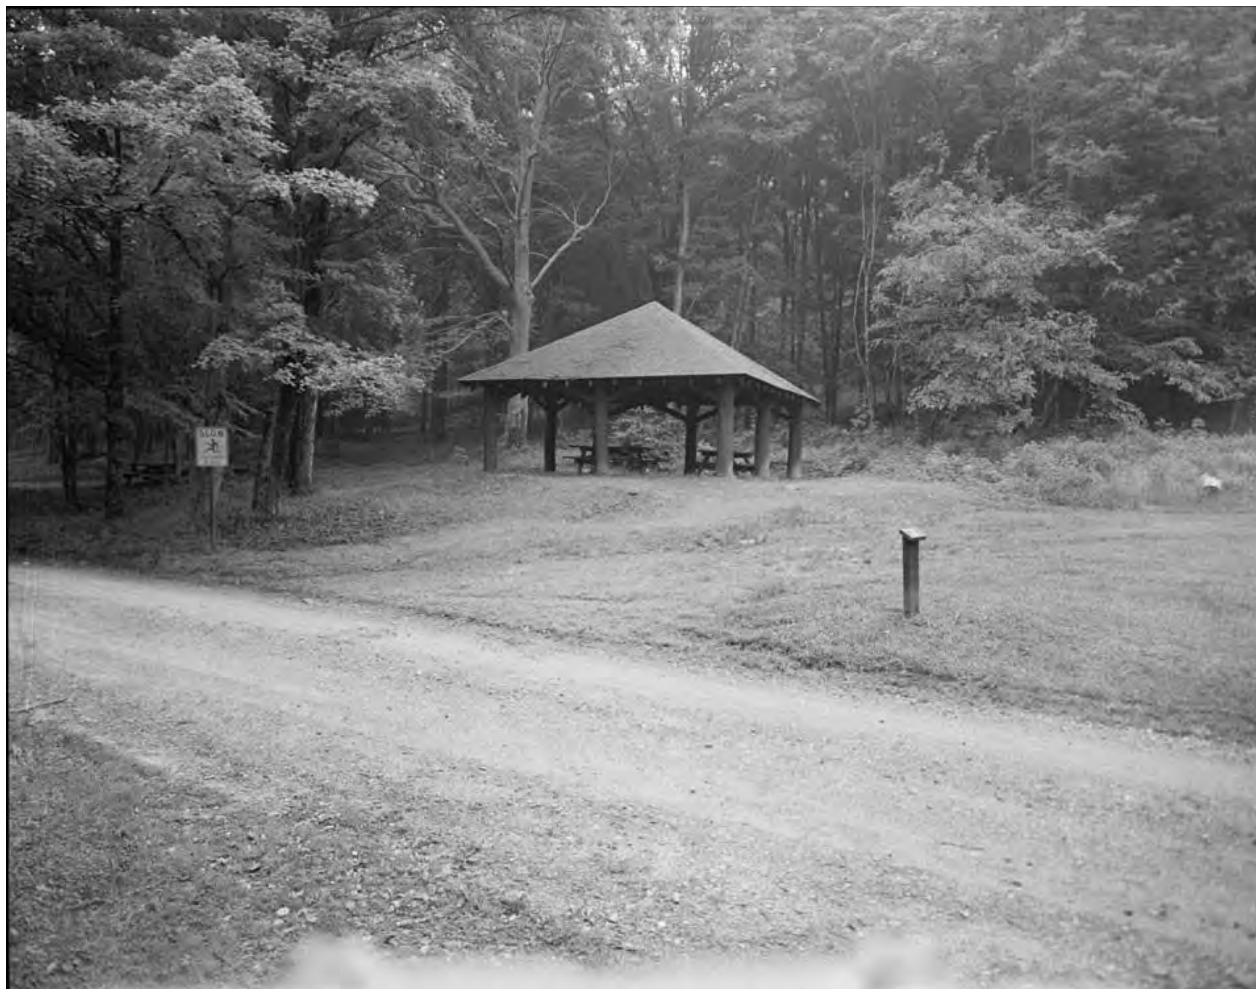
Figure 11: 1993 photo of picnic pavilion A. From HABS PA 5963, online, <http://www.loc.gov/pictures/item/pa2801.photos.357181p/>, accessed April 1, 2015.

integrity because the replacement was sensitive to the original design. Removed in 1994, pavilion A (Figure 11) would have been constructed similarly.⁶

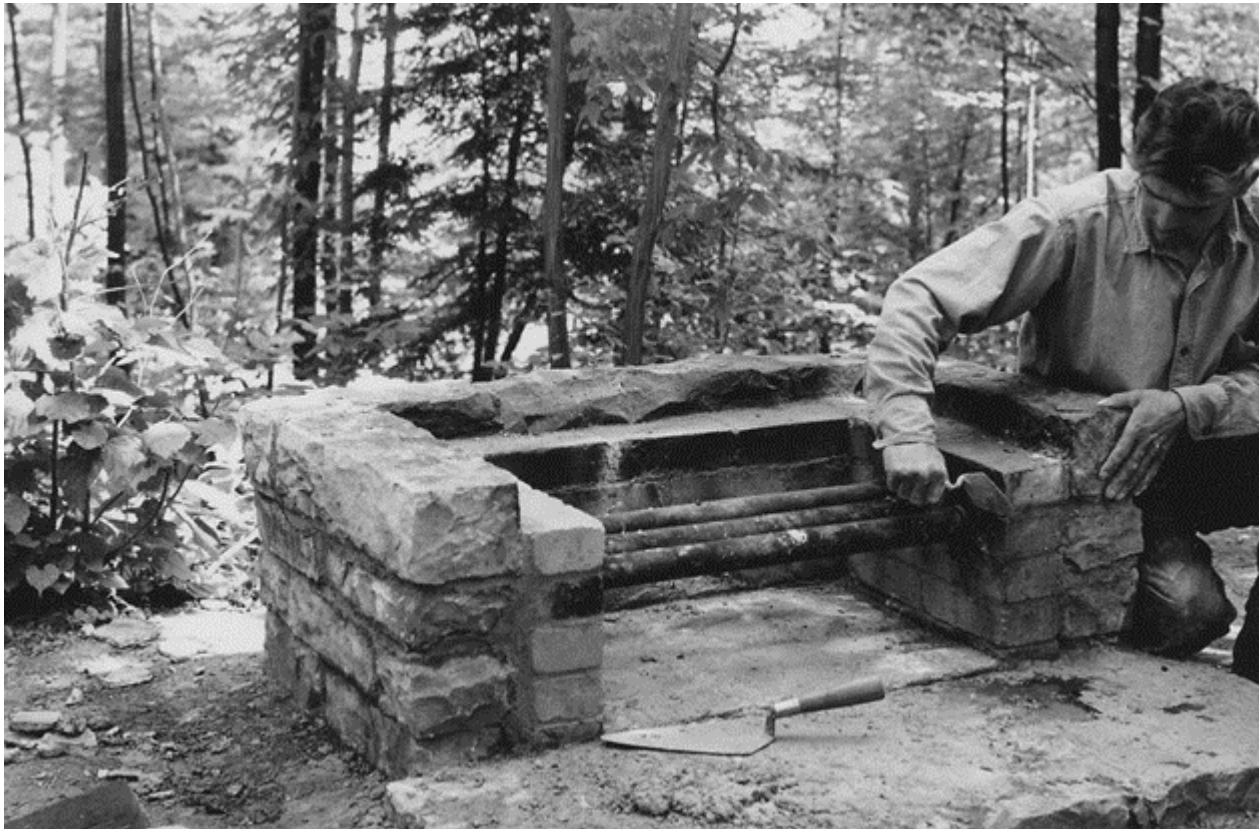
Figure 12: 1937 photo of CCC worker finishing stone fireplace at Allegheny Forest Camp. From The Forest History Society, "Camping in the National Forests," *U.S. Forest Service History*, online, <http://www.foresthistory.org/ASPNET/policy/Recreation/Camping.aspx>, accessed April 1, 2015.

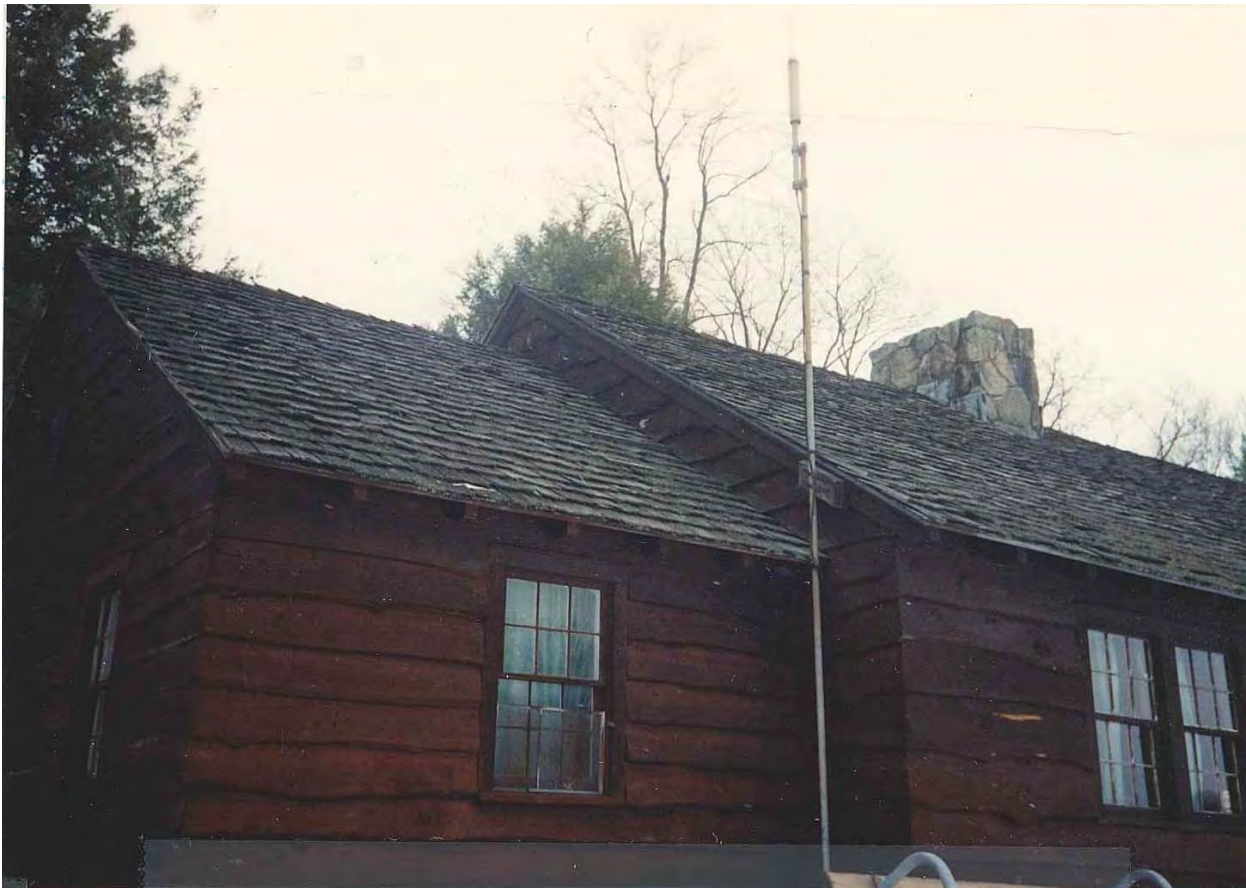
Figure 13: 1992 photo of Twin Lakes Forest Camp bathhouse. From historic resource survey file for Twin Lake Bath House, on file, Harrisburg PA: Bureau for Historic Preservation.

In terms of recreation, Twin Lakes was much larger than Loleta; however, unlike Loleta, it was never completed to its original plans. The original plans called for two lakes at the site (hence the name), but only one was ever completed due to budget constraints.⁴¹ In fact, the unspent money at Twin Lakes was diverted to Loleta.⁴² In addition, work at Loleta began in 1933, while work at Twin Lakes began in 1936. In terms of architecture, both Loleta and Twin Lakes were executed in the Rustic Style and both fit in with the surrounding natural environment and with the history of their sites. While half-logs were used in the construction of Loleta's bathhouse, however, the bathhouse at Twin Lakes used unfinished planed lumber for cladding (Figure 13).
