**National Register of Historic Places
Registration Form**

historic name Draize, August, Farmstead
other names/site number N/A

street & number 814 Tru-Way Road N/A not for publication
city or town Town of Union N/A vicinity
state Wisconsin code WI county Door code 029 zip code 54204

Description

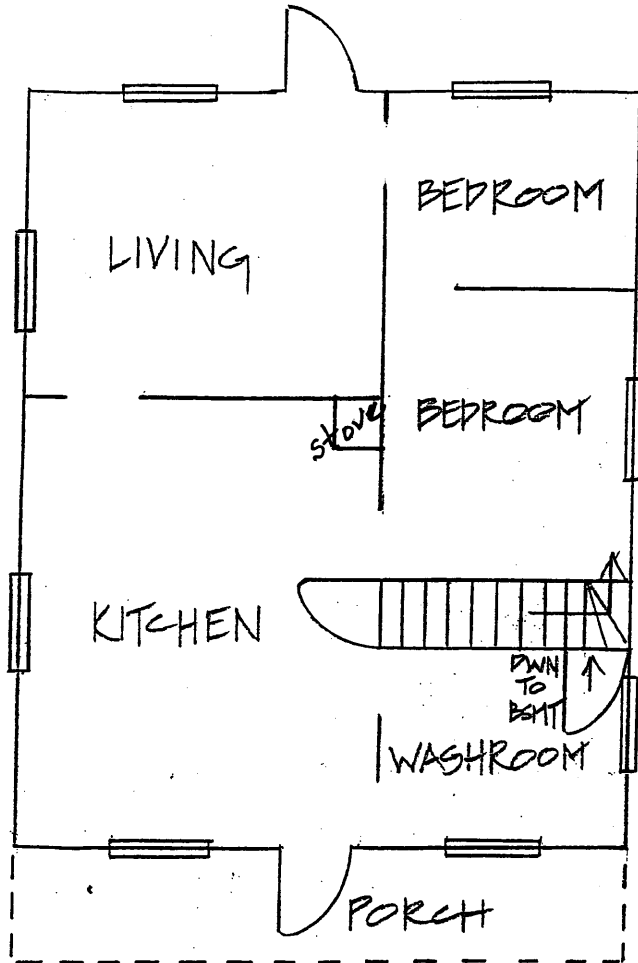
FIRST LEVEL FLOOR PLAN

FLOOR PLAN
814 TRU-WAY ROAD
TOWN OF UNION
DOOR COUNTY, WISCONSIN

The interior of the Draize House features the typical Belgian "Four-and-Two Floor Plan" that is characterized by four small rooms on one wall and two large rooms on the other. The first floor demonstrates this plan with a washroom, stairway, bedroom, and closet/storage room along the north wall, and a kitchen and living room on the south wall. The second floor of the Draize House includes three small bedrooms, one of which was used for clothing storage, on half of the floor, and a large open room on the other half. An open attic displaying sawn, wood rafters is accessed from the second level by a ladder. A plastered chimney stands to the south of the attic opening in the center of the large room. The entire interior of the house features plaster walls and ceilings with simple painted woodwork detailing. A majority of the rooms display linoleum flooring. Although the house was occupied until 1975, interior plumbing was never installed and two wood stoves heated the house. The Draize House remains in good condition and is a contributing resource of the farmstead because it has remained largely unaltered from its historic appearance.
