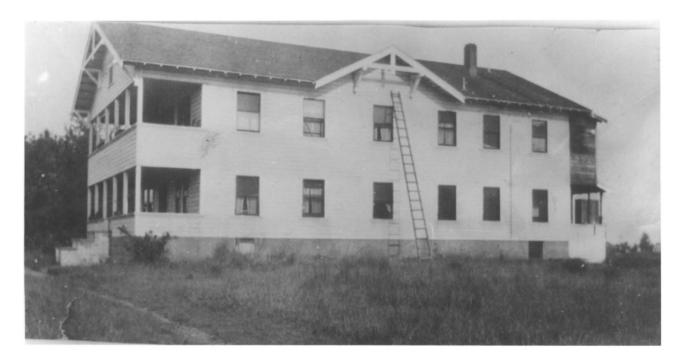
l of 6 Historic view, 1921; photographer unknown South and east elevations. Note minor second story addition over

rear porch as yet unfinished at time photograph was taken. Copy negative: Allen L. Cross 1095 Madrona Avenue S Salem, OR 97302

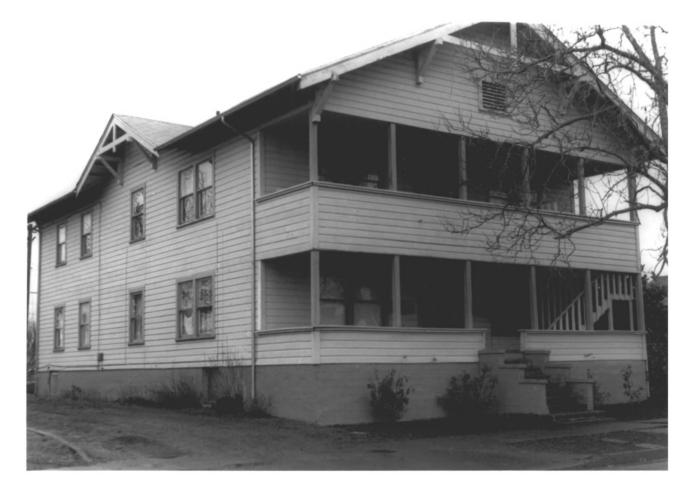
2 of 6 Westand south elevations

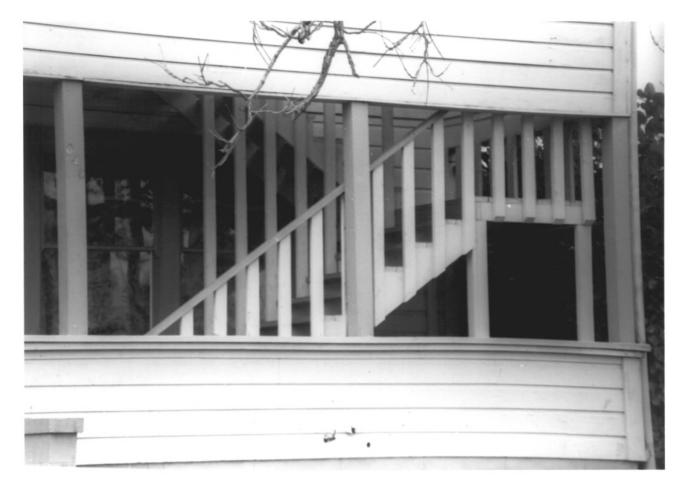
3 of 6 Detail of wood outside stairs added inside veranda after 1944 apartment house conversion.

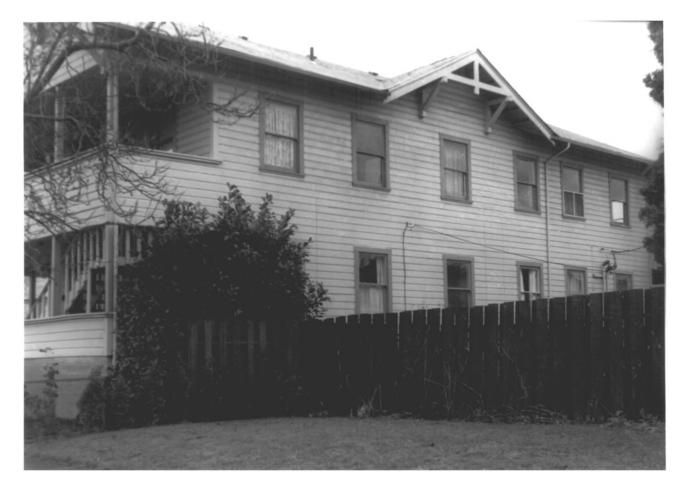
4 of 6 East elevation

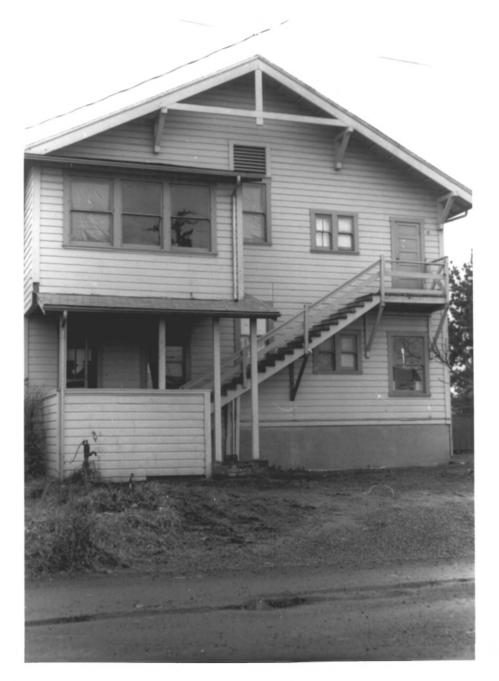
5 of 6 North (rear) elevation, showing outside stairs and second story addition of c. 1920 over shed-roofed porch.

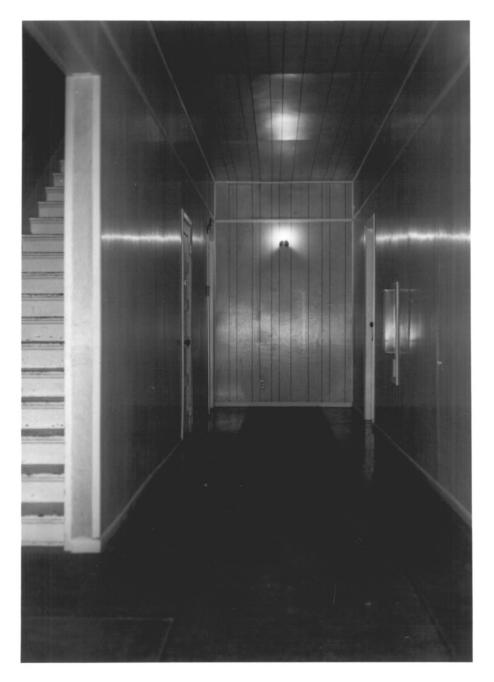
6 of 6
Interior view of north end of ground story longitudinal corridor.
Original lath and plaster wall and ceiling finish is intact under modern birch paneling.
