**National Register of Historic Places
Registration Form**

historic name Whitewater Hotel

street & number	226 West Whitewater Street	N/A	not for publication
city or town	Whitewater	N/A	vicinity
state Wisconsin	code WI	county Walworth	code 127
			zip code 53190

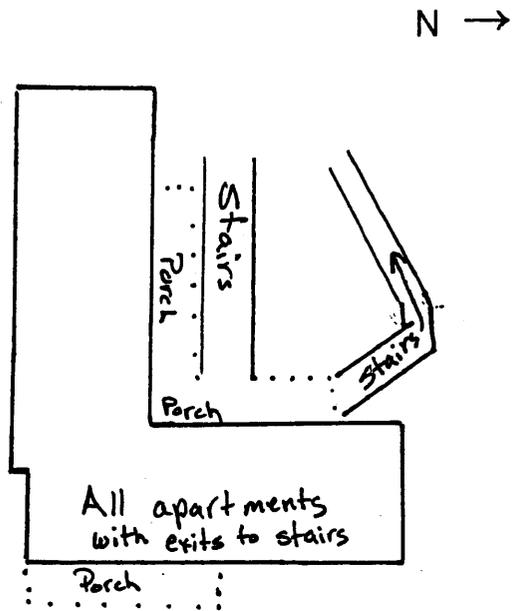
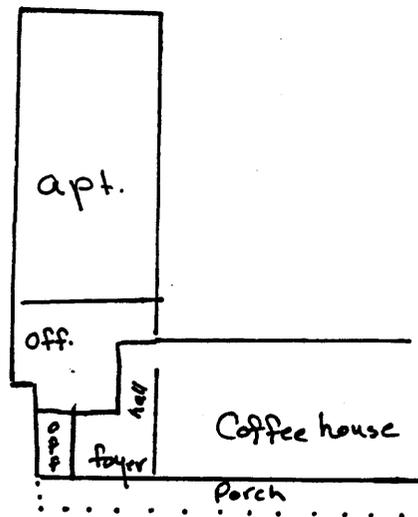
Rough New Floorplan

second floor

first floor

To the right of the foyer, the area that housed the tavern has been renovated into a coffee house. It takes up the same space as the old tavern. The floor has been covered with modern ceramic tile, and the ceiling of the saloon section of the tavern has been replaced. But, the pressed metal ceiling that was still extant was restored. Also, in this area, as well as in the foyer, the original fluted trim and bull's eye blocks have been repaired and retained, as have the original baseboards. A wall with French style doors was built along the west side of the coffee house for a separated space, and is used for more coffee house seating. In this area, though, the original trim was not extant, but the renovation replicated the fluted trim and used plain bull's eye blocks to blend in with the original incised blocks. The original secondary entrance is now the main entrance for the coffee house. The same carpenter who replicated the double entry doors made an identical single door for the coffee house.

This area also has an entrance into the hallway that once sat along the main staircase. However, the main staircase is not extant.² Its space was renovated into an office. The old dining room space and the kitchen and pantry were remodeled into a two-bedroom apartment. This apartment renovation retained some of the paneling from the old hotel dining room, as well as the pressed metal ceiling. An entrance from the old kitchen to the "courtyard" has been retained and is used for an apartment entrance. The rest of the apartment has modern finishes and fixtures.

Due to the extensive damage to the second story interior and the small dimensions of the rooms, it was completely renovated into apartments with modern walls, doors, ceilings, and other finishes. Access to each of the second story apartments was changed to the exterior walls, via outside staircases and porches.

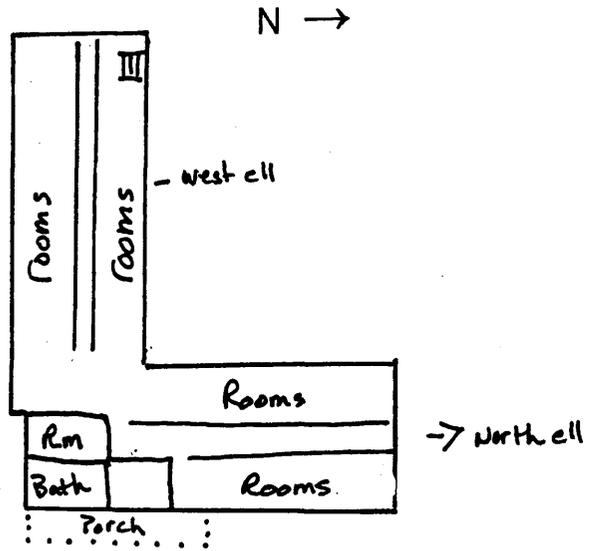
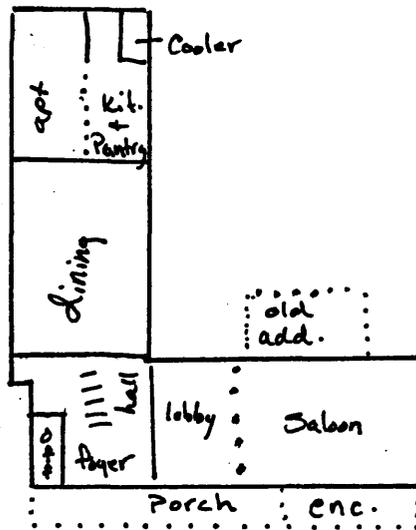
Figure #2: Whitewater Hotel
Whitewater, Walworth County, Wisconsin

second floor

first floor

Originally, as far as could be determined as there are no historic interior photographs of the building, the Whitewater Hotel consisted of large public spaces on the first floor and numerous small hotel rooms on the second floor in two different wings. Behind the double entry doors of the first story of the main block, there was a small foyer. To the right, or north, the foyer led into the lobby and reception area housed in the main block. Beyond the lobby was the hotel saloon, which could also be accessed via the secondary entrance of the main block. To the left of the foyer was an entrance into an individual room that was probably used as the hotel office or as a leased space. Just ahead in the foyer

was a wide staircase leading to the second floor hotel rooms. Running along the staircase on the right was a hallway that led to a rest room and a large dining room that sat in the interior space of the side ell. Behind the dining room was a large kitchen and pantry.

The two wings of small hotel rooms had similar details. Each wing had long, narrow hallways with rooms on either side. In the north wing (in the main block), there were eight rooms, four on each side
