National Register of Historic Places Registration Form

historic name St. Cloud Veterans Administration Hospital Historic District

other names/site number St. Cloud Veterans Affairs Health Care System / SN-SCC-1277

street & number 4801 Veterans Drive

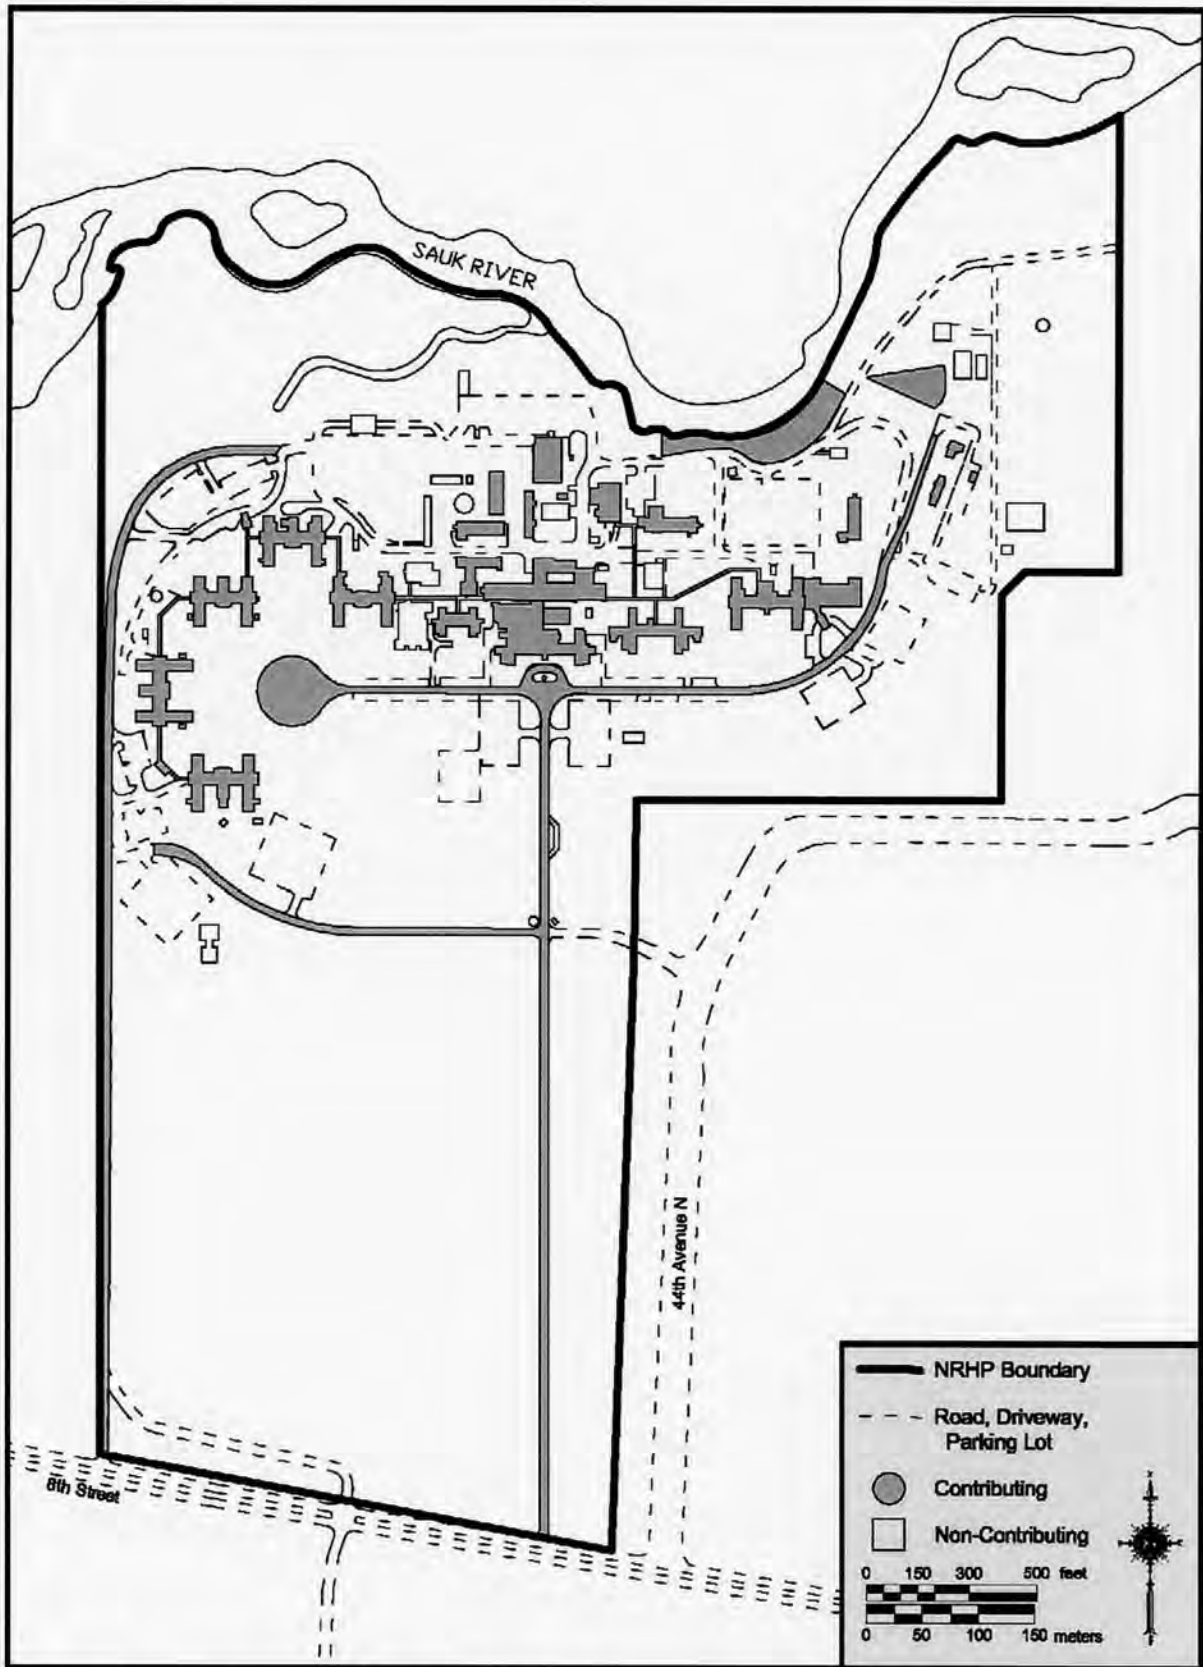
Sketch map indicating National Register boundary, contributing and noncontributing resources.

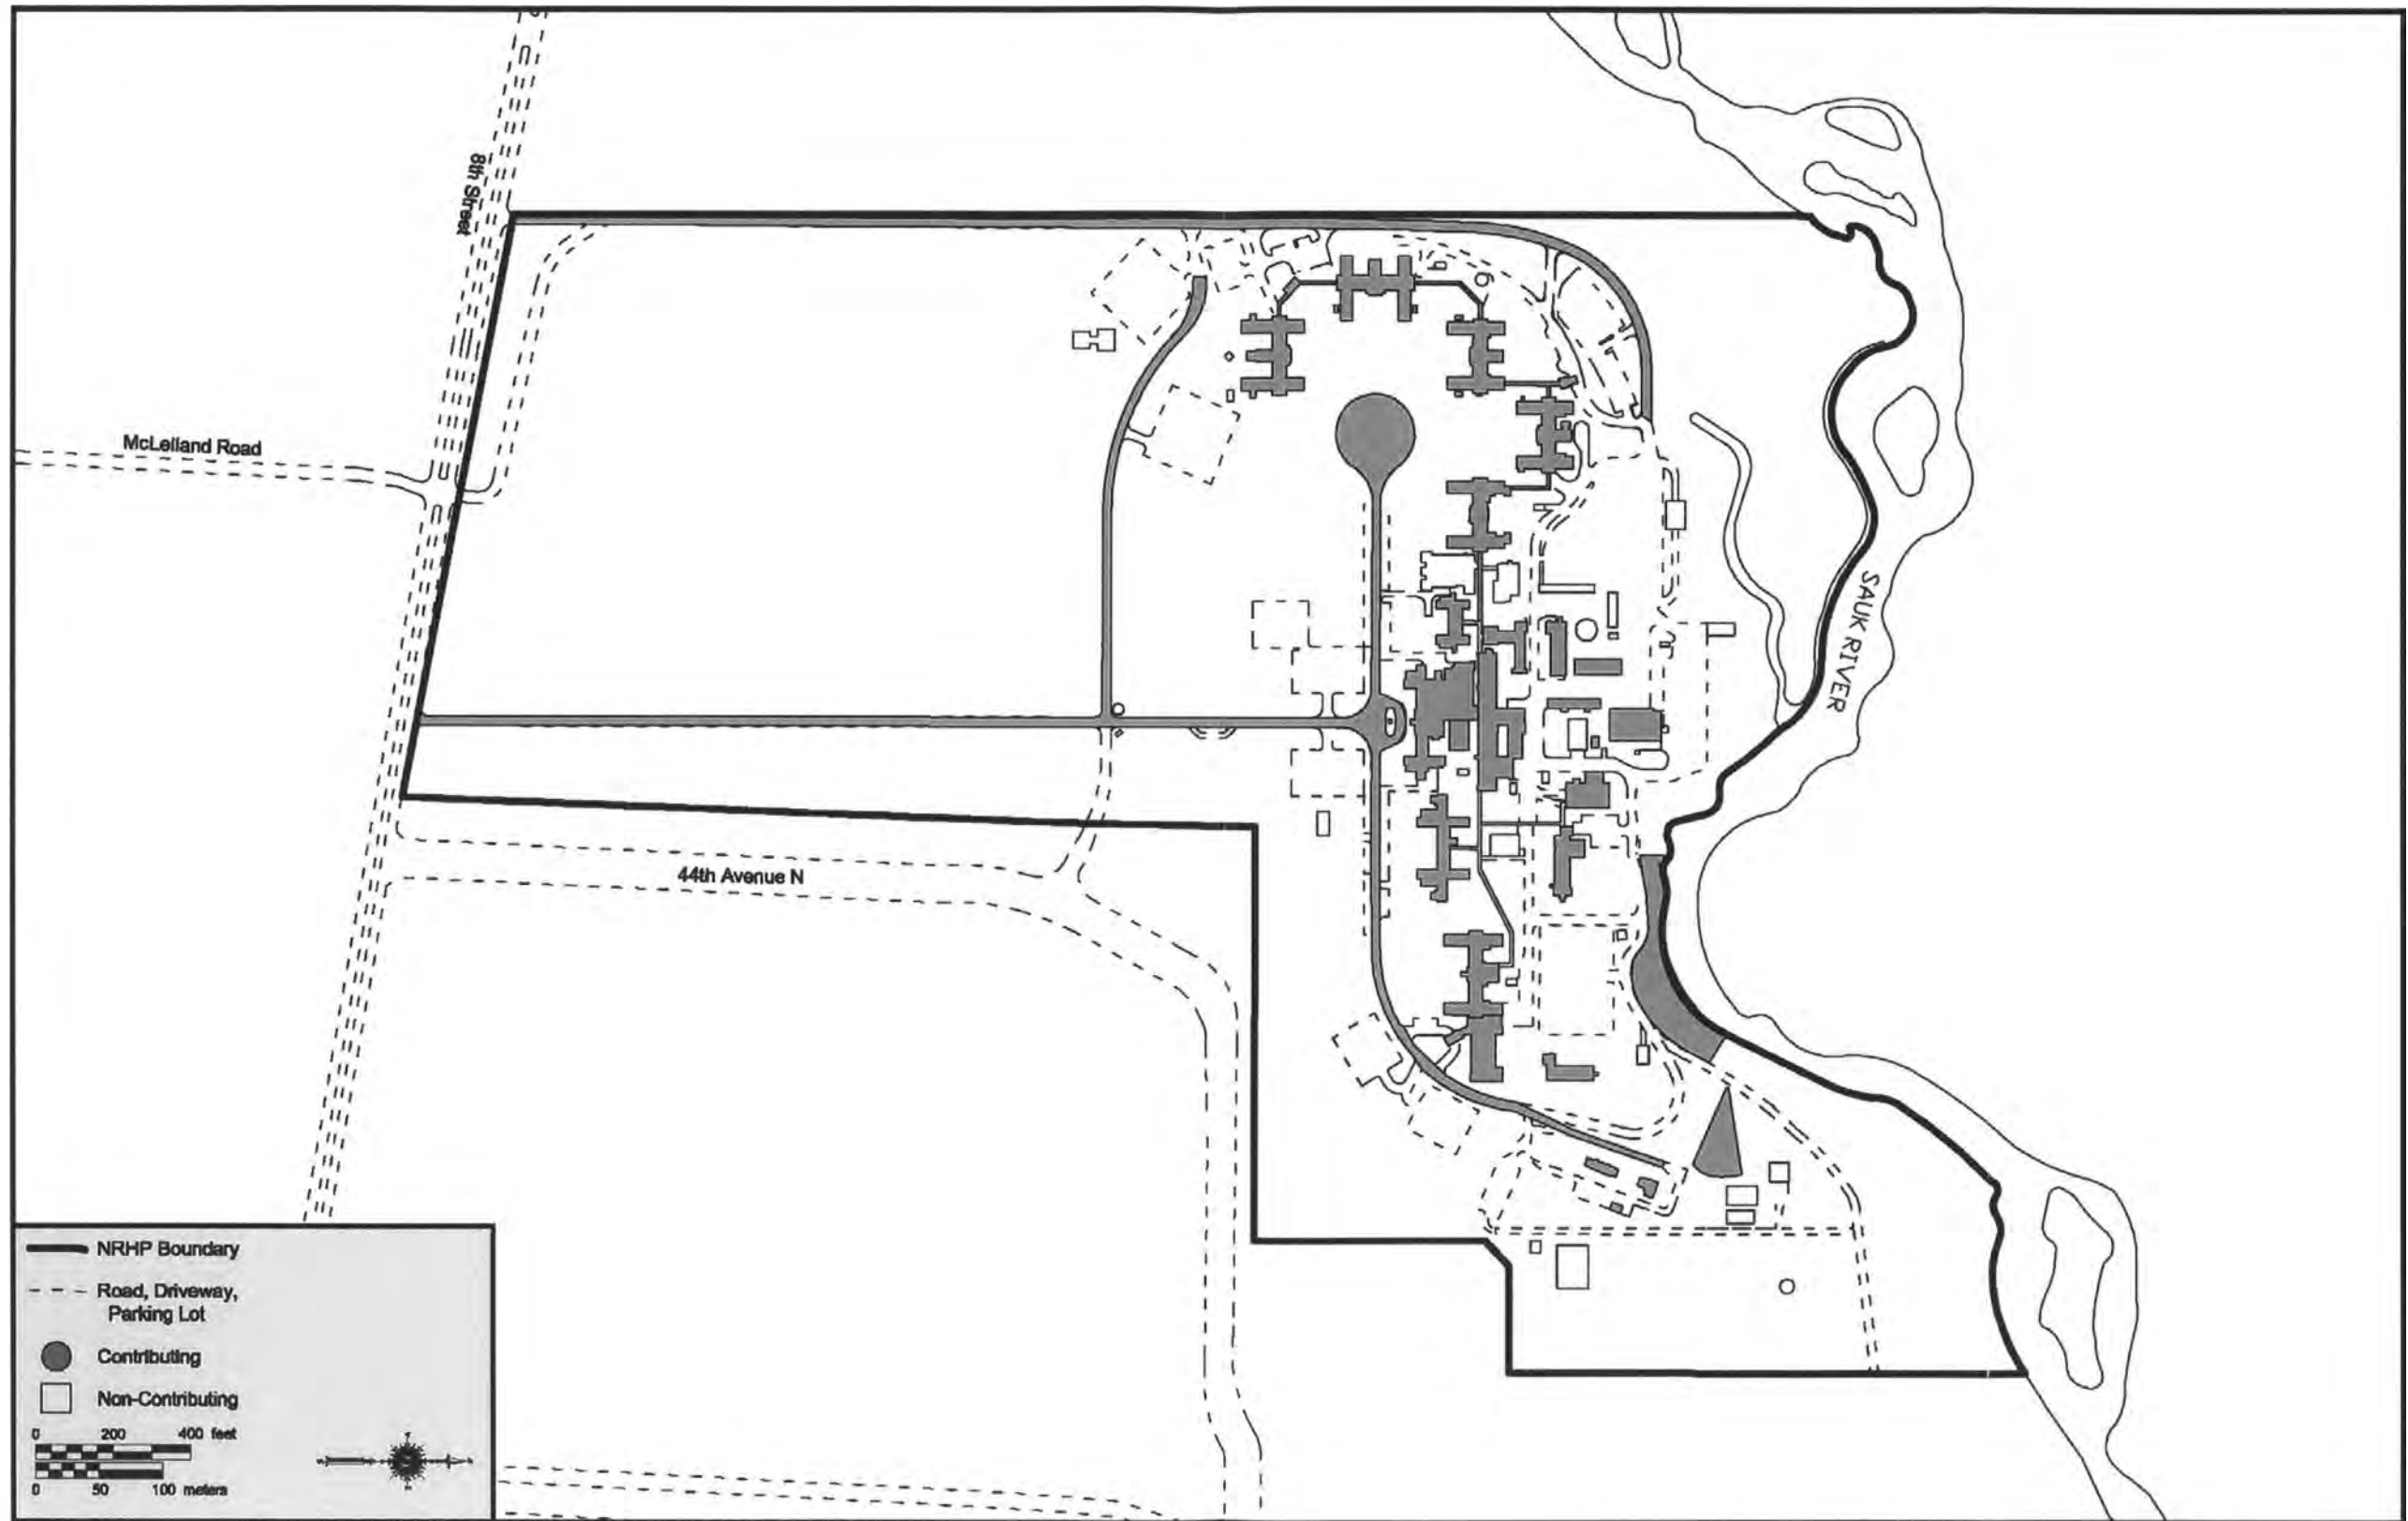
Sketch map indicating National Register boundary, contributing and noncontributing resources.

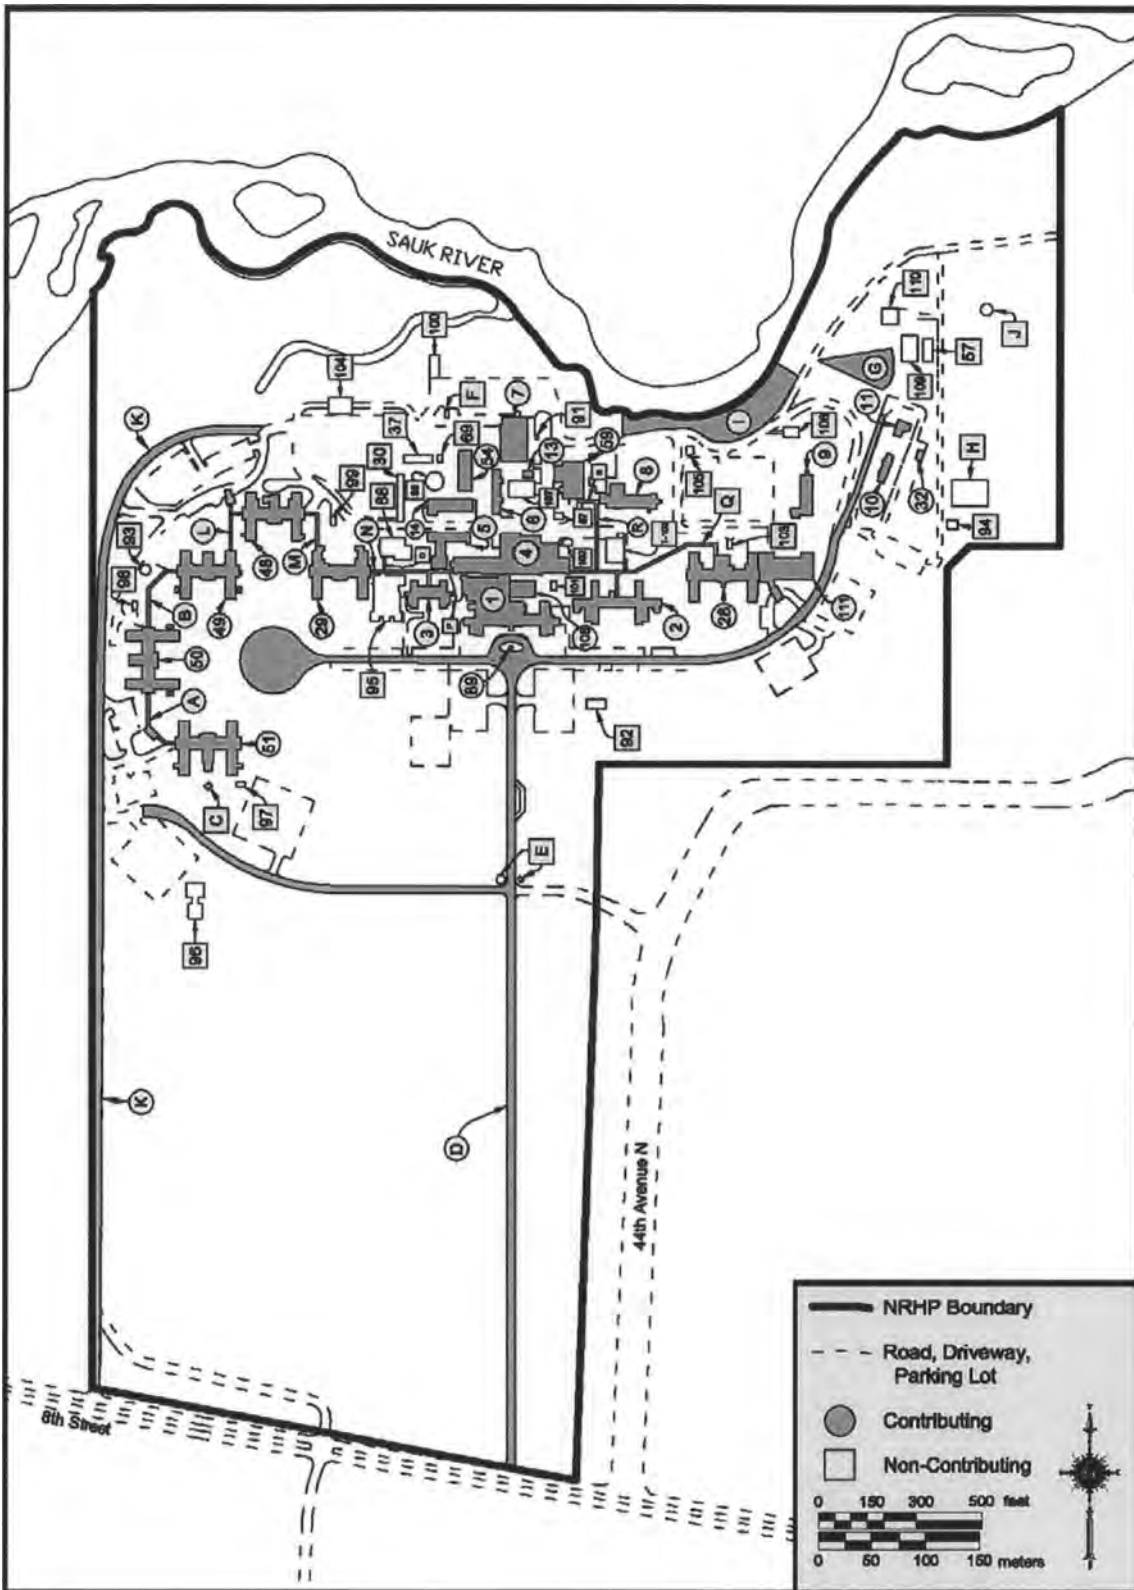
Sketch map indicating National Register boundary, along with resource numbers indicating contributing and noncontributing resources.

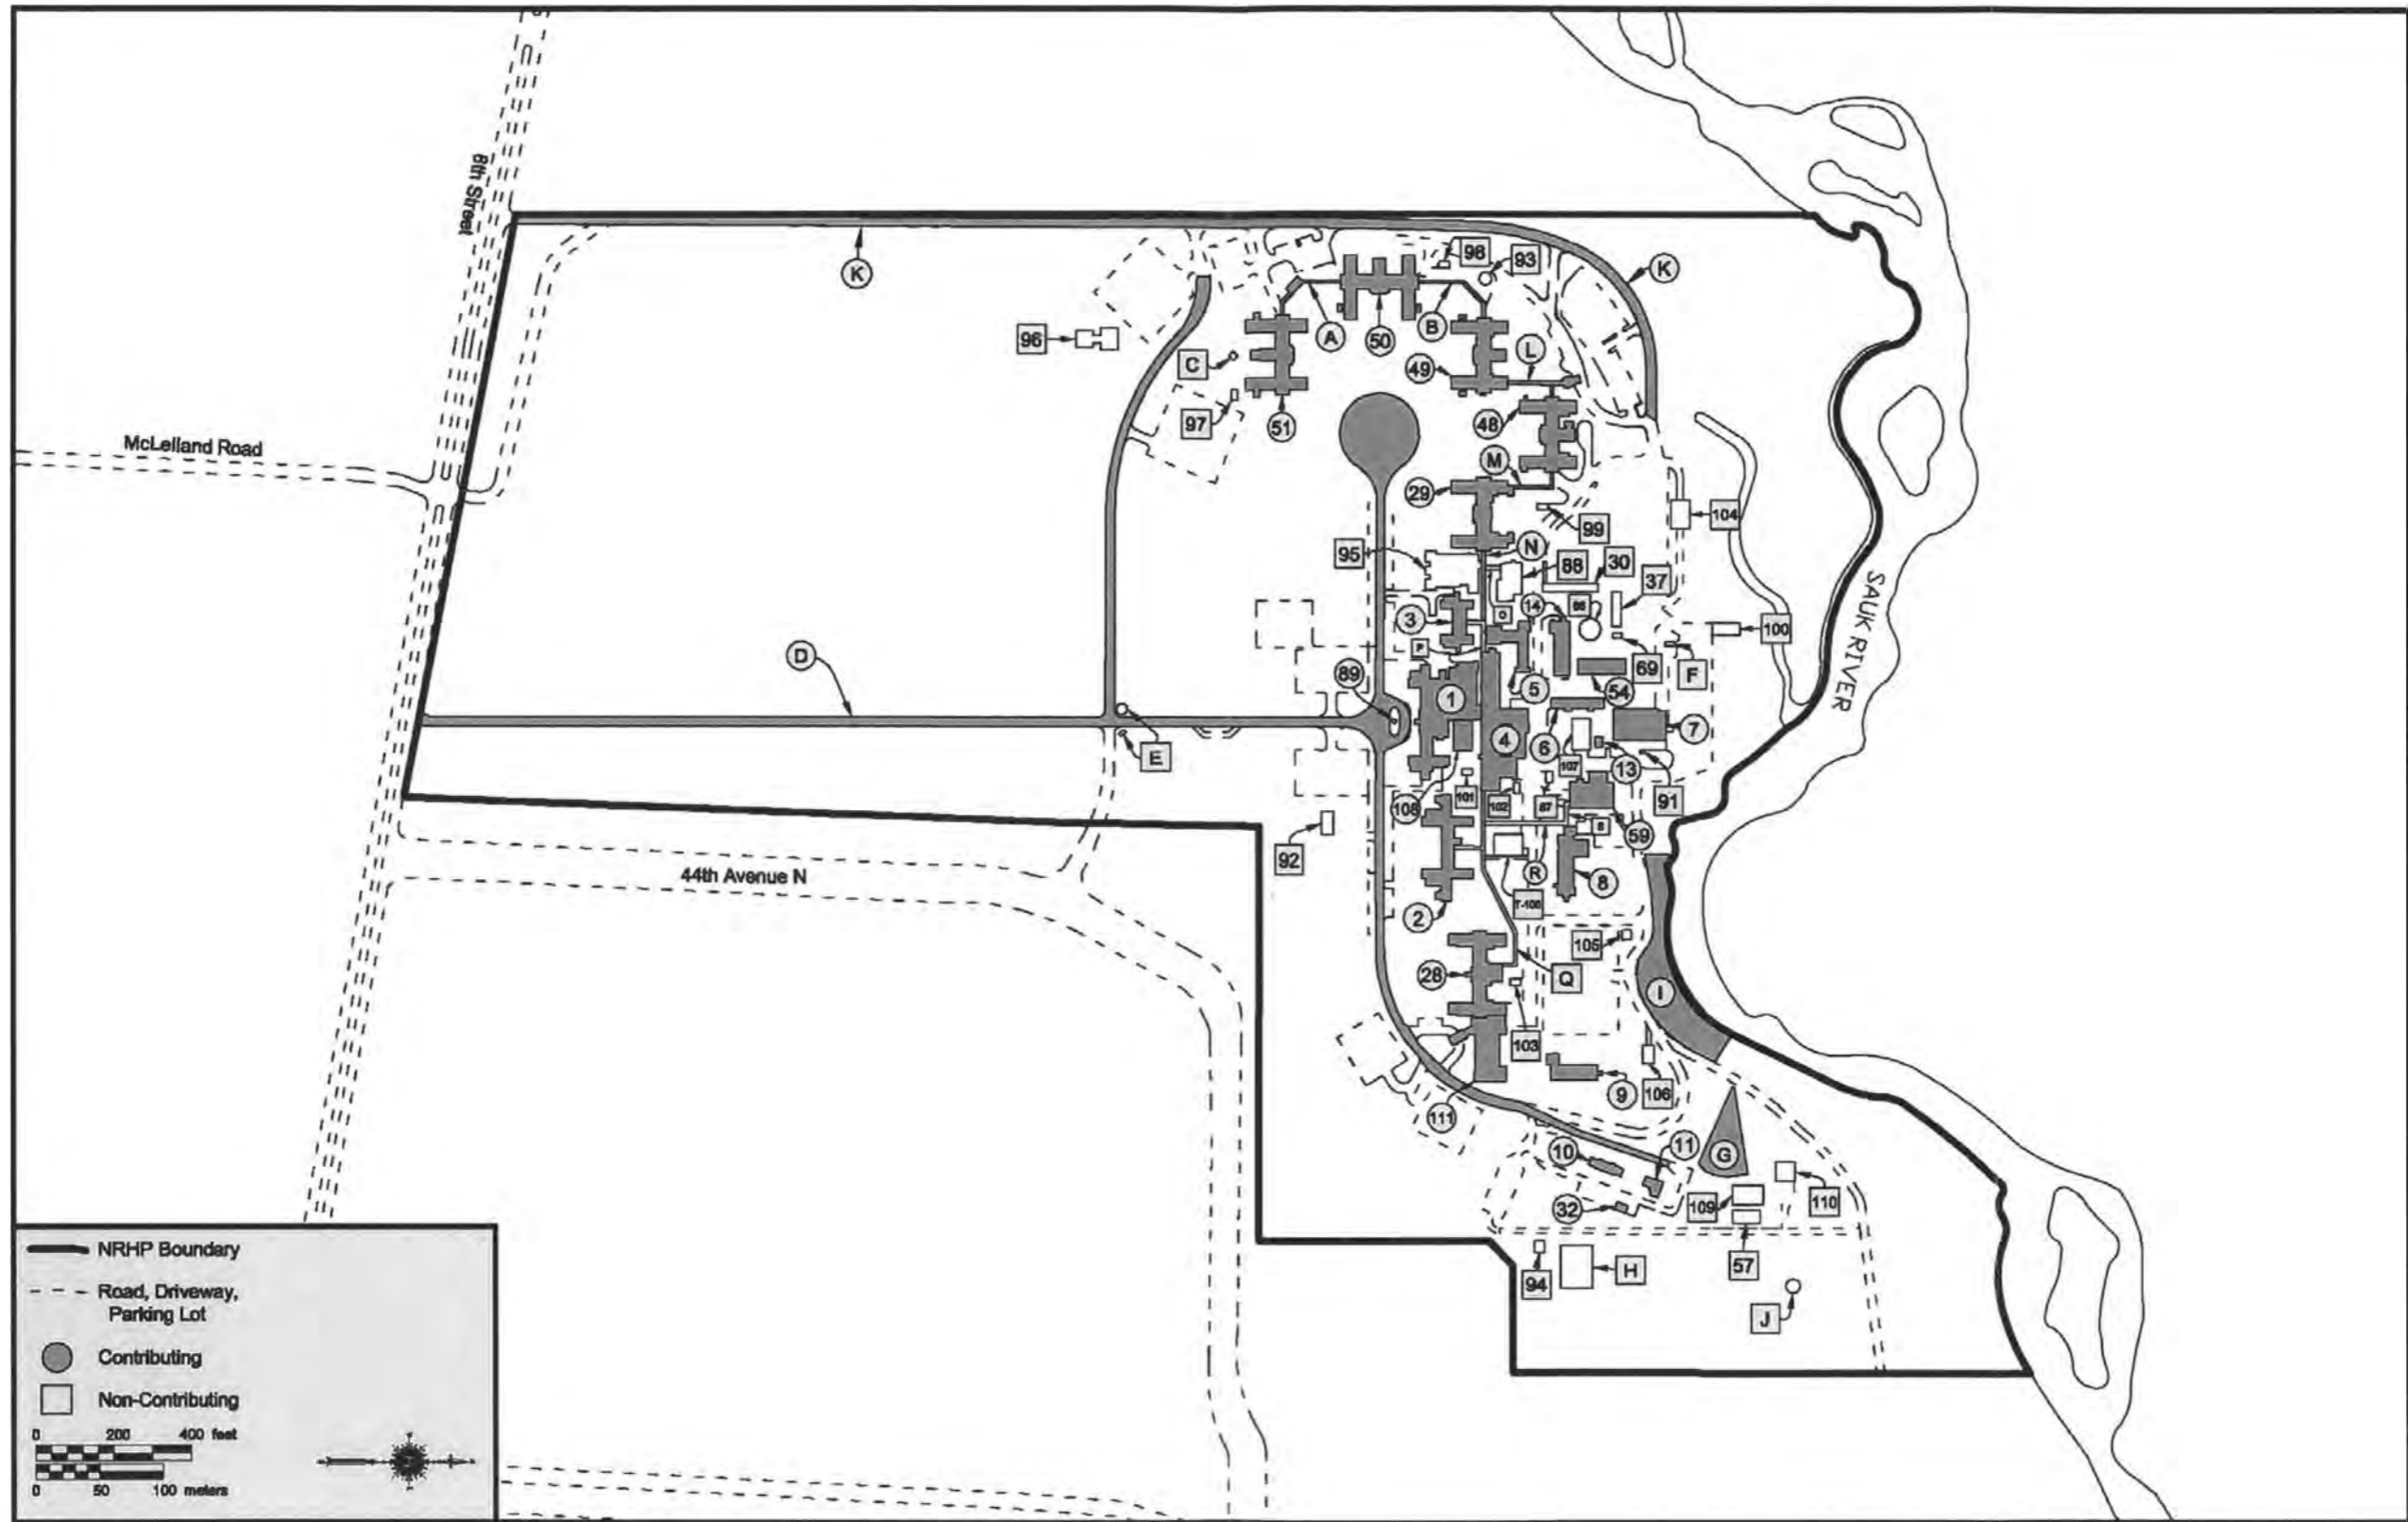
Sketch map indicating National Register boundary, along with resource numbers indicating contributing and noncontributing resources (oversize).

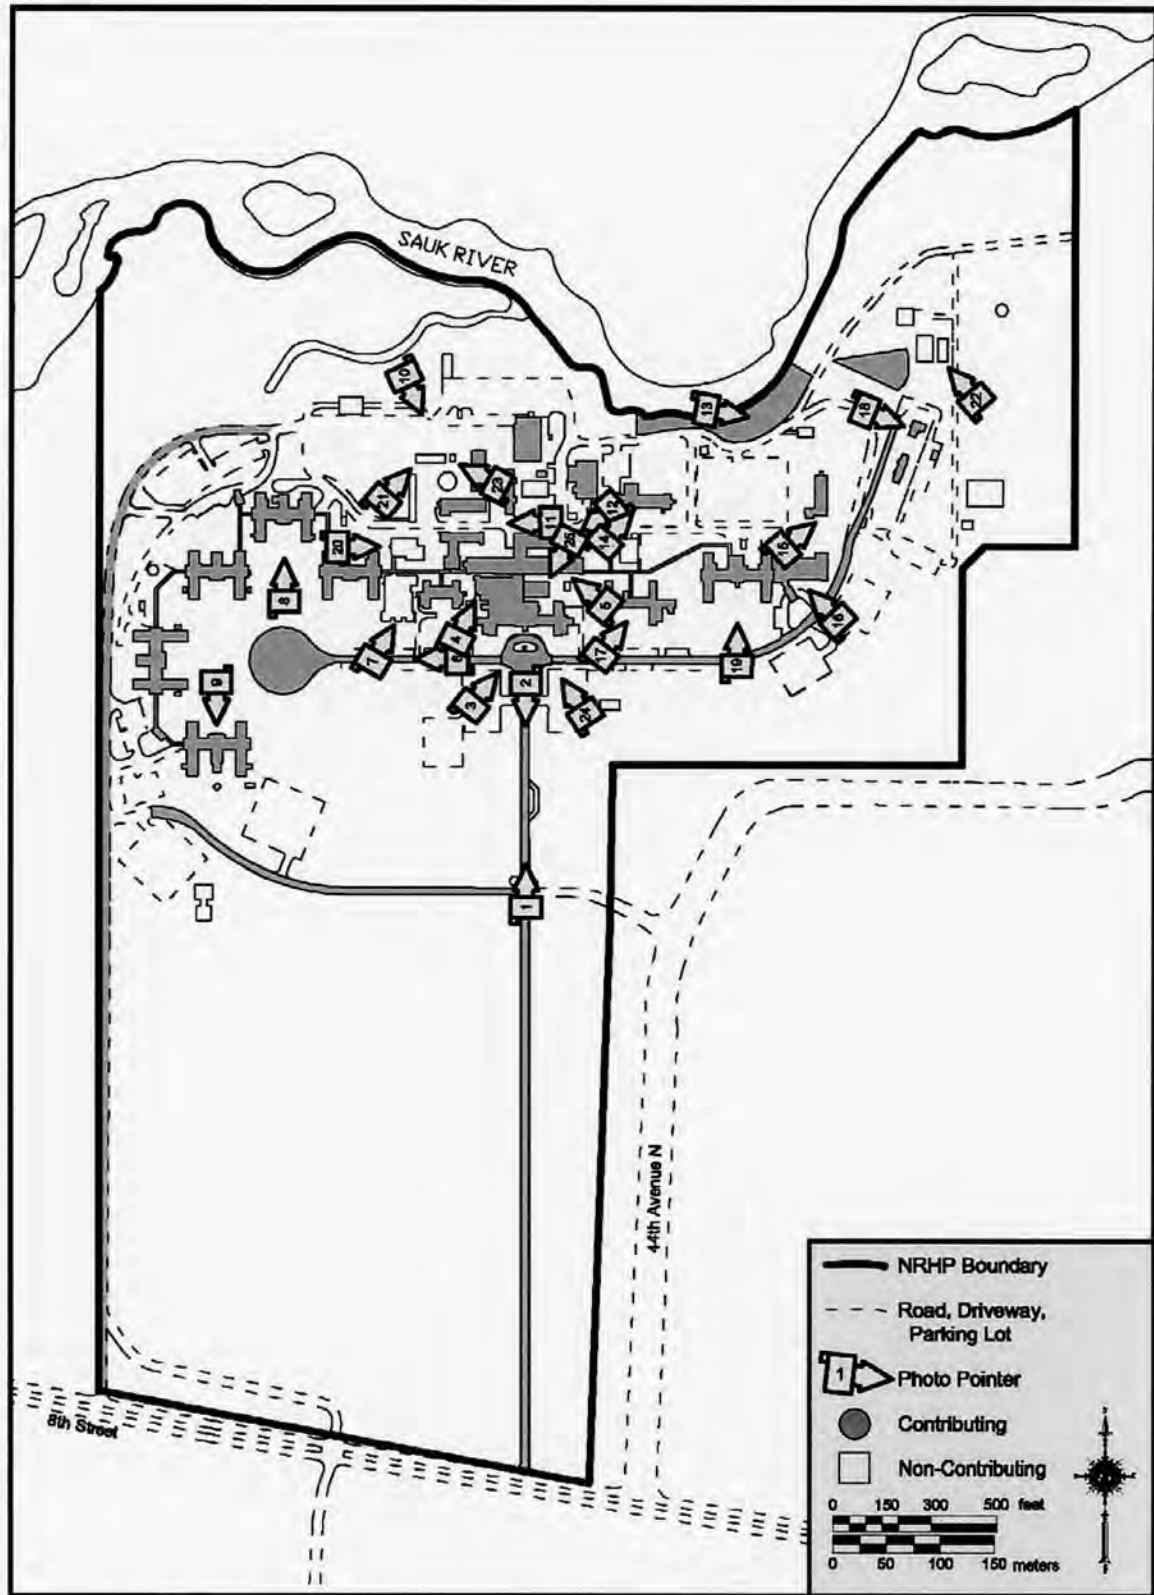
Sketch map indicating locations of photographs corresponding to those of the Photograph Continuation Sheet.

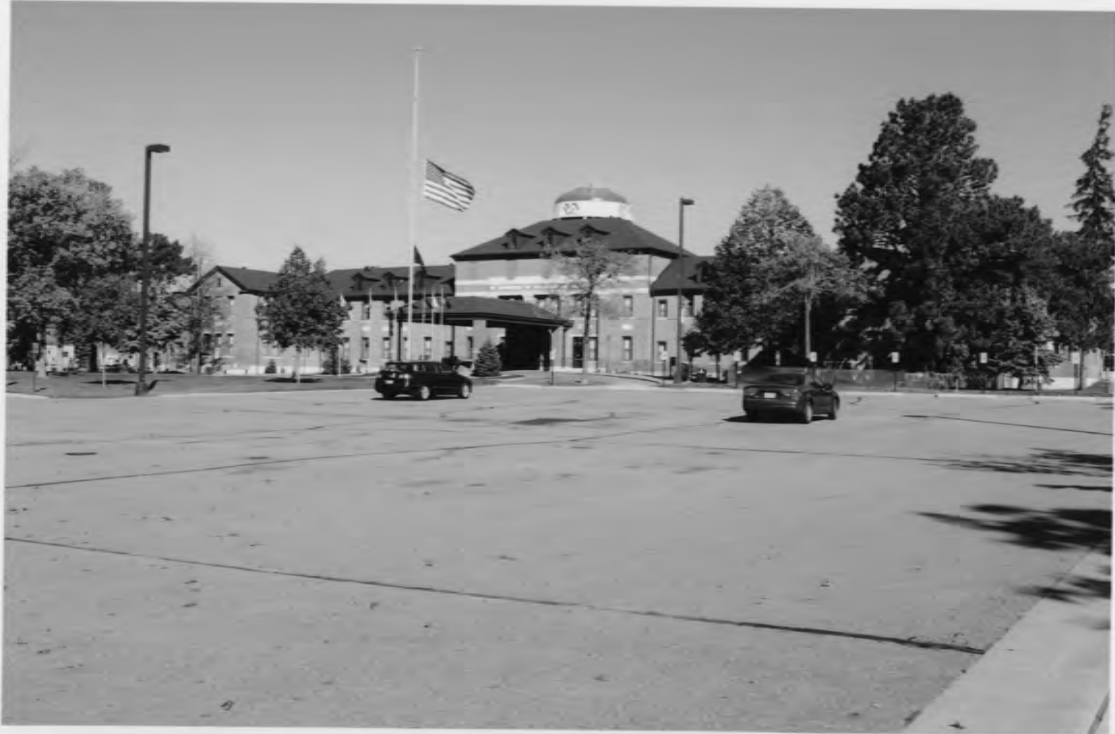
MN - Stearns County - 2nd Generation Veterans Hospitals MPS - St. Cloud VA Hospital - 0024

24. Façade (south) elevation of Resource 1 and view of Resources 89 and 86. View looking to the northwest.
25. East and north elevations of the Resource 108 addition and a portion of the northwest addition to Resource 1. View looking to the southwest.

The five former windows along the third floor of the central block of the main hospital building have been enclosed with brick. The central block has three gabled dormers with cornice returns and arched windows. All windows appear to be replacements: those on the first and second stories are one-over-one-light, double-hung, aluminum sashes, while those in the attic dormers and in the basement appear to have single, fixed sashes that mimic divided lights. Similar double-hung replacement sashes are found throughout the building. A brick soldier-course is exhibited under the cornice, which also forms the head casings for the former windows of the third story. The top of the entablature forms the precast concrete window sills of the three central former windows of the third story, and a precast concrete band extends outward to the corners and around the visible portions of the east and west elevations of the central block. A brick stringcourse is exhibited, extending between the second-story

The two-story, hip-roof extensions to the east and west of the central block each exhibit three gabled dormers with return cornices, all but one of which contain a louvered vent instead of replacement six-light, fixed sashes. A brick soldier-course is exhibited under the cornice, which also forms the lintels for the second-story windows. Precast concrete window sills and three precast concrete panels between the central first- and second-story windows in this elevation are also visible. The facade gable-ends of the return wings have arched, louvered vents, cornice returns, and display a continuation of the brick soldier-course that forms the lintels for the second-story windows. The facades of the return wings have three bays of recessed windows with concrete sills, concrete lintels on the first-story windows, and a single precast concrete panel between the central first- and second-story windows. The hip-roof of the central block and the gable roofs of the extensions and the return wings are sheathed in asphalt shingles.

A centered, two-story wing that appears to have a flat roof projects from the rear of Resource 1's central section. This central rear flat-roof wing dates to the original construction of the building. The original connecting corridor between Resources 1 and 4 has been replaced with a single-story, shed-roof corridor that is part of the additions previously described located to the rear (northwest portion) of the main building (Resource 1). The courtyard on the east side of the replacement connecting corridor is dominated by Resource 108 (information resource management building addition, 1990) and large air conditioning and electrical equipment located at grade. The information resource management building addition (Resource 108, 1990) is attached to the single-story, shed-roof, replacement connecting corridor between the main building and the subsistence and attendants' quarters (Resource 4, 1923). The information resource management building addition (Resource 108, 1990) is a single-story, hip-roof addition with a five-course, common-bond, brick exterior. The south elevation exhibits a single-leaf entry filled by a metal door. The north elevation has two single-leaf entries filled with metal doors and three windows filled with multi-light, double-hung sashes. The information resource management building addition (Resource 108, 1990) has a hip roof sheathed in asphalt shingles. The information resource management building addition (Resource 108, 1990) is not visible from the front of the main building (Resource 1), and its single-story massing is subordinate to the main building (Resource 1, 1923). Resource 108 is an addition to Resource 1 and is therefore part of the main building (Resource 1), but it is a noncontributing feature of Resource 1 and the historic district.
