National Register of Historic Places
Registration Form

historic name Moore-Webb-Holmes Plantation

city or town Marion vicinity

state Alabama code AL county Perry code 105 zip code 36756

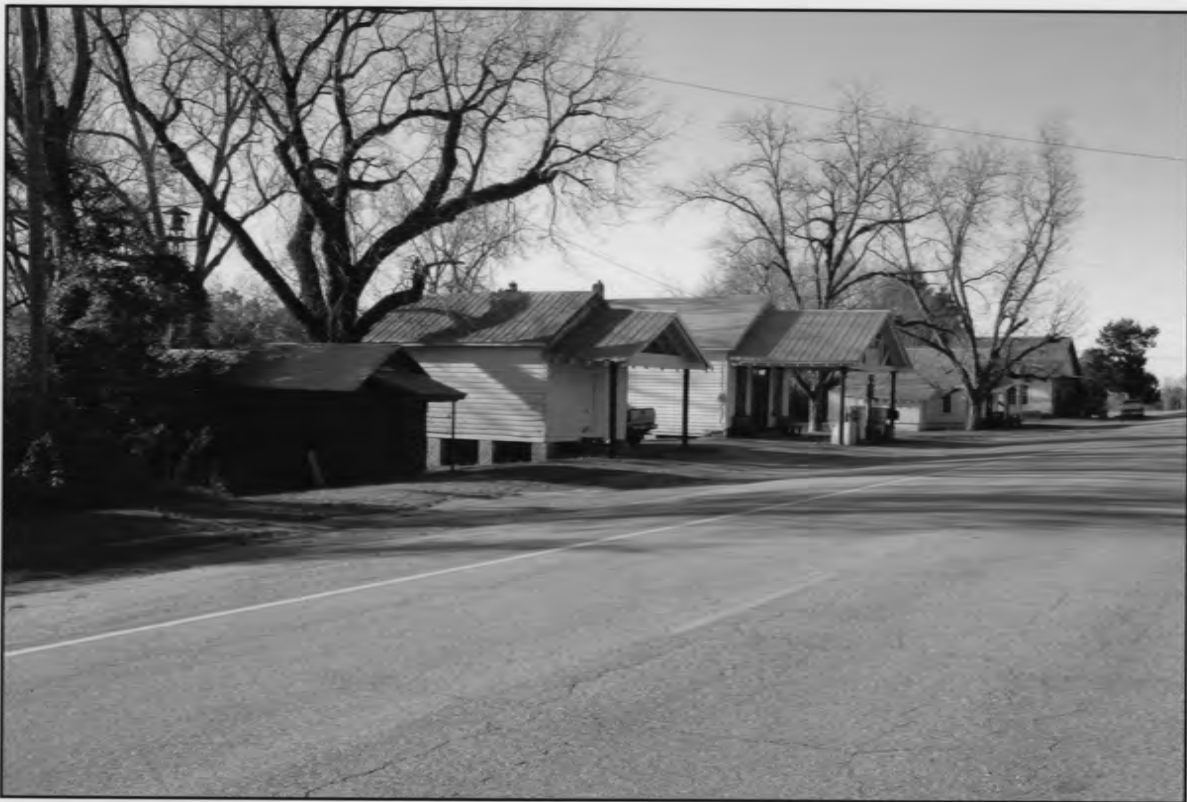
Photo #1
View of building complex (Inventory #s 6, and 1-5,
L-R), camera facing northwest
Image: AL_PerryCo_MooreWebbPlt_0001.tif
Print: Epson Ultrachrome Ink on Premium Glossy Photo Paper

| | One story frame building with a front-facing gable patterned metal shingle roof; faces east, 1x1 bay core with a 1-bay deep rear extension; less than full façade shed porch with wood posts; central entrance at façade, single windows at side elevations with vertical board shutters, entrance at north elevation of rear extension; plain weatherboard siding; brick pier foundation (Photos #1 and 2). | | |
| | One story frame building with a front-facing gable V-crimped metal roof; faces east, 3x1 bay core; full façade gable porch with wood posts; central entrance at façade flanked to either side by single windows with vertical board shutters; plain weatherboard siding; brick pier foundation (Photos #1 and 3) | | |
| | One story frame building with a front-facing gable patterned metal shingle roof with an interior brick flue; faces east, 3x1 bay core with a 1-bay deep rear extension and a rear L addition that extends to the north (ca. 1950); full façade gable canopy with cast iron columns; central entrance at façade with double leaf doors flanked to either side by single windows with vertical board shutters, entrance at rear bay of south elevation with shed awning, similar windows at the rear extension and addition; plain weatherboard siding; brick pier foundation with continuous brick at rear extension and addition (Photos #1, 4 and 7). | | |

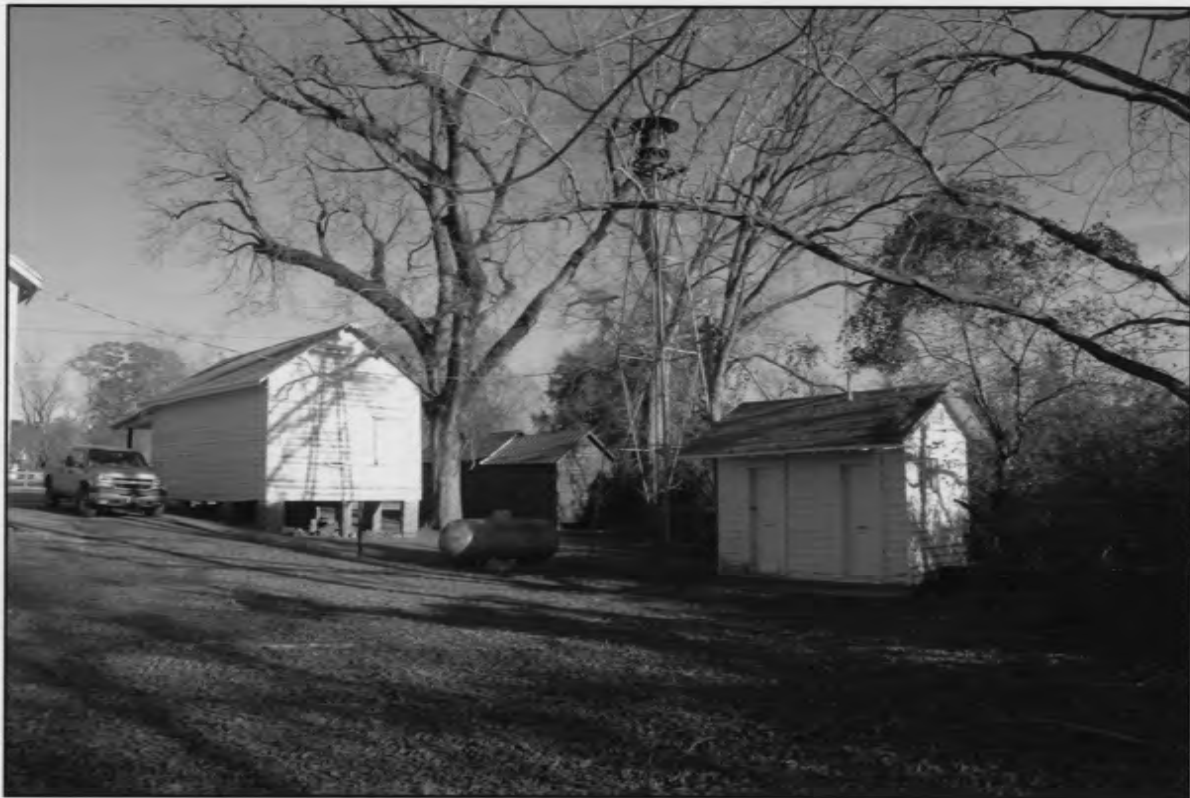
Photo #2
View of building complex (Inventory #s 2, 1,6 , & 7,
L-R), camera facing southeast

- 07 Outhouse ca. 1935 Contributing
One story frame building with a side gable pressed metal shingle roof with exposed rafter ends; faces north, 2x1 bay core with a rear 1-bay deep shed extension; full façade extended eave canopy; paired single doors at the façade, single wood 4-light single sash windows at side elevation with louvered gable vents; plain weatherboard siding; continuous concrete foundation (Photo #2).

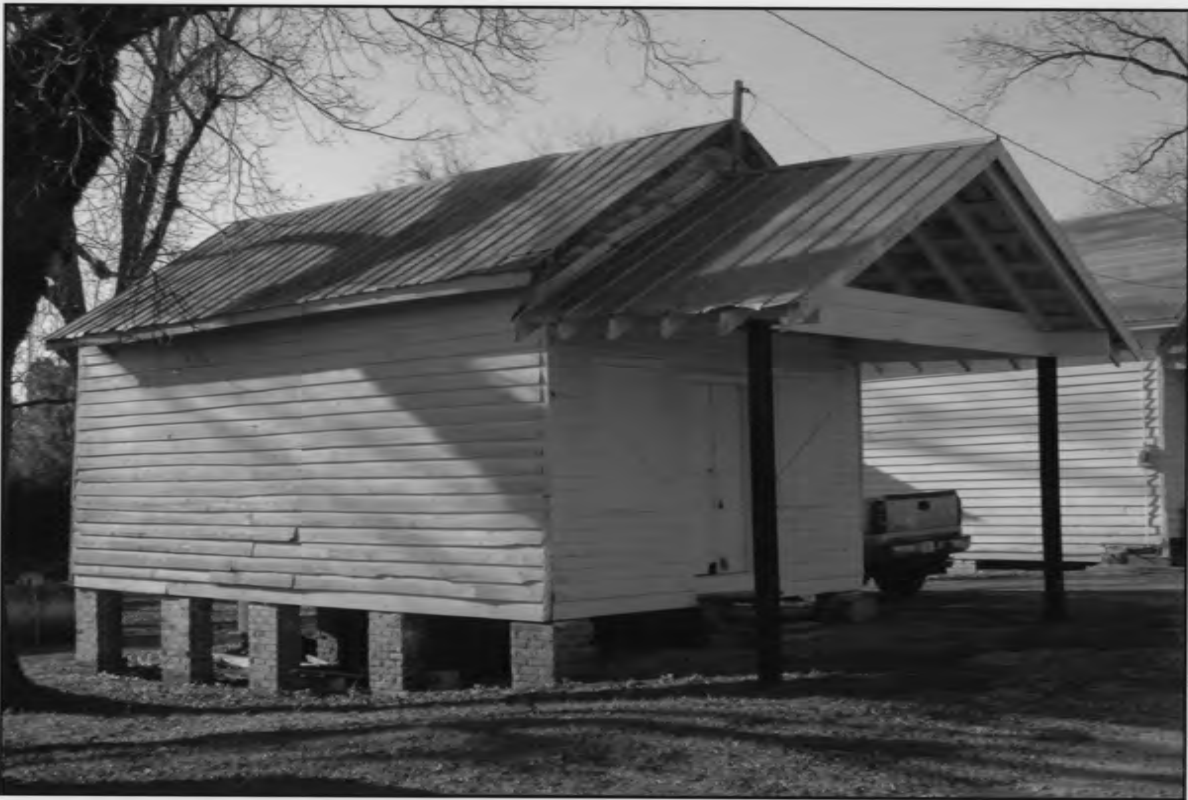
Photo #3
Old Store (Inventory #2), camera facing northwest
Image: AL_PerryCo_MooreWebbPit_0004.tif
Print: Epson Ultrachrome Ink on Premium Glossy Photo Paper

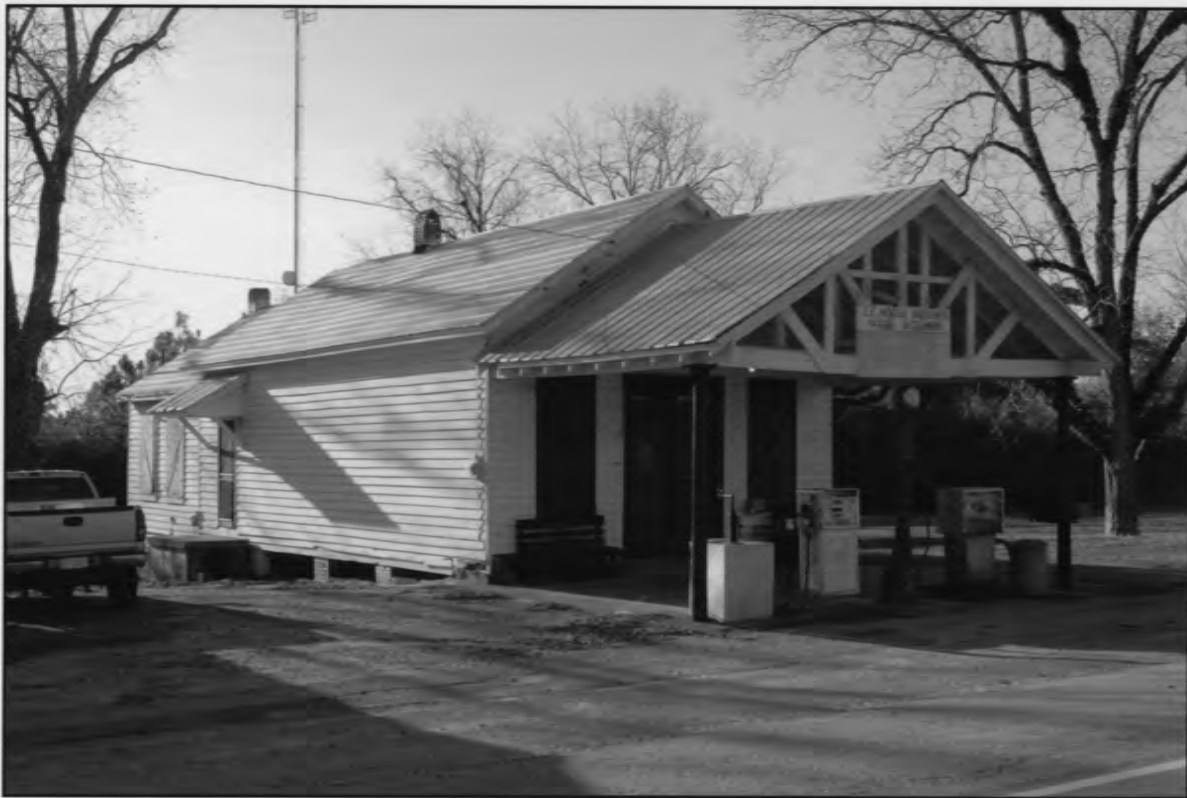
Photo #4
New Store (Inventory #3), camera facing northwest
Image: AL_PerryCo_MooreWebbPlt_0004.tif
Epson Ultrachrome Ink on Premium Glossy Photo Paper

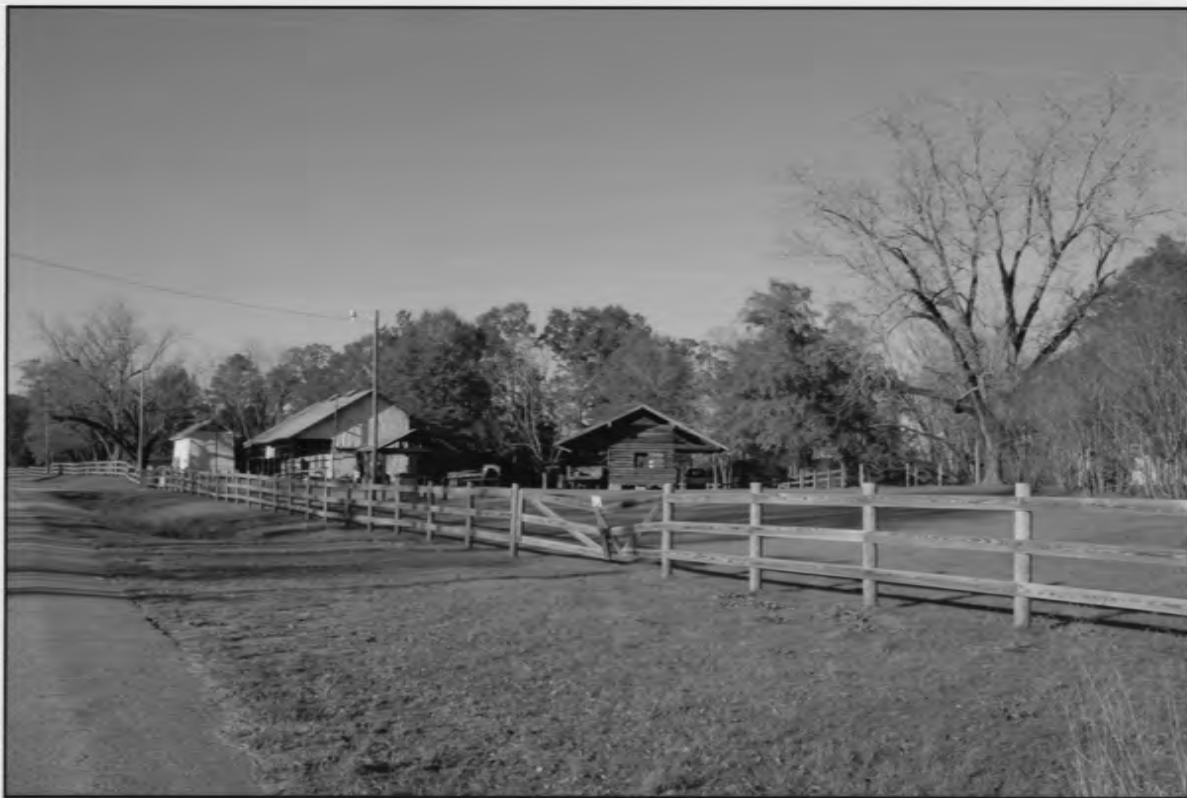
Photo #6
View of building complex (Inventory #s 25, 26, 47,
28, L-R), camera facing north
Image: AL_PerryCo_MooreWebbPit_0006.tif
Epson Ultrachrome Ink on Premium Glossy Photo Paper

- 25 Seed House ca. 1935 Contributing
Tall, one story frame building with a side gable V-crimped metal roof with exposed rafter ends, central raised gable roof ventilator, open gable ends; faces west, 1x1 bay rectangular core with long axis running north-south; the long axis walls are battered; central double leaf wood board and batten doors at west façade, similar off-center door at east elevation, no other openings; battered exterior walls with plain weatherboard siding; tapered concrete pier foundation (Photos #6, 15, 17, 20, and 22).

- 28 Seed House ca. 1835 Contributing
One story log building with a gable V-crimped metal roof with extended eaves and exposed rafter ends, central raised gable roof ventilator, open gable ends; single window opening with no sash centered at the gable end elevations, no openings at the long axis side elevations; exposed log exterior at south, east, and west elevations with square notched corners, corrugated metal siding applied to north elevation; brick pier foundation (Photos #6, 19, 21 and 22).

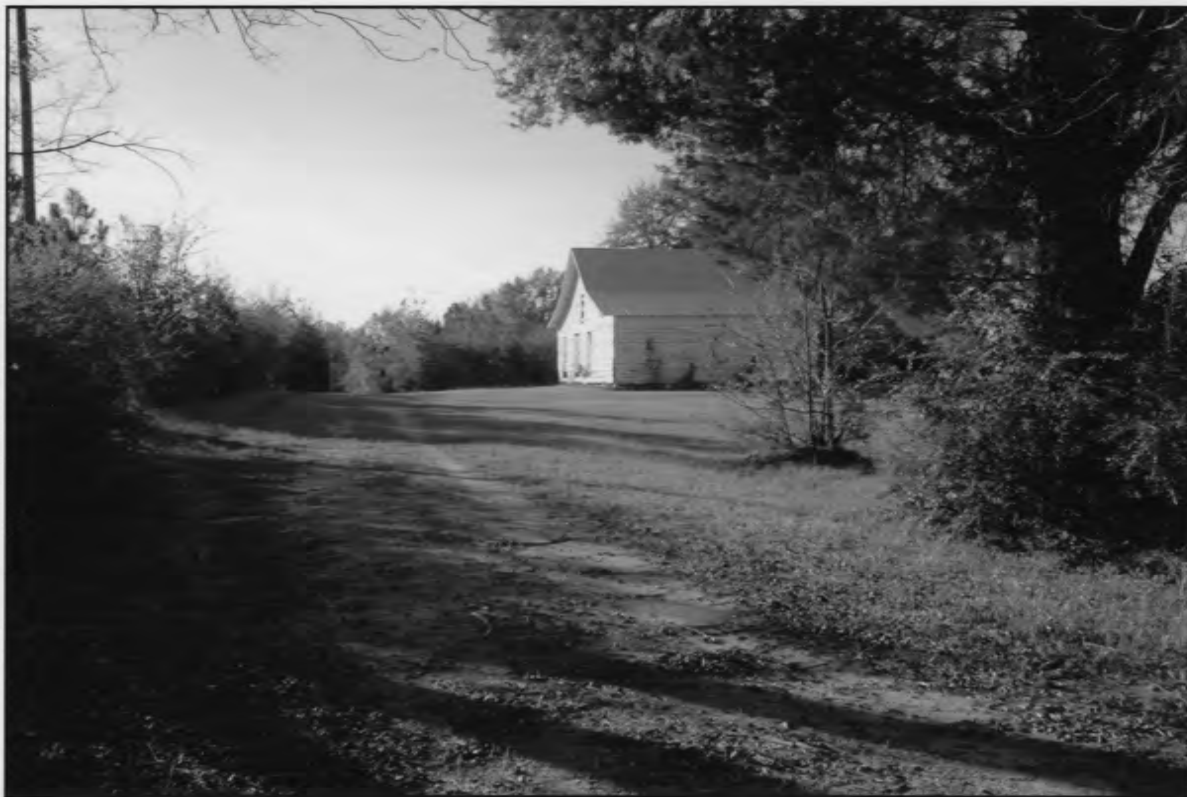
Photo #7
View of building complex (Inventory #s 3-5, L-R),
camera facing south
Image: AL_PerryCo_MooreWebbPit_0007.tif
Print: Epson Ultrachrome Ink on Premium Glossy Photo Paper

A new store building was added in 1875 (Inv. #3, Photos #1, 4 and 7). The building served as a general store for the plantation community and housed the post office for the community of Folsom from 1897 until 1903. The store continued to operate until 1986. The family acquired the Hogue/Scott House (Inv. #13, ca. 1835, Photos #11-12) at the north end of the present complex as part of a larger land purchase in 1910. The core of the house is constructed of logs but the house was later expanded with a second floor and covered with weatherboard siding. A grist mill was constructed next to the store circa 1915 (Inv. #4, Photos #1, 5 and 7). Other agricultural buildings constructed during this period include the dairy barn with a market house (Inv. #1, circa 1910, Photos #1 and 2), a pecan house (Inv. #30, circa 1935, Photo #25) used for the storage and processing of pecans, two chicken coops (Inv. #s 14 and 33, circa 1910), a potato storage house (Inv. #34, circa 1840, Photo #23), a tenant house (Inv. #11, circa 1915), an outhouse (Inv. #8, circa 1925), two barns (Inv. #s 9 and 15, circa 1925, Photos #8 and 9), an equipment shed (Inv. #10, circa 1925, Photo #8), a well and well house (Inv. #35, circa 1840/1925, Photos #23, 26, and 29), a dairy with an attached saddle house (Inv. #43, circa 1925, Photos #23, 26, and 27), and two tenant houses (Inv. #s 44 and 55, circa 1925, Photos #30 and 34).

Other buildings constructed during the 1930s included a mix of farm buildings and those designed to provide services to the plantation community. Among the former are a machine shop (Inv. #5, circa 1935, Photos #1 and 7), a bell tower (Inv. #6, circa 1925, Photos #1-2), two outhouses (Inv. #7 and 53, Photo #2), an equipment shed (Inv. #19, circa 1935, Photos #13 and 16), a tool building (Inv. #21, circa 1935, Photos #13, #14 and 16), two barns (Inv. #s 39 and 41, Photo #37), a mule barn (Inv. #42, circa 1935, Photo #36), a canning shed (Inv. #46, circa 1923, Photo #23), an Overseer's house (Inv. #50, 1923, Photo #32), three sheds (Inv. #s 23, 51, and 52), and a spring house (Inv. #54, circa 1920, Photo #33). The latter group includes a night watchman's shed (Inv. #48) and a firehouse (Inv. #22, circa 1935 Photos #13, 14, 15, and 20) that still houses its original 1939 fire truck.

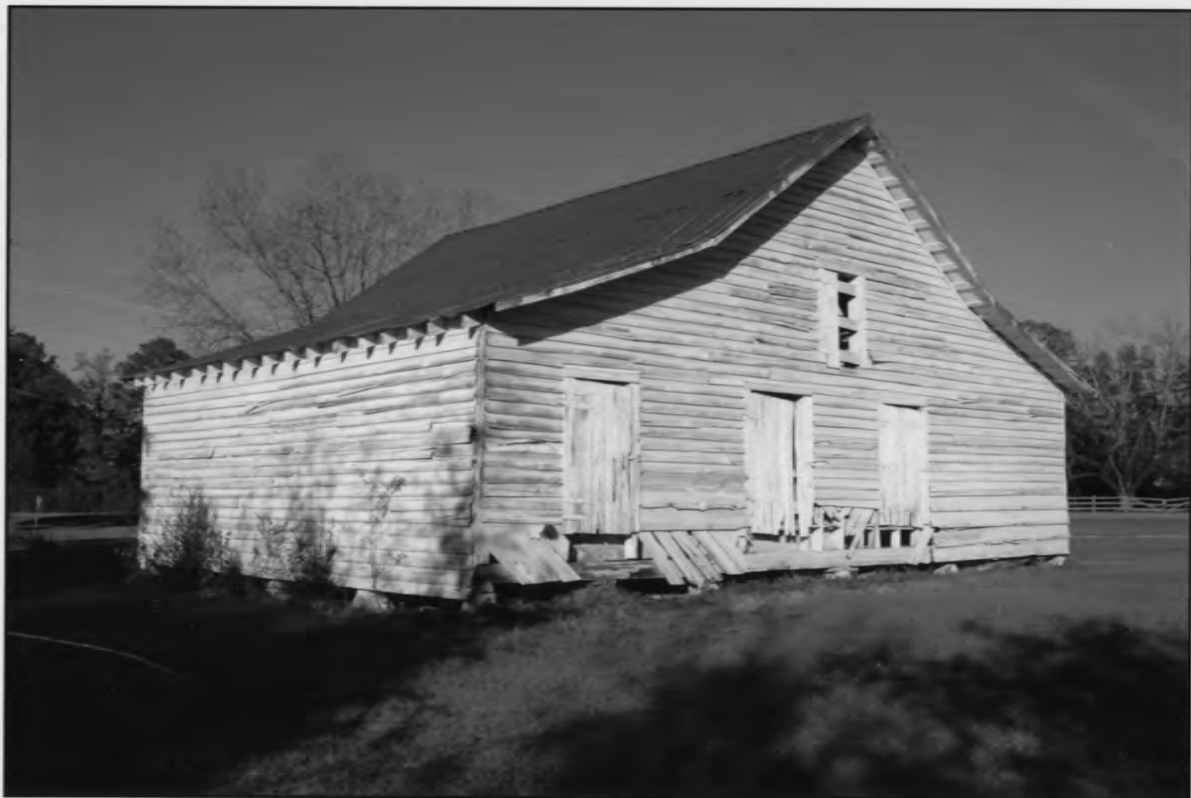
Photo #9
Barn, (Inventory #9), camera facing northeast
Image: AL_PerryCo_MooreWebbPlt_0009.tif
Print: Epson Ultrachrome Ink on Premium Glossy Photo Paper

- 09 Fertilizer and Seed House ca. 1925 Contributing
One and one-half story frame barn with a front-facing V-crimped metal roof with exposed rafter ends; faces south, 2x1 bay core with flanking enclosed outsheds; entrances with batten doors at both bays of the facade and west outshed,ⁱⁱ smaller loft door centered at gable end, similar door centered at the east elevation, no other openings; plain weatherboard siding; tapered concrete pier and brick pier foundation (Photos #8 and 9).

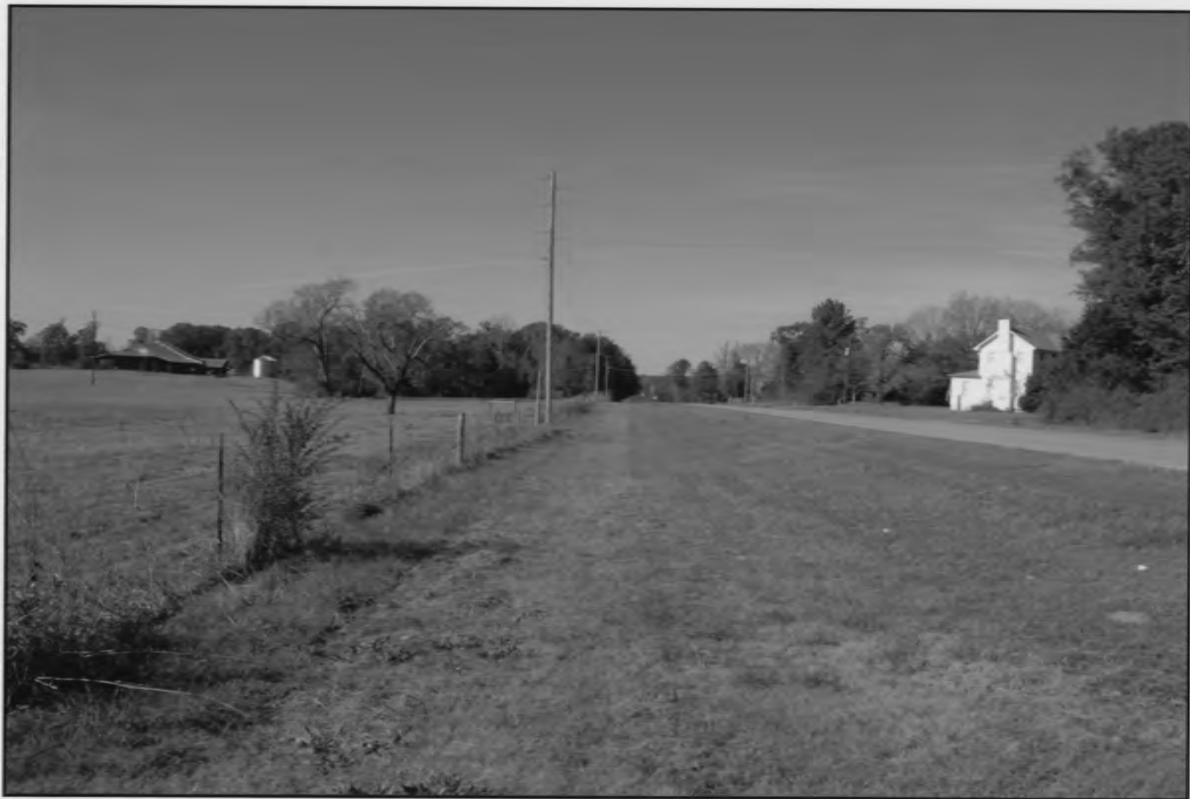
Photo #10
Site view, pasture with corn crib at right (Inventory
#12), camera facing northwest
Image: AL_PerryCo_MooreWebbPlt_0010.tif
Epson Ultrachrome Ink on Premium Glossy Photo Paper

Additional buildings and structures continued to be added after 1940. Among this group are a sweet potato storage house (Inv. #16, circa 1945), a well (Inv. #47, circa 1850/1935, Photos #6 and 21), a trough for watering mules (Inv. #37, circa 1945), a corn crib (Inv. #12, circa 1955, Photos #10 and 11), two groupings of metal grain bins (Inv. #s 17 and 20, circa 1955, Photo #16), and a large open silage pit (Inv. #40, circa 1965).

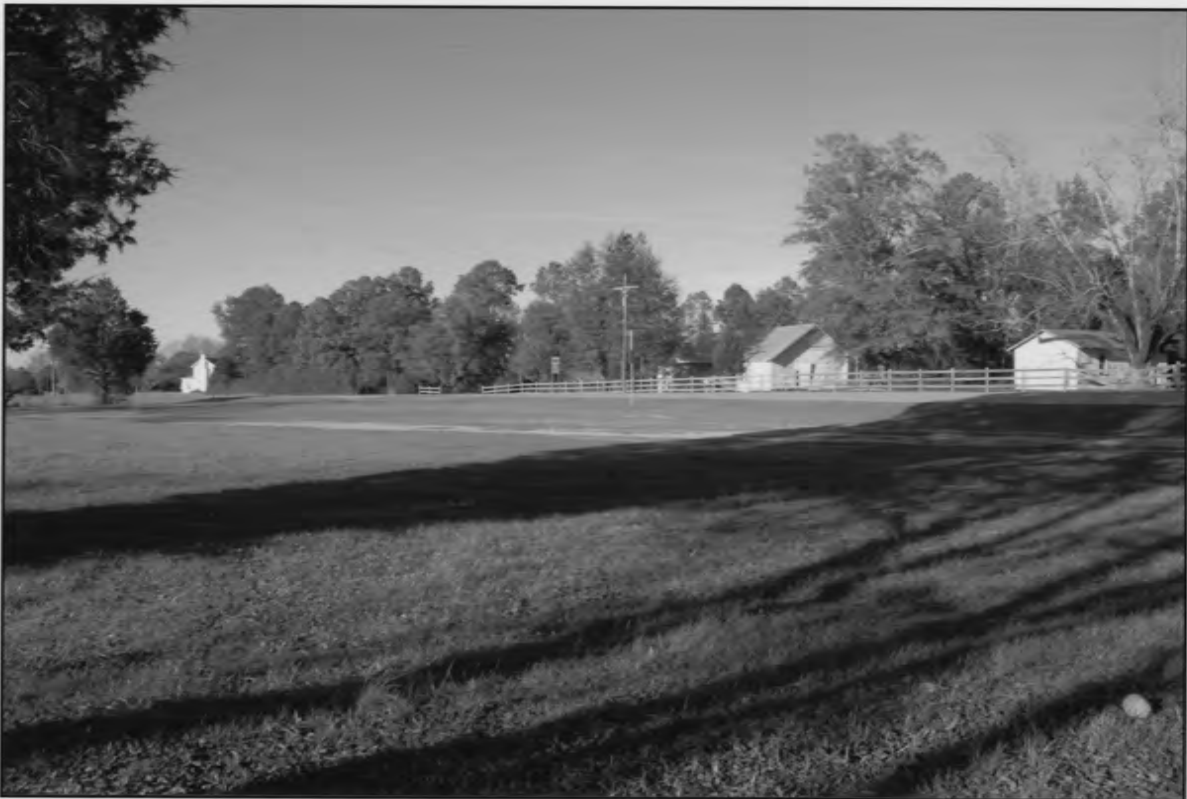
Photo #13
Site view, camera facing northeast (Inventory #s
13, 19, 21, & 22, L-R)
Image: AL_PerryCo_MooreWebbPit_0013.tif
Print: Epson Ultrachrome Ink on Premium Glossy Photo Paper

elevation; full height entrance bay pedimented portico with an intermediate balcony; central entrance at the first floor of its façade with transom and sidelights flanked to either side by wood 9/9 double hung sash windows, similar 6/6 windows in all corresponding bays at the upper level, similar windows at the side and rear elevations; plain weatherboard siding with flush board siding between the windows and entrance at the first level suggesting that the house may have had an earlier one story less than full façade porch; and a brick pier foundation (Photos #11, 12 and 13).

- 21 Tool Building ca. 1935 Contributing
One story frame building with a side gable V-crimped metal roof with exposed rafter ends; faces west, 3x1 bay core with rear shed extension; entrance bay gable canopy supported by pipe columns; central entrance at façade with double wood board and batten doors in a chevron pattern flanked to either side by a double wood 9/9 double hung sash window; cargo entrance at south elevation and 2 small 6-light windows at north elevation of the core with cargo openings at the side elevations of the rear shed extension; wood weatherboard siding; foundation concealed by metal skirting (Photos #13, #14 and 16).

west bay of south elevation with paired entrances at eastern bays; similar windows at side and rear elevations; composite shingle siding; concrete block foundation (Photos #13, 14, 15, and 20).

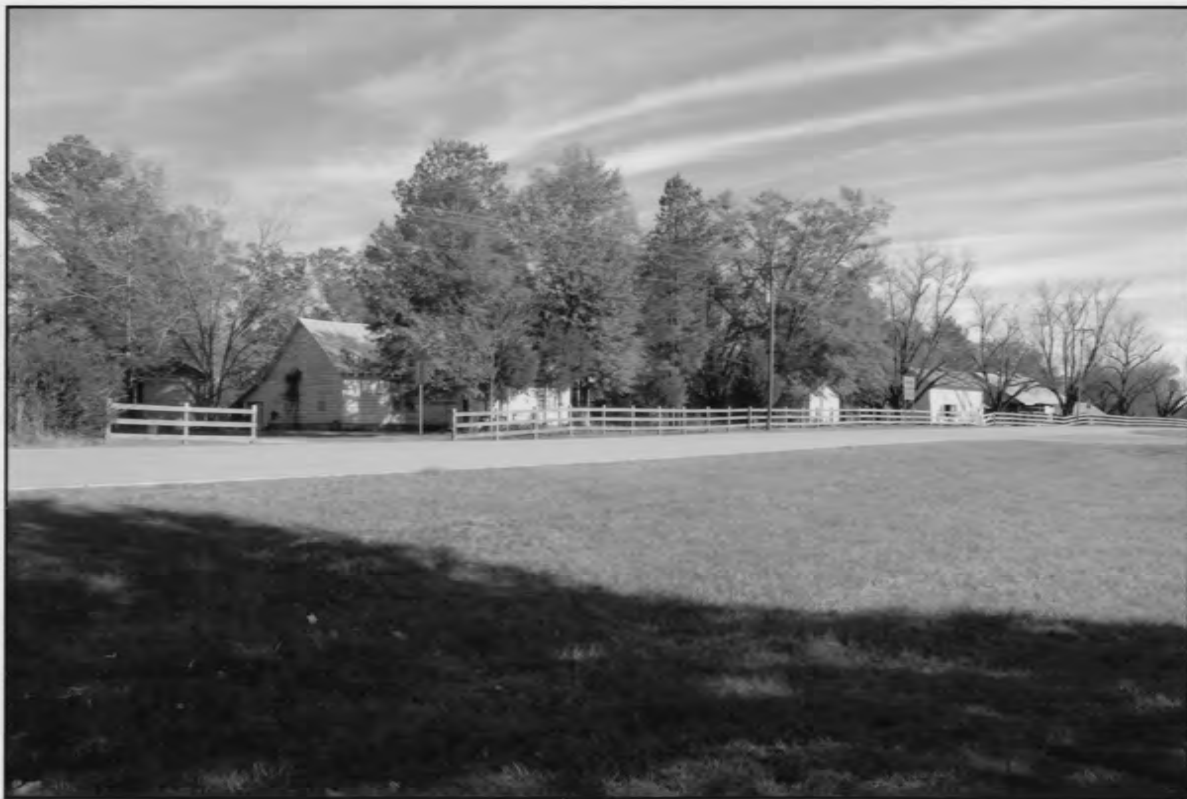
Photo #14
Site view, camera facing southeast (Inventory #s
20-22 & 25-26, L-R)
Image: AL_PerryCo_MooreWebbPlt_0014.tif
Epson Ultrachrome Ink on Premium Glossy Photo Paper

- 20 Grain Bins (2) ca. 1955 Contributing
Grouping of two round corrugated metal grain bins with conical roofs below central conical ventilators; raised concrete block foundations; single entrance doors with rounded metal doors (Photos #14 and 16).

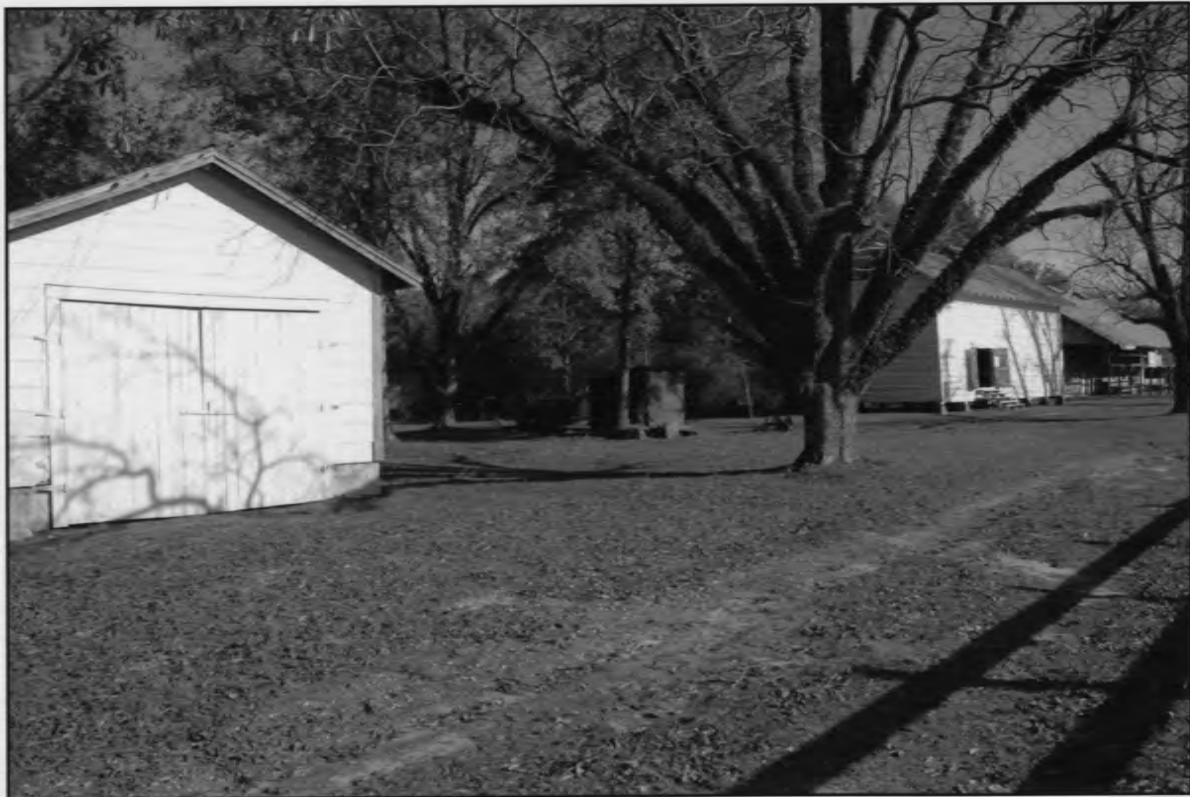
Photo #15
Site view, camera facing southeast (Inventory #s
22, 23, 25, & 26, L-R)
Image: AL_PerryCo_MooreWebbPit_0015.tif
Print: Epson Ultrachrome Ink on Premium Glossy Photo Paper

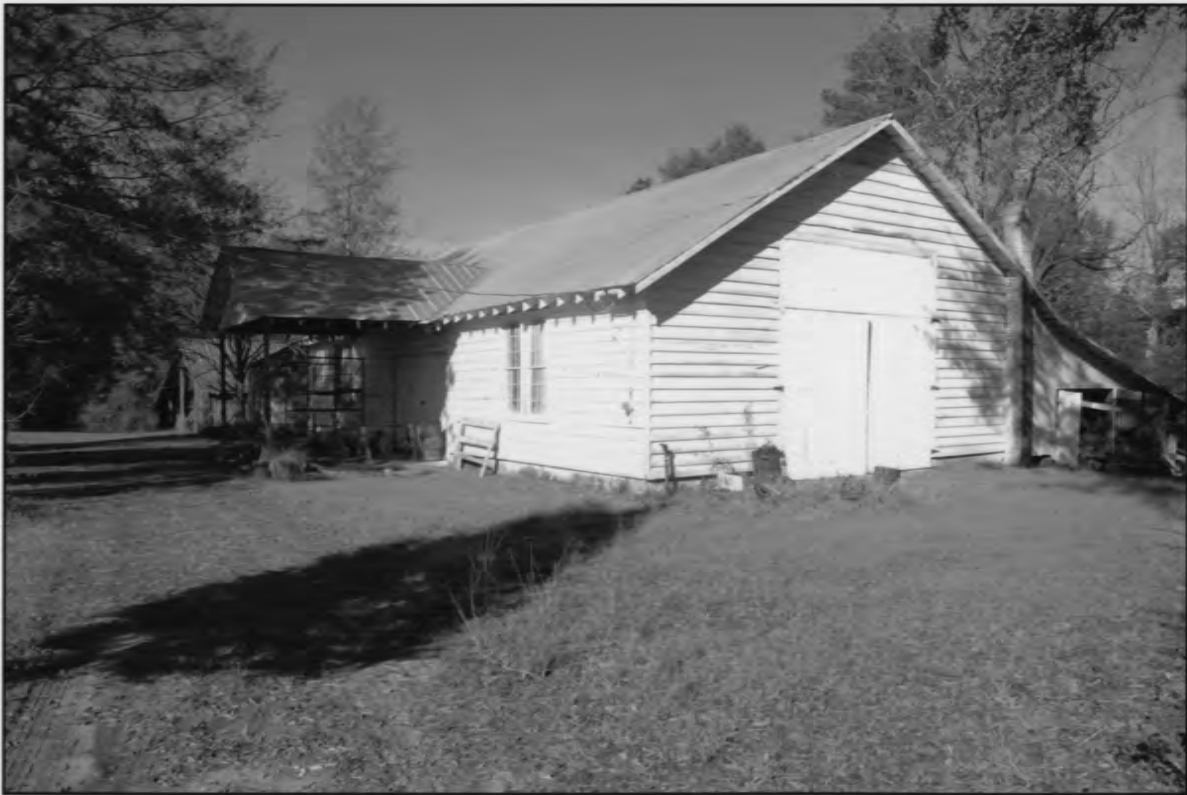
Photo #16
Site view, camera facing north toward tool building, grain
bins, and equipment shed (Inv. #19-21, L-R)
Image: AL_PerryCo_MooreWebbPlt_0016.tif
Epson Ultrachrome Ink on Premium Glossy Photo Paper

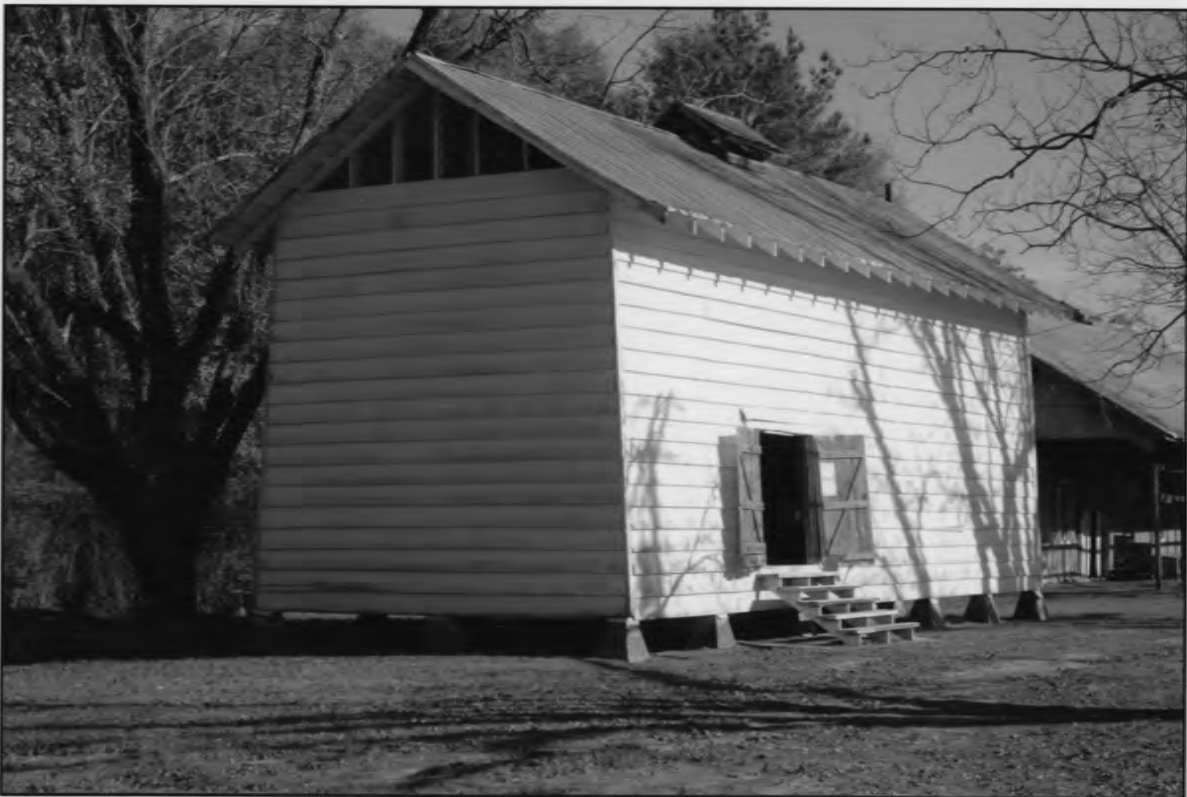
Photo #17
Seed house (Resource #25) camera facing
southeast

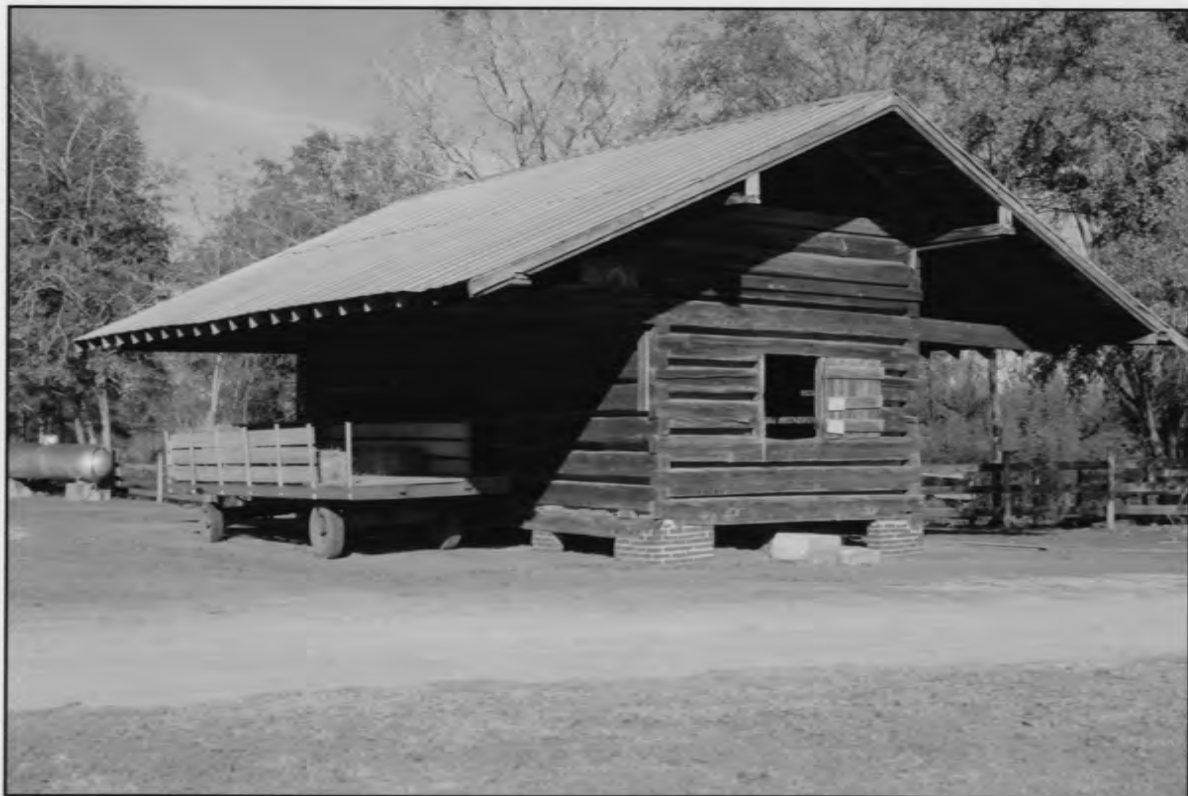
Photo #19
Log seed house (Resource #28), camera facing
north
Image: AL_PerryCo_MooreWebbPit_0019.tif
Print: Epson Ultrachrome Ink on Premium Glossy Photo Paper

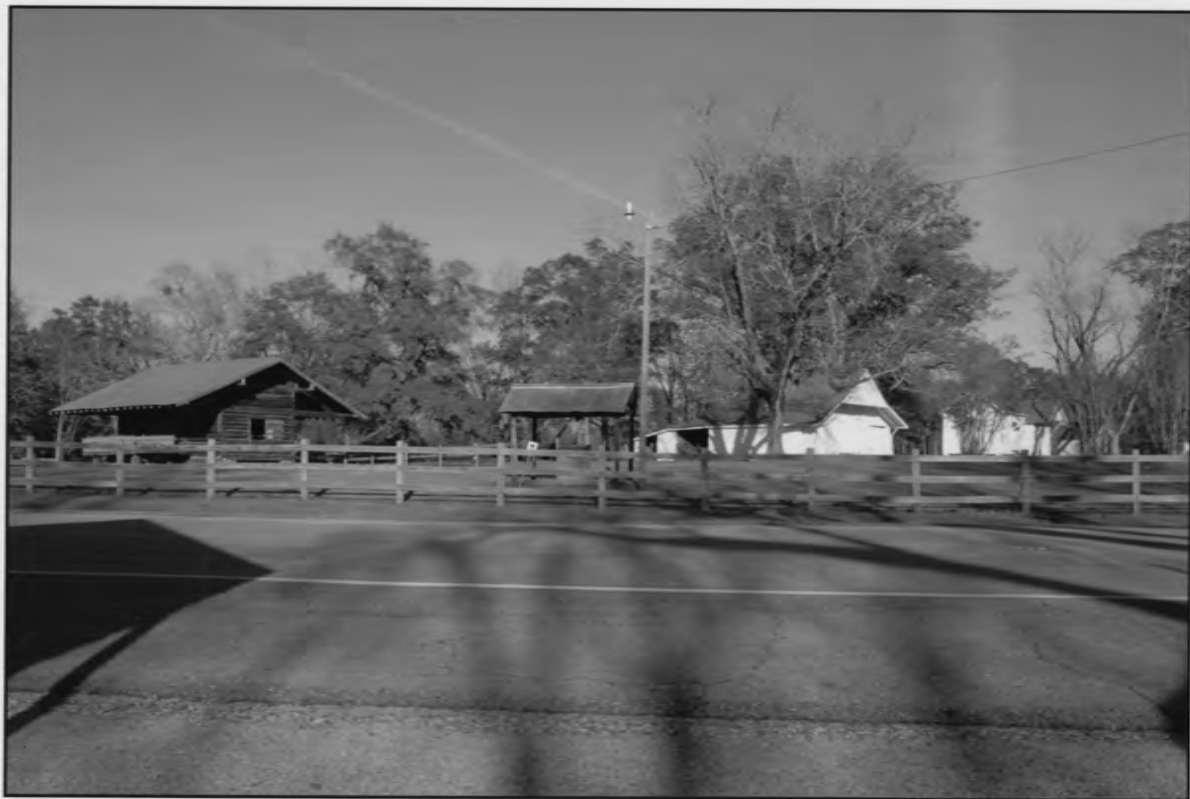
Photo #21
Site view, camera facing east (Inventory #s
28,47,29,31, L-R)
Image: AL_PerryCo_MooreWebbPlt_0021.tif
Print: Epson Ultrachrome Ink on Premium Glossy Photo Paper

- 29 Stable/Carriage House ca. 1840 Contributing
One story frame building with a front-facing gable V-crimped metal roof with enclosed outsheds and extended front eave; faces south; central entrance with double leaf doors flanked by similar doors at the outsheds; plain weatherboard siding at the core, vertical board siding at the outsheds; brick pier foundation (Photos #21, and 23-25).

- wood 6/6 double hung sash windows at the north and east elevations, no openings at the west elevation; plain weatherboard siding; brick pier foundation (Photos #21, 23, and 25).^{iv}

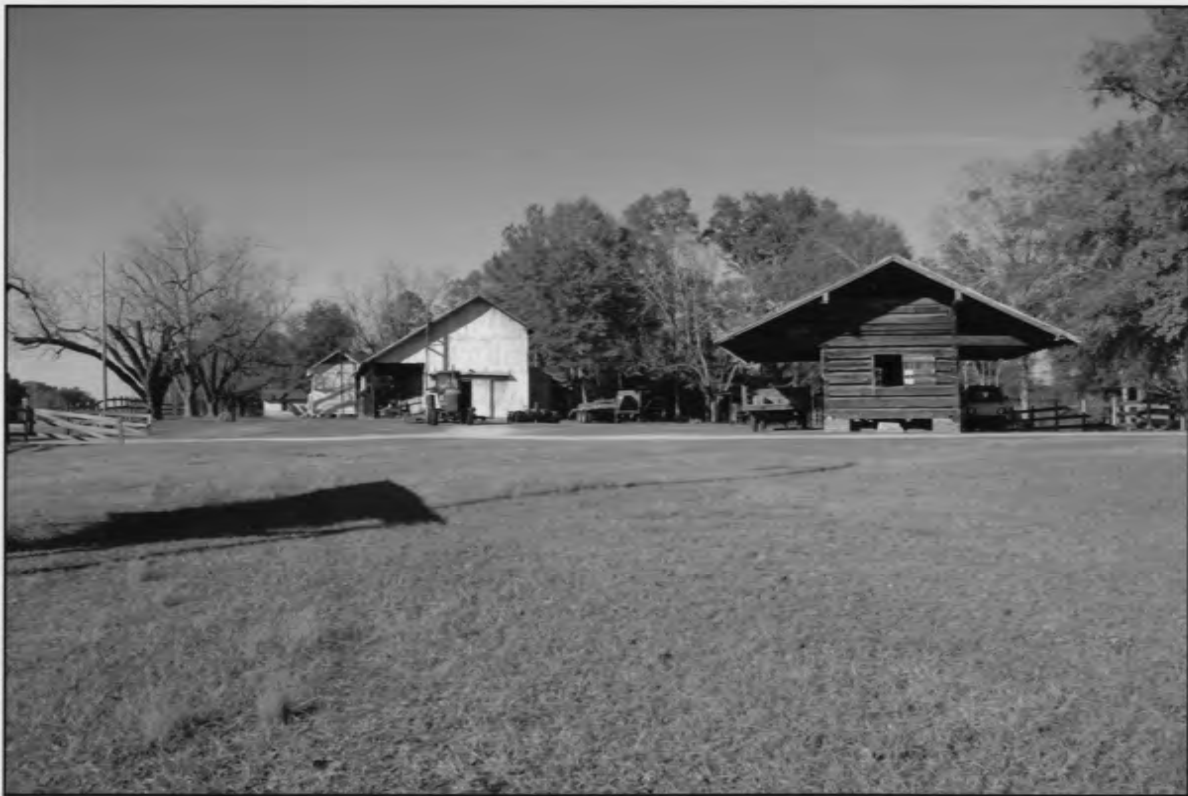
Photo #22
Site view, camera facing east (Inventory #s 25, 26,
and 28 L-R)
Image: AL_PerryCo_MooreWebbPlt_0022.tif
Epson Ultrachrome Ink on Premium Glossy Photo Paper

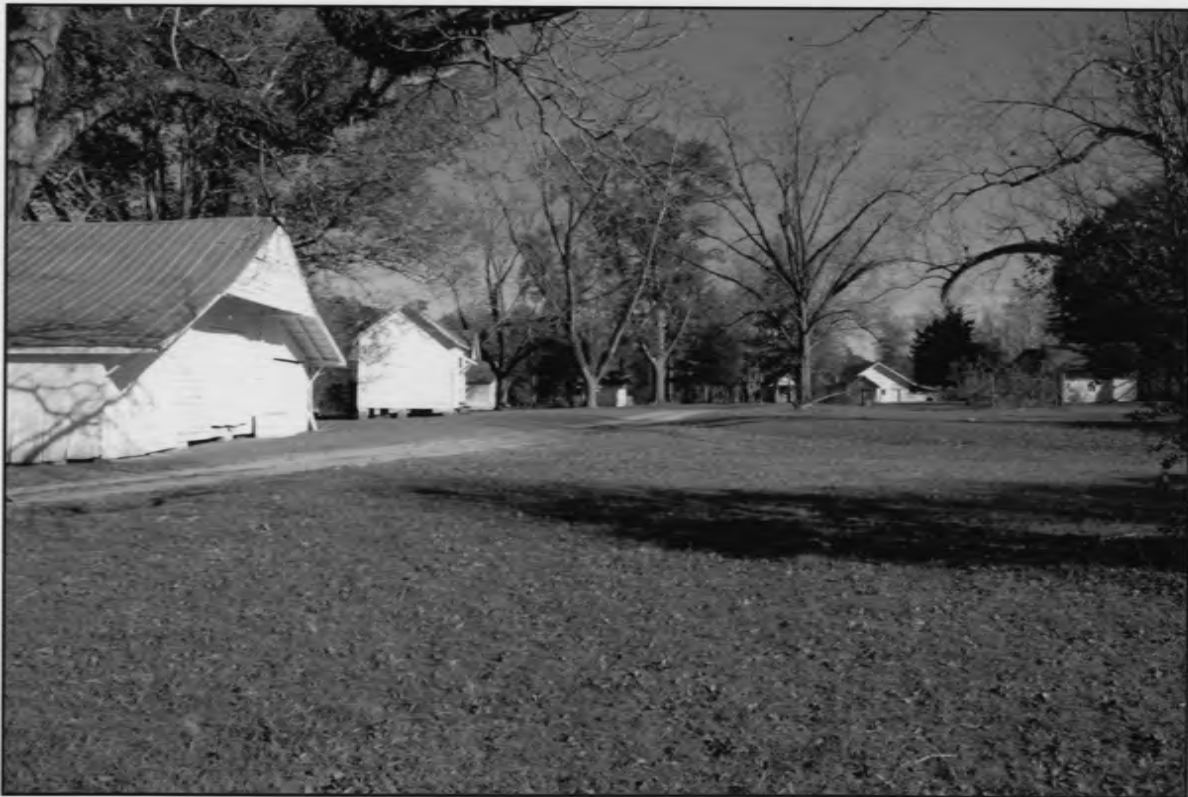
Photo #23
Site view, camera facing east (Inventory #s
29,31,34,35,43, and 46 L-R)
Image: AL_PerryCo_MooreWebbPlt_0023.tif
Print: Epson Ultrachrome Ink on Premium Glossy Photo Paper

- 34 Potato House ca. 1840 Contributing
One story brick building with a front-facing gable V-crimped metal roof with open gable ends; faces south; central entrance at the facade, no other openings; painted brick exterior walls and continuous brick foundation (Photo #23).

- 35 Well House and Well ca. 1840/1925^v Contributing
One story frame building with a front-facing gable corrugated metal roof with partially exposed rafter ends; faces west, 1x 2 bay core; full facade recessed canopy supported by wood posts; brick well head on concrete slab underneath the canopy; off-center entrance at facade, single wood 6-light single sash window at front bay of the south elevation with an entrance at its rear bay, no other openings; wood weatherboard siding; brick pier foundation (Photos #23, 26, and 29).

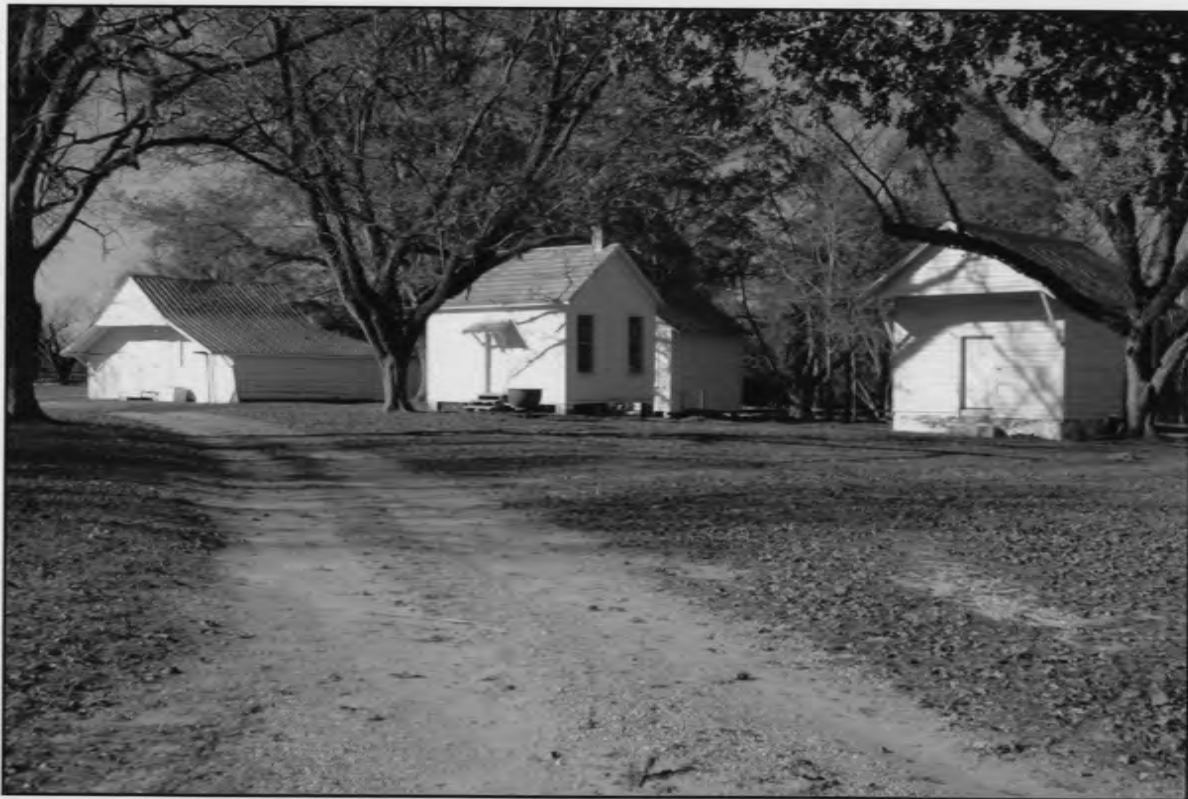
Photo #25
Site view, camera facing northwest (Inventory #s
29, 31, 30, and 32, L-R)
Image: AL_PerryCo_MooreWebbPlt_0025.tif
Print: Epson Ultrachrome Ink on Premium Glossy Photo Paper

- 30 Pecan House ca. 1935 Contributing
One story frame building with a front-facing gable V-crimped metal roof with exposed rafter ends; faces south; single central entrance with shed hood supported by angle brackets flanked by single wood 4/4 double hung sash windows; plain weatherboard siding; brick pier foundation (Photo #25).

- 32 Smoke House ca. 1840 Contributing
One story frame building with a front-facing gable V-crimped metal with an extended front gable supported by angle brackets; faces south; central entrance at the facade, single window opening (now enclosed) centered at rear elevation, no openings at side elevations; plain weatherboard siding; raised continuous brick foundation (Photo # 25).

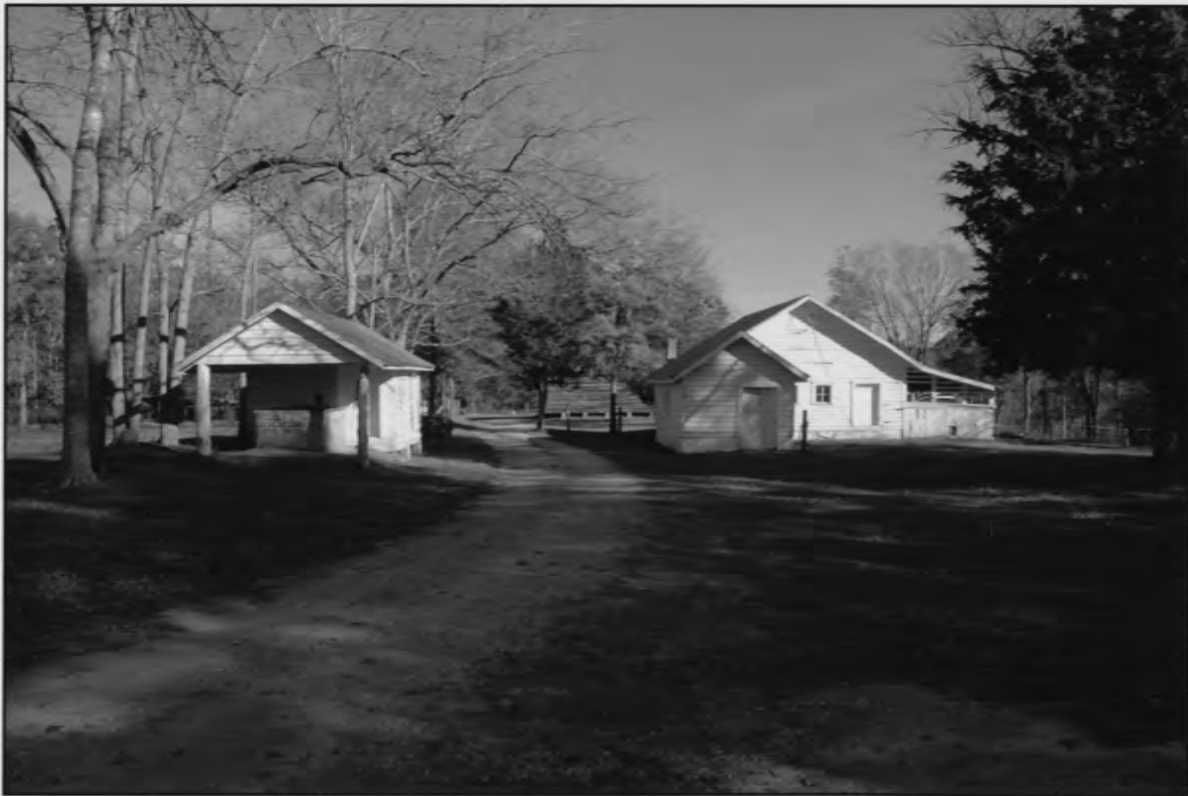
Photo #26
Site view, camera facing east (Inventory #s 35 and
43, L-R)
Image: AL_PerryCo_MooreWebbPlt_0026.tif
Epson Ultrachrome Ink on Premium Glossy Photo Paper
