National Register of Historic Places
Registration Form

historic name Moore-Webb-Holmes Plantation

city or town Marion vicinity

state Alabama code AL county Perry code 105 zip code 36756

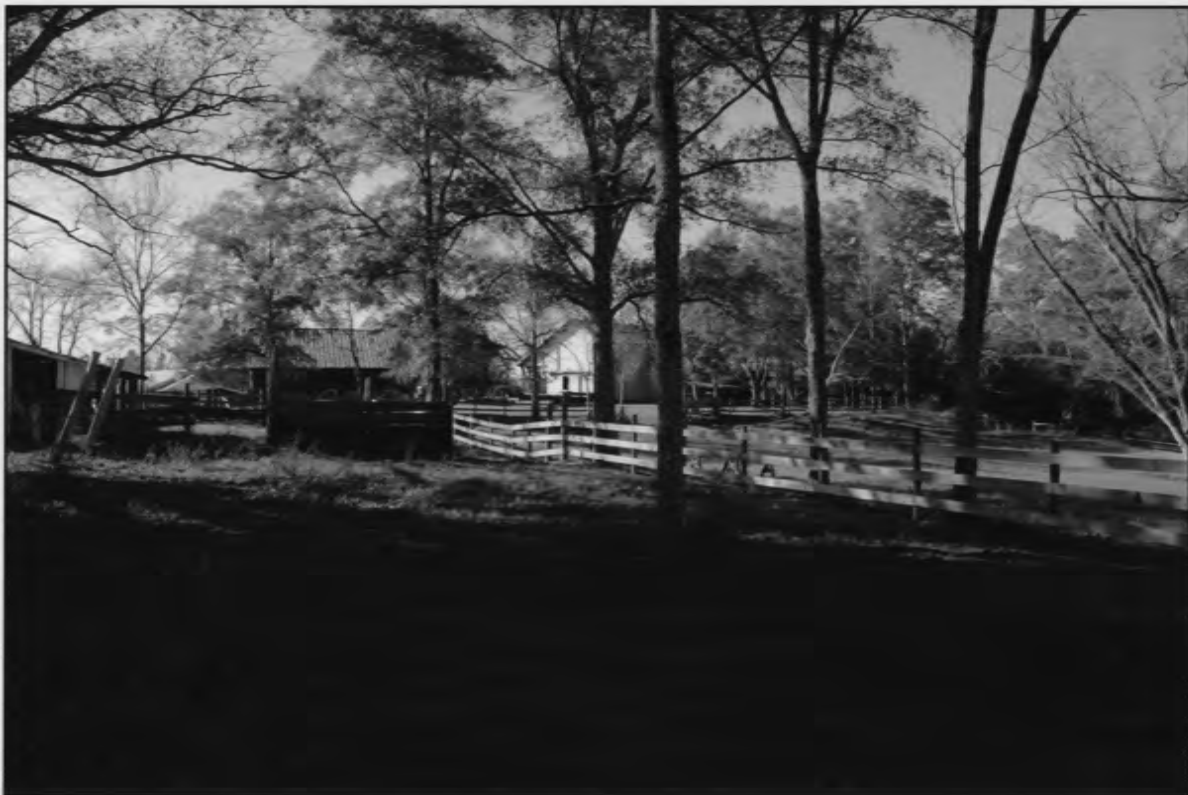
Photo #27
Dairy/Saddle house (Inventory #43), camera facing
northeast

A new store building was added in 1875 (Inv. #3, Photos #1, 4 and 7). The building served as a general store for the plantation community and housed the post office for the community of Folsom from 1897 until 1903. The store continued to operate until 1986. The family acquired the Hogue/Scott House (Inv. #13, ca. 1835, Photos #11-12) at the north end of the present complex as part of a larger land purchase in 1910. The core of the house is constructed of logs but the house was later expanded with a second floor and covered with weatherboard siding. A grist mill was constructed next to the store circa 1915 (Inv. #4, Photos #1, 5 and 7). Other agricultural buildings constructed during this period include the dairy barn with a market house (Inv. #1, circa 1910, Photos #1 and 2), a pecan house (Inv. #30, circa 1935, Photo #25) used for the storage and processing of pecans, two chicken coops (Inv. #s 14 and 33, circa 1910), a potato storage house (Inv. #34, circa 1840, Photo #23), a tenant house (Inv. #11, circa 1915), an outhouse (Inv. #8, circa 1925), two barns (Inv. #s 9 and 15, circa 1925, Photos #8 and 9), an equipment shed (Inv. #10, circa 1925, Photo #8), a well and well house (Inv. #35, circa 1840/1925, Photos #23, 26, and 29), a dairy with an attached saddle house (Inv. #43, circa 1925, Photos #23, 26, and 27), and two tenant houses (Inv. #s 44 and 55, circa 1925, Photos #30 and 34).

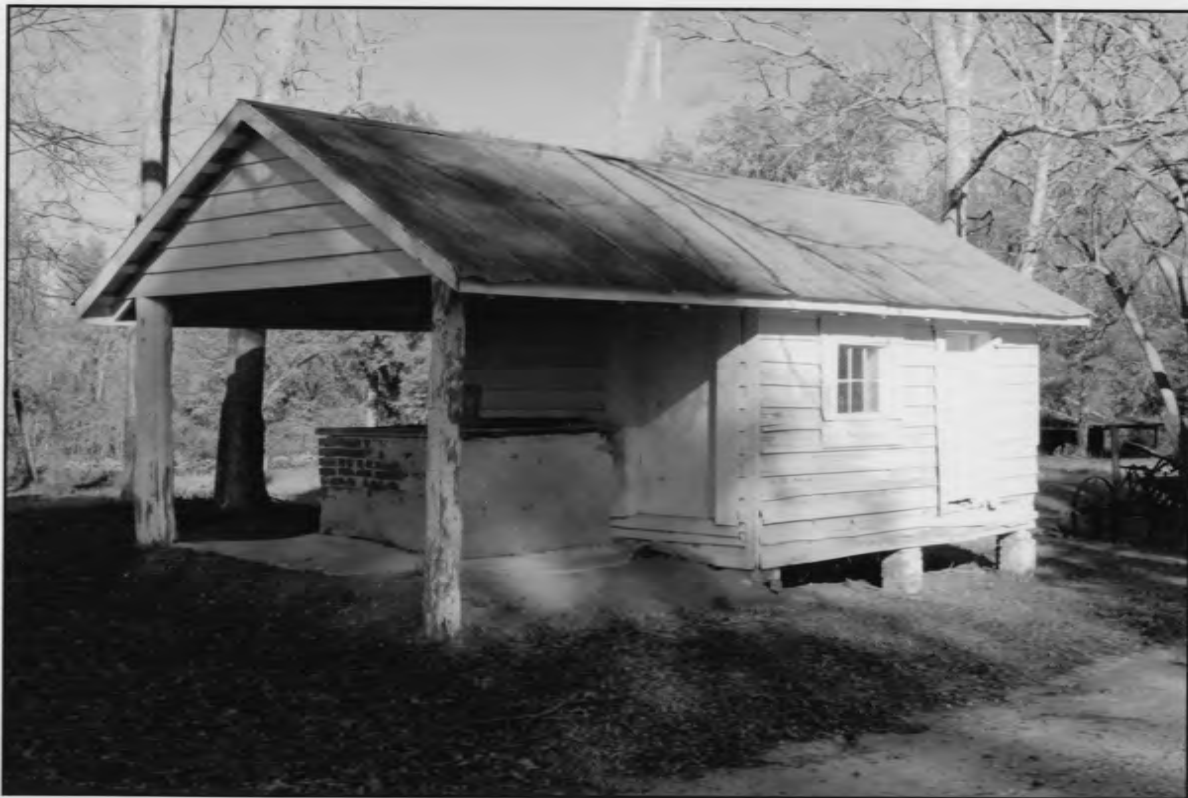
Photo #29
Well house and well (Inventory #35), camera
facing northeast
Image: AL_PerryCo_MooreWebbPlt_0029.tif
Print: Epson Ultrachrome Ink on Premium Glossy Photo Paper

- 35 Well House and Well ca. 1840/1925^v Contributing
One story frame building with a front-facing gable corrugated metal roof with partially exposed rafter ends; faces west, 1x 2 bay core; full facade recessed canopy supported by wood posts; brick well head on concrete slab underneath the canopy; off-center entrance at facade, single wood 6-light single sash window at front bay of the south elevation with an entrance at its rear bay, no other openings; wood weatherboard siding; brick pier foundation (Photos #23, 26, and 29).

^v The building and well were constructed circa 1840 according to family tradition and some of their architectural features and fabric are consistent with that date. However, the roof appears to have been replaced and other modifications (including possibly the canopy) appear to date from circa 1925.

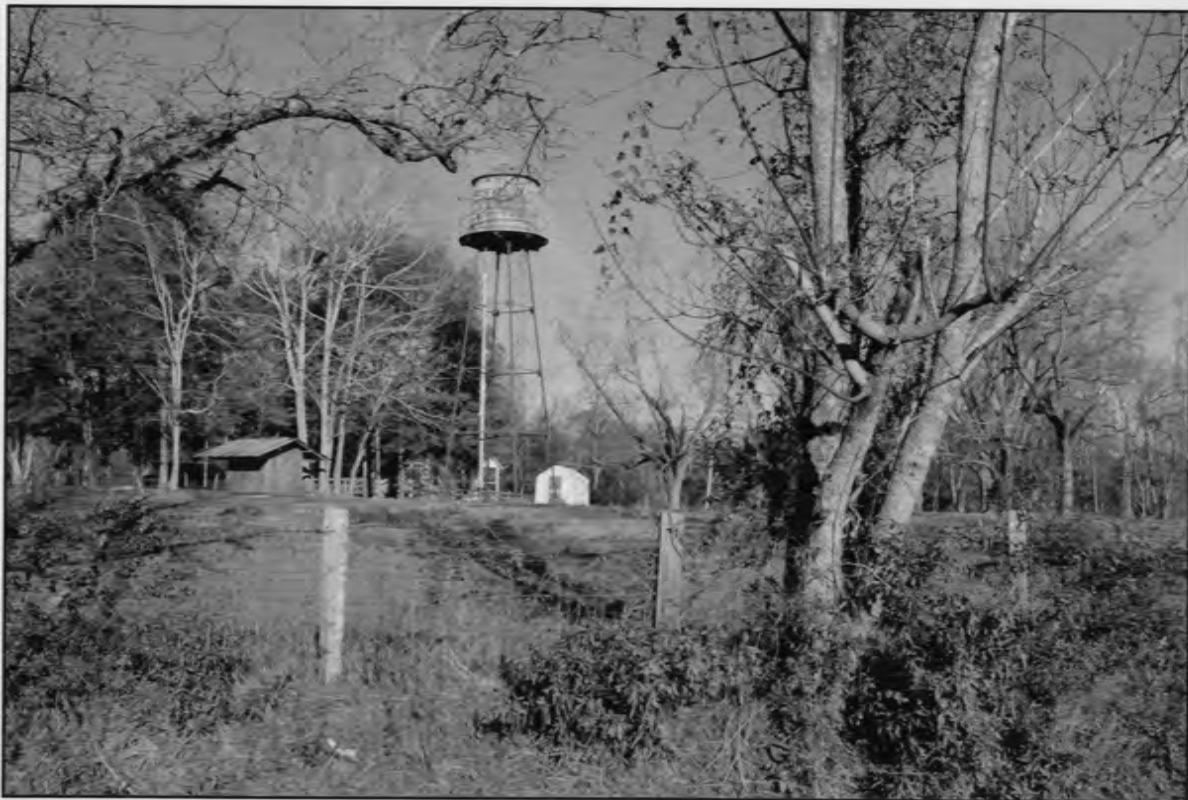
Photo #30
Tenant house (Inventory #44), camera facing
southeast

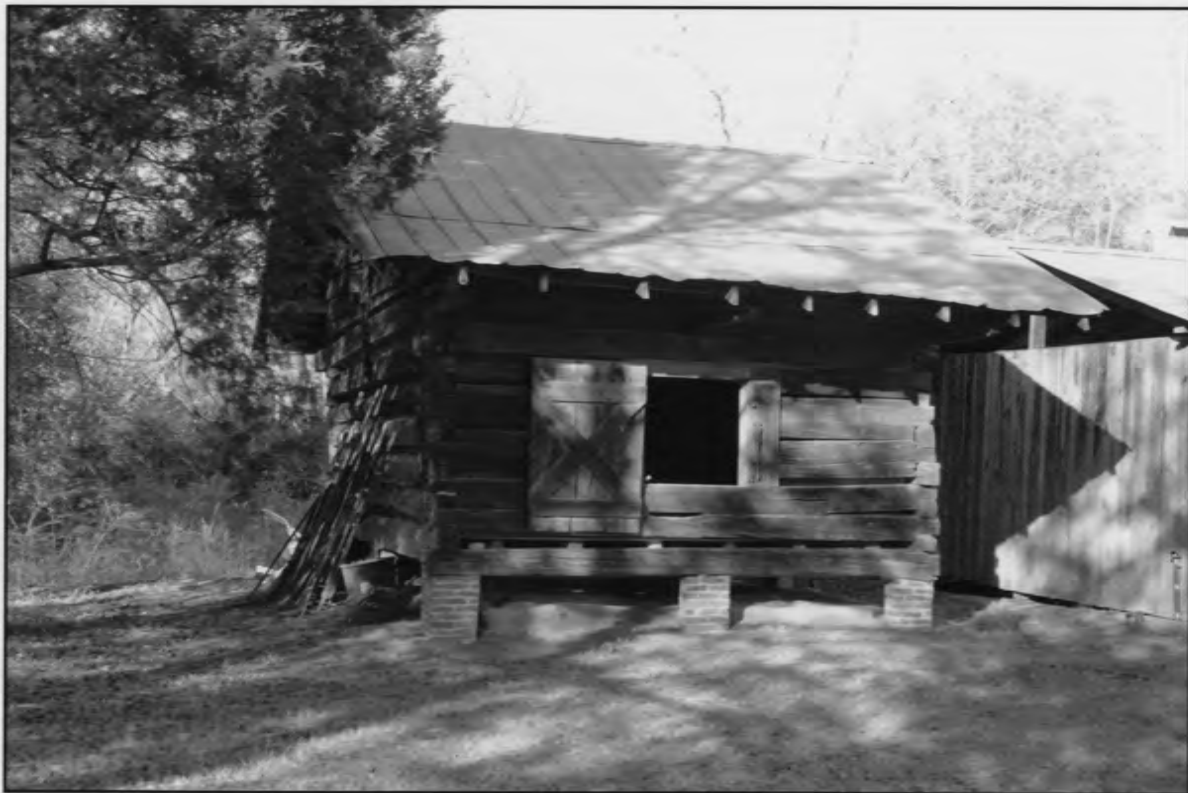
Photo #35
Log corn crib (Inventory #36), camera facing north
Image: AL_PerryCo_MooreWebbPlt_0035.tif
Print: Epson Ultrachrome Ink on Premium Glossy Photo Paper

- 36 Corn Crib ca. 1835 Contributing
One story log building with a side gable V-crimped metal roof with extended eaves and exposed rafter ends; single window opening with no sash centered at the front elevation, no other openings; exposed log exterior with square notched corners; brick pier foundation (Photo #35).

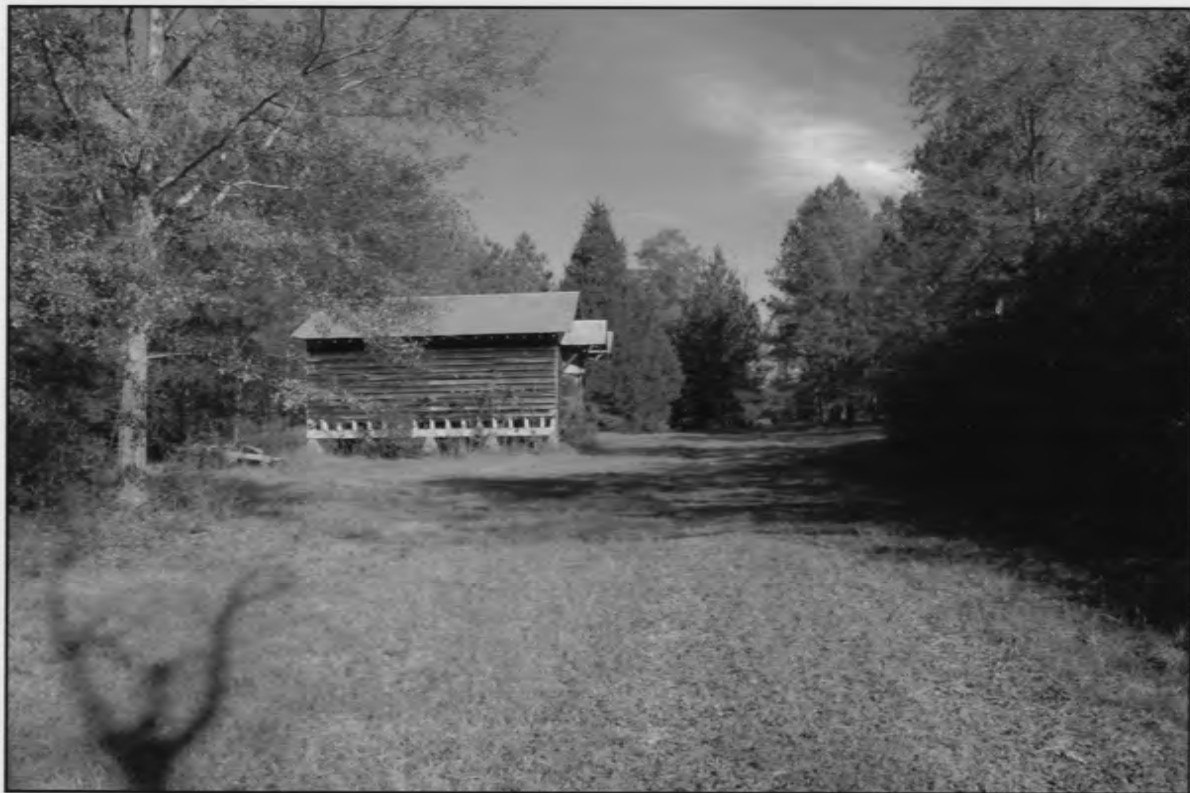
Photo #37
Site view, camera facing northeast toward barn
(Inventory #39)
Image: AL_PerryCo_MooreWebbPlt_0037.tif
Print: Epson Ultrachrome Ink on Premium Glossy Photo Paper

- 39 Grain Storage Barn ca. 1935 Contributing
One story frame barn with a front-facing gable V-crimped metal roof with exposed rafter ends; 2 entrances at facade with gable hoods supported by angle brackets, no other openings; plain weatherboard siding with lower boards removed; tapered concrete pier foundation (Photo #37).
