National Register of Historic Places Registration Form

Historic name Quality Hill Center Historic District

Other names/site number Quality Hill Towers, 910 Penn

Street & number 817, 905, and 929 Jefferson Street and 910 Pennsylvania Avenue N/A not for publication

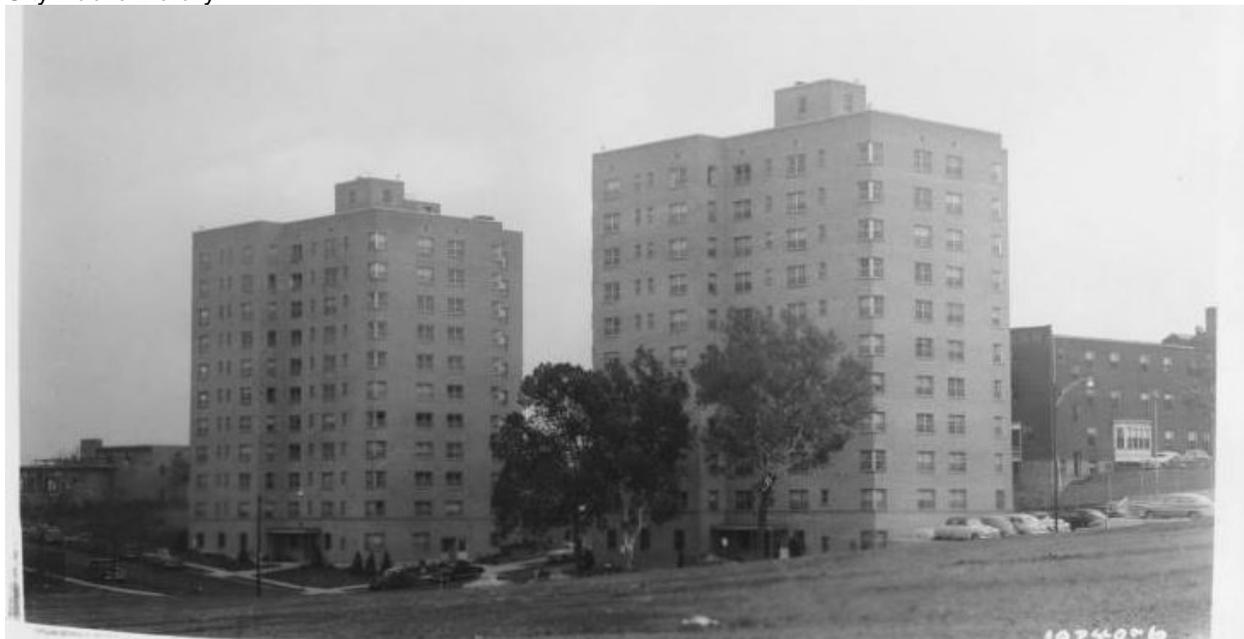
Figure 13. Buildings A and B, historic photograph, c.1951. Missouri Valley Special Collections, Kansas City Public Library.

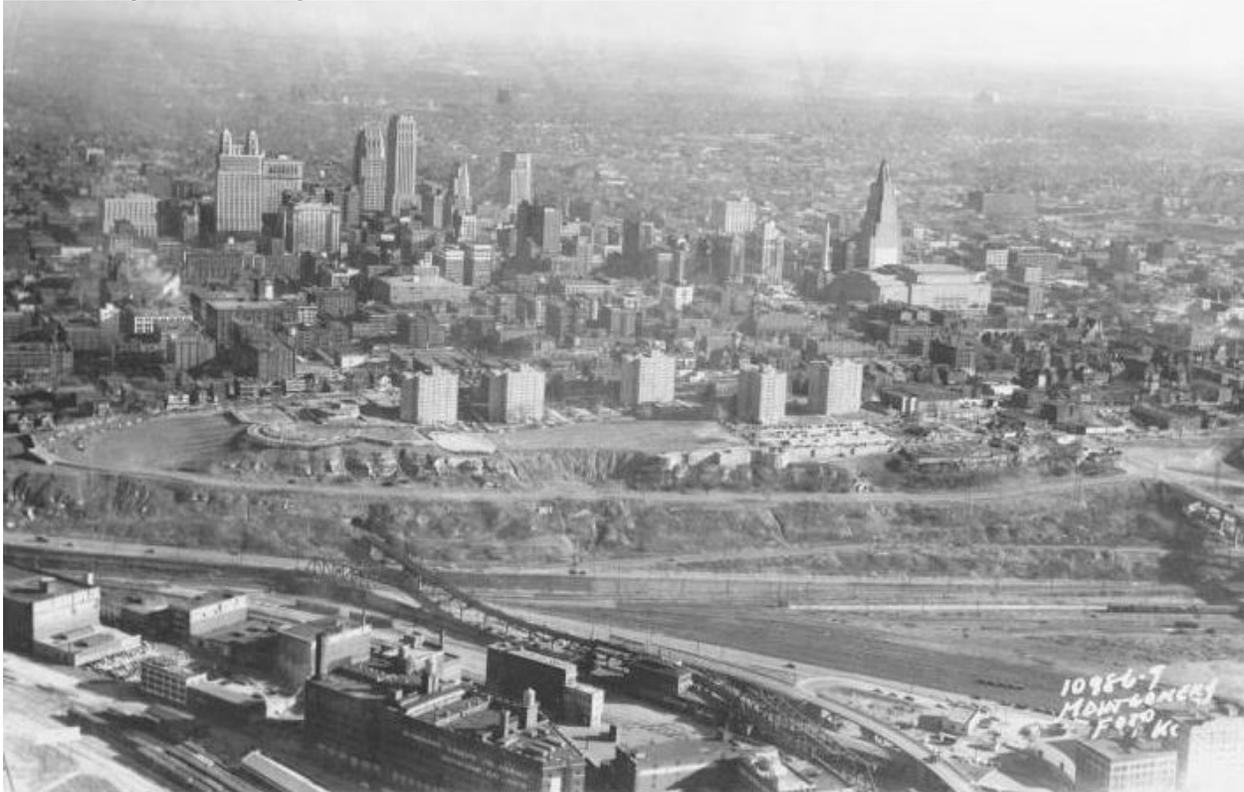
Figure 14. Quality Hill Towers, historic aerial photograph, c.1951. Missouri Valley Special Collections, Kansas City Public Library.

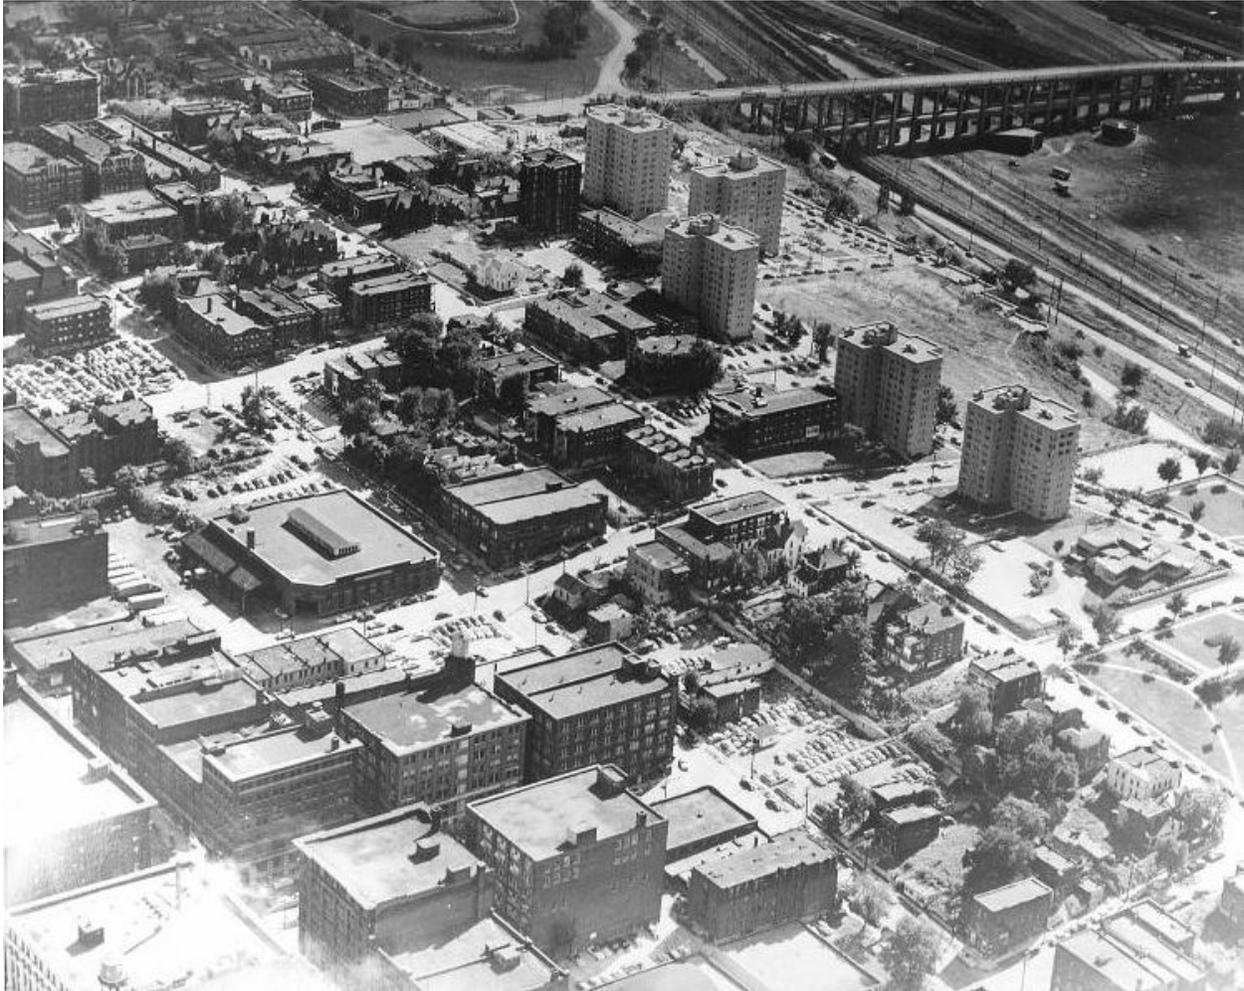
Figure 15. Quality Hill Towers, historic aerial photograph, 1956. Missouri Valley Special Collections, Kansas City Public Library.

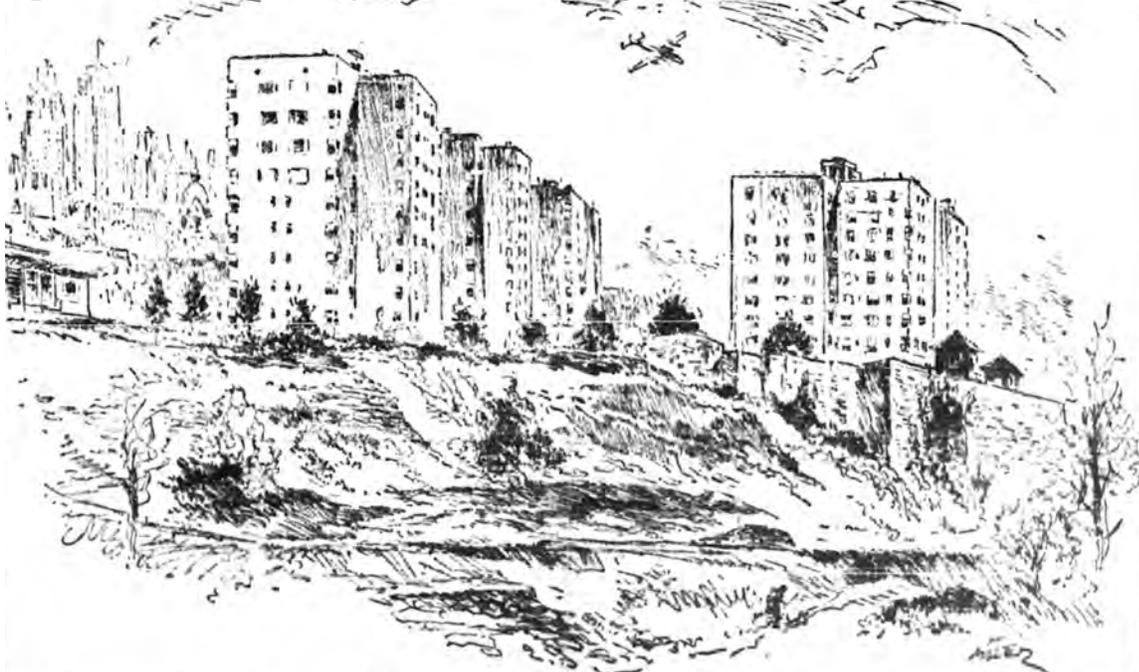
Figure 20. Rendering, "Quality Hill 1952," *Kansas City Star*, September 21, 1952.

Advertised as “Your Downtown Home with a Viewpoint,” promotional materials touted the property’s location in proximity to downtown churches, playgrounds, schools, and shopping areas as well as the view from the bluffs while also emphasizing rental fees designed to “suit even a young married’s budget” (*Figure 20*).⁴⁶ Rent for singles (studio apartments) was \$66 to \$83 per month, depending on the height and the view; rent for doubles (one-bedroom apartments) was \$80 to \$98 per month.⁴⁷ Within seven years, rents rose two dollars per month. The promotional brochure and application for prospective tenants outlined the amenities offered, including the lighted off-street parking lots, cleaning and laundry services,

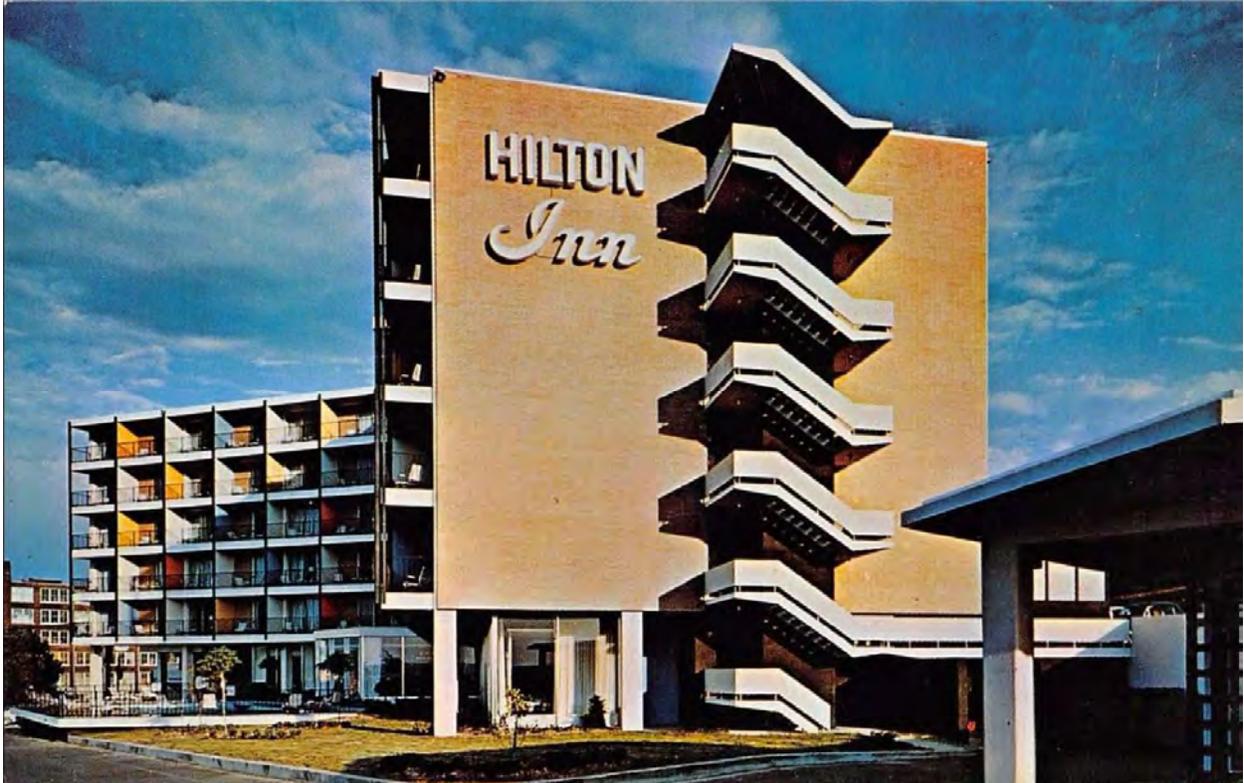
Figure 23. Hilton Inn (formerly Cliff House Motor Hotel), constructed 1960. Historic Postcard, c. 1970.

Lewis Kitchen constructed the other residential component of his 1955 expansion plan, the Cliff House Motor Hotel, in 1960. Kivett & Myers designed the Y-shaped six-story hotel building with a built-in parking garage for a large square lot at the north edge of downtown Kansas City. The square lot occupied the full 600 block of Washington Avenue, overlooking the Missouri River, the Downtown Airport, and the new interstate highway, dedicated in 1956.⁶⁰ By the late 1960s or early 1970s, the 180-room hotel building operated as the Hilton Inn (*Figure 23*). The hotel was demolished in 2002, although the parking garage still occupies the property.⁶¹ The office buildings proposed in the 1955 plan were never constructed. With the construction of 910 Penn and Cliff House underway, Kitchen returned his attention to the two blocks immediately east side of Quality Hill Towers between Pennsylvania and Washington avenues from W. 7th to W. 10th streets, immediately south of the Cliff House Motor Hotel. Kitchen’s 1955 plan called for seven multi-story office buildings. By 1958, Kitchen superseded the office plan with a plan to construct additional apartment buildings.⁶² The details of the revised plan expanded from six twelve-story towers in 1958 to four twenty-story towers in 1959 (*Figure 24*).⁶³ Neither of these plans came to fruition and nothing new

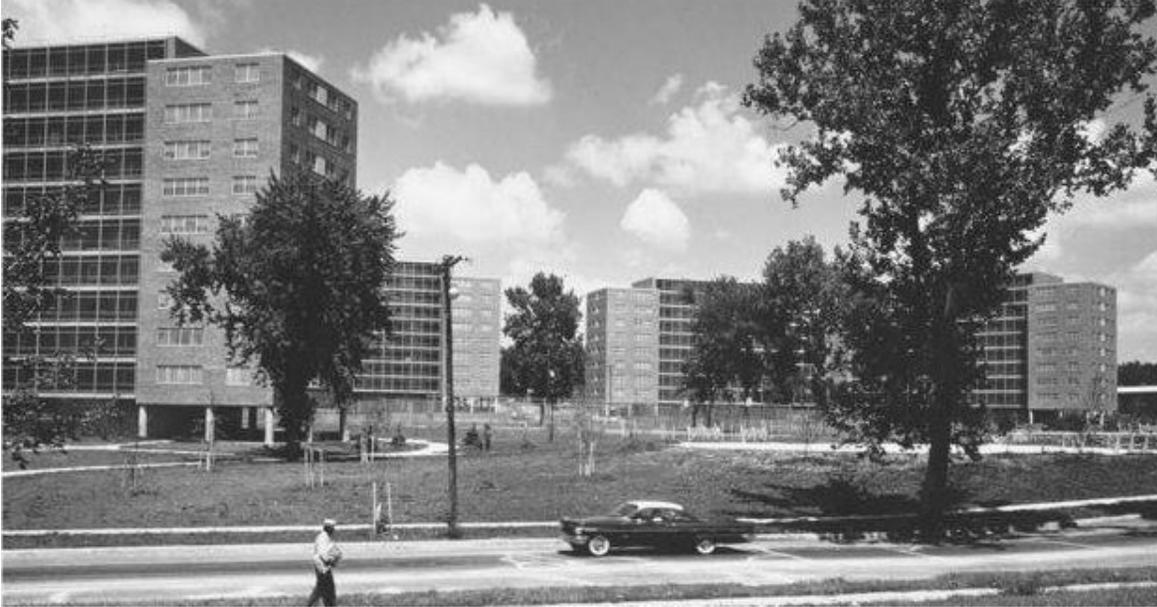
Figure 26. Historic photograph of Wayne Miner Housing Development, constructed 1960. Photo taken 1962. Missouri Valley Special Collections, Kansas City Public Library.

The high-rise apartment buildings at Wayne Miner were similar to the buildings in the Quality Hill Center Historic District in size, massing, and material (*Figure 26*). The Wayne Miner buildings had brick-clad sections at the ends of the building, flanking center sections of aluminum and glass curtainwalls with strong horizontal banding. The brick sections were elevated on piloti and had deeply recessed first-story walls. In the 1970s, private corporations and the Housing Authority of Kansas City used federal funds for the construction of high-rise towers for senior housing. The 1974 Brush Creek Towers and the 1977 Cathedral Square Towers are both thirteen stories tall and reflect Brutalist and Postmodern architectural aesthetics. The Wayne Miner public housing project was demolished in 1987 while the later towers are extant.⁷⁰

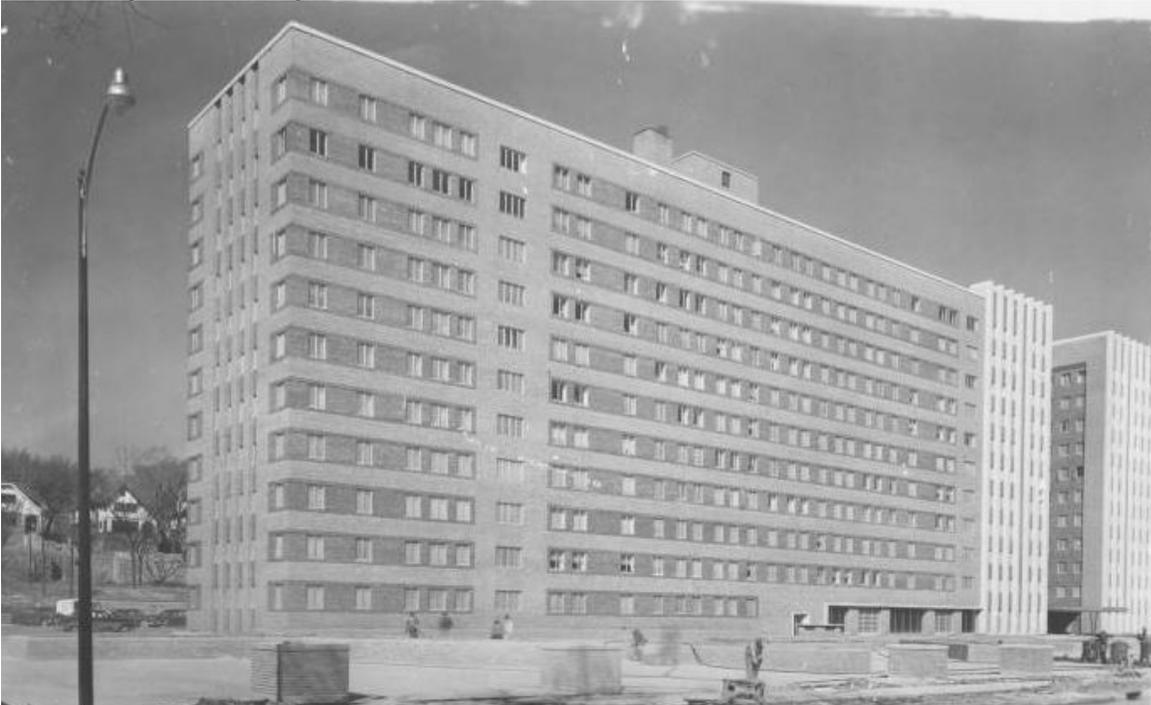
Figure 27. Historic photograph of Twin Oaks, constructed 1951, n.d., Missouri Valley Special Collections, Kansas City Public Library.

Plaza House Apartments (NR listed 10/16/2013), the 1956 Carlton Plaza Apartments, the 1964 Churchill Apartments, and the 1965 Sunset Apartments (*Figures 27-30*).⁷³ They all have brick cladding and banded fenestration patterns and/or corner windows, similar to the resources in the Quality Hill Center Historic District. Only the Churchill Apartments employs continuous banding similar to 910 Penn, although it still has solid masonry bands between the windows (*Figure 29*). These buildings are examples of private construction projects that took advantage of the FHA mortgage insurance program to assist in the financing of the project, but were not associated with slum clearance programs or officially recognized urban redevelopment areas. These similar buildings were constructed three to five miles south of the nominated property in stable, upscale neighborhoods.

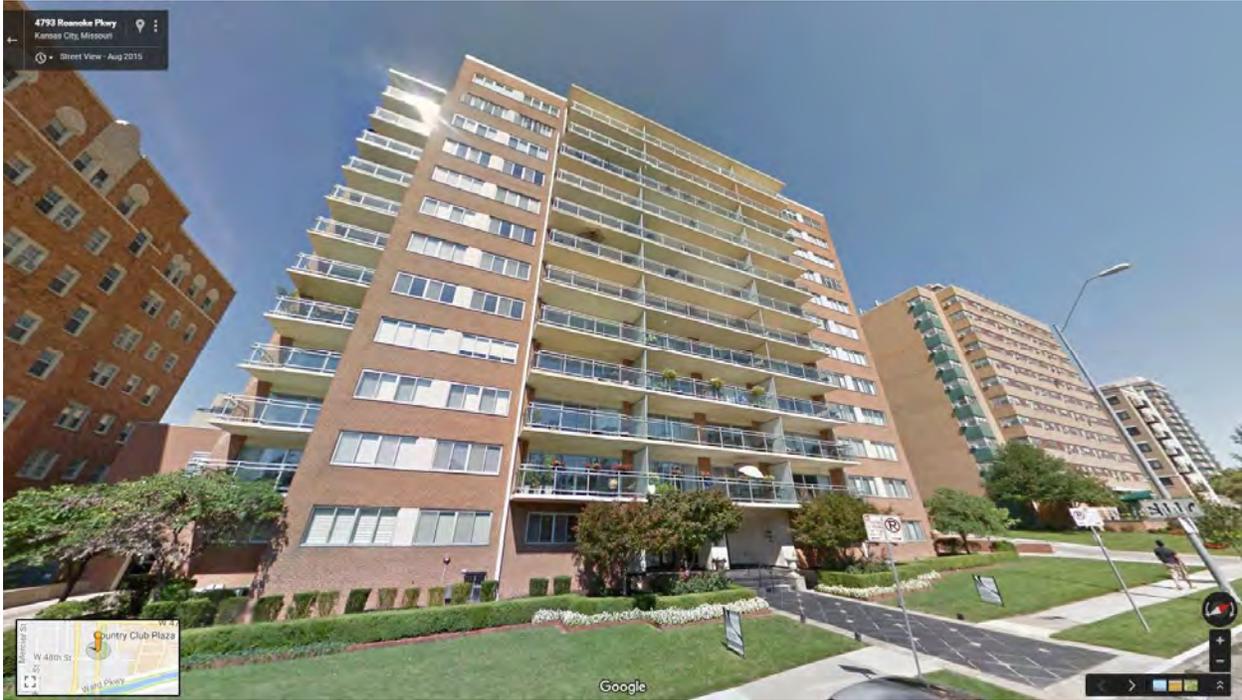
Figure 28. Carlton Plaza Apartments (1956) and Plaza House Apartments (1955). Google Street View, 2016.

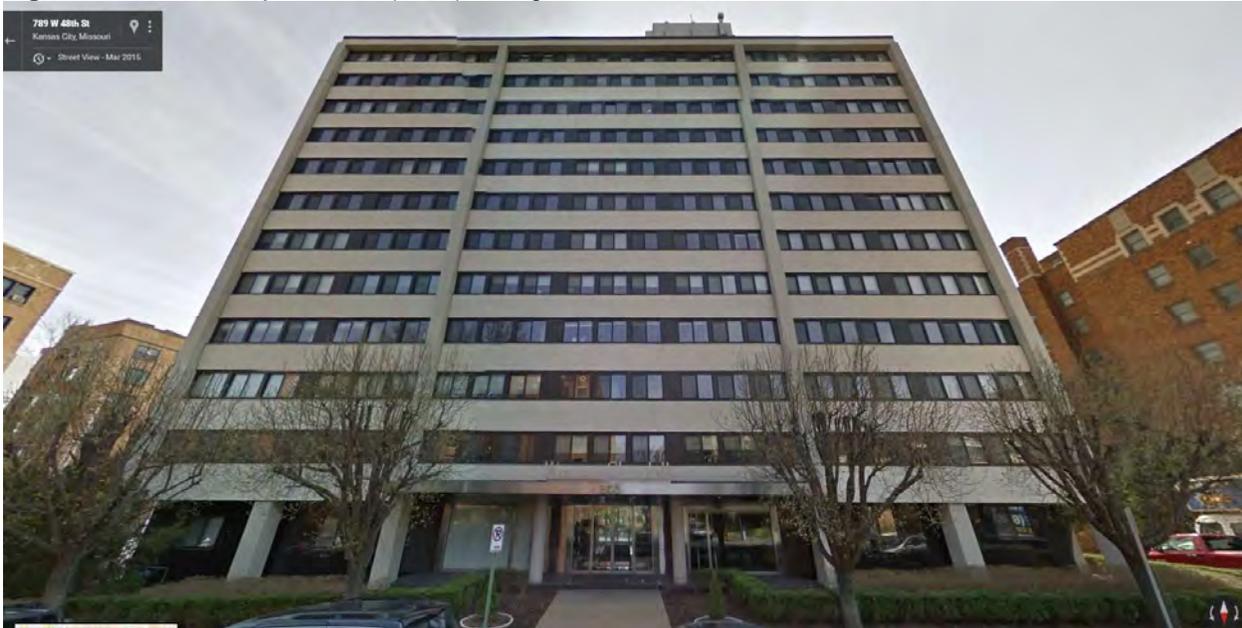
Figure 29. Churchill Apartments (1964). Google Street View, 2016.

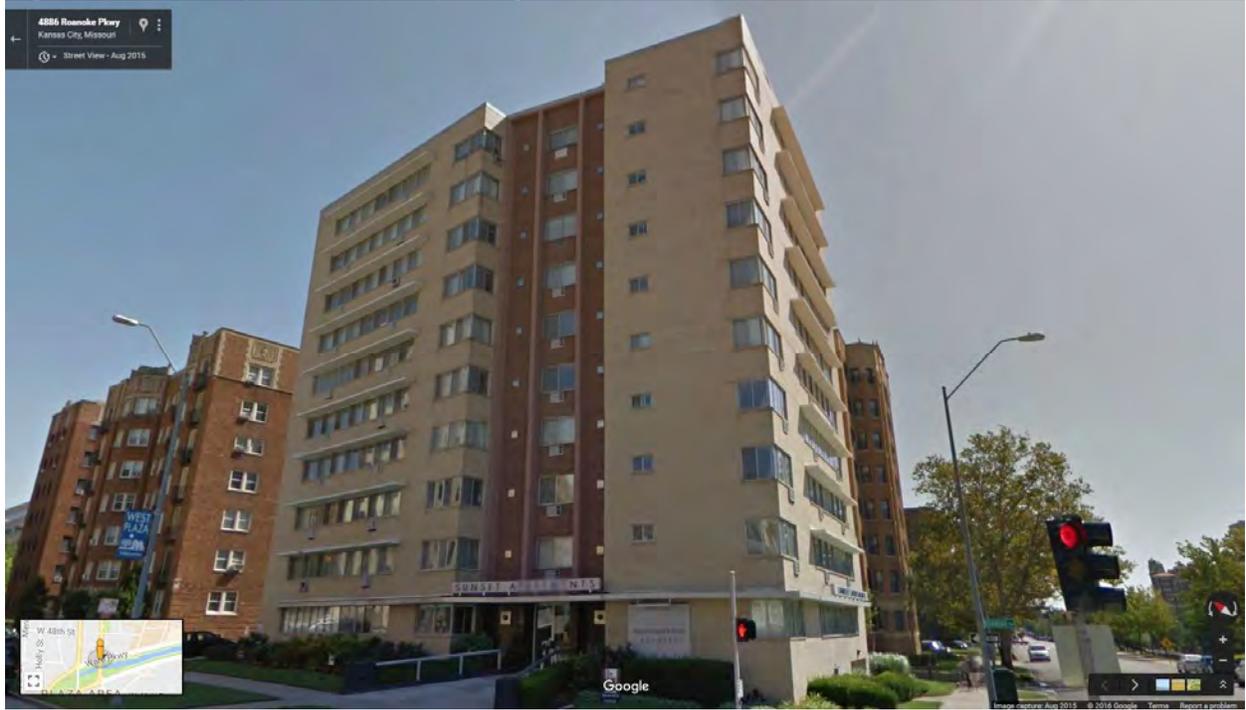
Figure 30. Sunset Apartments (1965). Google Street View, 2016.
