National Register of Historic Places  
Inventory—Nomination Form

historic Harlan Commercial District

Harlan Commercial District

Continuation sheet Harlan County, Kentucky

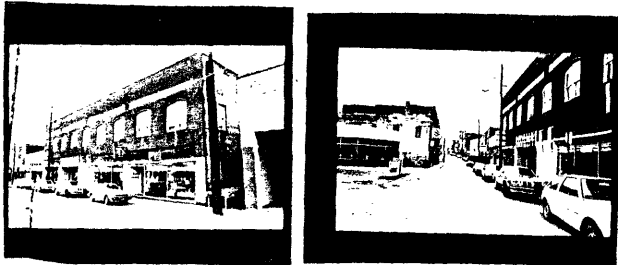
This brick building is a typical 20th c. commercial structure. The 1st floor is divided into 4, 25' x 100' stores and the front elevation reflects this with its large glass storefronts. A transom of 4" square lights runs the entire length of the building. The second floor is apartments and the front elevation is a series of nine double, 1-over-1 windows under jackarches. A series of 4 stone horizontal bands above these windows mark the top of the 2nd floor and the four store divisions below. Some of the stores retain their pressed metal ceilings on the interior and mezzanines to the rear.
