KENTUCKY HISTORIC RESOURCES
Individual Inventory Form

Resource # 144
Shelby County

1. Name of Resource: Olive Branch M.E. Church

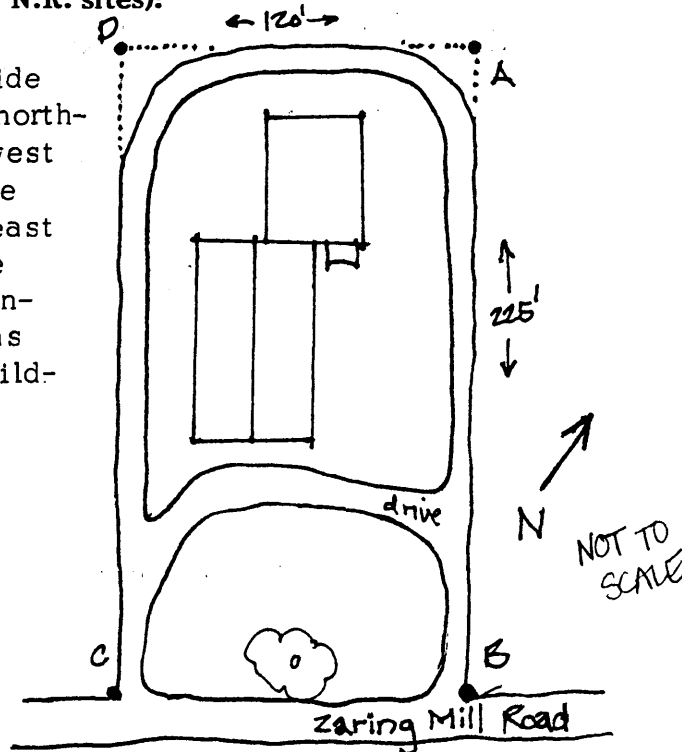
14. Site Plan (and boundary description and justification for N.R. sites):

Beginning at A, southeast 225' along the south side of a road to B, thence southwest 120' along the north-west side of Zaring Mill Rd. to C, thence northwest along the east side of the drive encompassing the church on the north and west to D, thence northeast 120' following the south side of said drive to the point of origin. The boundaries were chosen to encompass the lot on which the church is located as defined by roads and a drive. There are no outbuildings.

Point A is 40 feet north of the northern corner of the church.

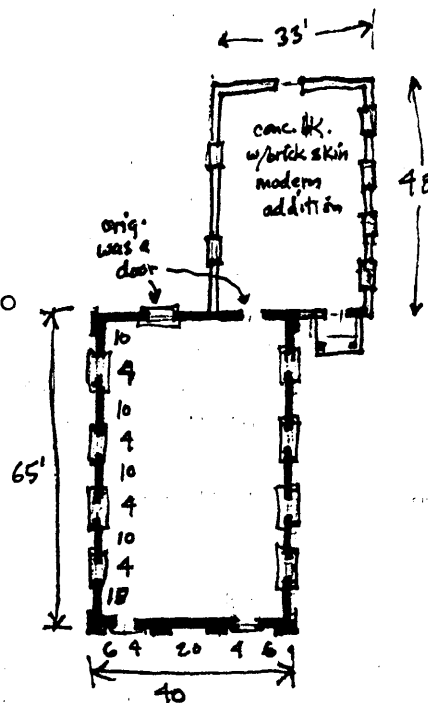
45. Description and House Plan:

1-story, brick, 4-bay, nave plan church; 7-course common bond with Flemish bonding course, gabled, asphalt shingle roof; low, ashlar foundation; wooden sills and lintels, colored glass windows; pilasters divide bays on principal (SE) facade; 2 4-panel doors located in outer bays have flat wood lintels, heavy Doric entablature on front and sides of building, entrances in rear (NW) gable end are original: one has been made into a window and the other gives access to a modern concrete block addition on the southwest corner of the building. The building is similar to Sh-103 (Salem Baptist Church, before its alterations) and nearly identical to Rockbridge Church (Sh-106, on the same circuit). Of the three, Olive Branch is the best preserved on the exterior.

Sanctuary shortened to provide for Sunday school and nursery space before addition of concrete block wing: ceiling lowered, imitation wood panelling, mid-to late 19th century trim including deep shouldered architrave trim on all openings, original pews replaced (some stored in the basement).
