National Register of Historic Places Registration Form

historic name Matus, Antonio, House and Property
other names/site number Mesa, Elisa, House and Property

street & number 856 W. Calle Santa Ana N/A not for publication
city, town Tucson N/A vicinity
state Arizona code AZ county Pima code 019 zip code 85705

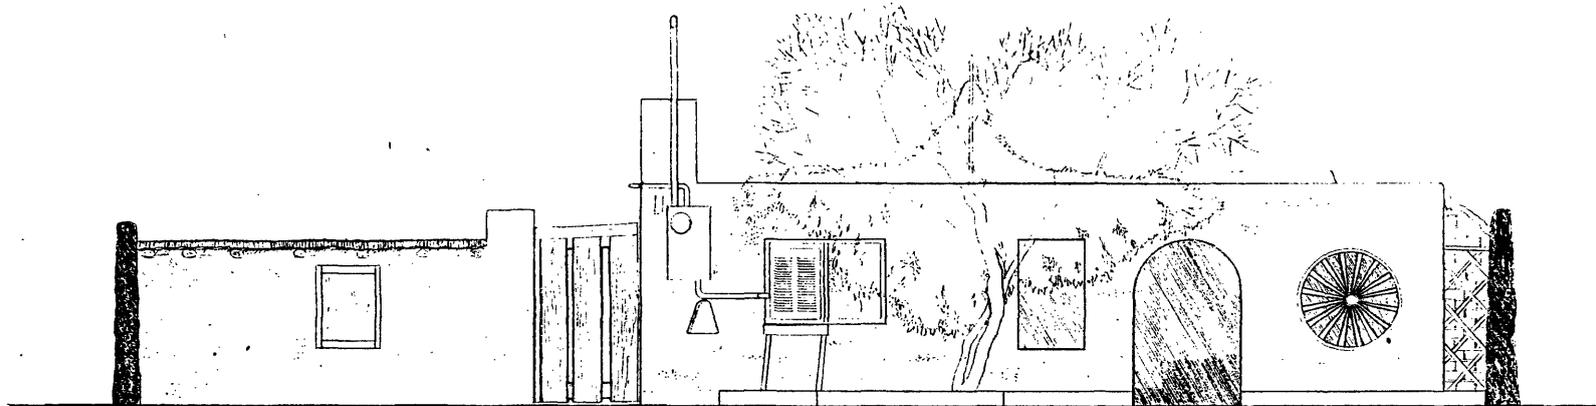
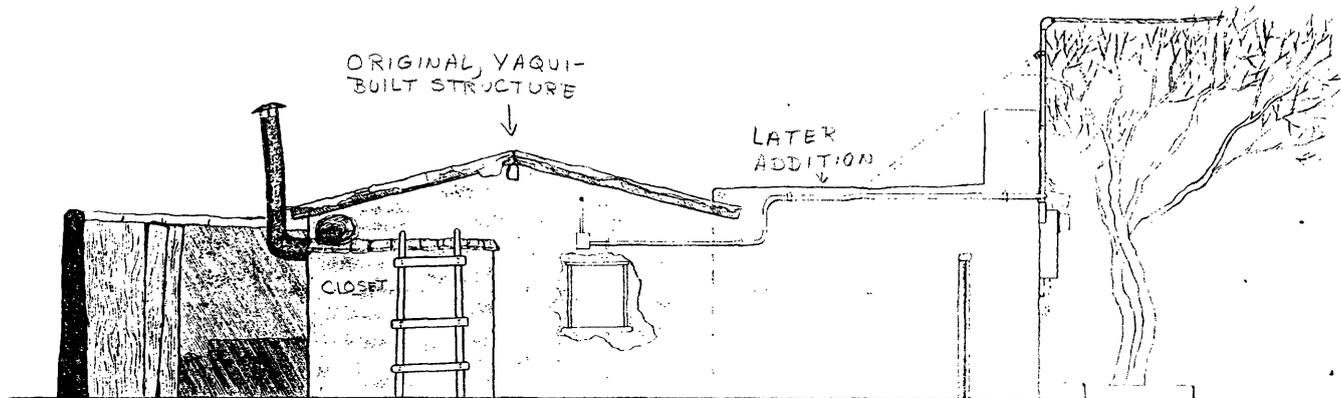
FIGURE 10

SOUTH FACADE, SHOWING PLASTERED MASONRY ADDITIONS

WEST FACADE

The house is at the north end of the Matus property. The portion of the house built around 1926 is adobe and consists of three rooms (a kitchen and two bedrooms), with a low-pitch, gabled, hewn-timber roof and a concrete floor (see Map 1 and Figures 1 and 2). The pitched roof is specifically a Yaqui building trait. The original structure measures 26 feet east-west by 14.5 feet north-south (outside dimensions). Walls of the structure are about 8 feet high and interior ceilings are low. It is of indigenous Yaqui style.

Additions to the original structure include a bedroom on the southwest corner, a "closet" on the northwest side of the house, an enclosed porch with a dirt floor, and a hall-like storage area on the east side of the house (see Map 1 and Figure 1). These additions are made of masonry and are flat-roofed. Their construction date is unknown, but the best

estimation is that the additions date to Mexican occupation of the house, which began some time between 1950 and 1962. The flat roof on the addition is a good indicator of Mexican, rather than Yaqui construction. The two rooms on the south side are 28 feet east-west by 12 feet north-south (outside dimensions). The main entry into the structure is an arched doorway that opens into the enclosed porch.

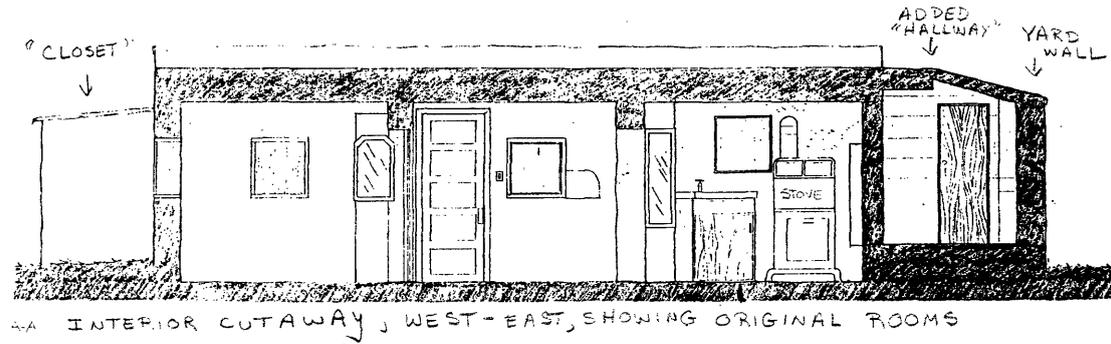
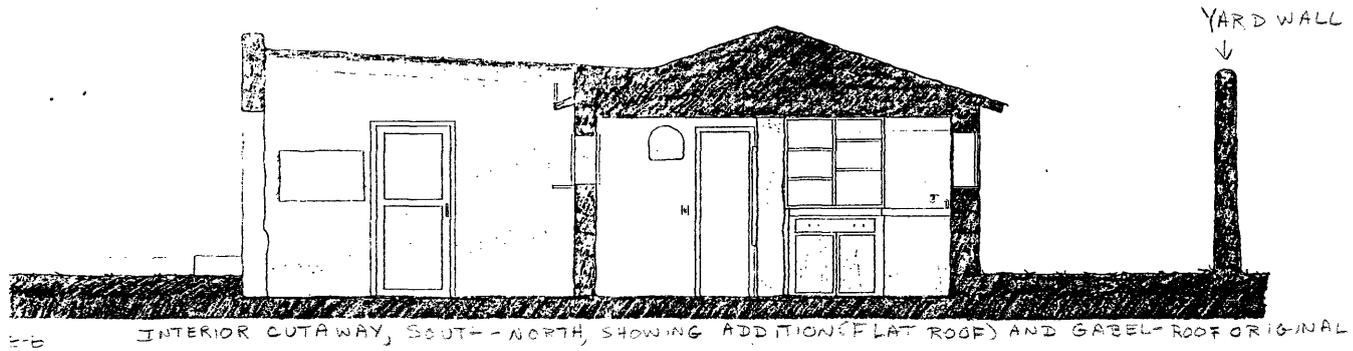
FIGURE 2.

SECTIONS

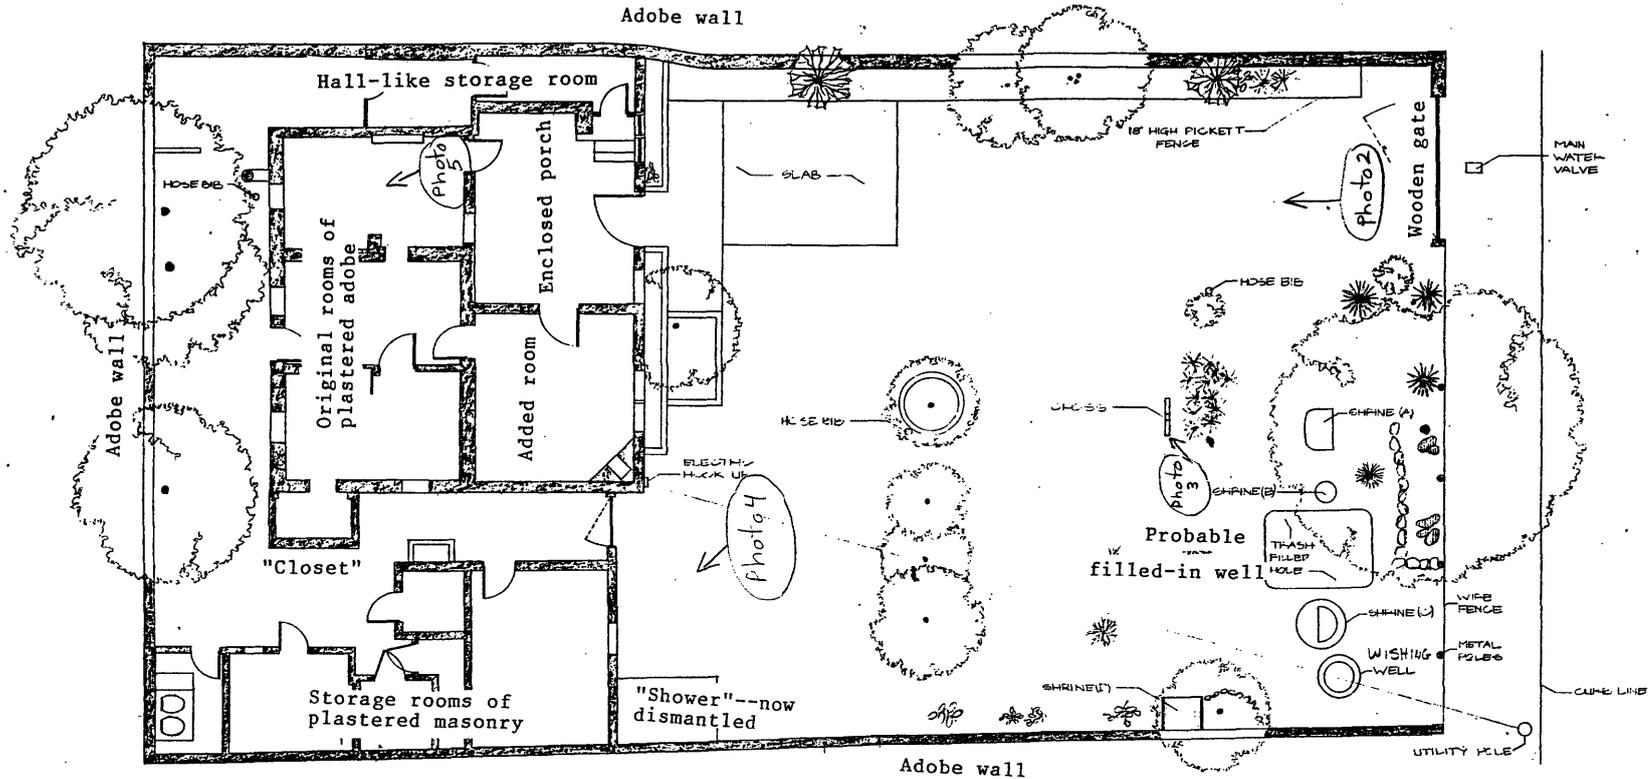
SITE
PLAN

- Contributing Features are:
- House
 - Yard--especially layout and vegetation
 - Probable filled-in well
 - Yard cross
- Noncontributing Features are:
- Storage rooms
 - Adobe wall around yard
 - Shrines and wishing well

The yard measures 45 feet east-west by 90 feet north-south. On the south side of the yard are four shrines and a wishing well, probably constructed by the final resident, Elisa Mesa, a Mexican. In the center of the south side of the yard is a cross, most likely erected by Yaqui residents and maintained by Mrs. Mesa. In the southeast corner of the yard is a rectangular, trash-filled pit and another circular pit that is probably a filled-in well (see Map 2) used from the 1920s until the 1970s (when Old Pascua got a piped-in water system). The south end of the yard is bounded by a chain-link and wood fence with a large wooden gate. Plantings in the yard, including a huge prickly pear, a mesquite tree, a palo verde tree, and carrizo, could date to

West of the main house are storage rooms (measuring 34 feet north-south by about 13 feet east-west at their widest), which have been built against the west wall yard, creating a small, patio-like space between the house and the sheds. The storage rooms are also of plastered masonry. At the north end of these detached rooms is a functioning wood-frame and cement block outhouse. (Although it has been hooked up to a water line, the house has never been hooked up to a sewer.) Construction dates of these additions are unknown, but probably are later than 1937.

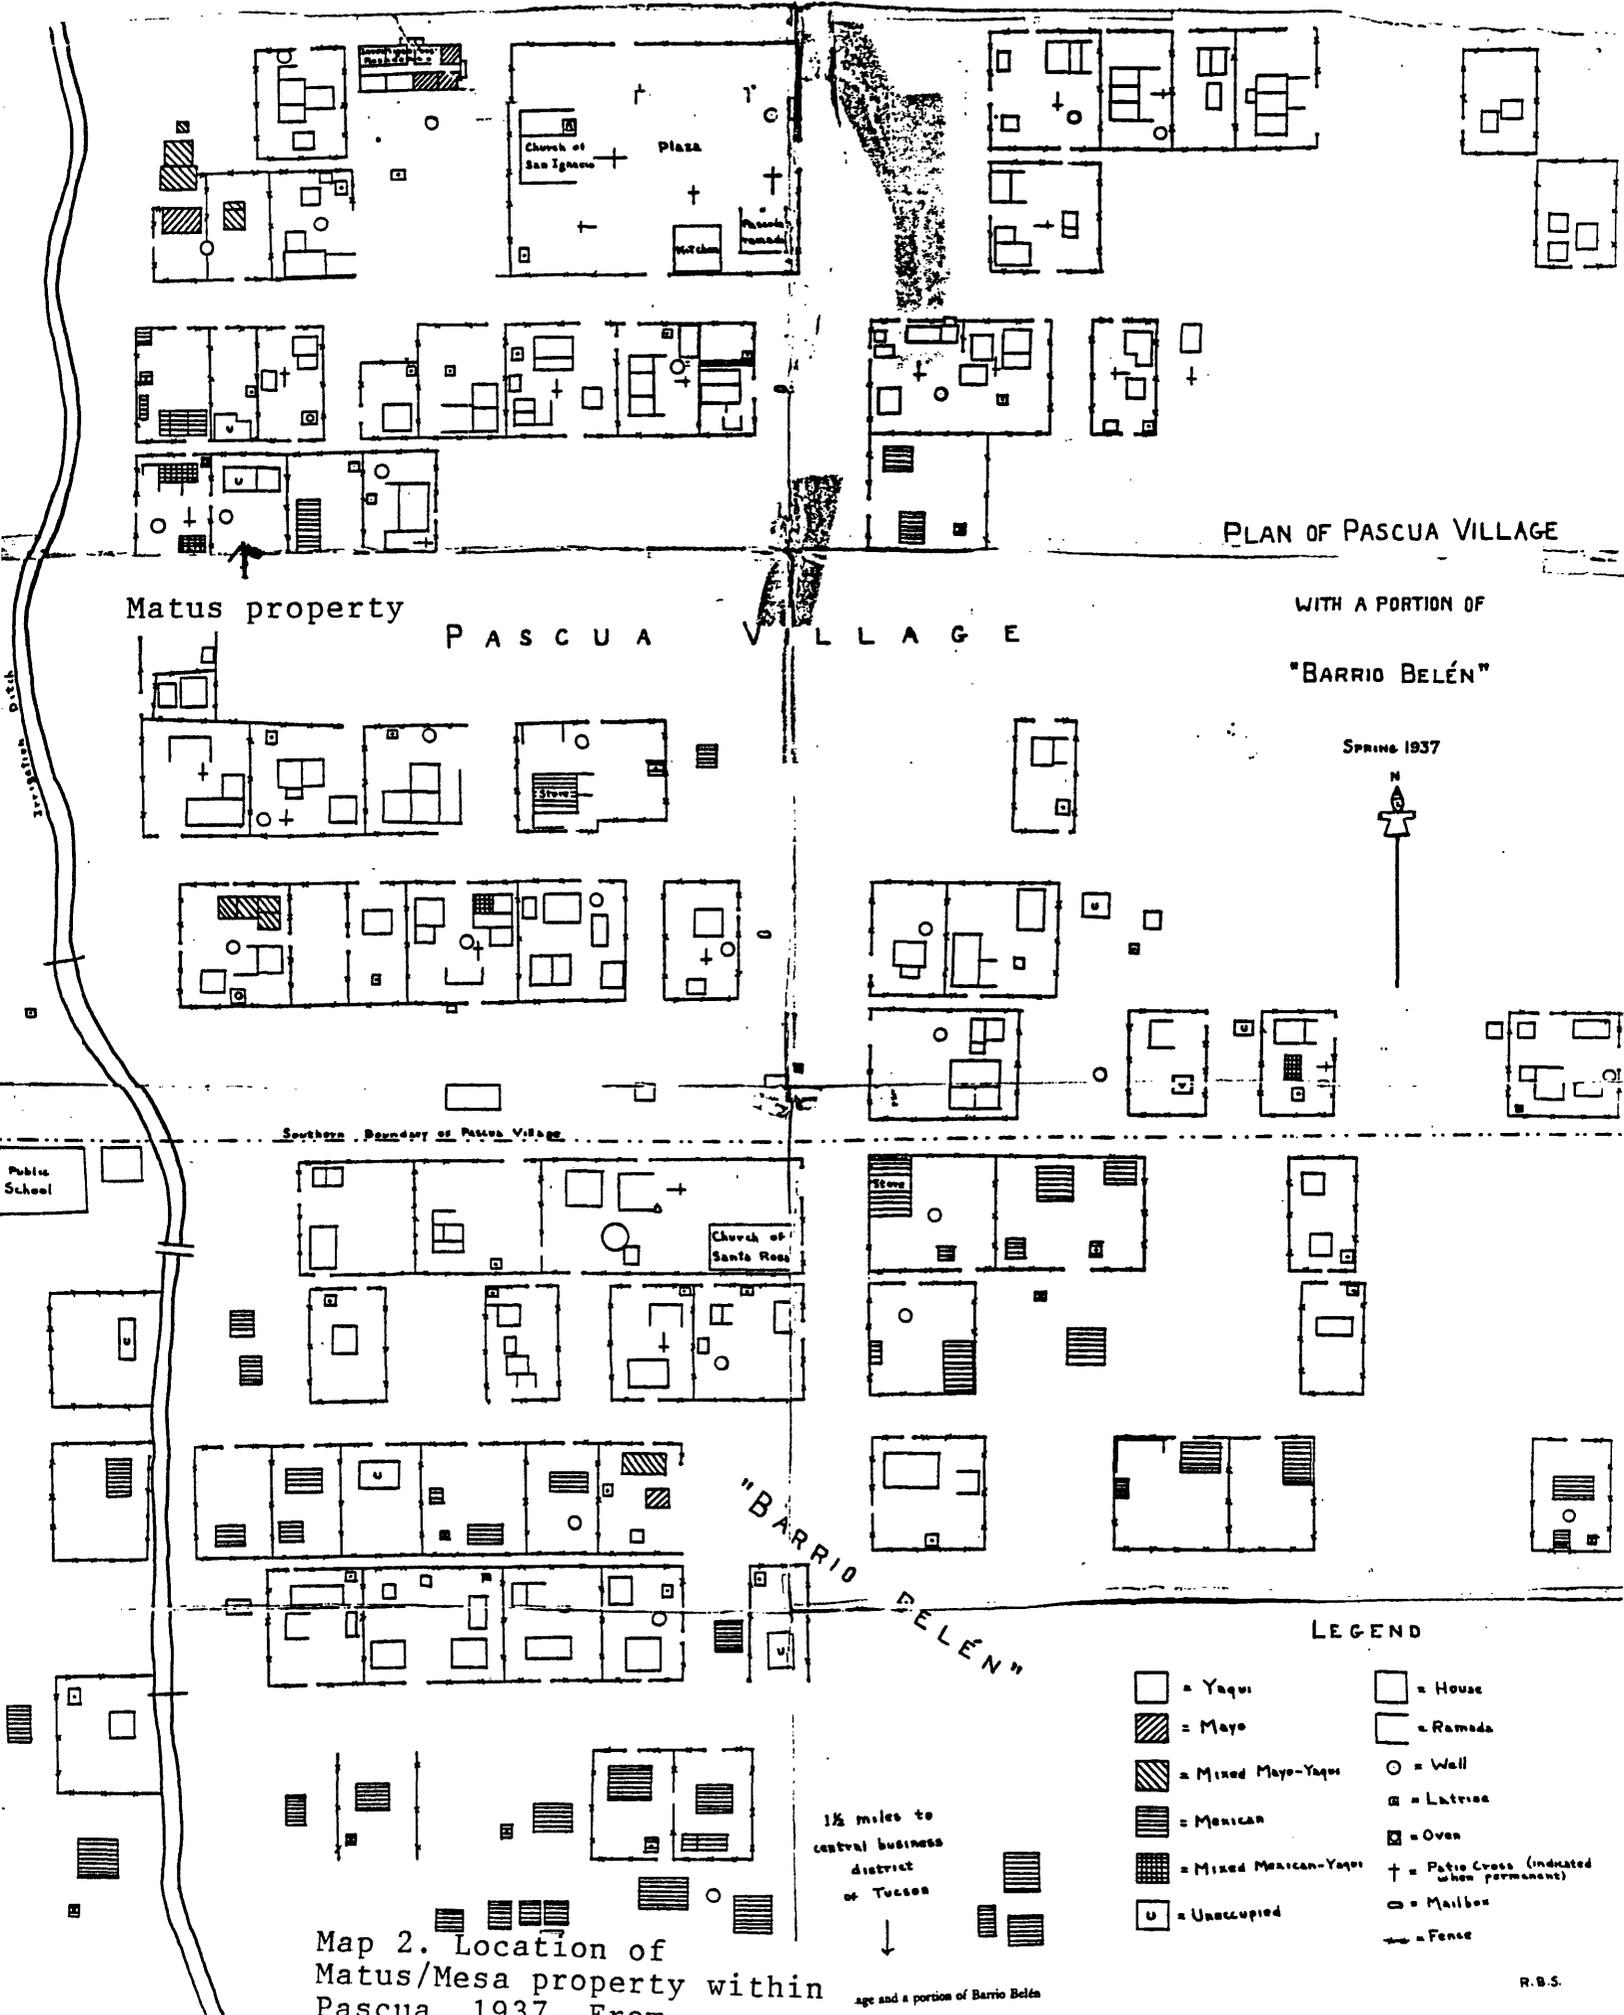
Map 2. Location of Matus/Mesa property within Pascua, 1937. From Spicer. Pascua: A Yaqui

PLAN OF PASCUA VILLAGE

Matus property

Most of the older homes in Old Pascua have been demolished, and many have been replaced with low- or no-cost-to-the-owner housing as a result of Community Block Development Grants and assistance from Habitat for Humanity. Houses and compounds on the east and west side of the Matus property (see Map 2) that dated to the 1930s or earlier have been demolished, and on the north side replaced with new housing. A yard enclosed by a sheet-metal fence remains on the west side of the Matus property, but only an open shed remains on that property. The Matus property is one of four or five residences in Old Pascua and Barrio Belen that retain characteristics of the 1921 to 1940 village.
