KENTUCKY HISTORIC RESOURCES
Individual Inventory Form

Resource # 111
Shelby County

1. Name of Resource: Shady Rest

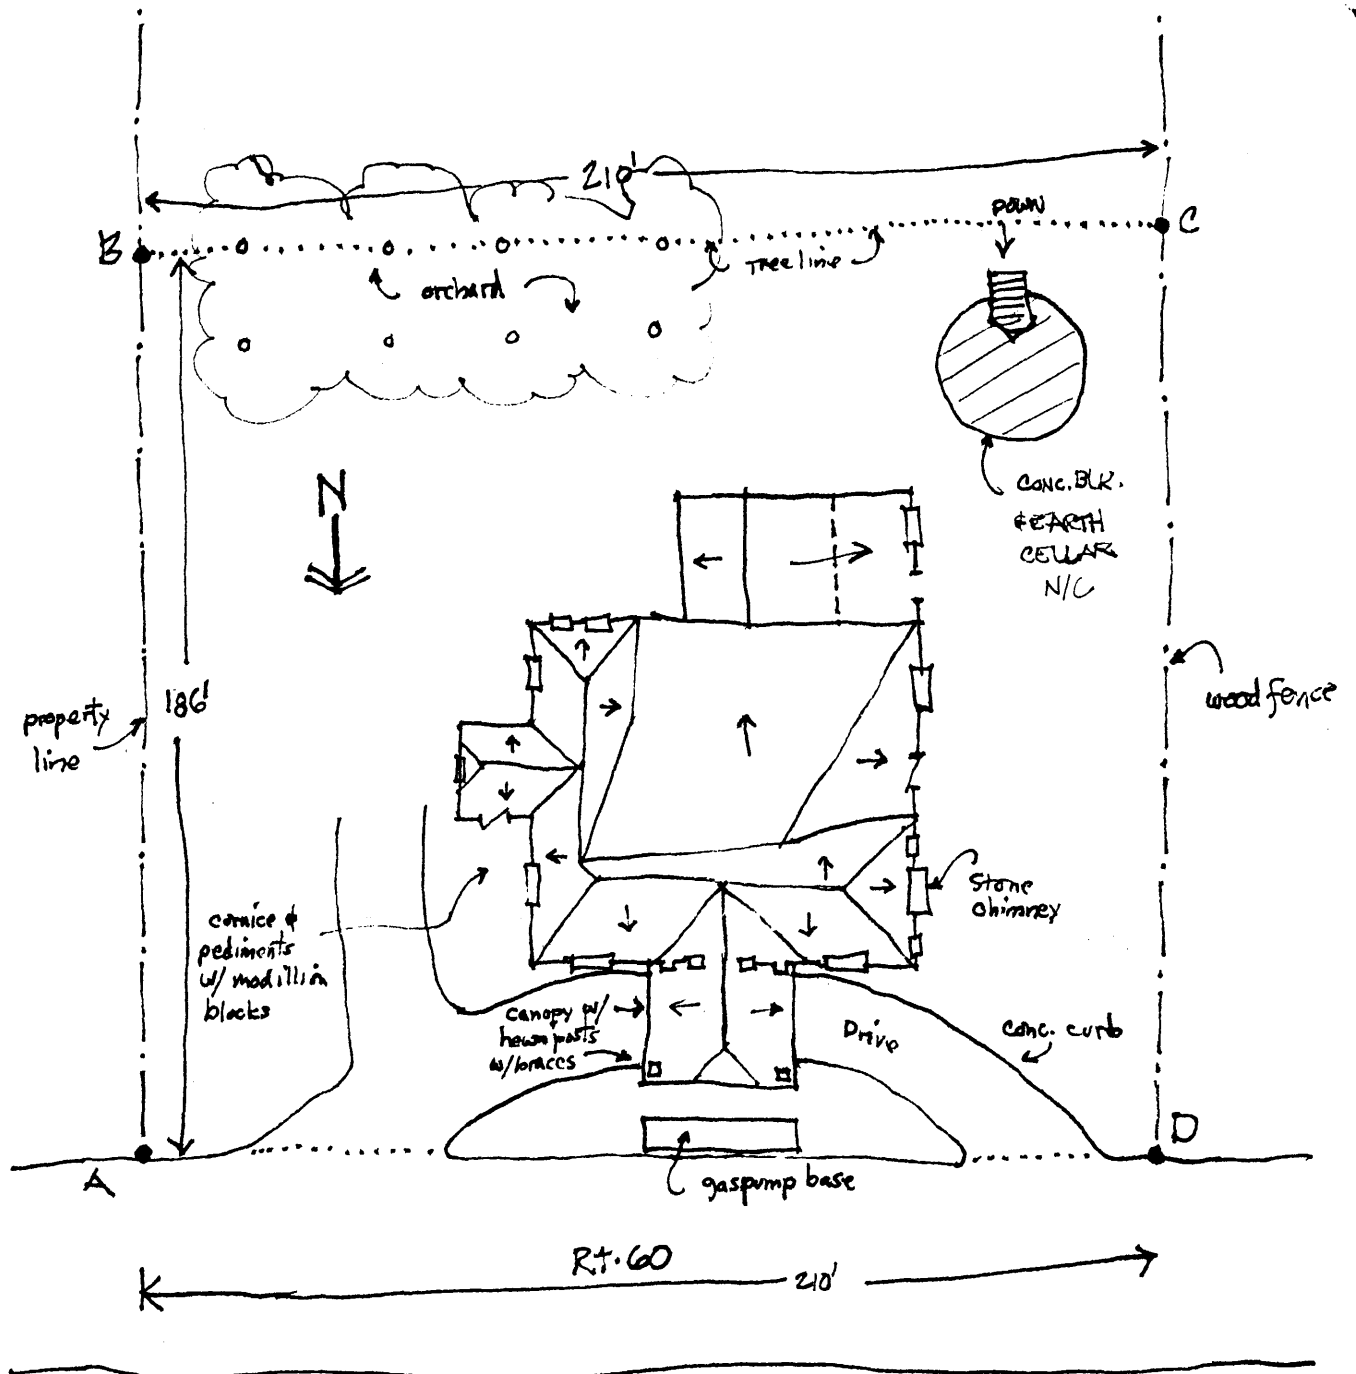
Shady Rest Sh-111

Beginning at A on the south side of U.S 60, south 186' along the property line to B, thence west 210' along the tree line to C, thence north 186' along a fence to D, thence east 210' along the south side of U.S. 60 to the point of origin. The boundaries were chosen to encompass the building and its immediate environs, including a non-contributing modern concrete block cellar. See page four for site plan.

Point A is located on the southern edge of U.S. 60, 20 feet west of the point where the western edge of the westernmost arm of the drive meets the road.

The 1-story, hip-roofed structure with clipped gable pediment in two locations, is reached from the highway by a curved drive, which passess beneath a canopy supported by massive hewn braced timber posts. The building is entered by an elaborate Palladian entry under the canopy, and carries a cornice with modillion blocks. The windows are 2/2 (horizontal) sash with arched transoms. The building is sheathed with wood shingles, and a stone chimney stands at the west side. The hipped roof front (north)section has a rear shed-roofed wing which in concealed behind a hipped roof on the east side. A gabled wing projects from it to the south. The rear wing is a modern addition.
