National Register of Historic Places Registration Form

Historic name: Edward Ford Plate Glass Company Employee Relations Building

Other names/site number: The Ford Club

City or town: Rossford State: Ohio County: Wood

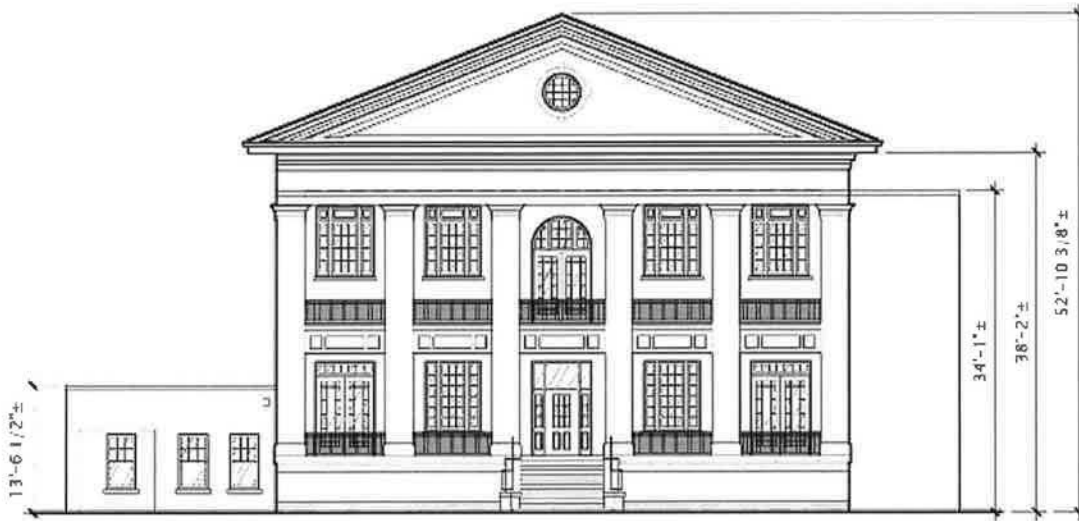
SOUTH ELEVATION - EXISTING

The gabled front of the Employee Relations Building is approximately 60 feet wide with pronounced full-height porch, which provides a distinct public entrance. The large porch provides respite to the spaces inside and allows a substantial gathering place, useful for between functions or at intermission from the second floor auditorium. At the first level, three pairs of original doors open onto the porch with windows between them. This front elevation is largely intact and the windows, doors, and railings appear to be original. Each pair of doors has sidelights. (Photo 1, 3) The top of the second floor porch forms an entablature with a simple frieze and wood cornice with dentils. The porch includes a wrought iron balustrade although the second floor porch appears to have had the rail replaced with fencing. The second floor porch has one centered pair of doors and two windows flanking each side of it. The entablature forms the base of a gabled pediment. Within the pediment is an oculus window with stone keystones at the quarter points vertically and horizontally. The pediment is supported by six full height square brick columns with simplified stone bases and capitals.

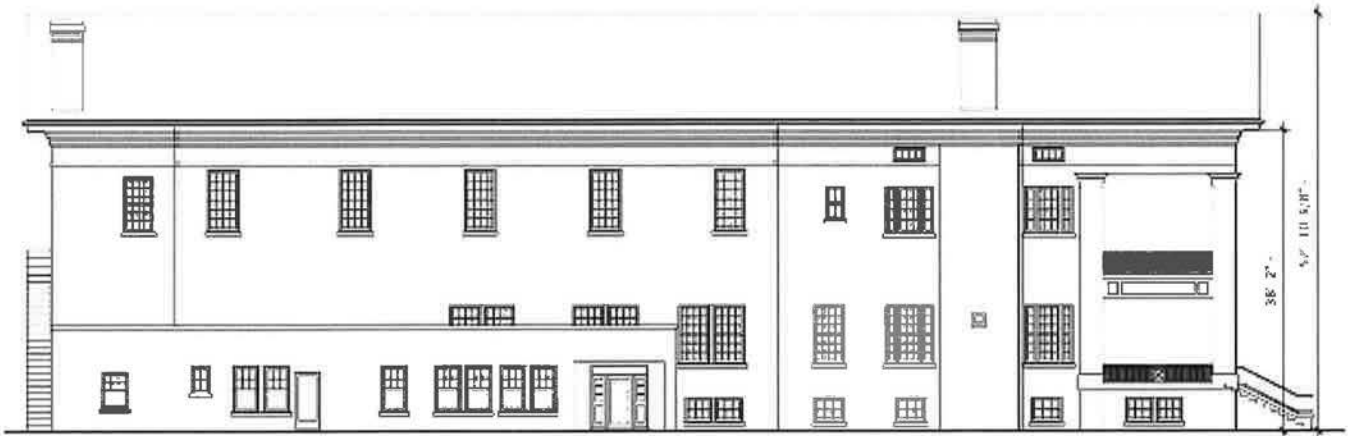
WEST ELEVATION - EXISTING

The side elevations (east and west) are approximately 148 feet long and reflect the interior with strategically located windows indicating room locations. All of the window openings appear to be original. The punched openings reflect the office uses inside and include either historic 9 over 9 wood windows or 12 over 12 wood windows most of which have deteriorated sash and muttons as well as broken glass.(Photos 2,3,5,6) The east side has rectangular a two story projection that includes a freight elevator and stair. The west side includes a rectangular one story projection which is at grade. (Refer to the Sanborn map.) A small covered entry way at the west side leads directly into the building at this point. The west projection was used as office space for LOF into the 1980's. Both sides of the building include the original wood trim extension of the entablature which supports a gutter and include continuous dentil trim. Both the east and west sides include a continuous gutter with various spaced downspouts.

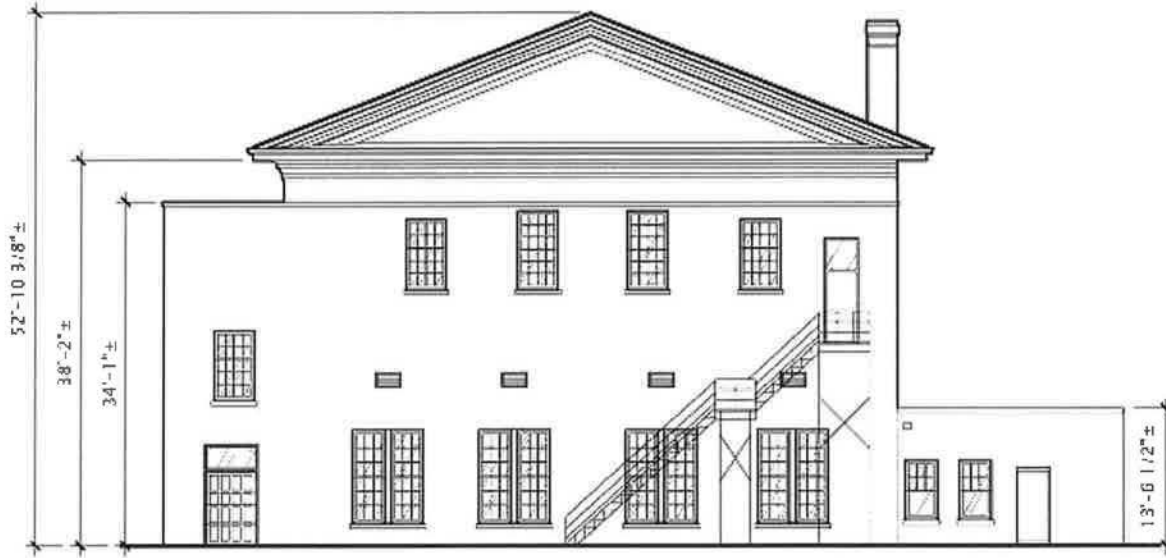
NORTH ELEVATION - EXISTING

The rear elevation shows the pediment and an emergency exit from the auditorium above. (Photo 7, 8) A fire escape extends along the rear wall, most likely added during the 1930's. Four

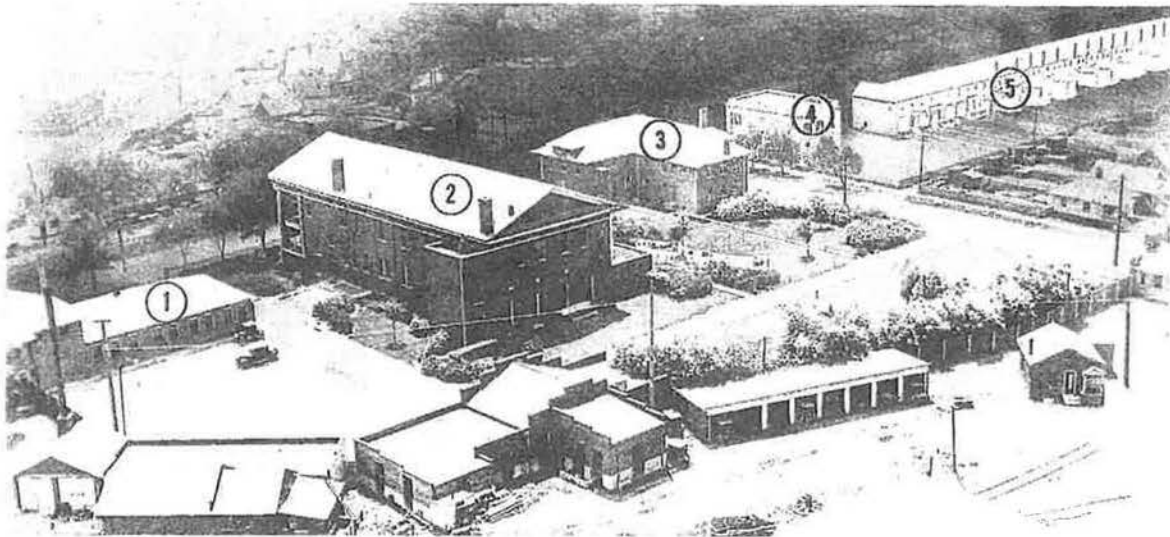
Figure 3. From The Roots Grow Deep Aiken; Lezius-Hiles Co. Cleveland OH, 1957

Taken from a water tower, this back view shows several interesting construction progress factors. At extreme left, (1) the office wing extension, still used and where Edward Ford's office was located; the Rossford Club (2) (completed in 1917), the old Rossford hotel (3) (since razed); the Rossford Savings bank, (4) where early Rossford baseball enthusiasts cavorted and the Terraces, (5) still occupied by Rossford employees and where several retired men and their families live.
