# National Register of Historic Places Registration Form

historic name Idlewild

other names/site number Furness Summer Cottage

Idlewild, Delaware County, PA

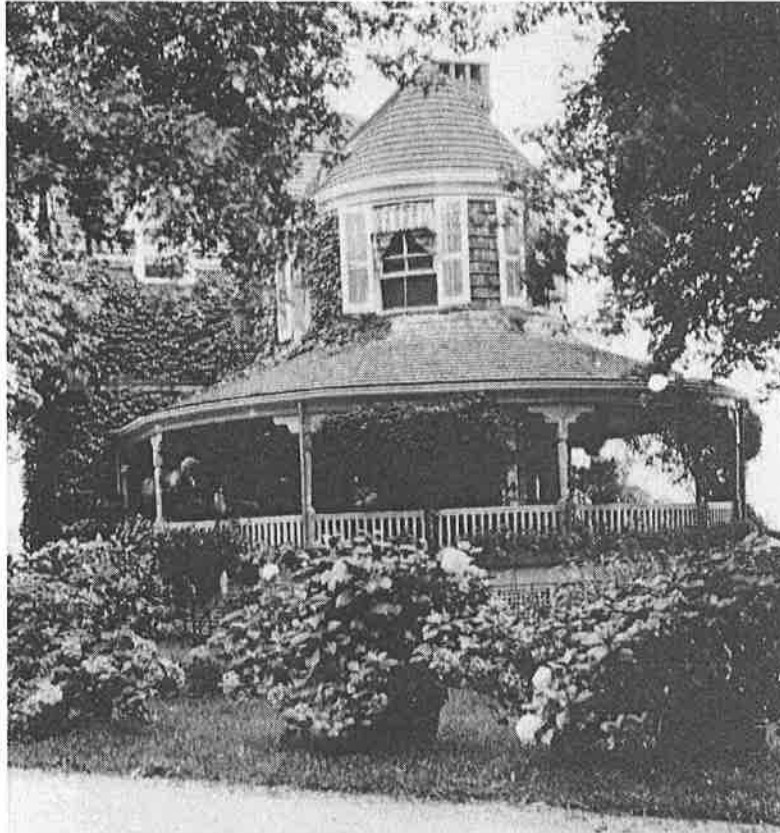
Figure 11: Historic photo, 1899, showing west end of house. Courtesy of current owner.  
(Also provided as Photo #1)

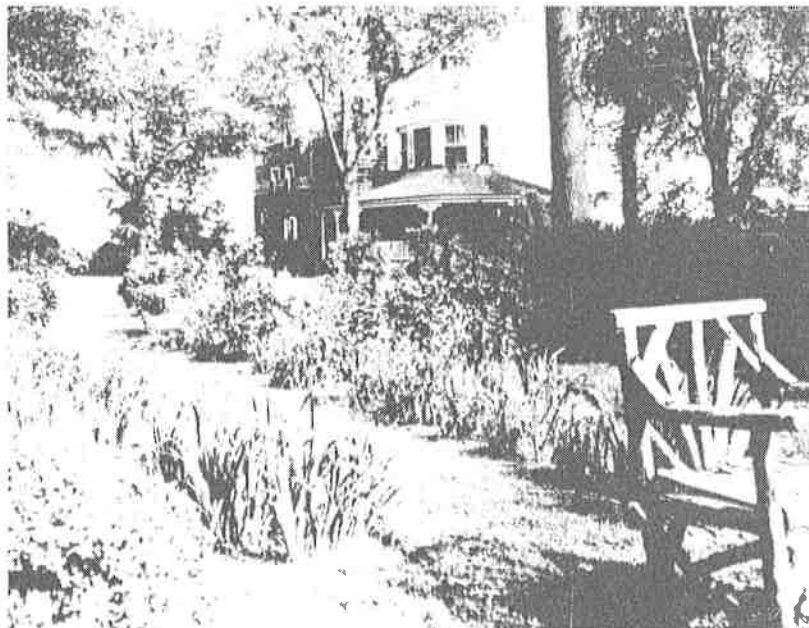
Figure 12: Historic photo, c.1890, showing north façade and west end of house. Courtesy of current owner. (Also provided as Photo# 2)
