**NATIONAL REGISTER OF HISTORIC PLACES
REGISTRATION FORM**

historic name: Bridge 22

other names/site number: Creamery Bridge

Bridge No. 22 is a well-preserved, single span, steel Warren pony truss bridge built in 1934 and fabricated by the American Bridge Company at its plant in Elmira, New York. The structure carries Town Highway 27 (Creamery Road) across the Waits River in Bradford. In 2007 the bridge was rehabilitated for continued highway use, its original intended purpose, and it retains substantial integrity in location, design, setting, materials, workmanship, feeling and association.

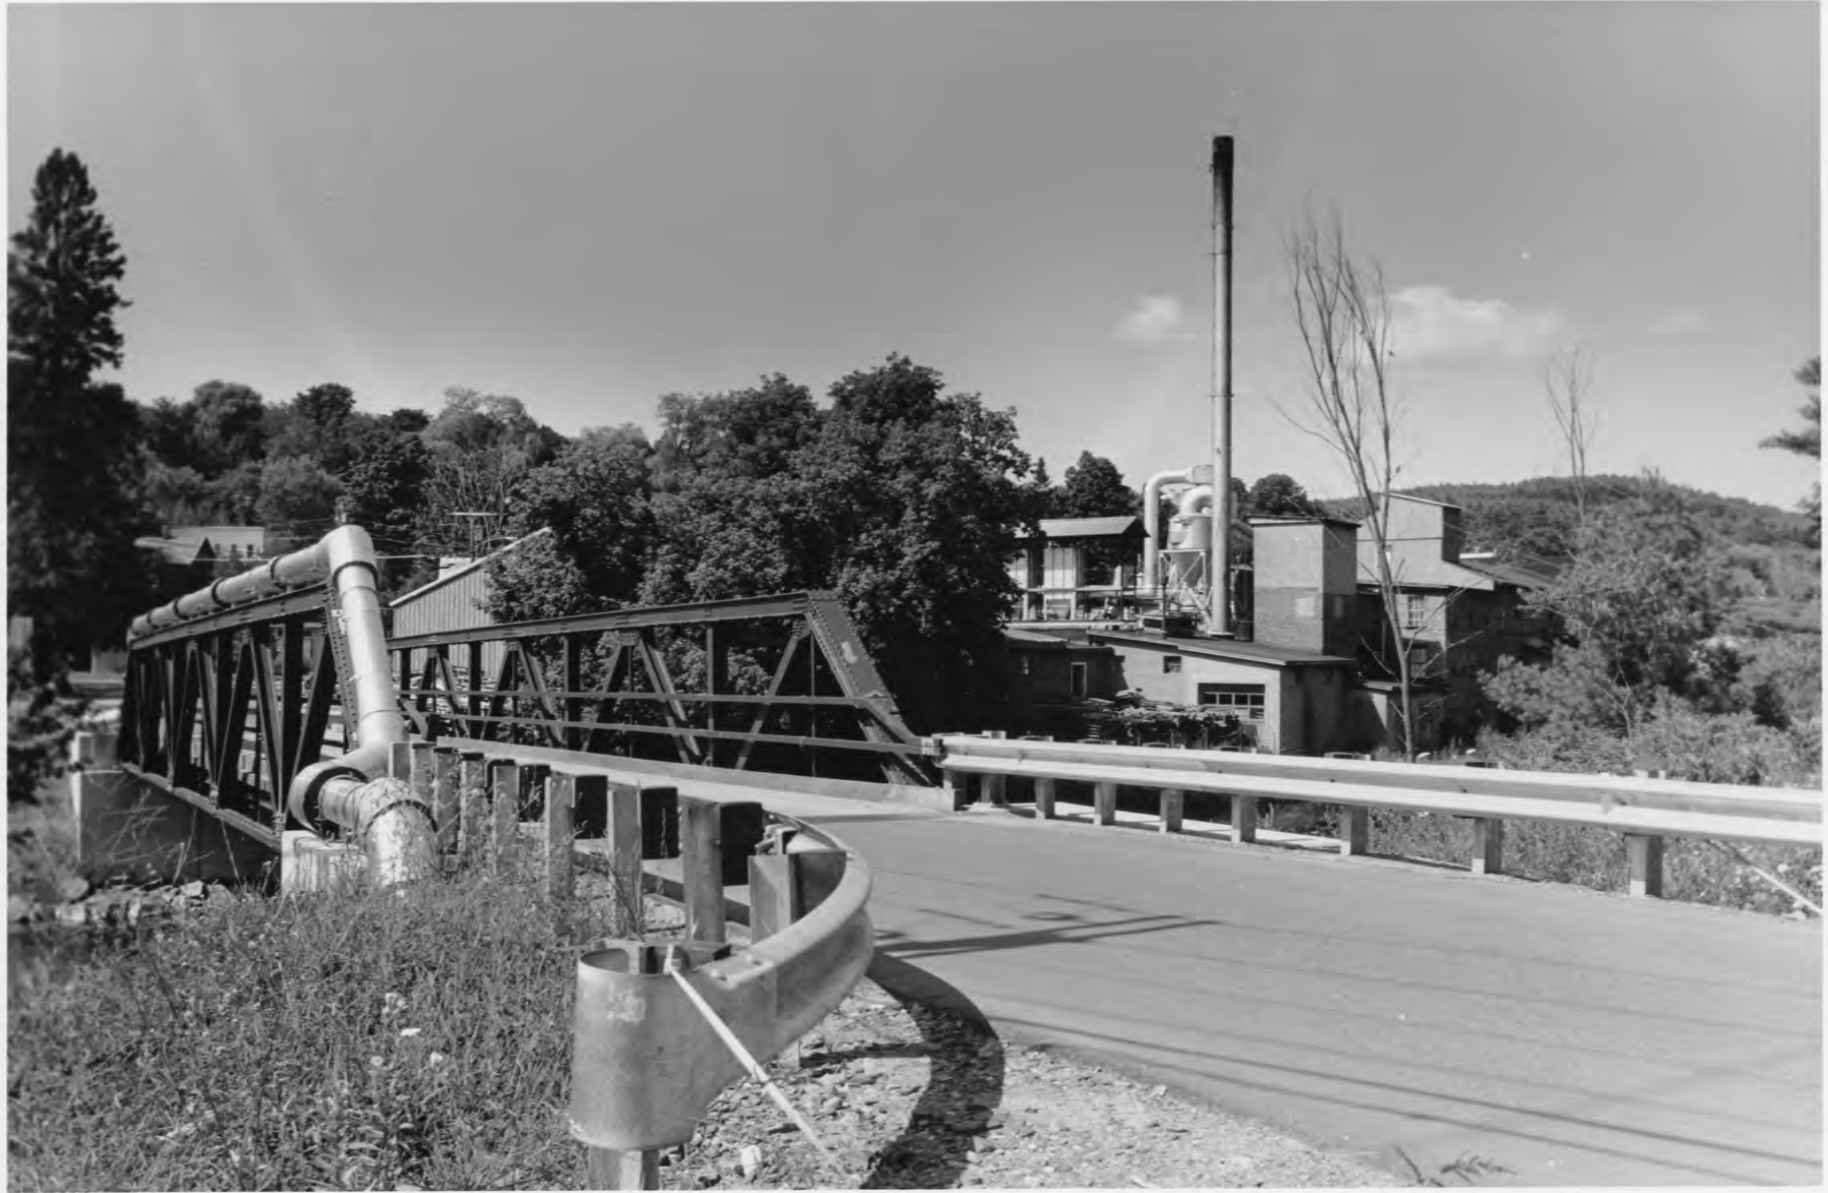
PHOTOGRAPH NO. 1

Photograph No. 1: View looking northwest.

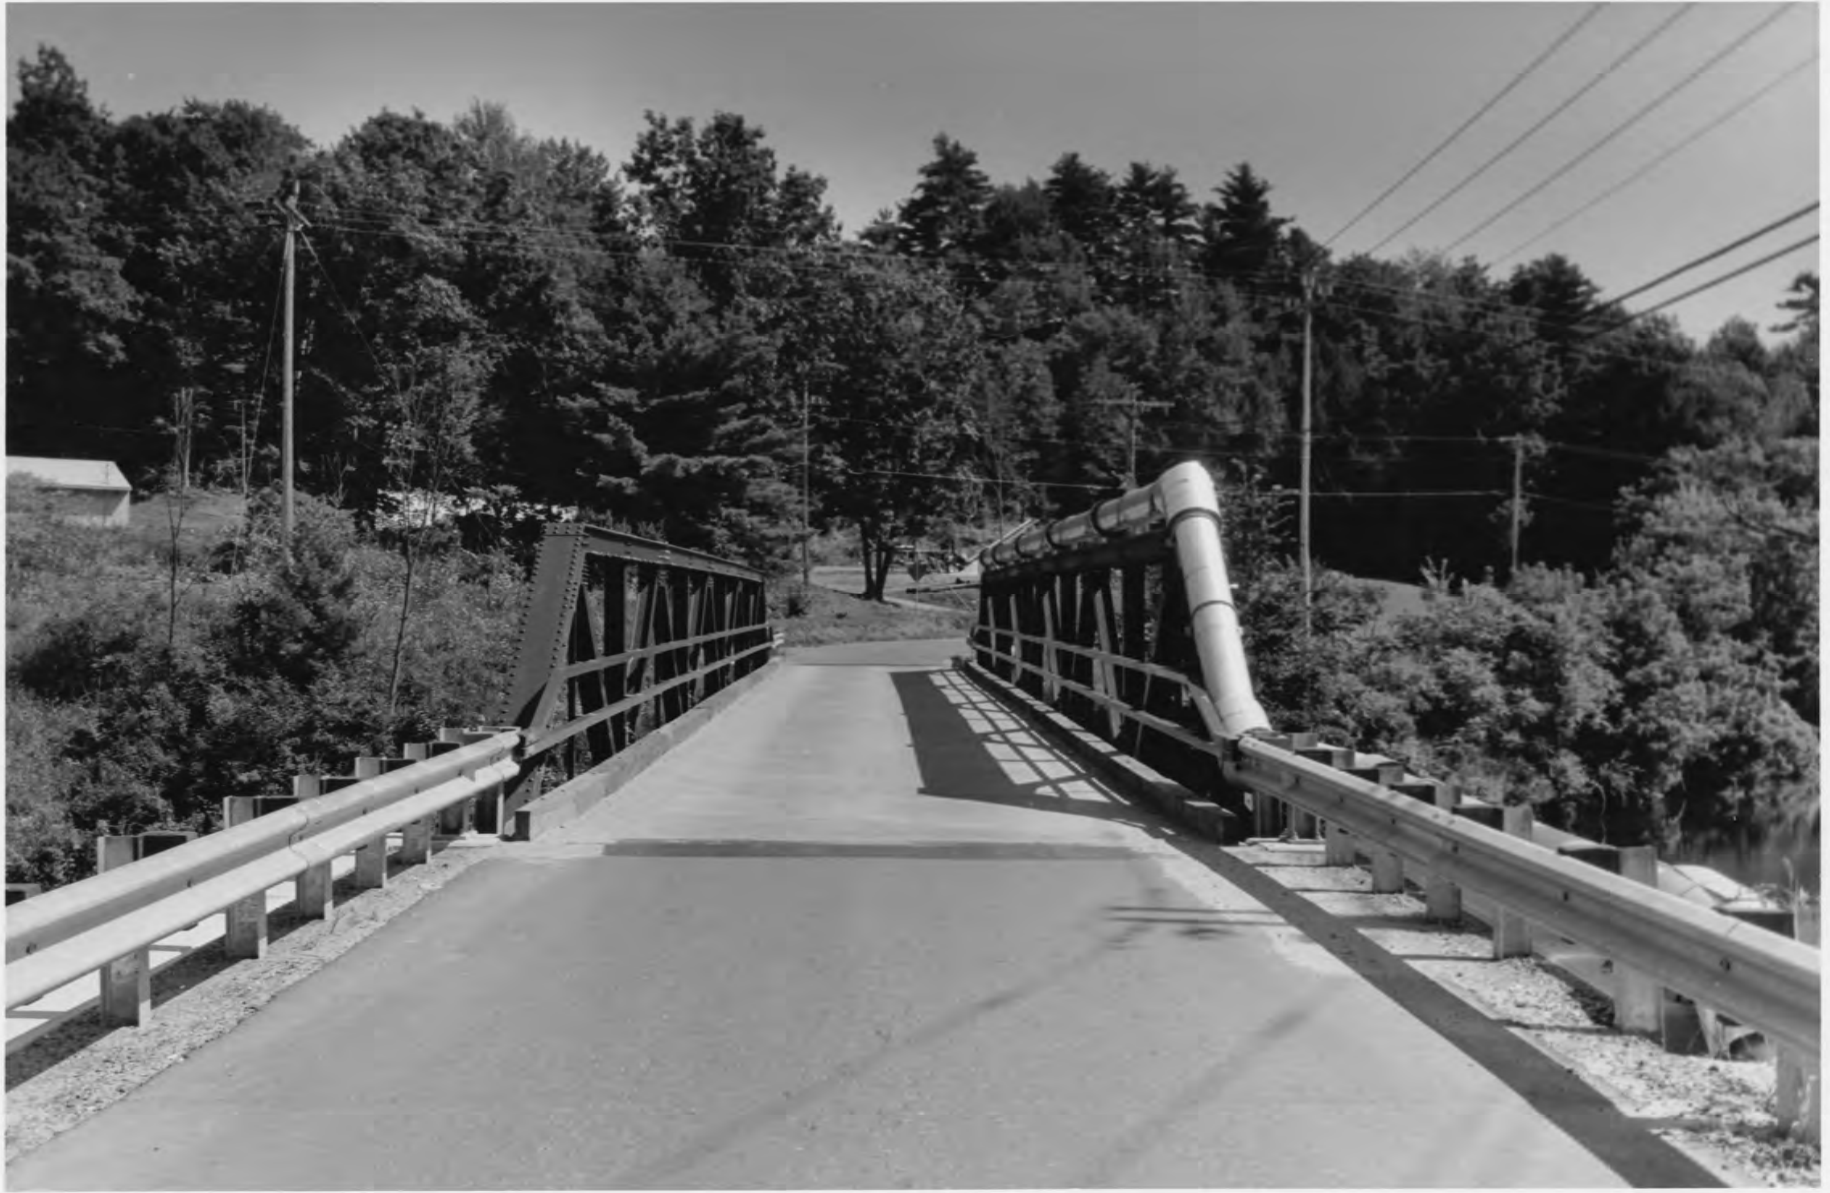
BRIDGE 22
BRADFORD, ORANGE COUNTY, VERMONT
PHOTOGRAPH NO. 2

Photograph No. 2: View looking southeast
