National Register of Historic Places Registration Form

historic name Haugen, E. E., Residence

street & number 202 Fifth Street not for publication

city or town Brookings vicinity

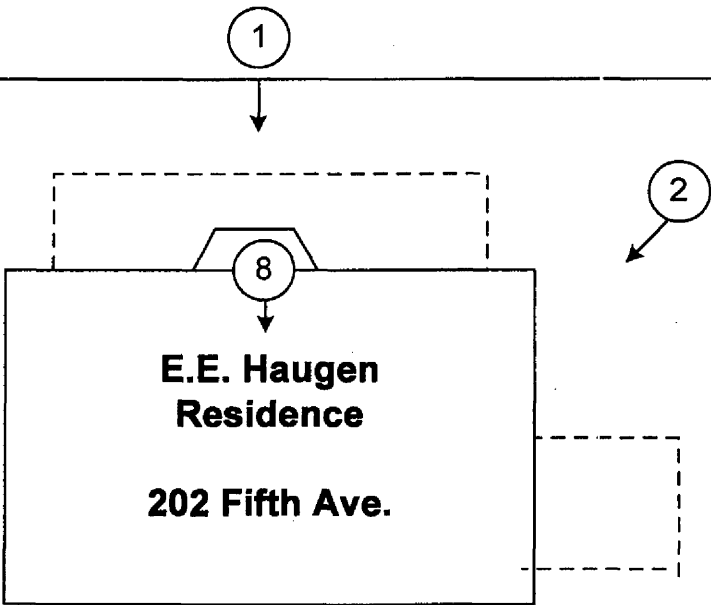
**E.E. Haugen
Residence**

Fifth Street

Second Avenue

202 Fifth Ave.
