National Register of Historic Places Registration Form

historic name: Devils Kitchen Picnic Shelter

The Devils Kitchen Picnic Shelter (HS-10H) is located near the east entrance of Colorado National Monument in the vicinity of Grand Junction, Colorado. It is a one-story irregular shaped building constructed of native red sandstone with a cedar shake roof. Designed by the National Park Service (NPS) and constructed by the Civilian Conservation Corps (CCC) in 1941, the picnic shelter is an excellent example of NPS Rustic Architecture. The building is in good condition and has suffered few alterations, maintaining integrity of location, setting, design, materials, workmanship, feeling, and association from the historic period.

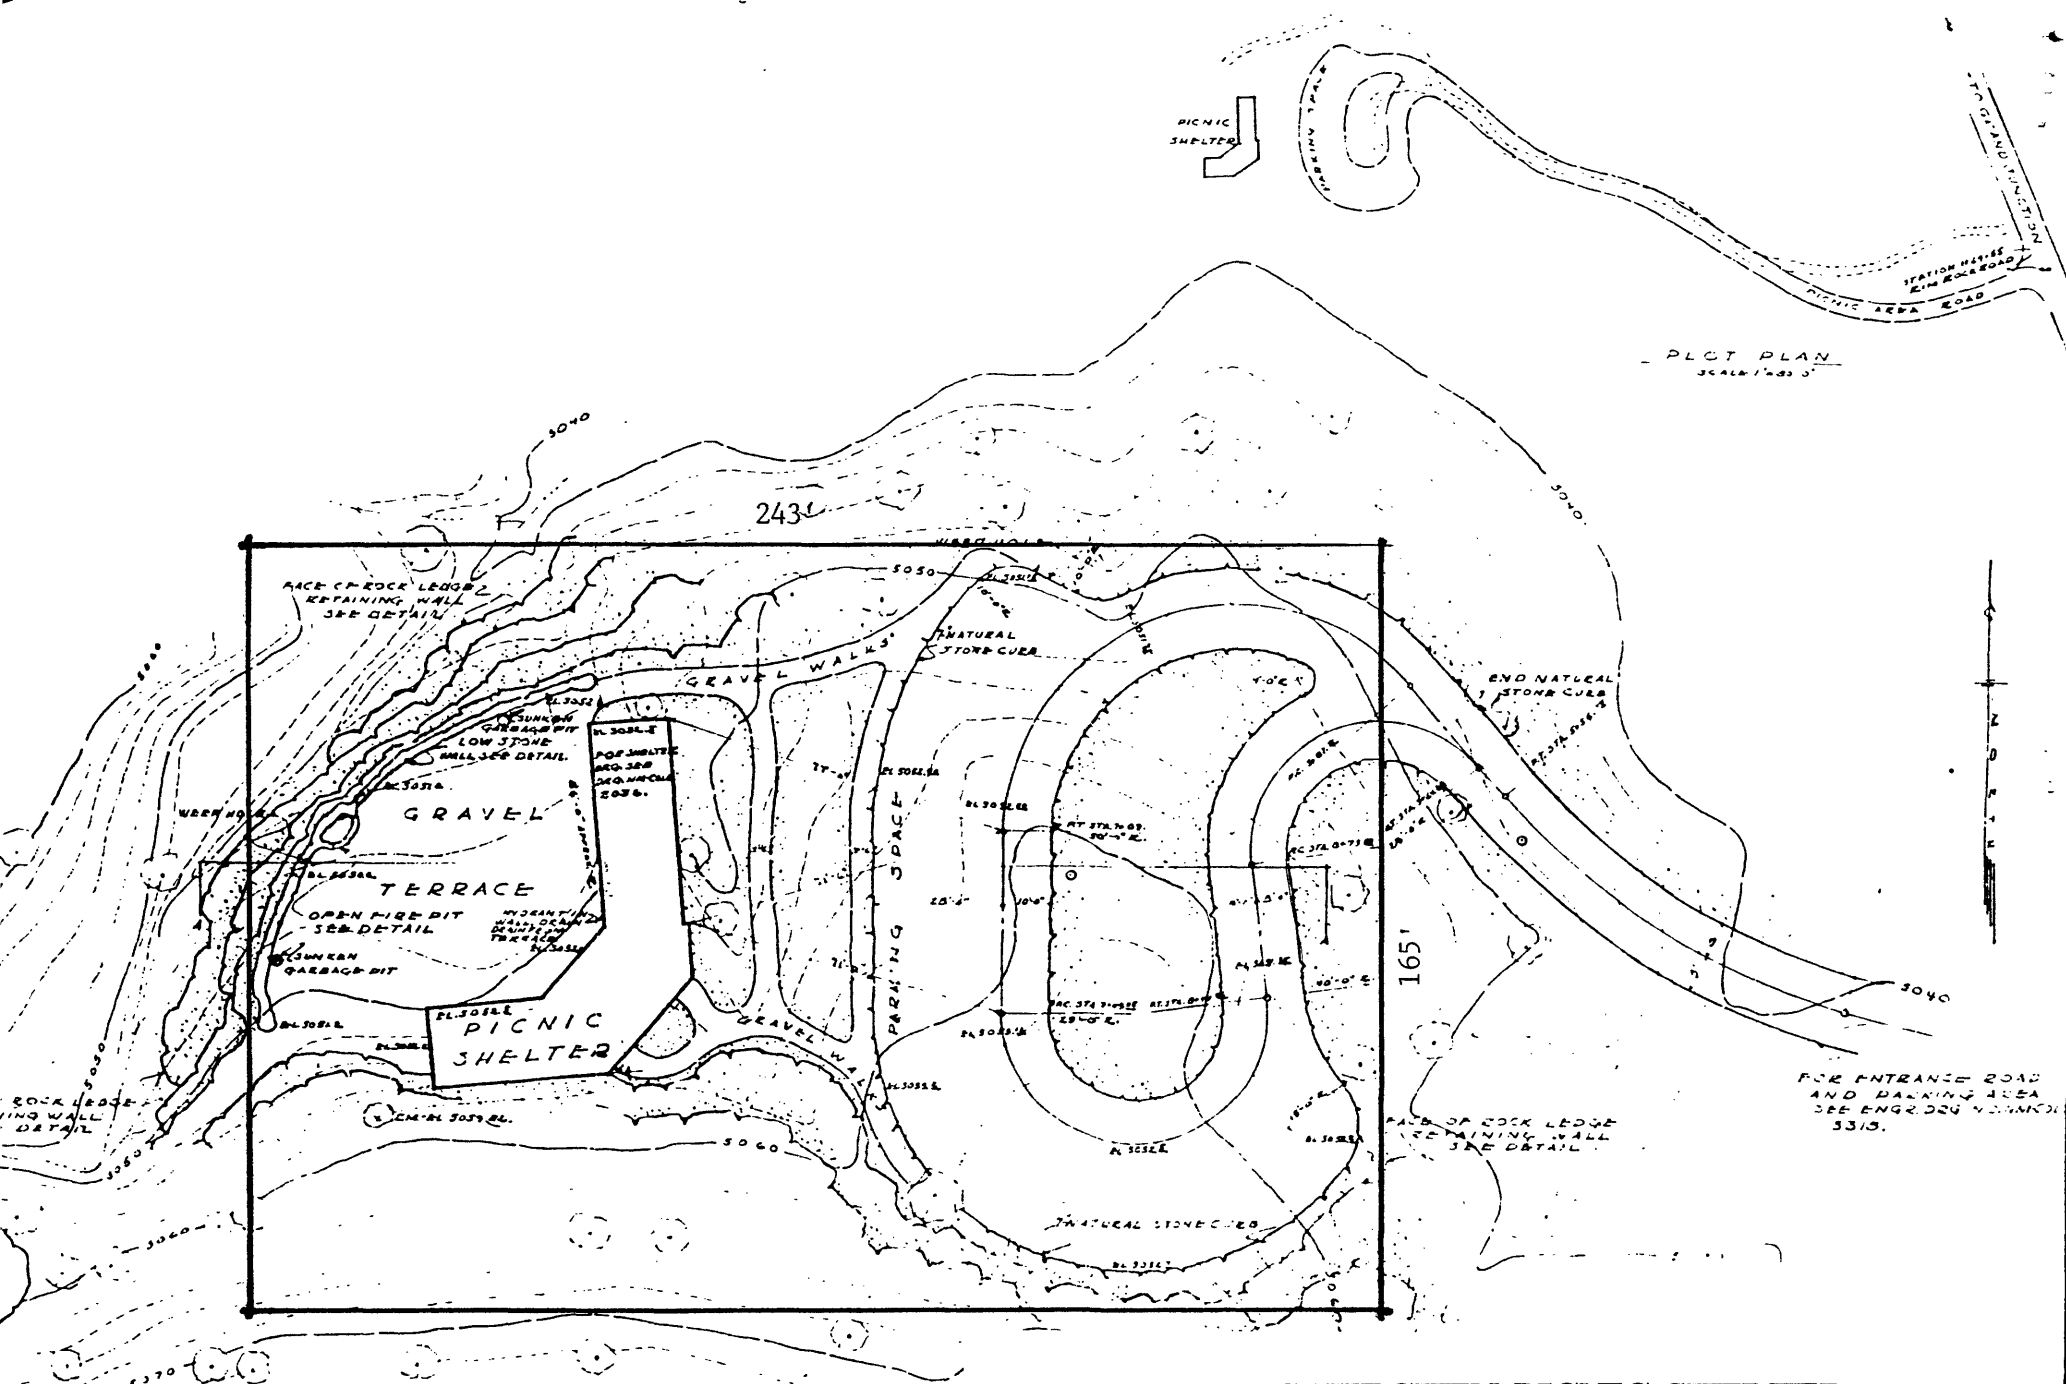
DEVILS KITCHEN PICNIC SHELTER SITE MAP

Rectangle surrounding resources denotes boundary line.

The Devils Kitchen Picnic Shelter is situated amongst rock outcroppings, approximately 400 feet west of Rim Rock Drive. The boundary is a 243' by 165' rectangle that is bounded by the parking lot to the east, the terrace to the west, and rock cliff wall on the south, as shown on the accompanying site map.

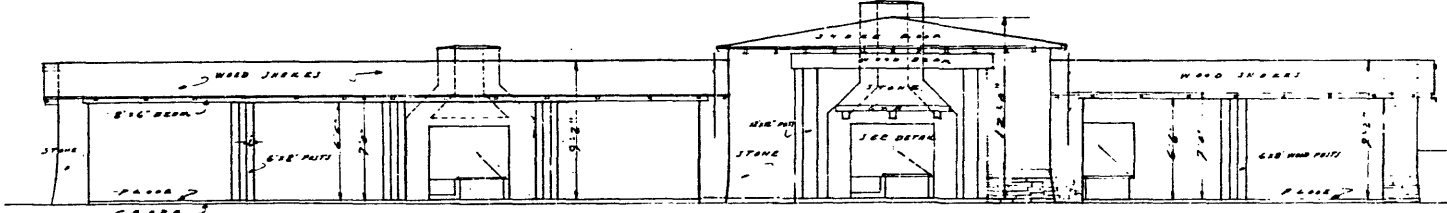
TRUE FRONT ELEVATION. Scale 1/4" = 1'-0"

STONE THIN NATURAL STONE LAID IN HORIZONTAL COURSES.
NATURAL SAWN EDGES EXPOSED - AVOID JOINTS.
DO NOT USE LARGE THICK STONES!
USE LONG THIN STONES THAT WILL MAKE
LONG HORIZONTAL LINES.
