# **National Register of Historic Places Continuation Sheet**

NATIONAL REGISTER OF HISTORIC PLACES REGISTRATION FORM

1. Name of Property
historic name Sirrine House
other names/site number Sirrine House Historic Museum; Joel E. Sirrine House
2. Location
street & number 160 North Center Street not for publication N/A city or town Mesa vicinity N/A state Arizona code AZ county Maricopa code 013 zip code 85201

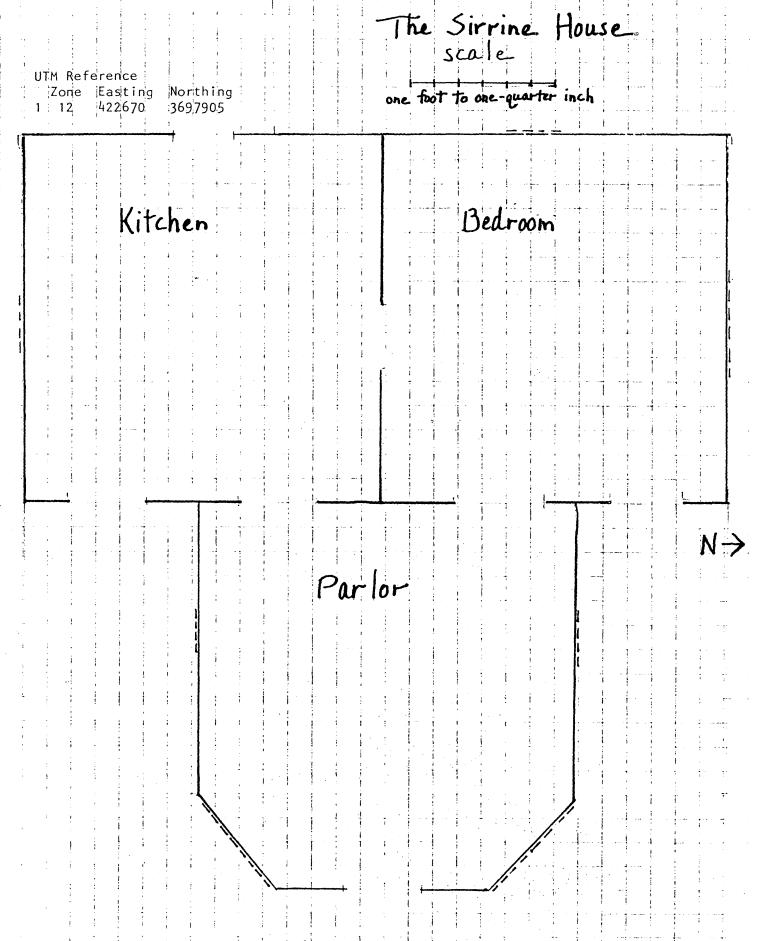
The Sirrine House; The South 65 feet of the North 115 feet of the das the decoration of Lot 6, Block 3, of Mesa, according to Book 3 of Maps, page 11, records of Maricopa County, Arizona.

The South 65 feet of the North 115 feet of the East 159 feet of Lot 6, Block 3, of Mesa, according to Book 3 of Maps, page 11, records of Maricopa County, Arizona.

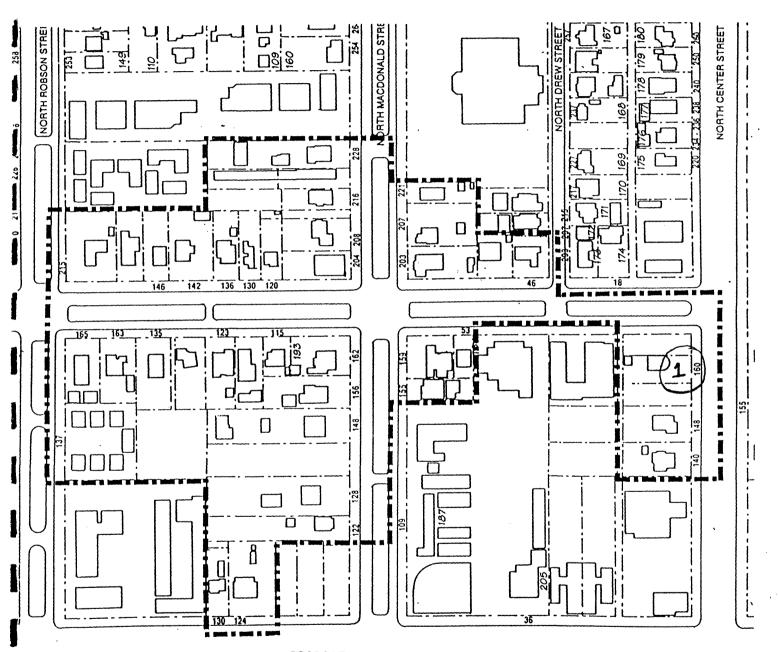
1. Sirrine House, 160 North Center Street, Mesa, Arizona 85201

The Sirrine House scale UTM Reference one foot to one-quarter inch Zone Easting Northing 422670 1 : 12 :369,7905 Kitchen Bedroom Parlor

The "T" interior floor plan of the Sirrine House Historic Home Museum contains three rooms and 857 square feet. The east facing porch entrance leads directly into the parlor. The bedroom, accessed from the kitchen or parlor, is located in the northwest portion of the house. The kitchen, accessed from the parlor or bedroom occupies the southwest portion of the house. All rooms have exterior access doors as well, with the kitchen having two such doors. The parlor contains a small brick interior chimney, while the bedroom and kitchen have end-wall chimneys on the north and south, respectively.
