**National Register of Historic Places
Inventory—Nomination Form**

1. Name Oregon Caves Chateau

city, town Oregon Caves National Monument vicinity of

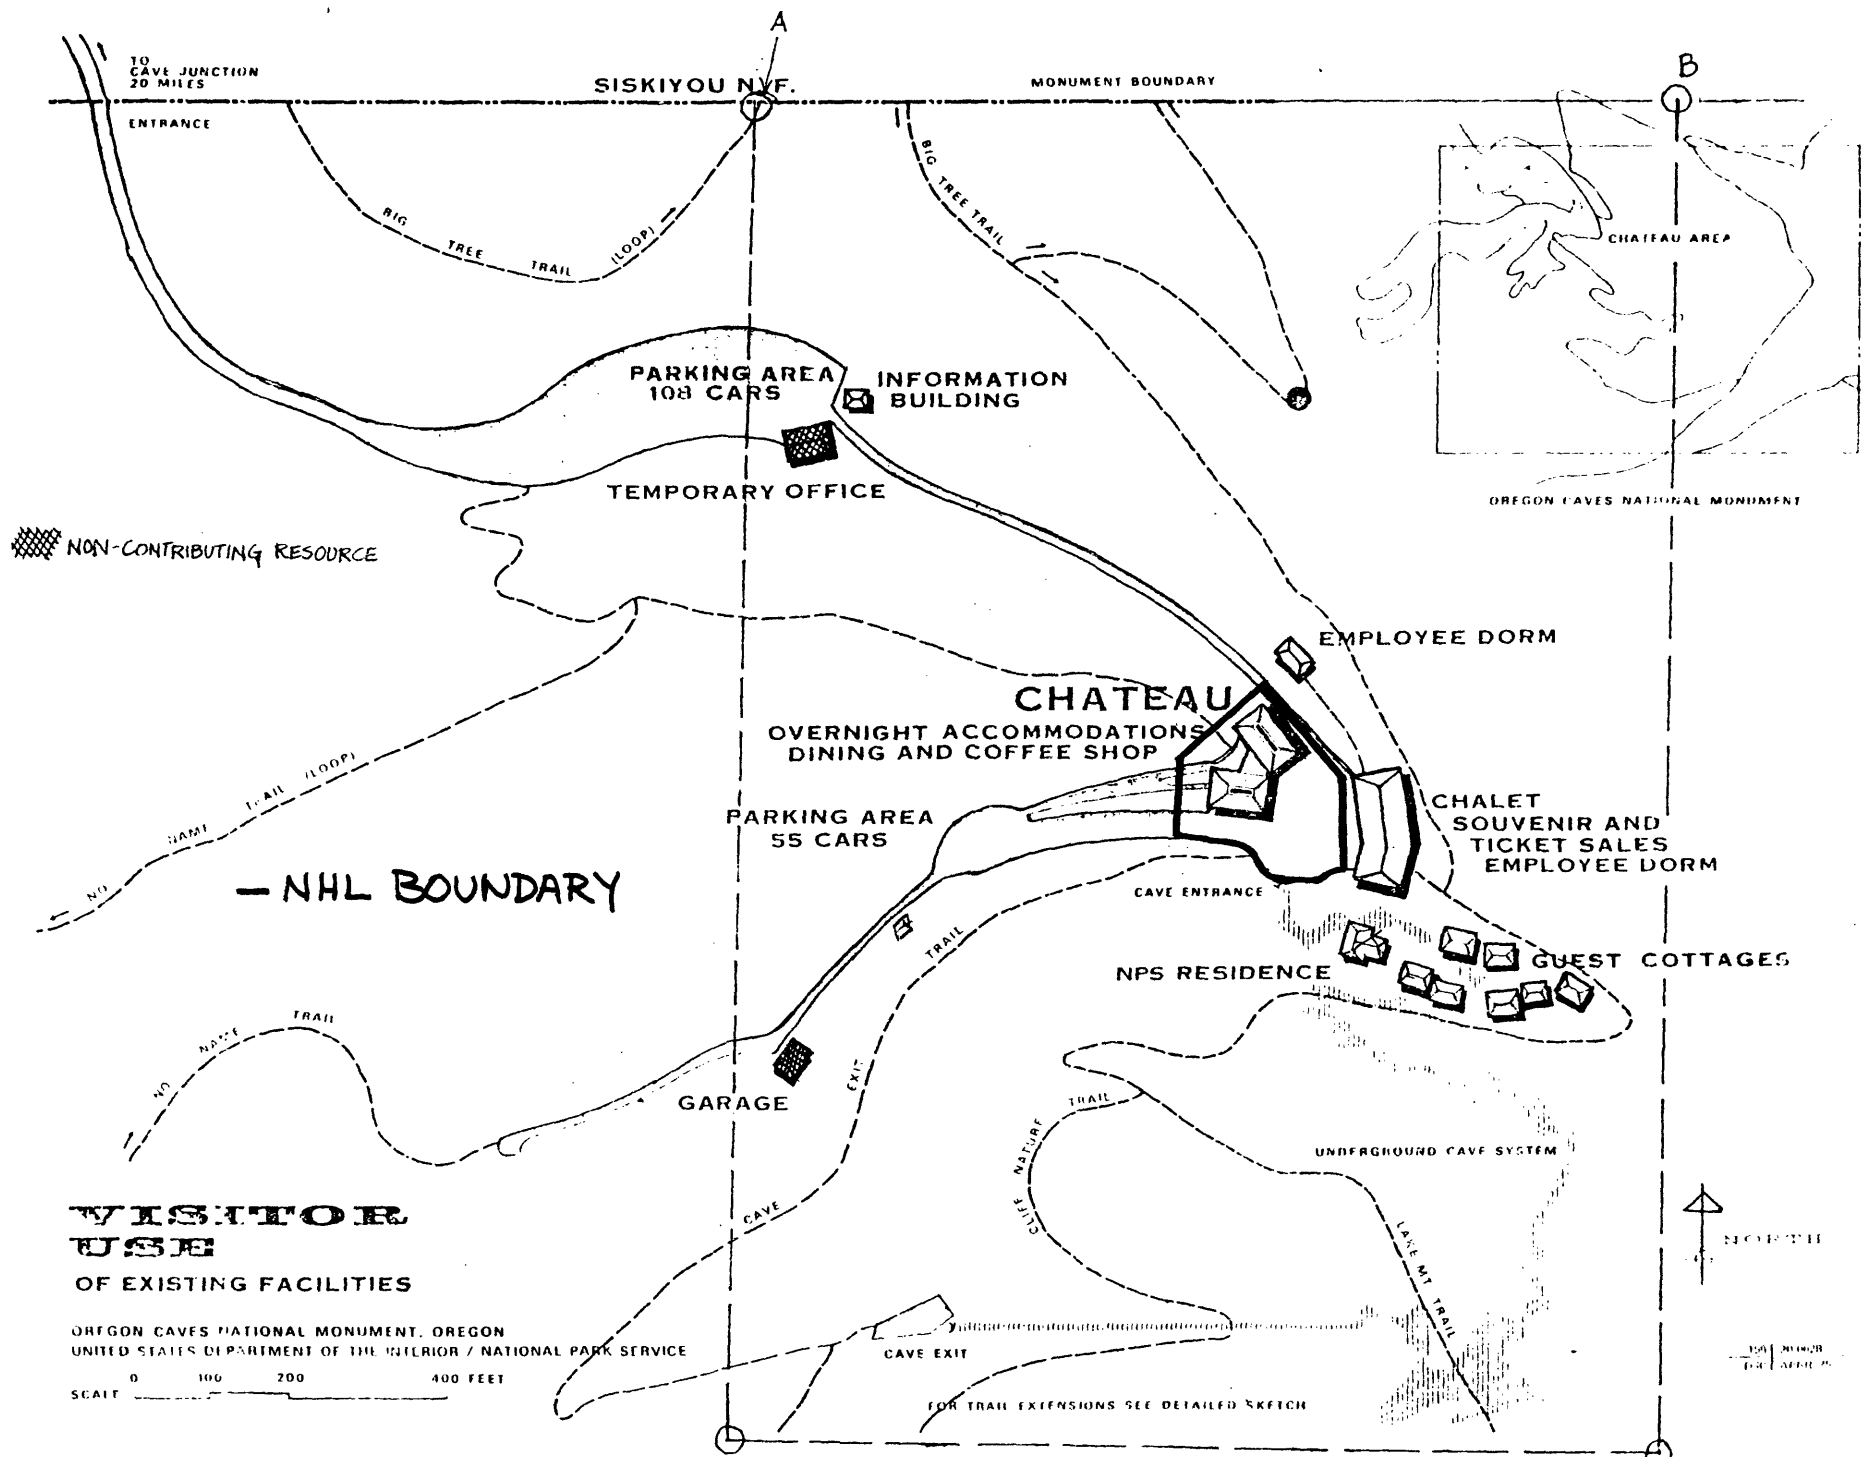
150 200028
 FIG. APR. 75

VISITOR USE OF EXISTING FACILITIES

OREGON CAVES NATIONAL MONUMENT, OREGON
 UNITED STATES DEPARTMENT OF THE INTERIOR / NATIONAL PARK SERVICE
