FORM B - BUILDING

Town Rehoboth
 Address 141 Hornbine Road
 Historic Name Hornbine Baptist Church

Community: Rehoboth	Form No: 63
Property Name: Hornbine Baptist Church

Hornbine Baptist Church (Rehoboth MRA)
Bristol County
MASSACHUSETTS

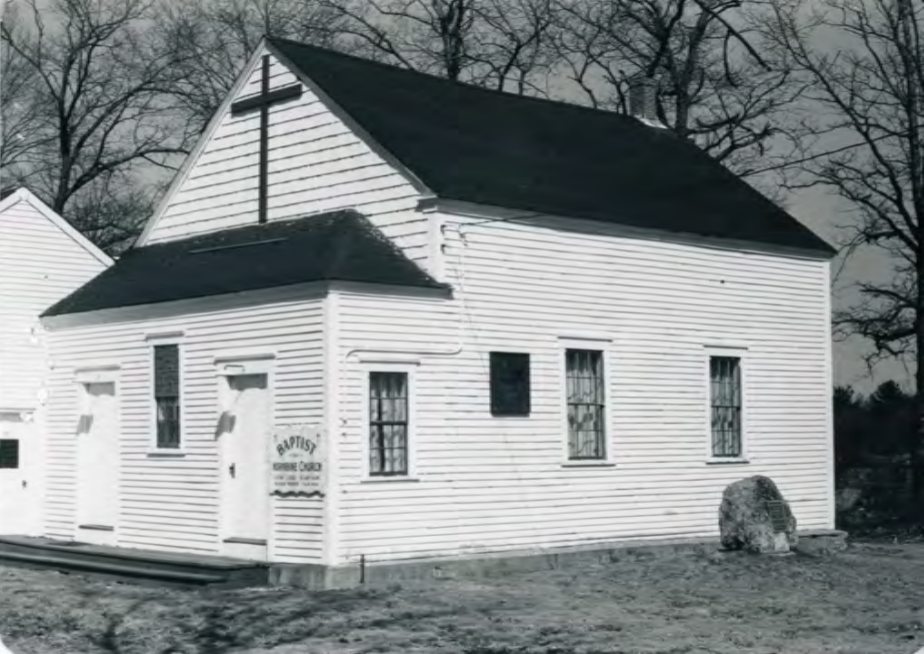
BAPTIST
MEMBER CHURCH
1871
1872

Hornbire Baptist Church

The Hornbine Baptist Church, a small one-story frame structure with a diminutive projecting hip roof porch with double entrances, is the earliest surviving Baptist meetinghouse in southeast Massachusetts. Originally, when erected in 1753, this building was a simple barn-like structure with a single large room. The entrance was in the bagle flank facing south onto Baker Street (stone step still in place) and the pulpit was on the north wall opposite. By 1802, the parish had grown, and increase in the congregation necessitated remodelling. A gallery was built at both ends of the room and pews were installed. The pulpit, made of hornbeam (presumably

the origin of "Hornbine"), was enlarged with stairs on either side. This pulpit has since been cut down several tiems and is presently located in the southeast corner of the main floor. Further renovations in 1869 consisted of moving the entrance to its present location, lowering the ceiling, and erecting a raised alcove to serve as a pulpit. The chandelier and four bracket lamps, now electrified and still in use, were installed at this time. A social hall sixteen feet square added to the northwest corner that same year was enlarged by nineteen feet in 1874 and remodelled in the 1960s when a kitchen was installed. A four-stall horse shed and several storage sheds of the 1870s were removed in the mid 20th century. The potential for subsurface remains of these structures is undetermined.

Aside from modifications of the social hall and removal of late 19th century sheds, the Hornbine Church has not altered significantly since the 1870s, nor has its setting. It is located where Baker Street meets Hornbine, a minor intersection which is unmarred by any attempts to straighten or widen the roads. Another historically significant structure, the Hornbine School (#62) is directly across Hornbine Street.

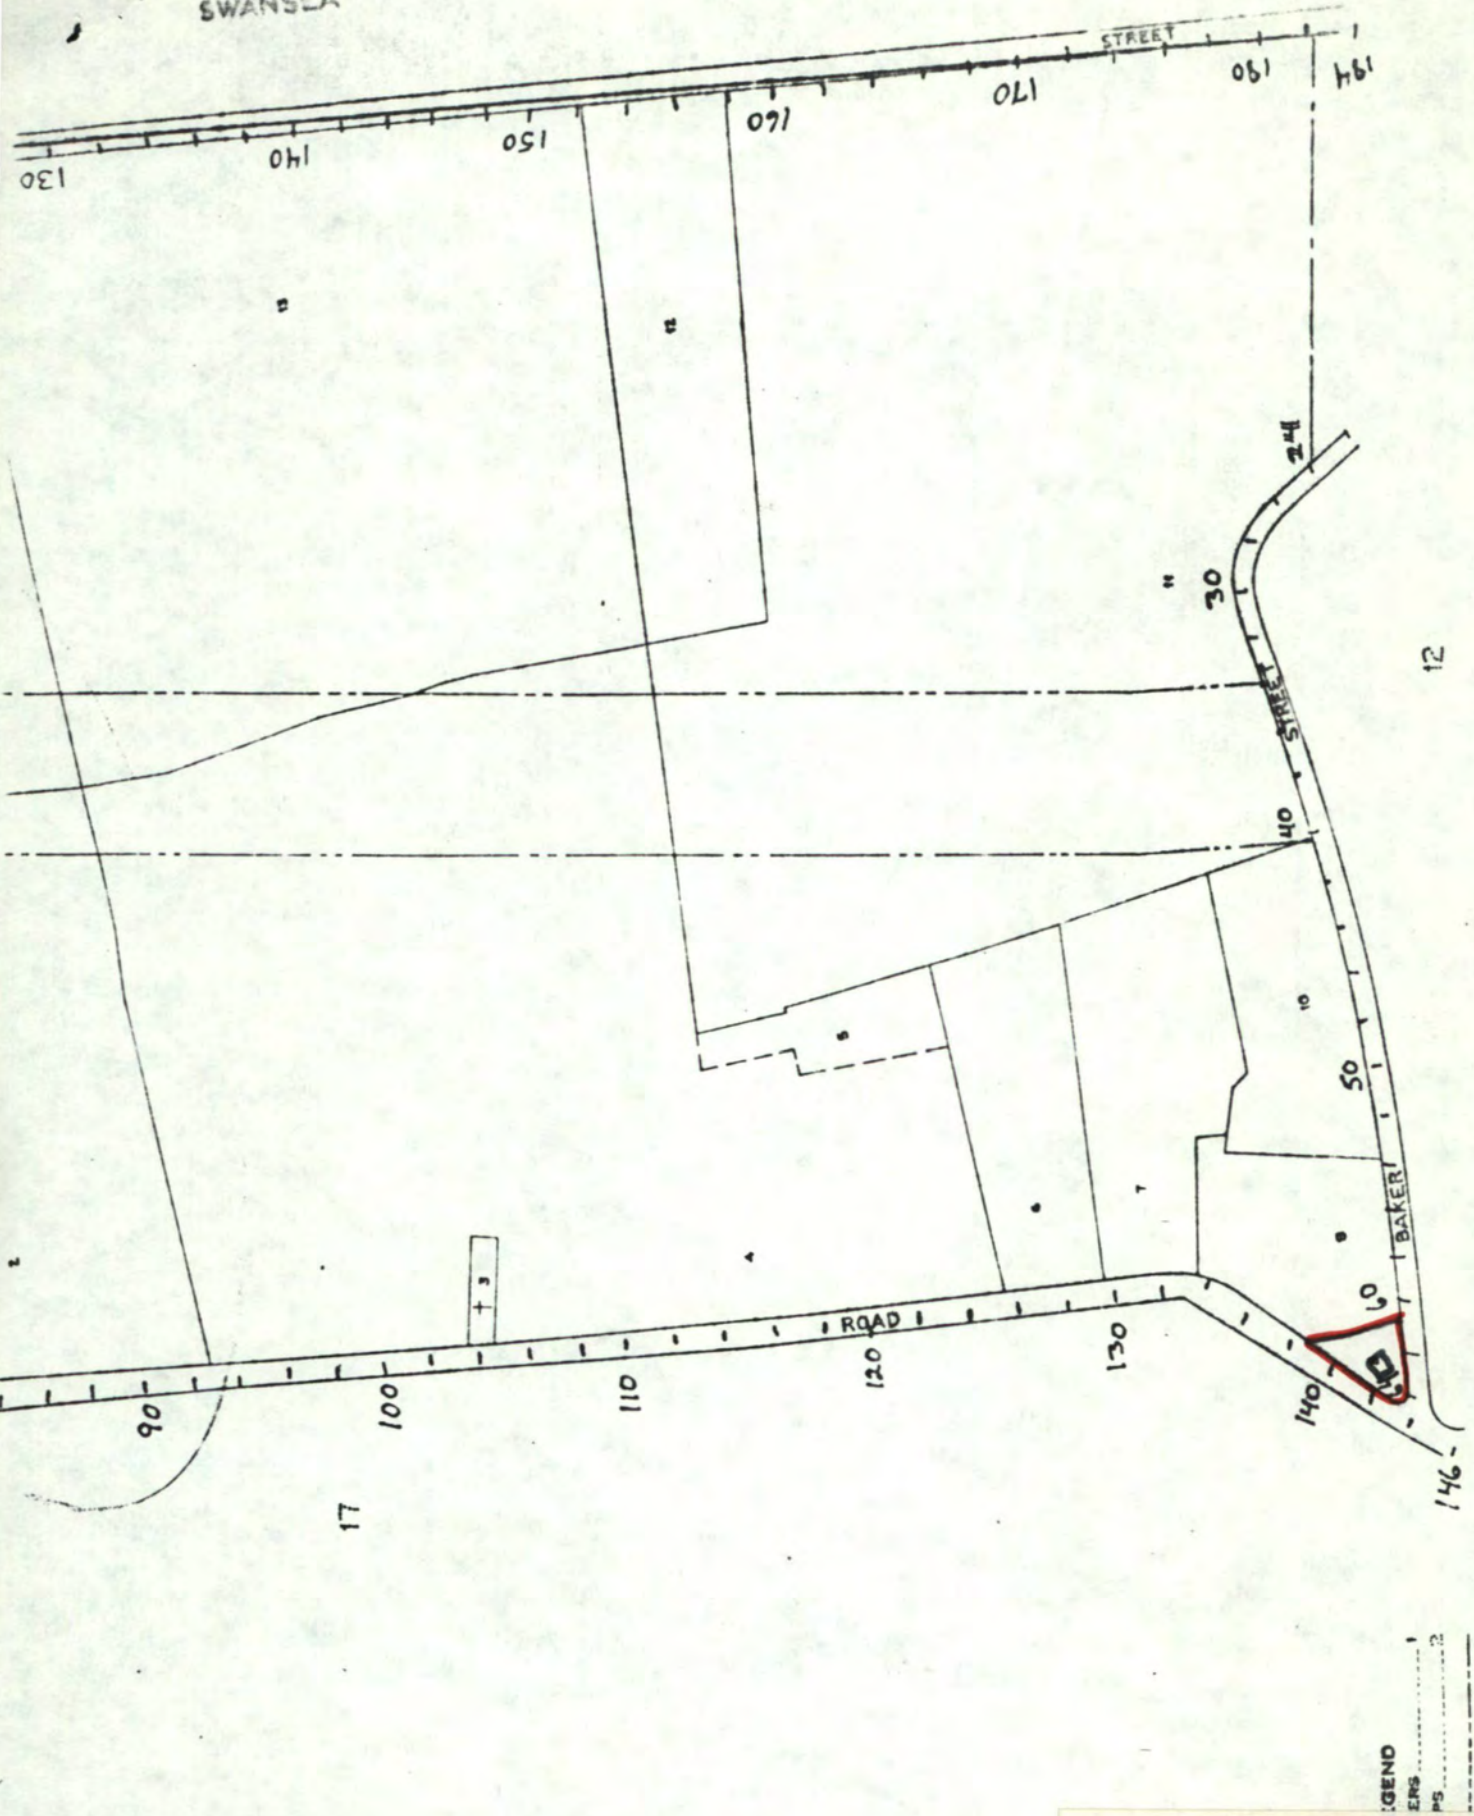
141 Hornbine Road
 Hornbine Baptist Church
 (form 63) Town of Rehoboth
 Property Map 1978
 scale 1" = 200'

Setting center of triangular lot at
intersection of Hornbine Road and
Baker Street
