# National Register of Historic Places Registration Form

Historic name Lindenwood Neighborhood Historic District  
Other names/site number N/A  
Name of related Multiple Property Listing N/A

Street & number Roughly bounded by Watson, Gamble, Sibley and Elm Streets, and the alley between Houston and North Kingshighway N/A not for publication  
City or town St. Charles N/A vicinity  
State Missouri Code MO County St. Charles Code 183 Zip code 63301

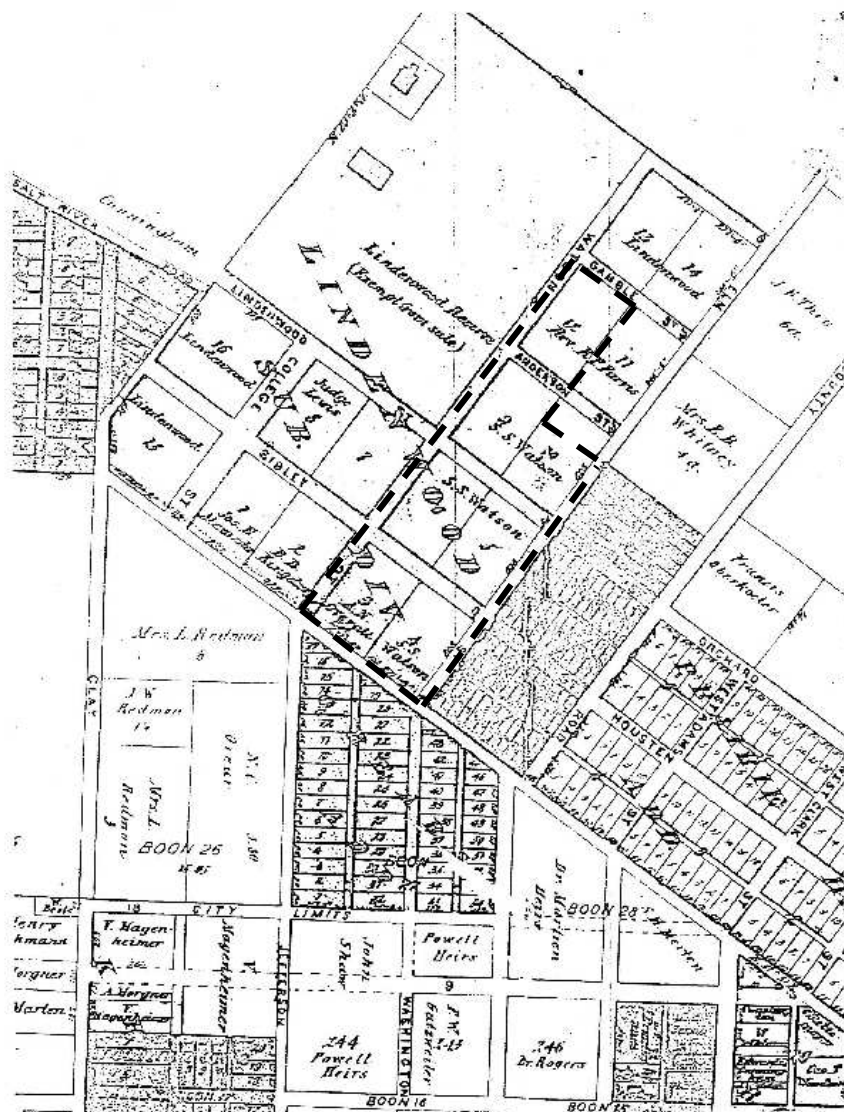
**FIGURE NO. 3**  
**Excerpt from W.R. Brink. *Illustrated Atlas Map of Saint Charles County, MO, 1875.***  
*(The three subdivisions making up the district are shown by the dotted line.)*
