National Register of Historic Places Registration Form

Historic name: Reynolds Property
Other names/site number: Alphin Stone House; VDHR File No. 011-0138
Name of related multiple property listing:
N/A
(Enter "N/A" if property is not part of a multiple property listing)

Street & number: 514 Rocky Road
City or town: Buchanan State: VA County: Botetourt
Not For Publication: N/A Vicinity: X

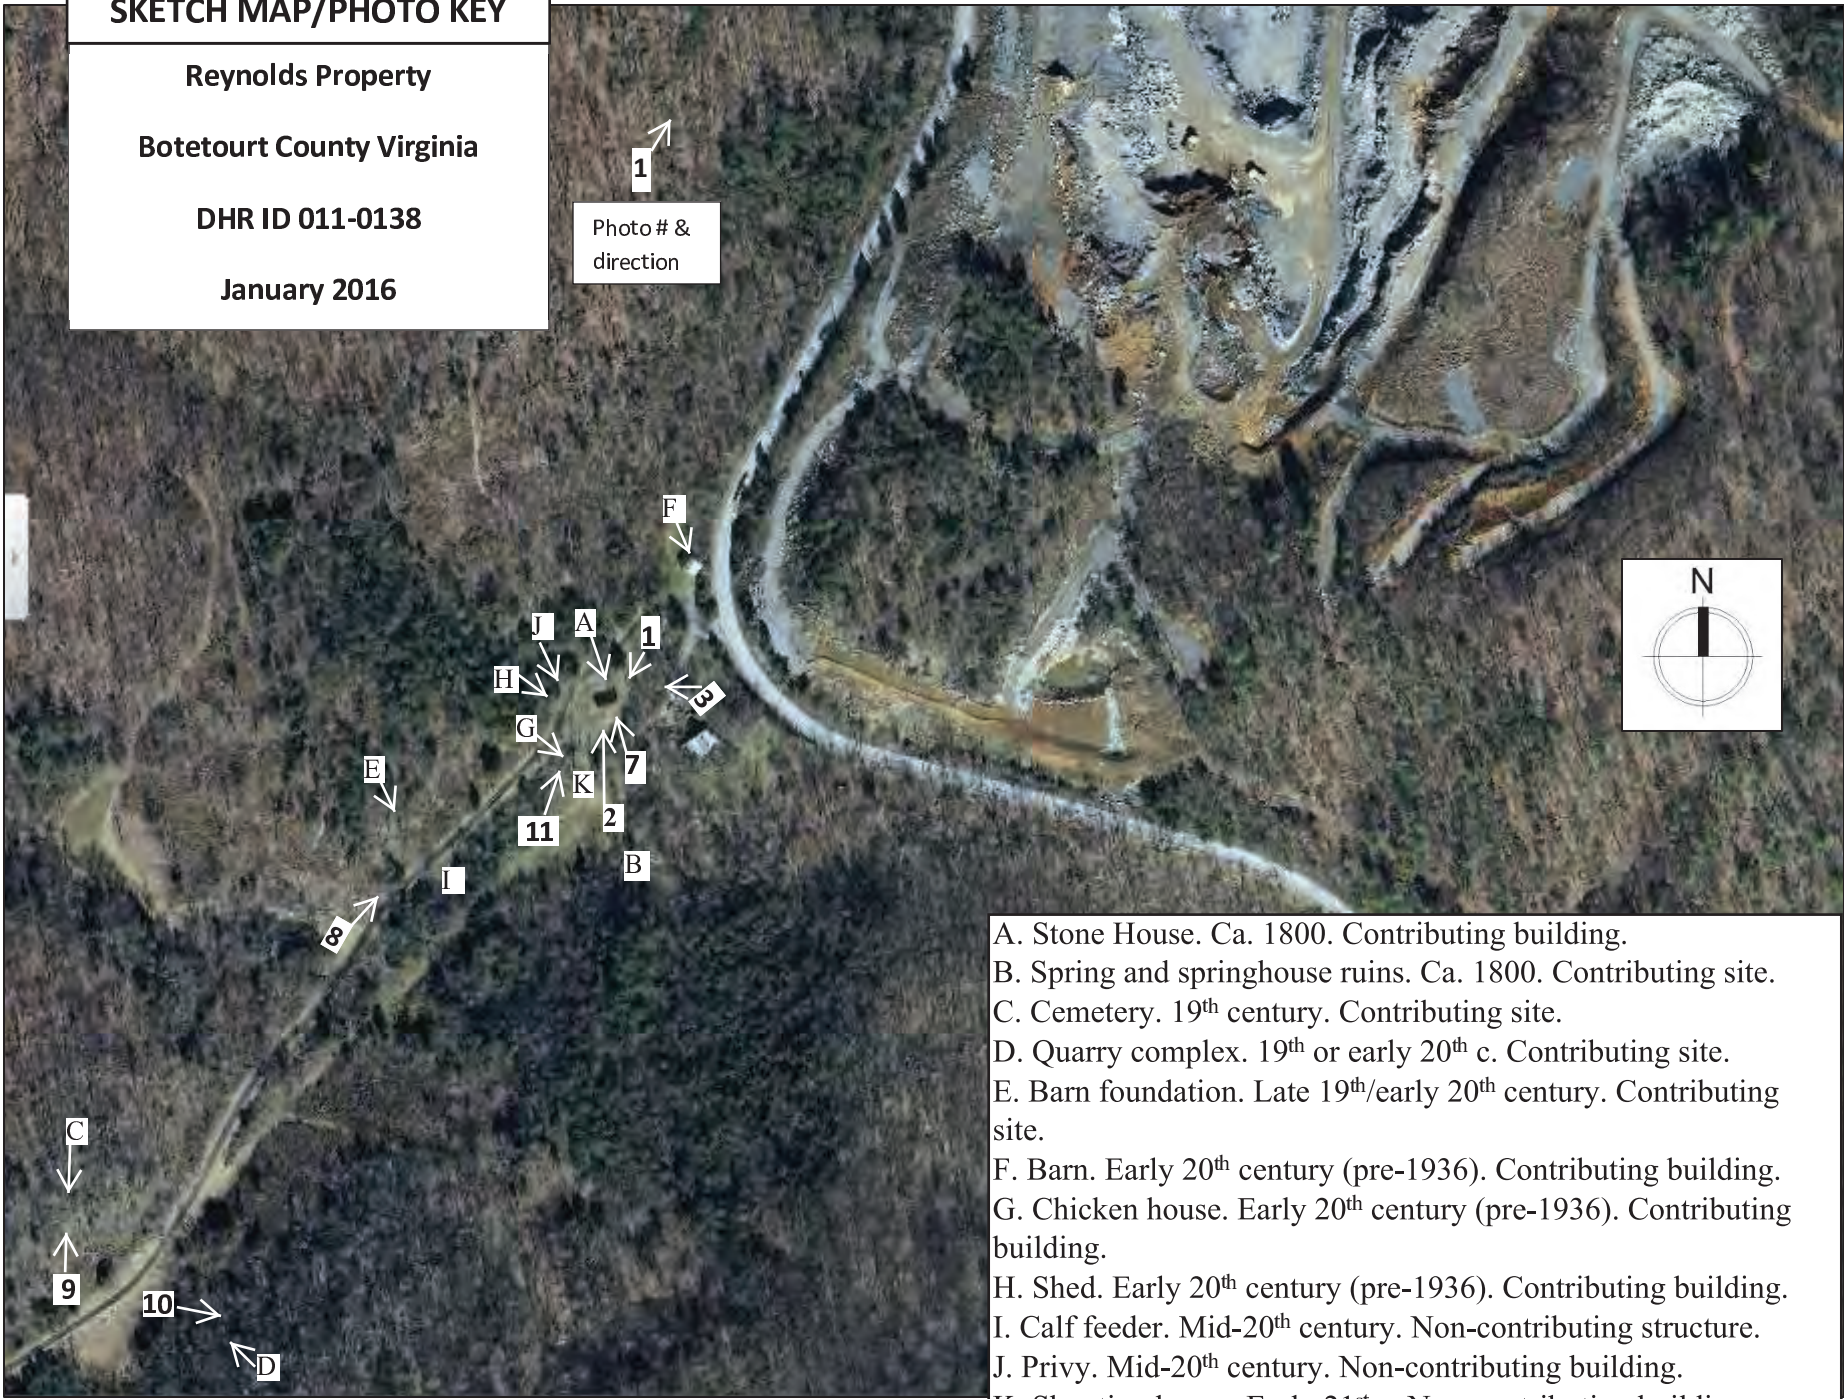
Tax Parcel Map
Reynolds Property
Botetourt County, Virginia
DHR No. 011-0138

- A. Stone House. Ca. 1800. Contributing building.
- B. Spring and springhouse ruins. Ca. 1800. Contributing site.
- C. Cemetery. 19th century. Contributing site.
- D. Quarry complex. 19th or early 20th c. Contributing site.
- E. Barn foundation. Late 19th/early 20th century. Contributing site.
- F. Barn. Early 20th century (pre-1936). Contributing building.
- G. Chicken house. Early 20th century (pre-1936). Contributing building.
- H. Shed. Early 20th century (pre-1936). Contributing building.
- I. Calf feeder. Mid-20th century. Non-contributing structure.
- J. Privy. Mid-20th century. Non-contributing building.
- K. Shooting house. Early 21st c. Non-contributing building.
