Historic Sites Survey

STREET NO: 1410 Bowen Avenue

TOWN/VIC: Ocean Springs

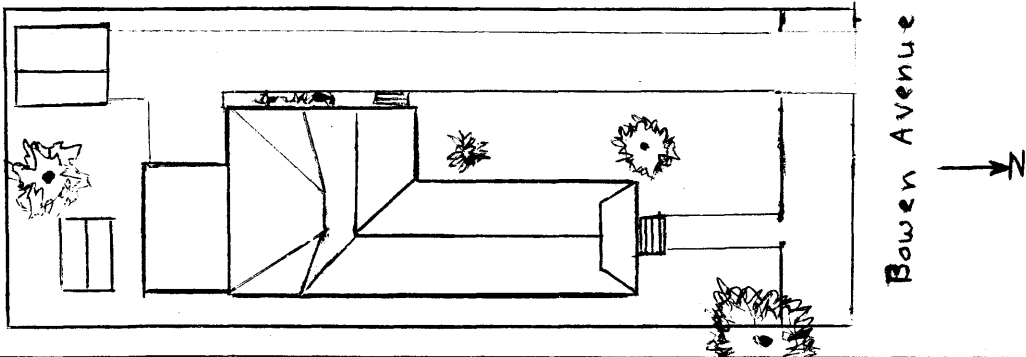
PHOTOS

The building at 1410 Bowen Avenue is a one story, wood frame, L-shaped "shotgun" house which is set on low brick piers and is covered by a cross gable roof. The body of the house consists of a north-to-south file of rooms across the southern end of which is a rear wing. A wrap-around gallery extends across the two-bay north facade of the rear wing and main block and along the western elevation of the latter. The gallery, which is undercut along the side and rear sections, projects from the main facade and is covered by a hip roof. This creates a gable on hip roof arrangement, the gable of which is pierced by a lozenge-shaped, louvered ventilator and clad in imbricated shingles. The porch is supported by chamfered posts with sawn brackets. One of the three entrances from the gallery has a transom. The windows have six-over-six double-hung sash.

Rear porch enclosure
