National Register of Historic Places Registration Form

Historic name The Wiltshire Apartment Hotel

Street & number 703 E. 10th Street N/A not for publication

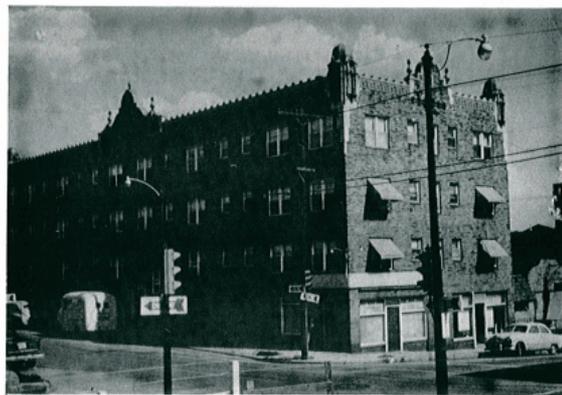
VIEW OF SUBJECT PROPERTY

The metal fire escape on the east side exterior is a post 1958 addition because a 1958 “Engineering and Economic Analysis” of the building says that “There are no fire escapes.”²⁴ There is water damage and cracked tile along the rooftop on all sides that require restoration work; however, the overall ornamentation along the rooftop remains in good condition and retains its original character.

The plaster finishes throughout the interior have been altered. The 1958 “Engineering and Economic Analysis” indicates that the interior walls and ceilings originally had a “palm finish”—which was very likely a Spanish palm finish to match the other Spanish Colonial Revival style details.²⁵ The current tiled floor in the lobby area of the interior is an alteration of the original terrazzo floor. In the apartments, the linoleum flooring described in the “Engineering and Economic Analysis” has been replaced with vinyl sheeting.²⁶ There are closets in the apartments where there were once Murphy beds; originally, the majority of the apartments excluding the smaller apartments that were located near the stairs had Murphy beds.²⁷ The interior finishes and fixtures of the building are in need of renovation, although the floors of the building “are relatively level, and the walls are relatively plumb.”²⁸
