**NATIONAL REGISTER OF HISTORIC PLACES
INVENTORY -- NOMINATION FORM**

HISTORIC Daniel Tilden house

Tilden, Daniel, House, Peninsula, Summit County, Ohio

These drawings were prepared during the spring of 1983 by the following architectural students of Kent State University: Bob Orovets, Tom McBride, and Craig Curtis. The originals are on file at Cuyahoga Valley National Recreation Area.

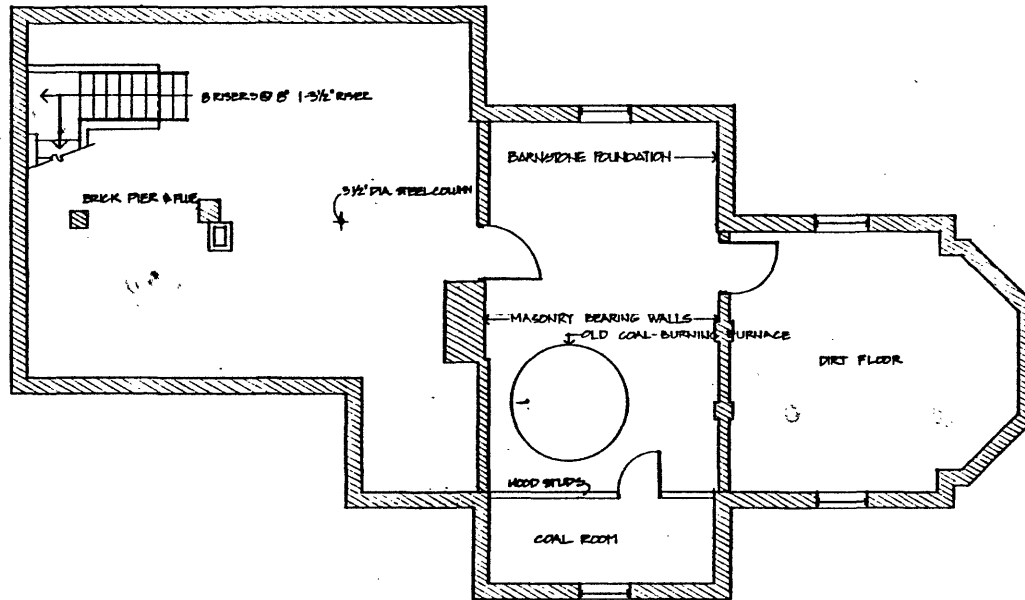
DESIGNED:	SUB SHEET NO.	TITLE OF SHEET	DRAWING NO.
DRAWN: BOB CROVETZ		BASEMENT FLOOR PLAN	644 BOJEB
TECH. REVIEW:		EXISTING CONDITIONS APRIL 1982	PKG. NO. SHEET
DATE: /		DANIEL TILDEN HOUSE	2
		CUYAHOGA VALLEY NATIONAL RECREATION AREA	OF 11

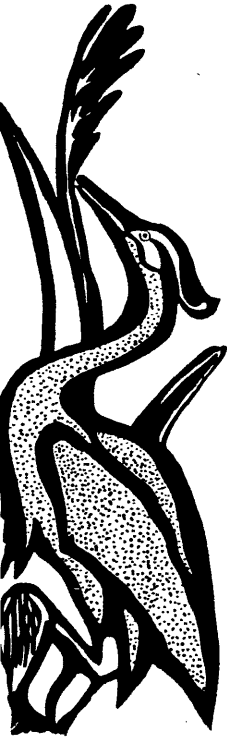
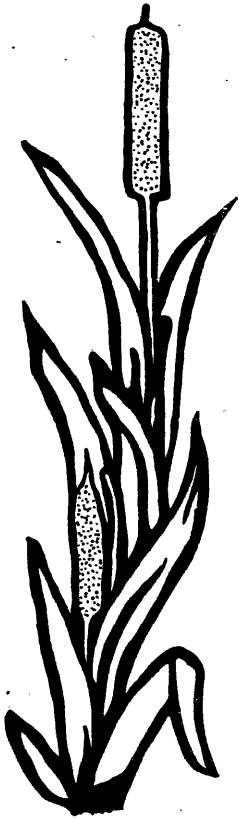
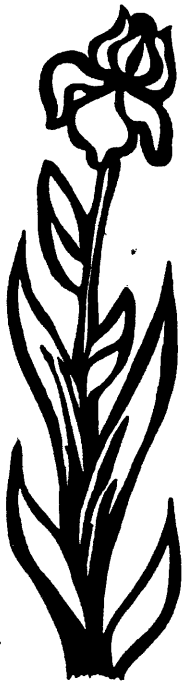
1 TYPICAL MOLDING CARVINGS
N.T.S.

NOTE THESE CARVINGS ARE TO BE USED IN THE HOUSE ARE ALIKE

With the exception of the additions mentioned above, the interior plan configuration has not been altered. Each doorway and window is framed in an elaborate casing of decorative white oak. The wood is purported to have been cut from the site, sawn in Cleveland, and then carved back on the site. The bases of many of these massive casings feature hand-carved and wood-burned depictions of natural scenes (birds, flowers, etc.) no two of which are identical. Much of the original door and window hardware also remains throughout the house.

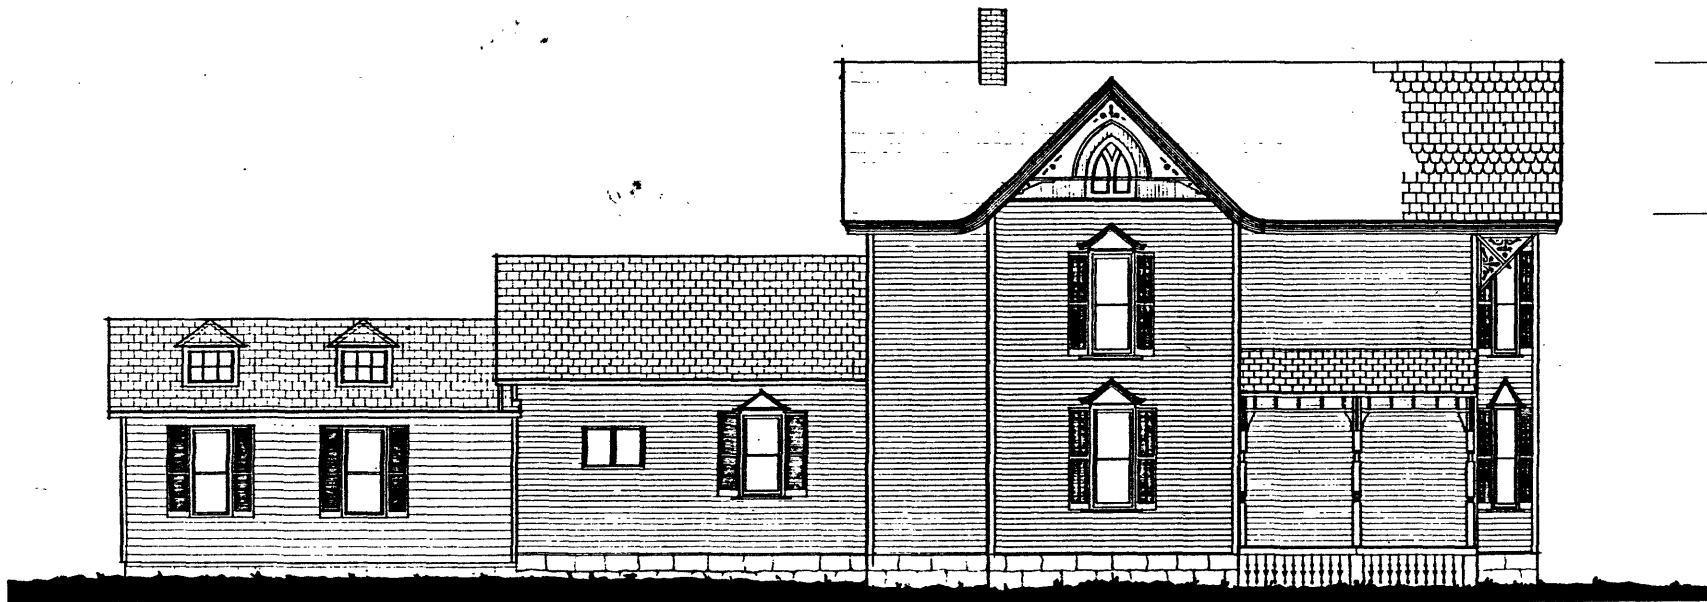
—◆— 26'-10"
 —◆— 24'-5" ATIC FLOOR
 —◆— 17'-2" 2ND FLOOR
 —◆— 8'-0" 1ST FLOOR

DESIGNED:	SUB SHEET NO.	TITLE OF SHEET	DRAWING NO.
DRAWN: GRAIG CURTIS		WEST ELEVATION	644 60028
TECH. REVIEW:		EXISTING CONDITIONS APRIL, 1982	PRG. NO. SHEET
DATE: 1		DANIEL ELDON HOUSE	10
		CUYAHOGA VALLEY NATIONAL RECREATION AREA	OF 11

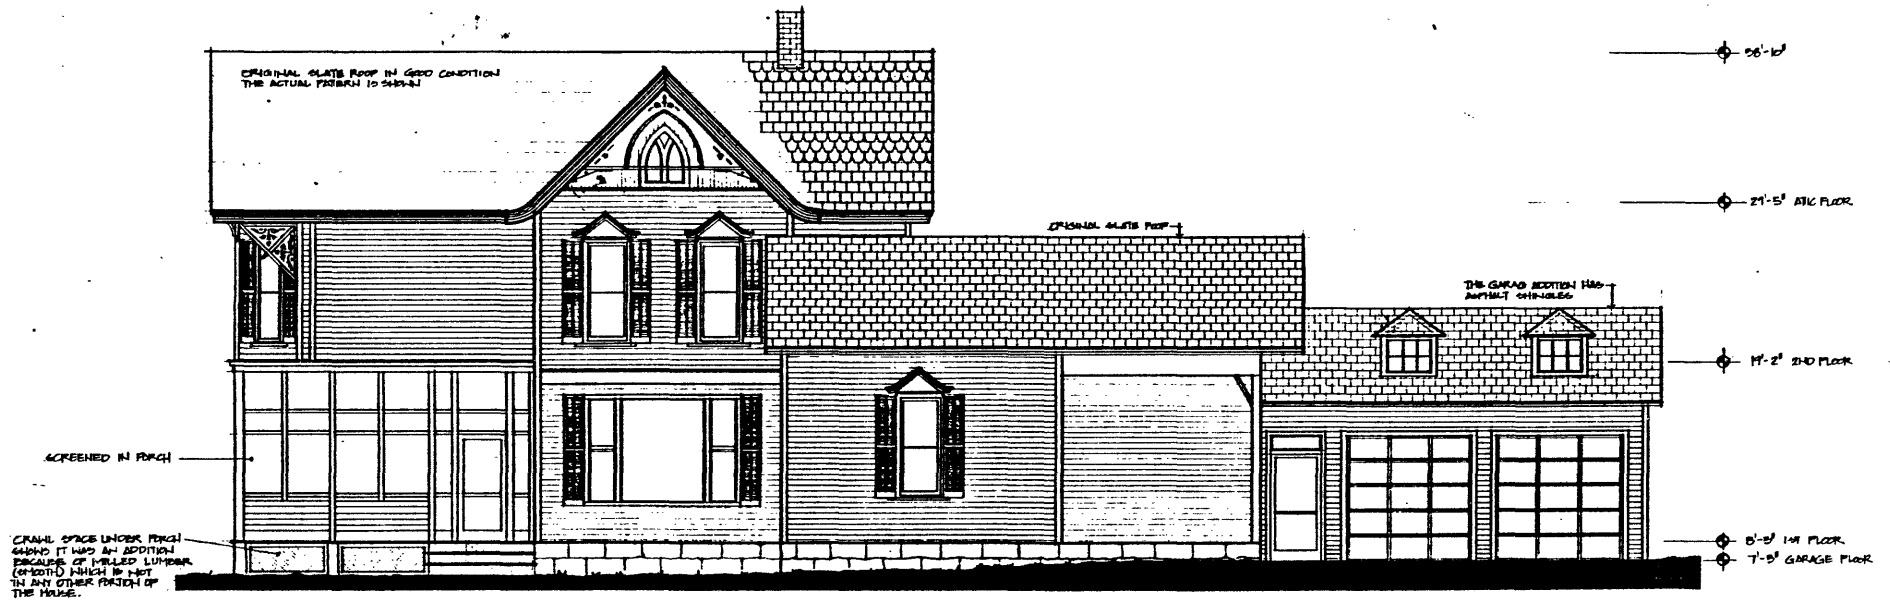
DESIGNED:	SUB SHEET NO.	TITLE OF SHEET	DRAWING NO.
DRAWN: CRAG CURTIS		EAST ELEVATION	644 60,022
TECH. REVIEW:		EXISTING CONDITIONS APRIL, 1982	PKG. NO.
DATE: /		DANIEL TILDEN HOUSE	9
		CUYAHOGA VALLEY NATIONAL RECREATION AREA	OF 11

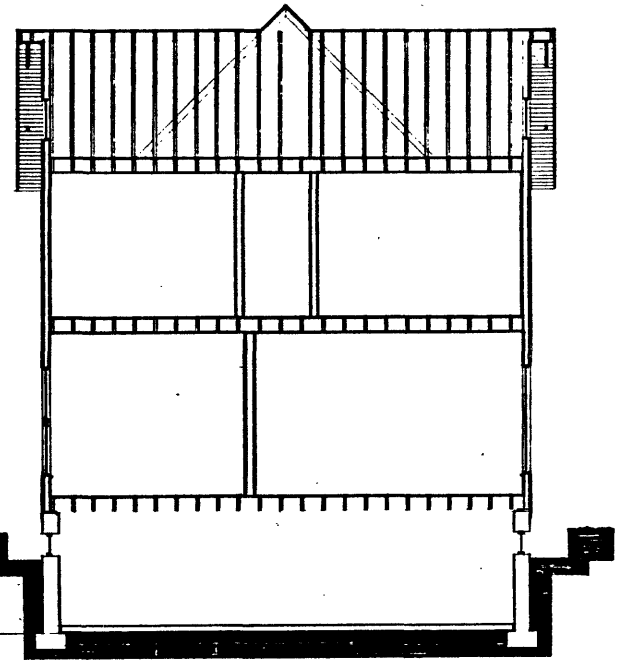
2 TRANSVERSE SECTION
SCALE 1/8" = 1'-0"

- ALL ROOFS SLATE EXCEPT GARAGE
- CHIMNEY IN NEED OF REPAIR
- VARIOUS EXTERIOR DETAILS IN NEED OF REPAIR
- BARNSTONE FOUNDATIONS
- ALL GUTTERS & DRAINSPOUTS IN NEED OF REPLACEMENT

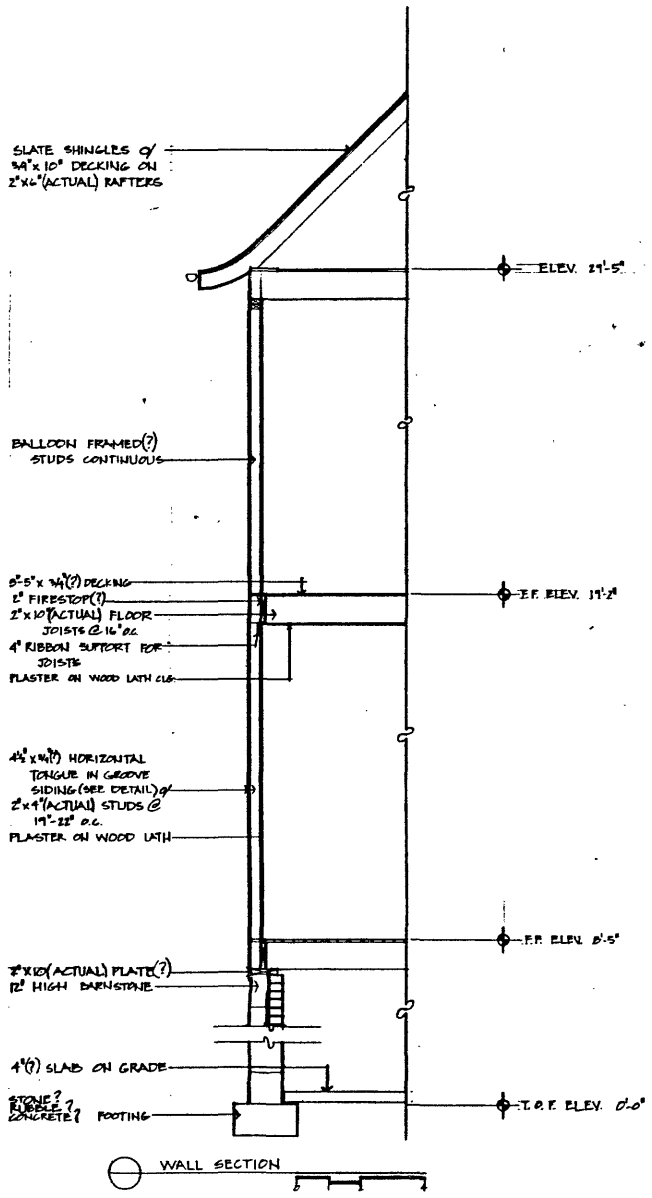
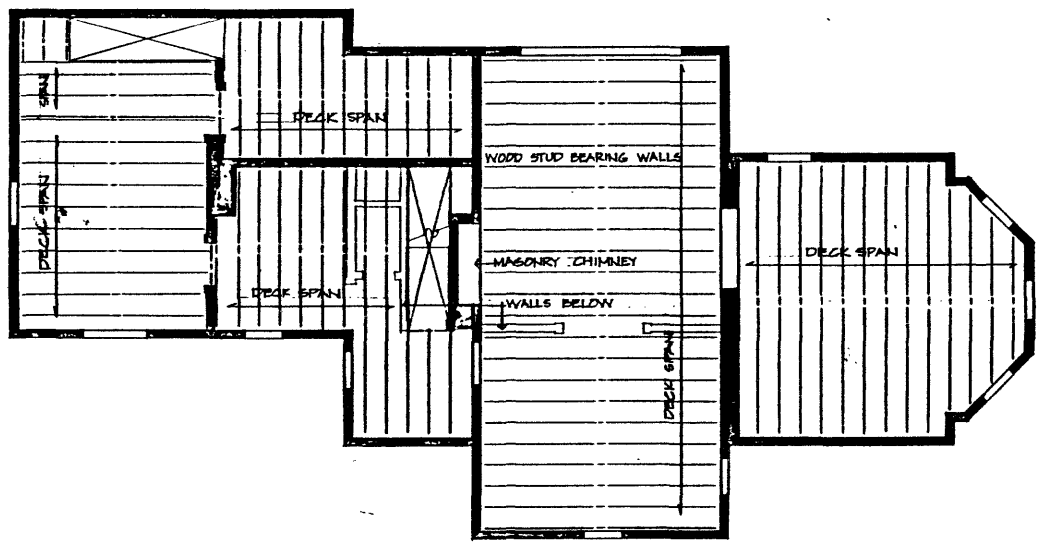
DESIGNED:	SUB SHEET NO.	TITLE OF SHEET	DRAWING NO.
DRAWN:		WALL SECTION & FRAMING PLAN	644 60023
TECH. REVIEW:		EXISTING CONDITIONS APRIL, 1982	NO. SHEET
DATE:		DANIEL TILDEN HOUSE	6
		CUYAHOGA VALLEY NATIONAL RECREATION AREA	OF 11

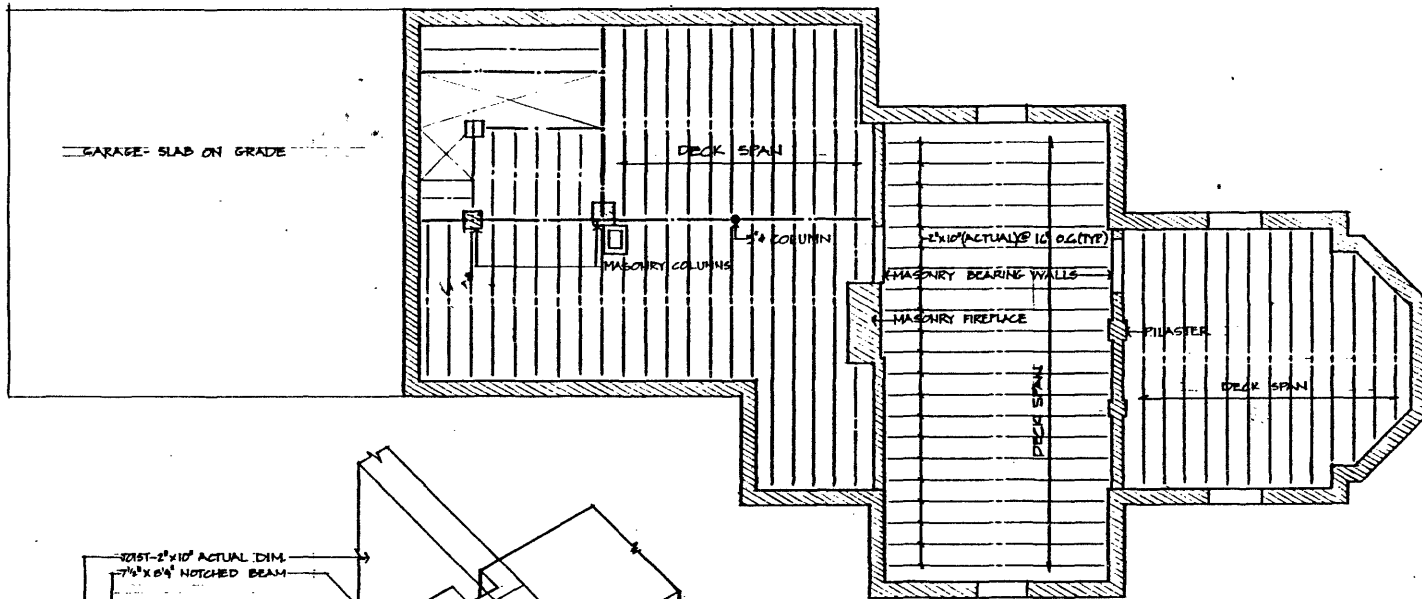
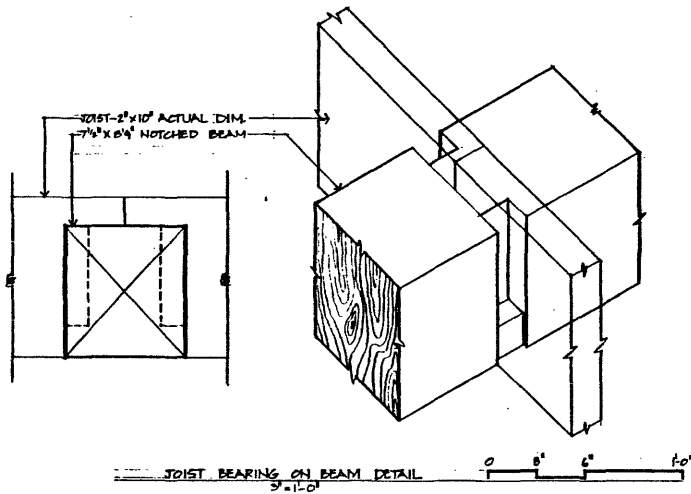
DESIGNED:	SUB SHEET NO.	TITLE OF SHEET	DRAWING NO.
DRAWN:		FRAMING PLAN & BEAM DETAIL	644 6002B
TECH. REVIEW:		EXISTING CONDITIONS APRIL, 1982	PKG. NO. SHEET
DATE: /		DANIEL TILDEN HOUSE	5
		CUYAHOGA VALLEY NATIONAL RECREATION AREA	OF 11

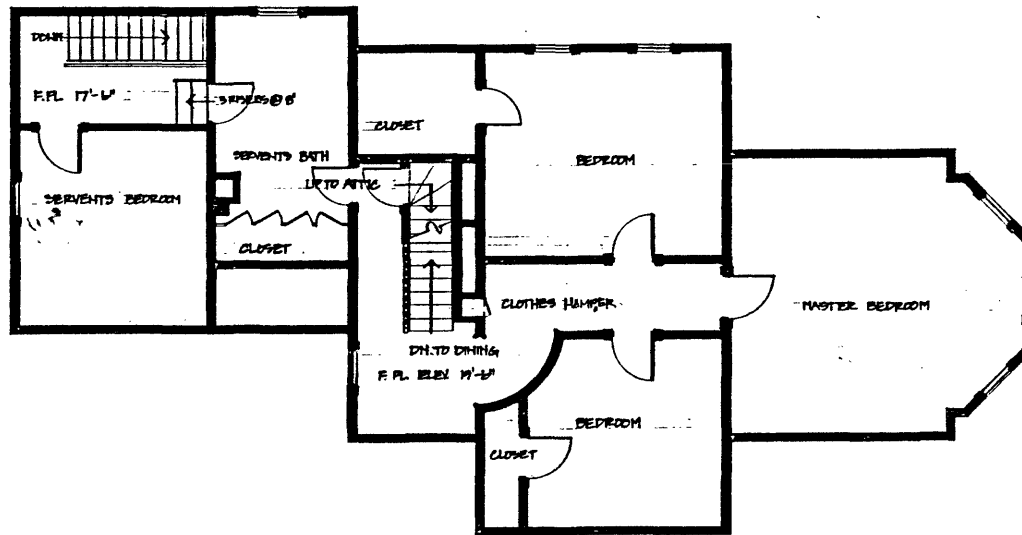
DESIGNED:	SUB SHEET NO.	TITLE OF SHEET	DRAWING NO.
DRAWN:		SECOND FLOOR PLAN	644
TECH. REVIEW:		EXISTING CONDITIONS APRIL, 1982	60,023
DATE:		DANIEL TILDEN HOUSE	PAGE NO.
		CUYAHOGA VALLEY NATIONAL RECREATION AREA	4
			OF 11
