KENTUCKY HISTORIC RESOURCES INVENTORY

Site No. Me 49

1. Historic Name(s) <u>Shaker West Lot</u>		22. ADD/County <u>Bluegrass, Mercer</u>	
Original Owner <u>Shaker Community</u>		23. U.S.G.S. Quadrant (15'/75') <u>Harrodsburg, Vir.</u> G.I.S. Mod. <input type="checkbox"/>

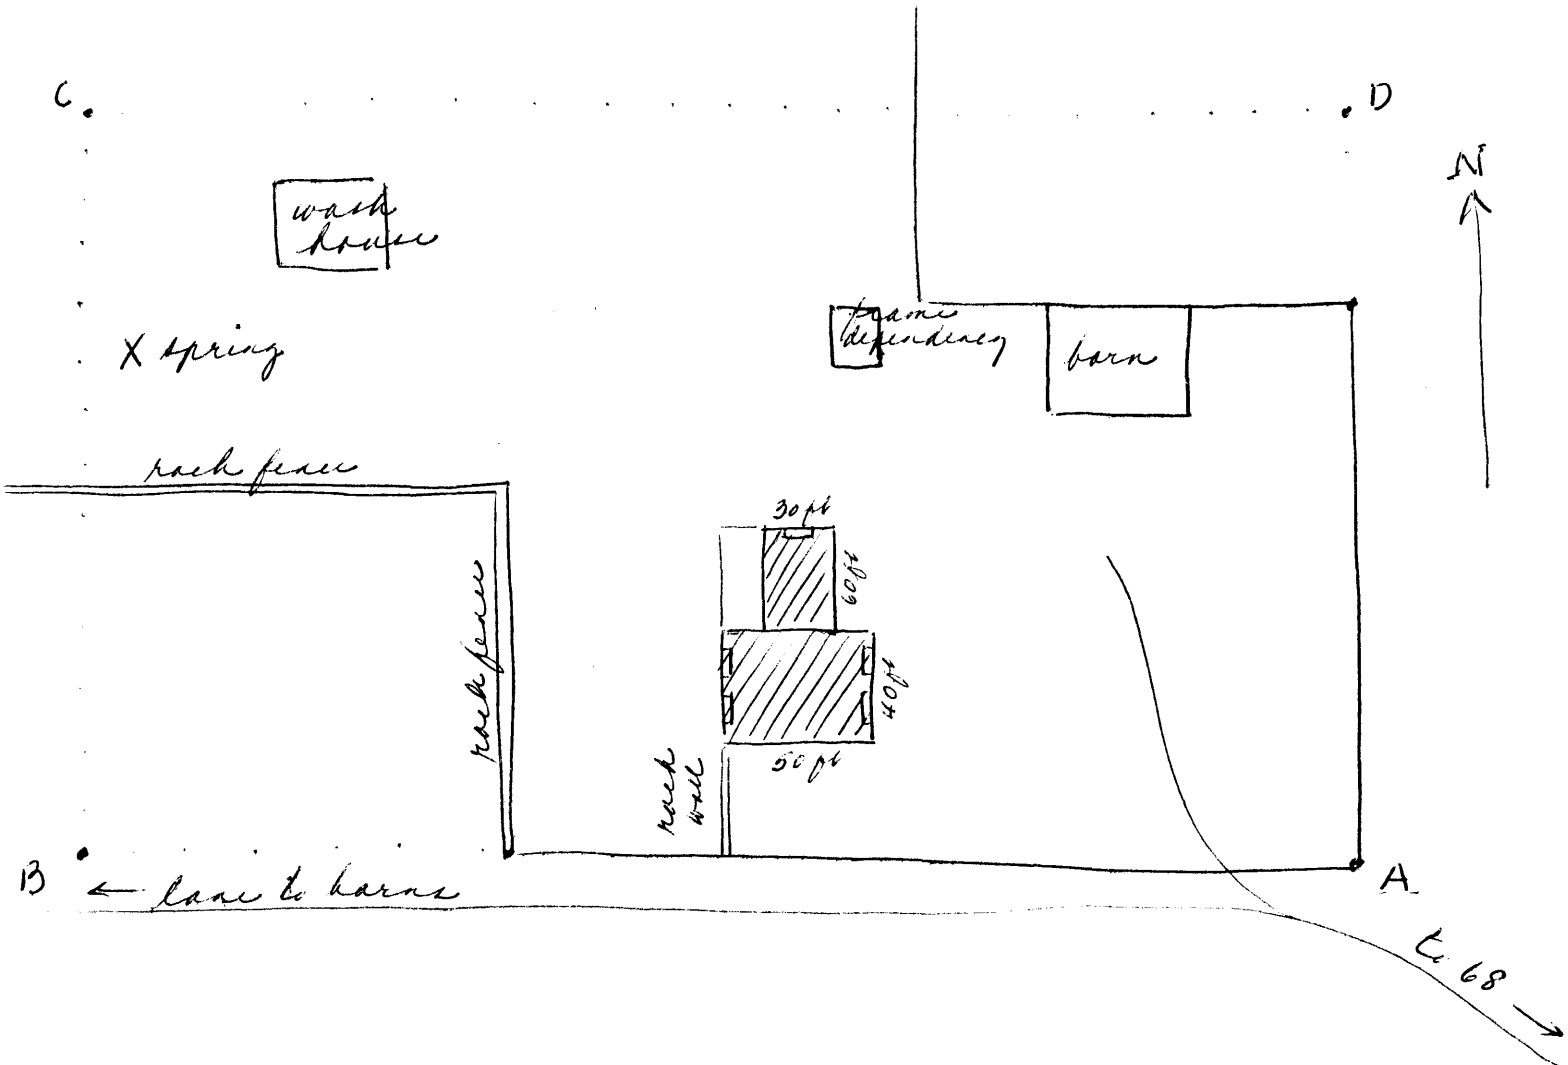
SKETCH MAP OF SITE SHOWING BOUNDARIES AND KEY BUILDINGS AND FEATURES WITH NORTH ARROW.

Beginning at A at a fence corner in SE corner of yard at lane, thence along lane 500 ft <sup>W</sup> to B, thence at right angle 400 ft N to C, thence parallel to A-B 500 ft E to C, thence parallel to B-C 400 ft S to the beginning containing the stone dwelling house, <sup>frame dependency</sup> brick wash house and spring - about 4 1/2 acres. Barns are of later date.
