**National Register of Historic Places
Registration Form**

historic name Morgan/Skinner/Boyd Homestead

other names/site number Walnut Grove

street & number 111 East 73rd Avenue

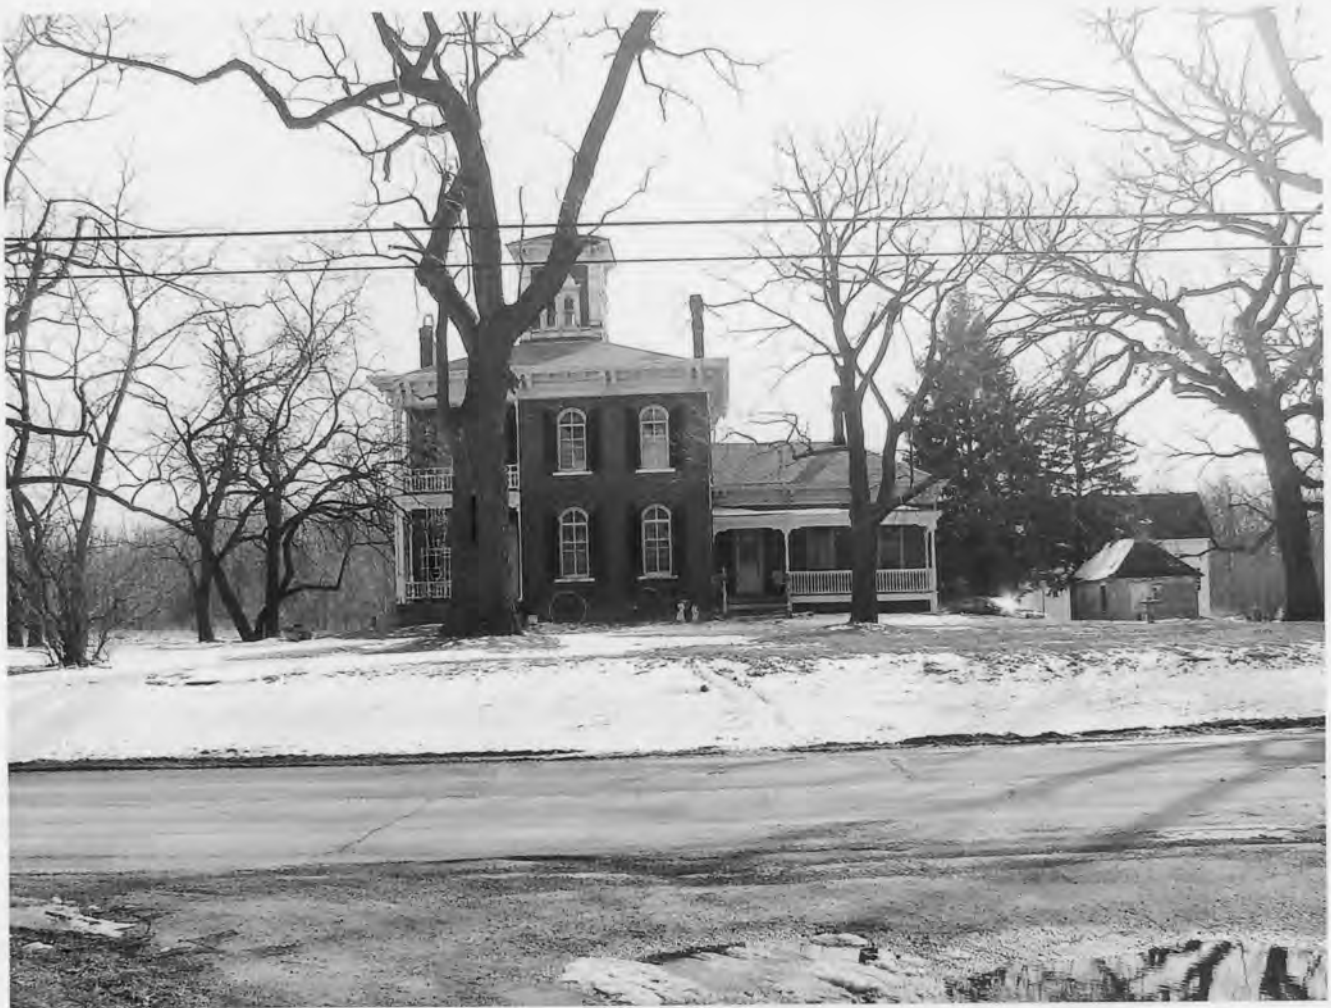
Morgan/Skinner/Boyd Homestead, Lake Co., IN #1

sits at grade and is constructed of concrete blocks. The east side of the main, or north, façade is recessed forming an area into which a two tier porch has been constructed. (photo 1).

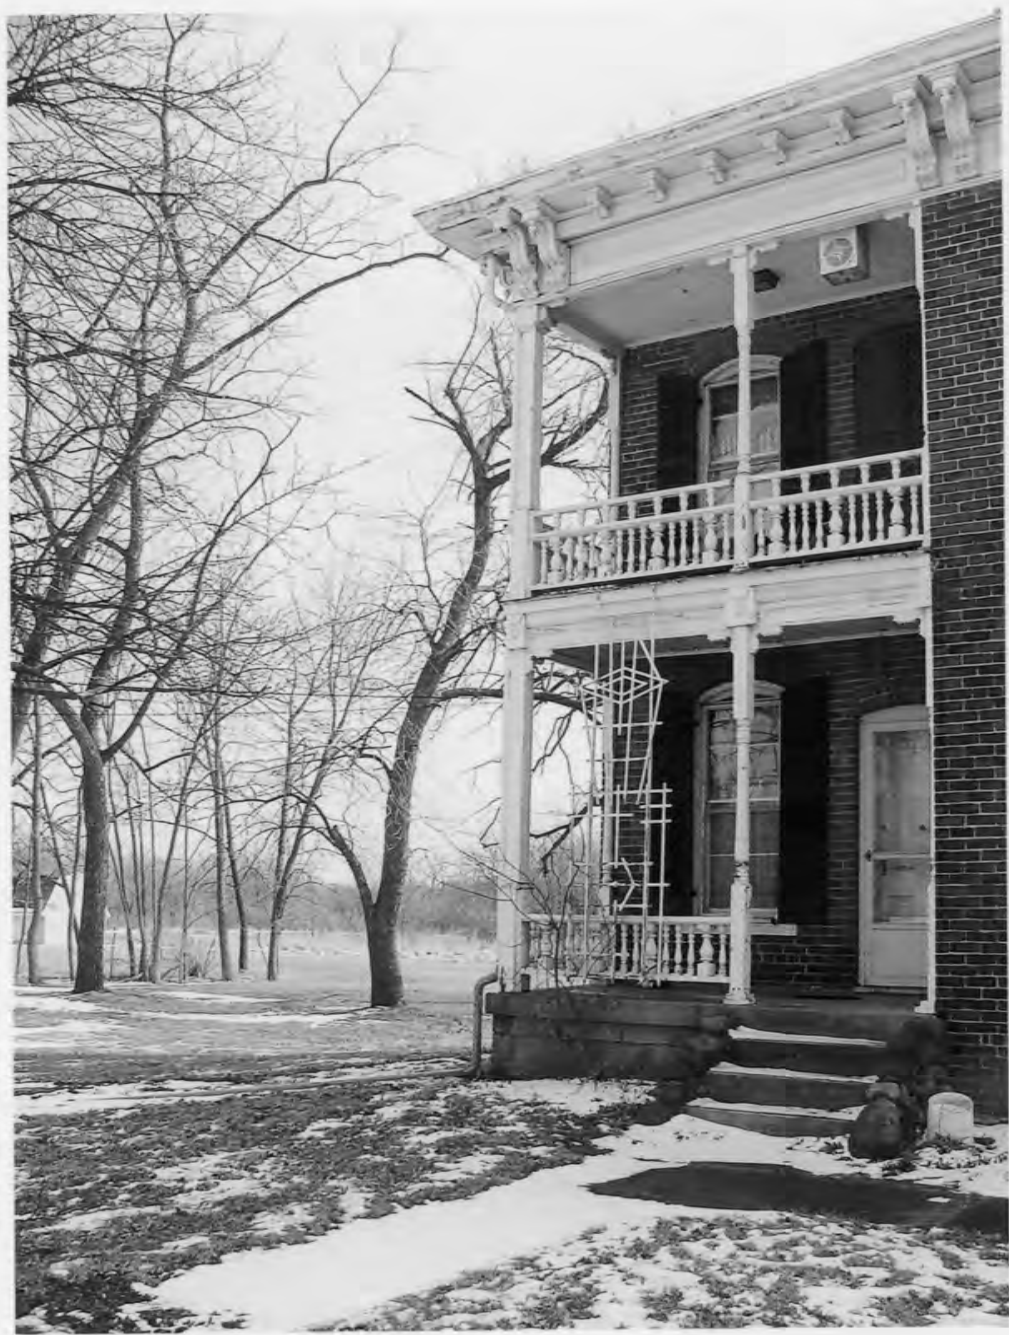
Morgan/Skinner/Boyd Homestead, Lake Co., IN #2

There are three porches on the north elevation of the structure; a full width single story porch on the kitchen addition and a two tiered porch that fills the recess in the northeast corner of the house. The two porches are similar in construction but not identical. Both porches have machined three dimensional spindle work detailing in the Eastlake tradition. The two tier porch has a square pillar on both first and second floor levels that supports the northeast corner of the roof; there are no square posts on the kitchen porch. Centered on the northern edge on both levels the two tier porch is a turned and carved post; one supporting the second level porch floor and the other the roof eave. Each pillar, or post, has a scroll-sawn bracket that supports the cornice above it. Where the porch meets the brick walls of the house there is a half post, identical in detailing to the center post. Between these posts are banister rails with turned balusters and spindles. These connect between each of the turned posts and corner pillar and enclose the porch except in front of the entry where the porch stairs provide access. (photo 2)

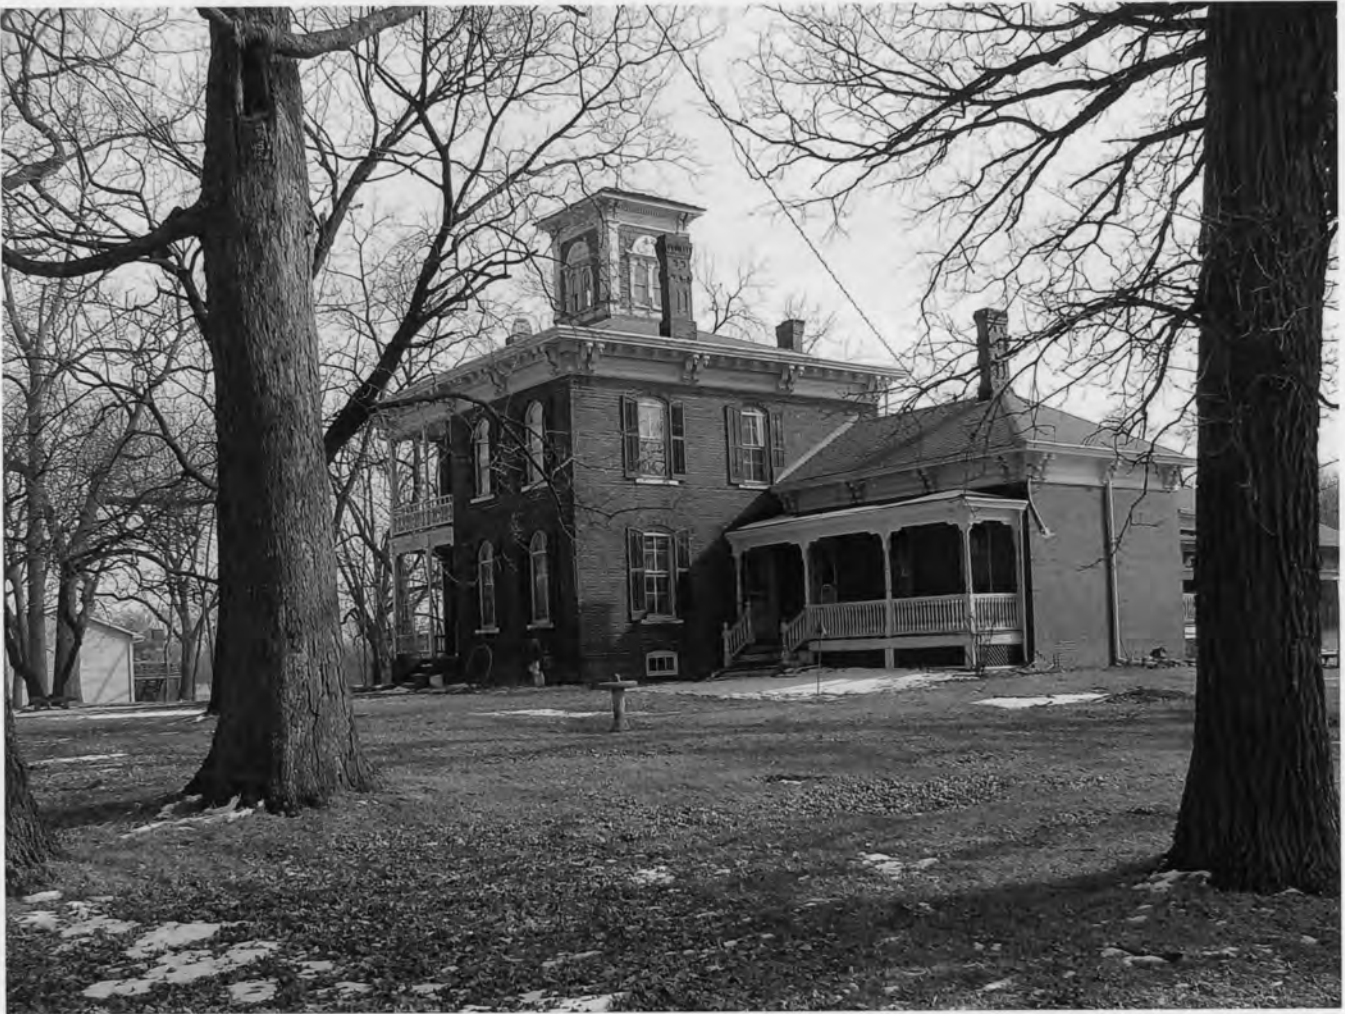
Morgan/Skinner/Boyd Homestead, Lake Co., IN #5

hipped portion of the addition's roof joins the ridge of the main gable a corbelled brick chimney pierces the roof. (photo 5)

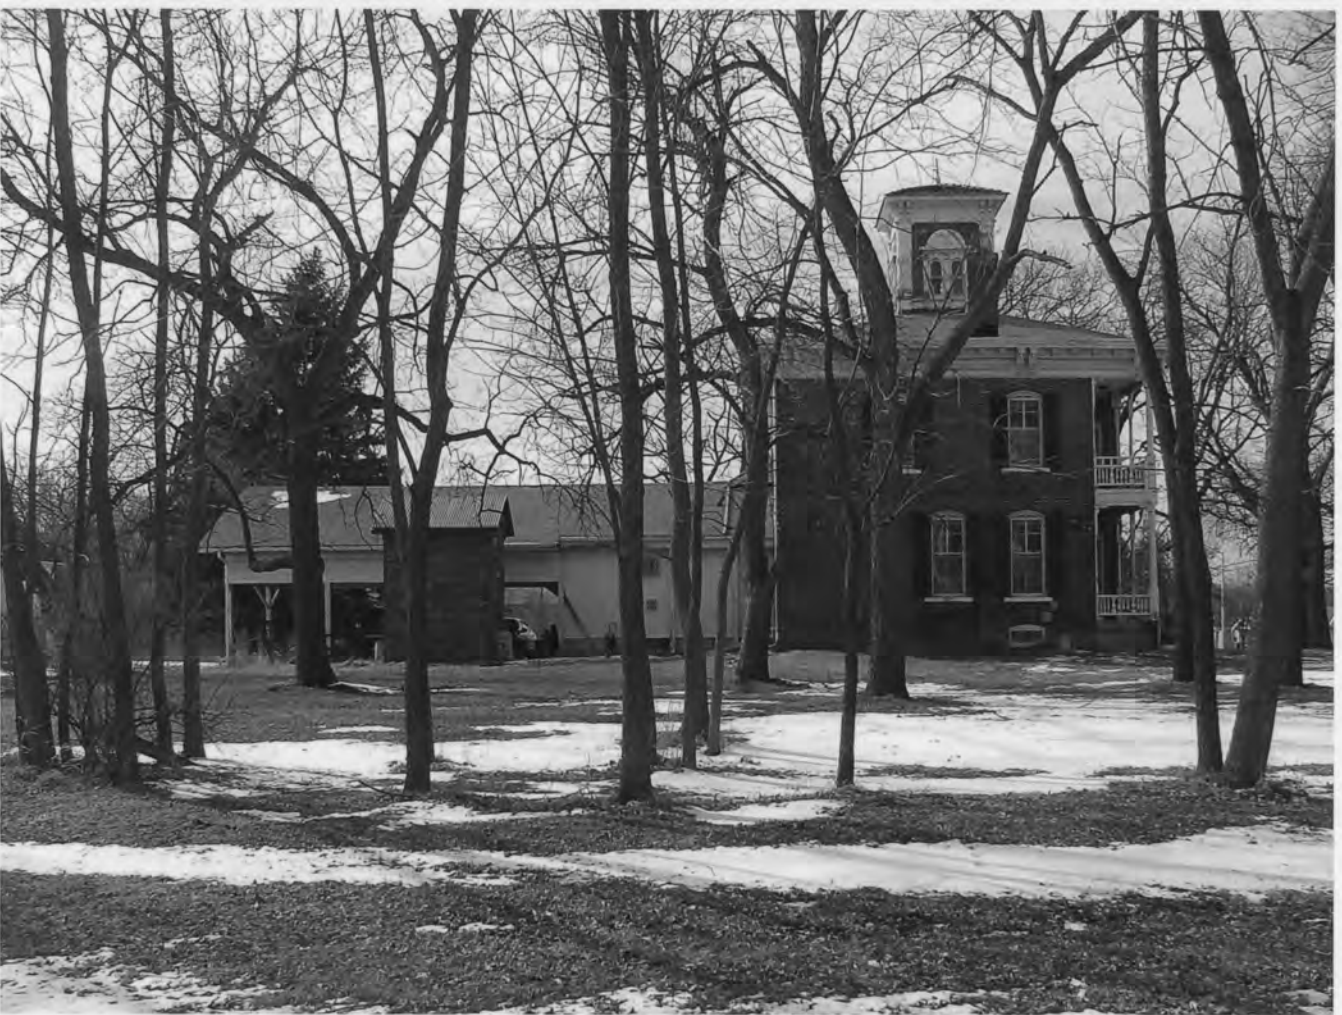
Morgan/Skinner/Boyd Homestead, Lake Co., IN #9

one third of its width with wood lapboard, the remaining two thirds, where the addition's roof is supported by wood posts, is open to the elements. (photo 9)

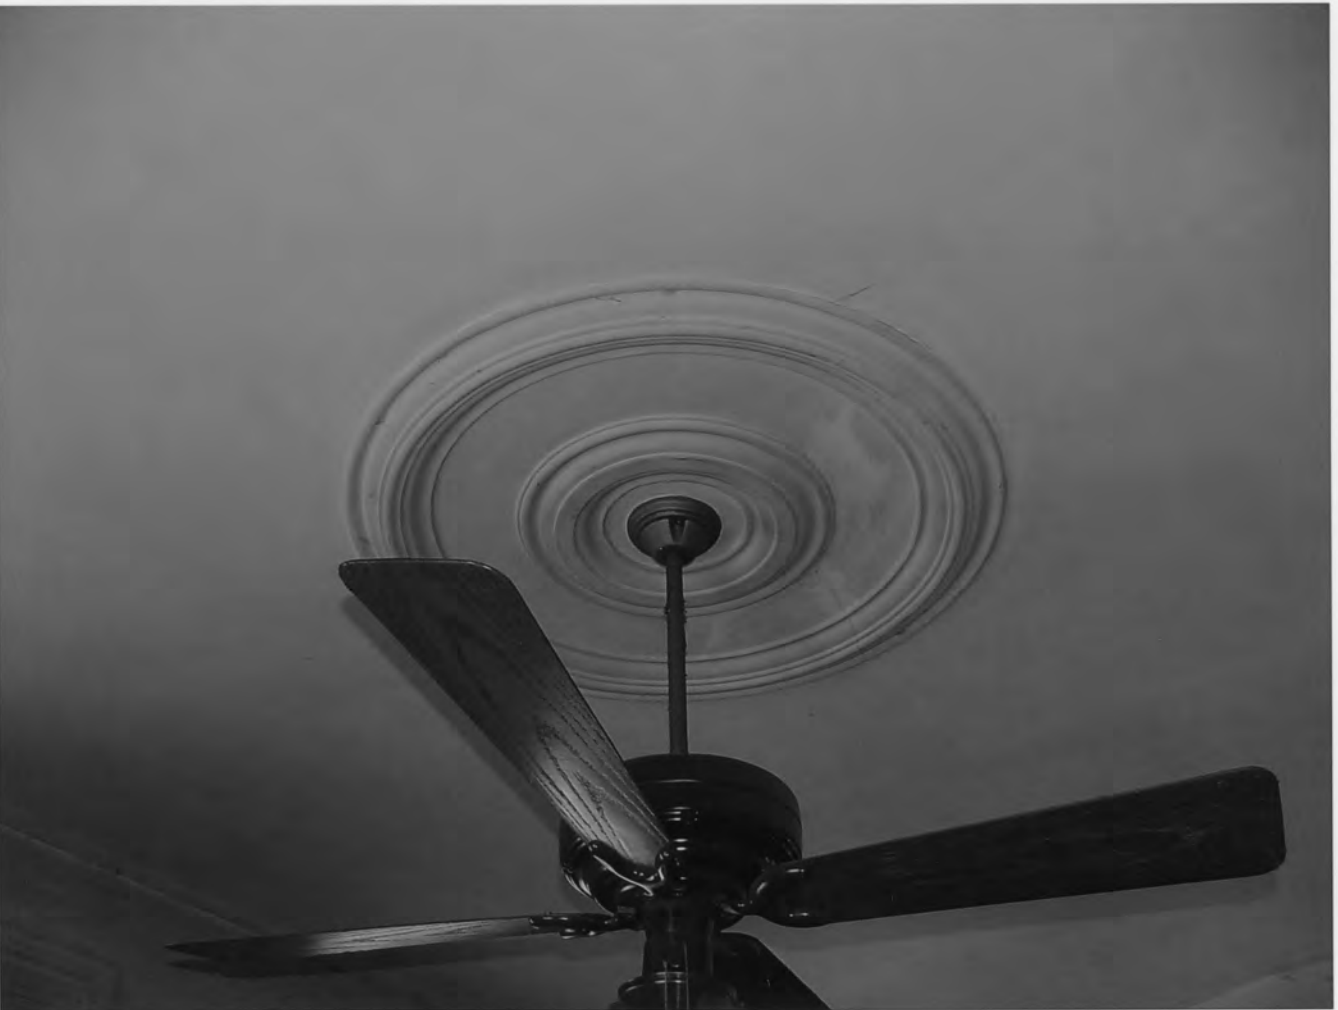
Morgan/Skinner/Boyd Homestead, Lake Co., IN #14

south wall has no openings. All walls in the room are plastered as well as is the ceiling. The ceiling in this room also retains the only piece of original molded decorative plaster; a set of two molded rings that surround the opening from which the ceiling light was suspended. (photo 14) The light fixture is of recent vintage.

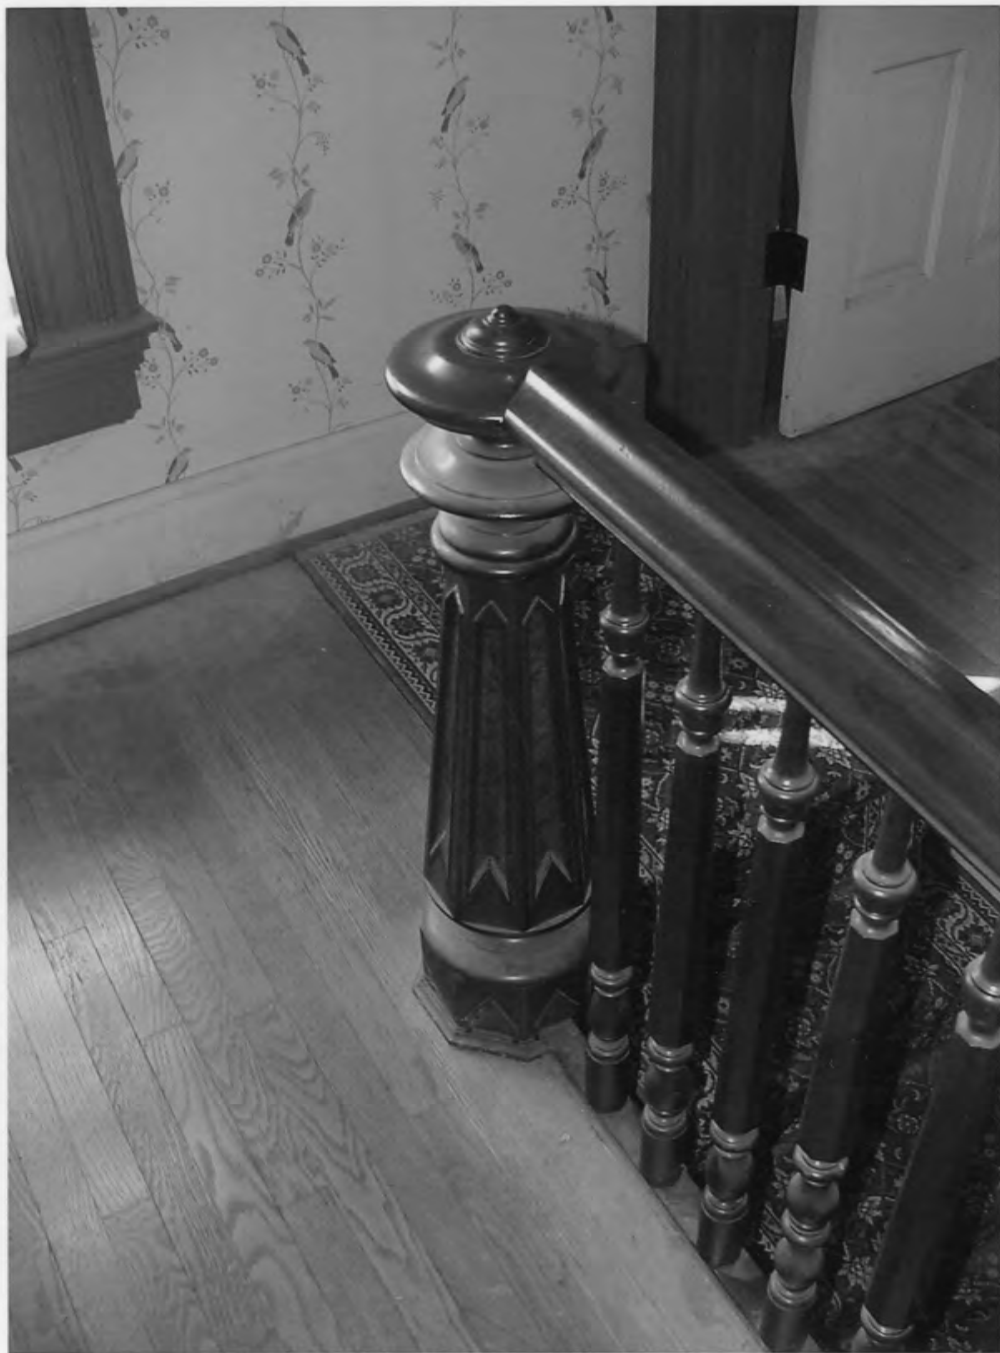
Morgan/Skinner/Boyd Homestead, Lake Co., IN #20

of the hall where the wall turns north, opens into the second story bath. The third door enters a bedroom through the north/south wall at the east end of the hall. All of the doors opening onto the hall are the original four panel wood doors, each with a fixed transom filled with stained leaded glass. (photo 20)

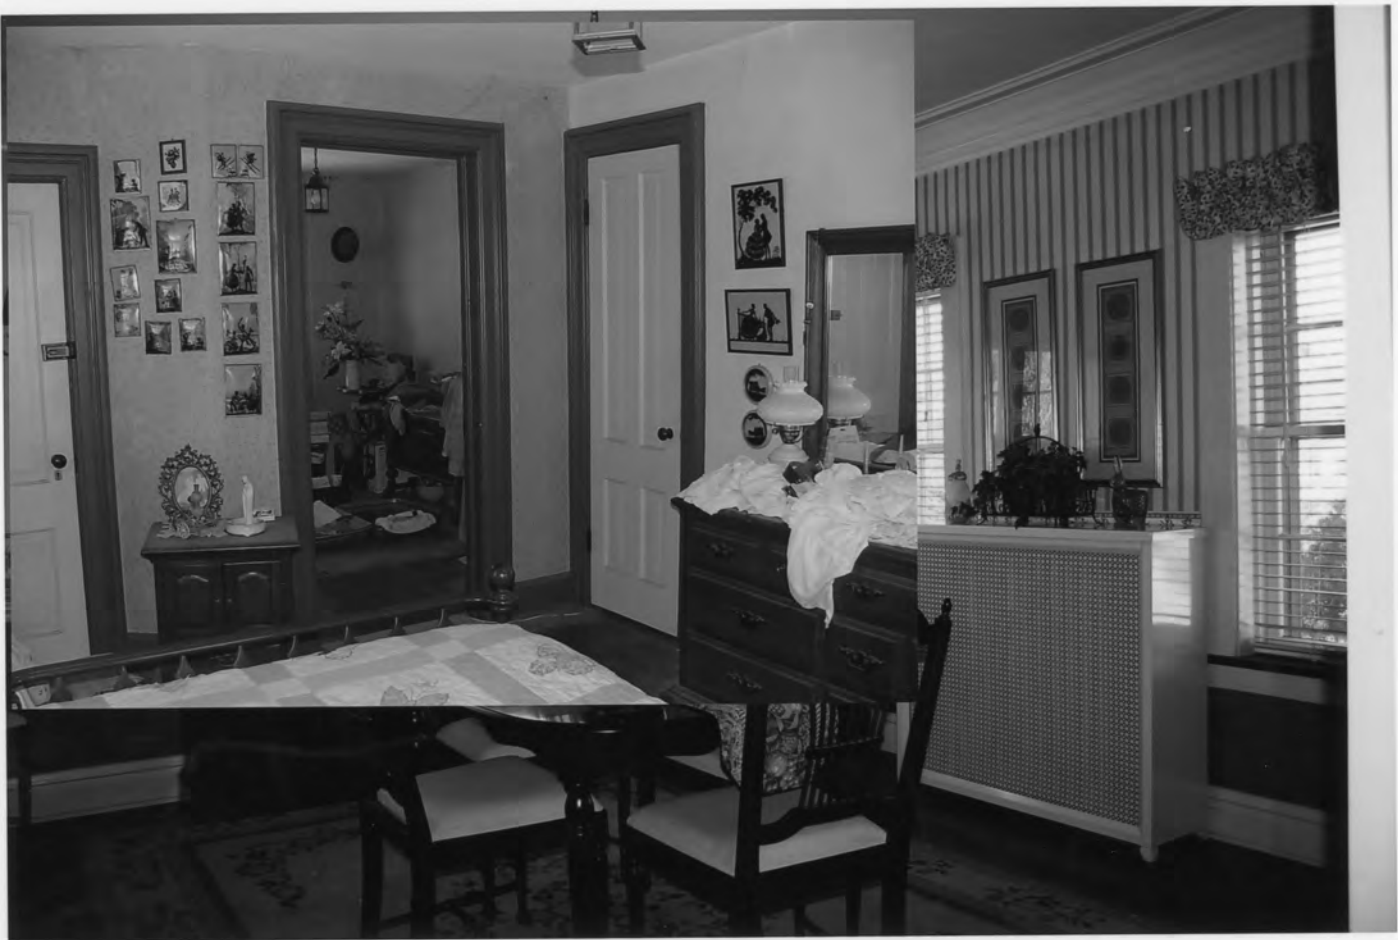
Morgan/Skinner/Boyd Homestead, Lake Co., IN #22
(top of image to left)

The master bedroom, the largest room on the second floor, sits in the northwest corner of the structure. It is accessed through a door on the north side of the second story landing. The nursery, in the northeast corner of the floor is accessible only through the master bedroom. Both rooms are finished with the same base board, door and window trim that was used on the first floor. The walls of both rooms are plaster and the flooring in both rooms is oak plank and original to the house. Counting the entry door there are four doors within the master bedroom; two on the south wall and two on the east wall. On the south wall the entry door from the hall is located on the west end of the wall and a door accessing a closet located at the walls east end. The doors on the east wall of the master bedroom are evenly spaced with the south door accessing the nursery and the north door providing exterior access to the second story of the two tier porch. All of the door openings have their original four panel oak doors and brass hardware; they all have been painted white. (photo 21) The closet door on the south wall of the master bedroom is narrower than the other three doors and the door leading to the porch is approximately six inches shorter than the other three doors which is due to restrictions caused by the ceiling height of the porch. Both rooms have large segmental arched windows identical to those on the first floor. There are three windows in the master bedroom, two evenly spaced on the north wall and one near the south end of the west wall, and three in the nursery, two evenly spaced on the north wall and one centered on the east wall. The ceilings are modern acoustic tile drop ceilings the original eleven foot ceilings remain above these tiles and are visible in the closet. (photo 22)

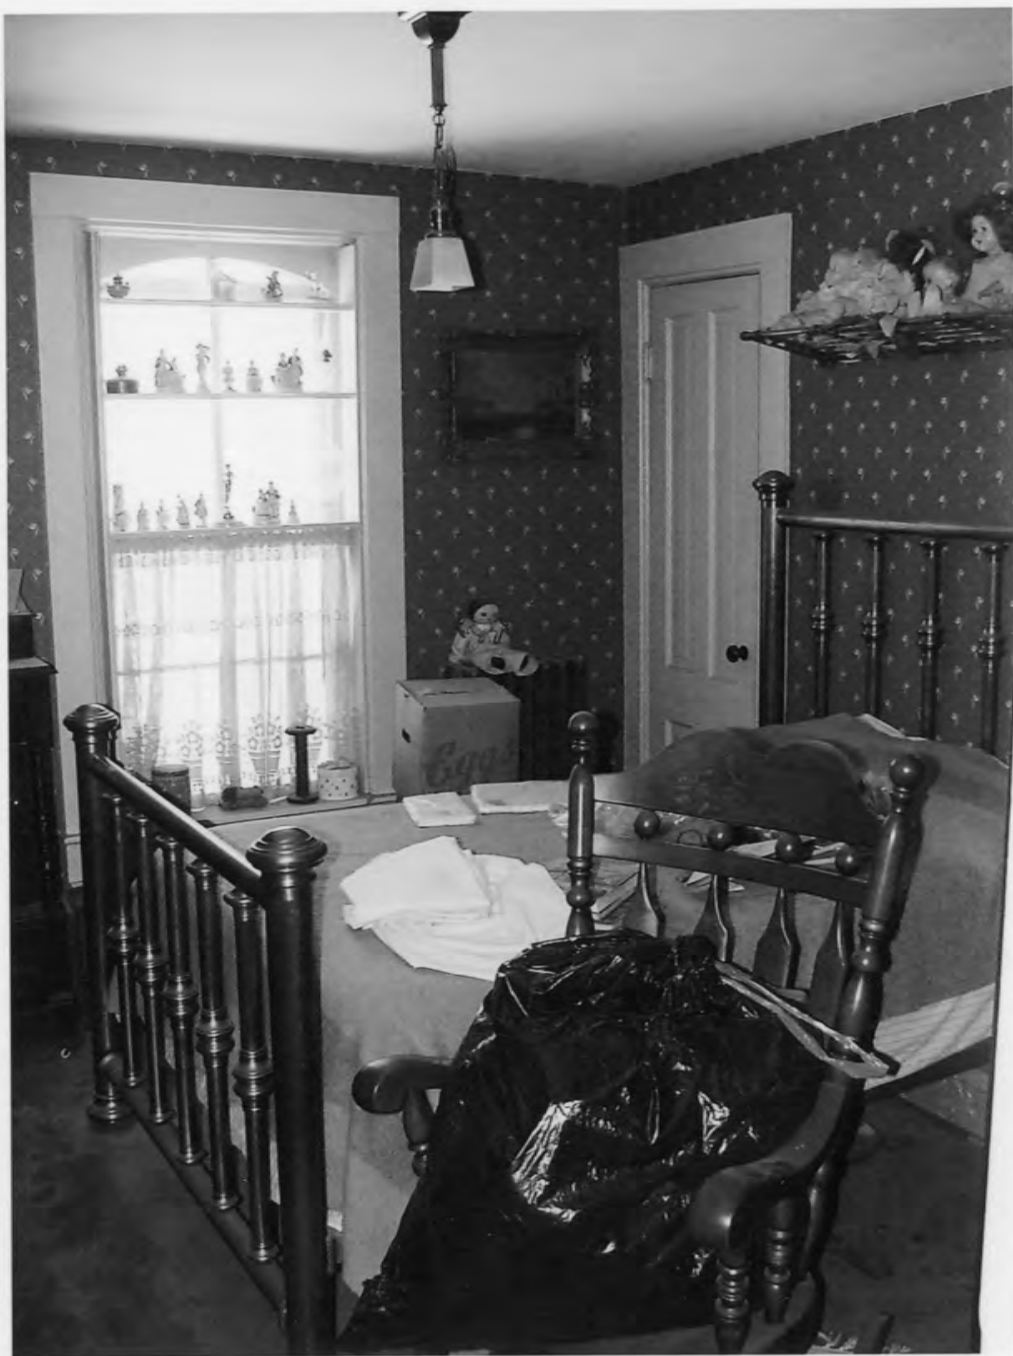
Morgan/Skinner/Boyd Homestead, Lake Co., IN #24

The third bedroom on the floor is located at the east end of the hallway in the southeast corner of the house. The floor is covered with the original oak planks. This room retains its original wood baseboard, window and door trim; all have been painted. There are two four panel wood doors in the room. One is the entry door with transom located on the north end of the west wall. The other is located on the east end of the south wall and provides access to a small hall that runs east/west and connects with the stairs going into the attic and cupola. There is one segmental arched window centered on the east wall of the room. (photo 23) The outline of the stairwell leading to the cupola can be seen on the south end of the west wall. This has been enclosed and a small closet created in the space beneath stairs. This closet is covered with a small painted wood batten door. (photo 24)

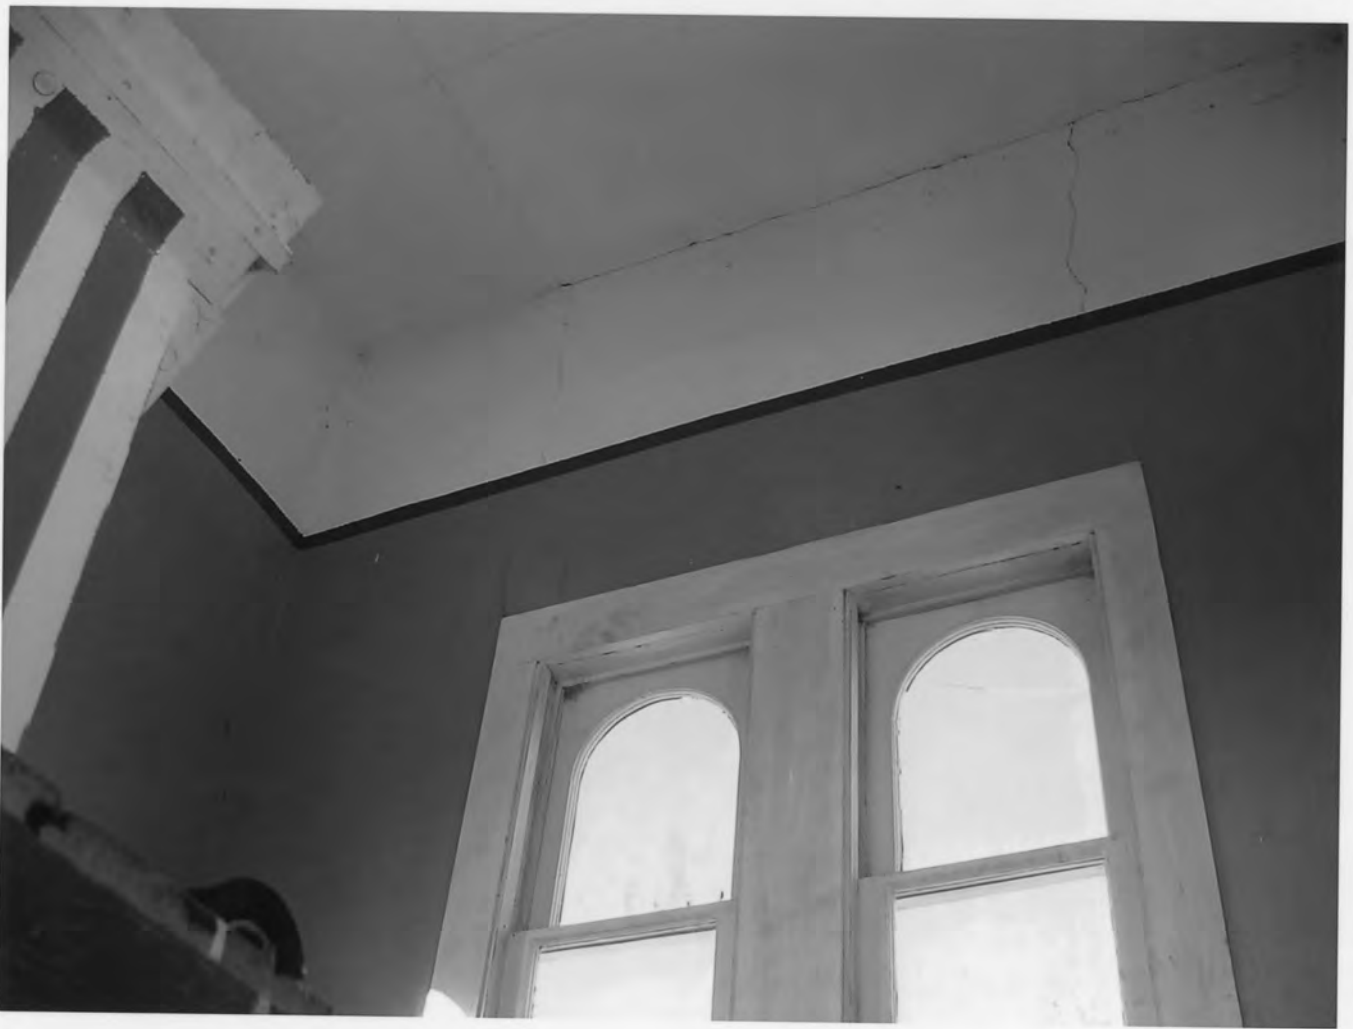
Morgan/Skinner/Boyd Homestead, Lake Co., IN #26

floors. The floor is of pine planks. A solid, short height wall guards the stair opening. The walls have been covered with plaster and painted. (photo 26)

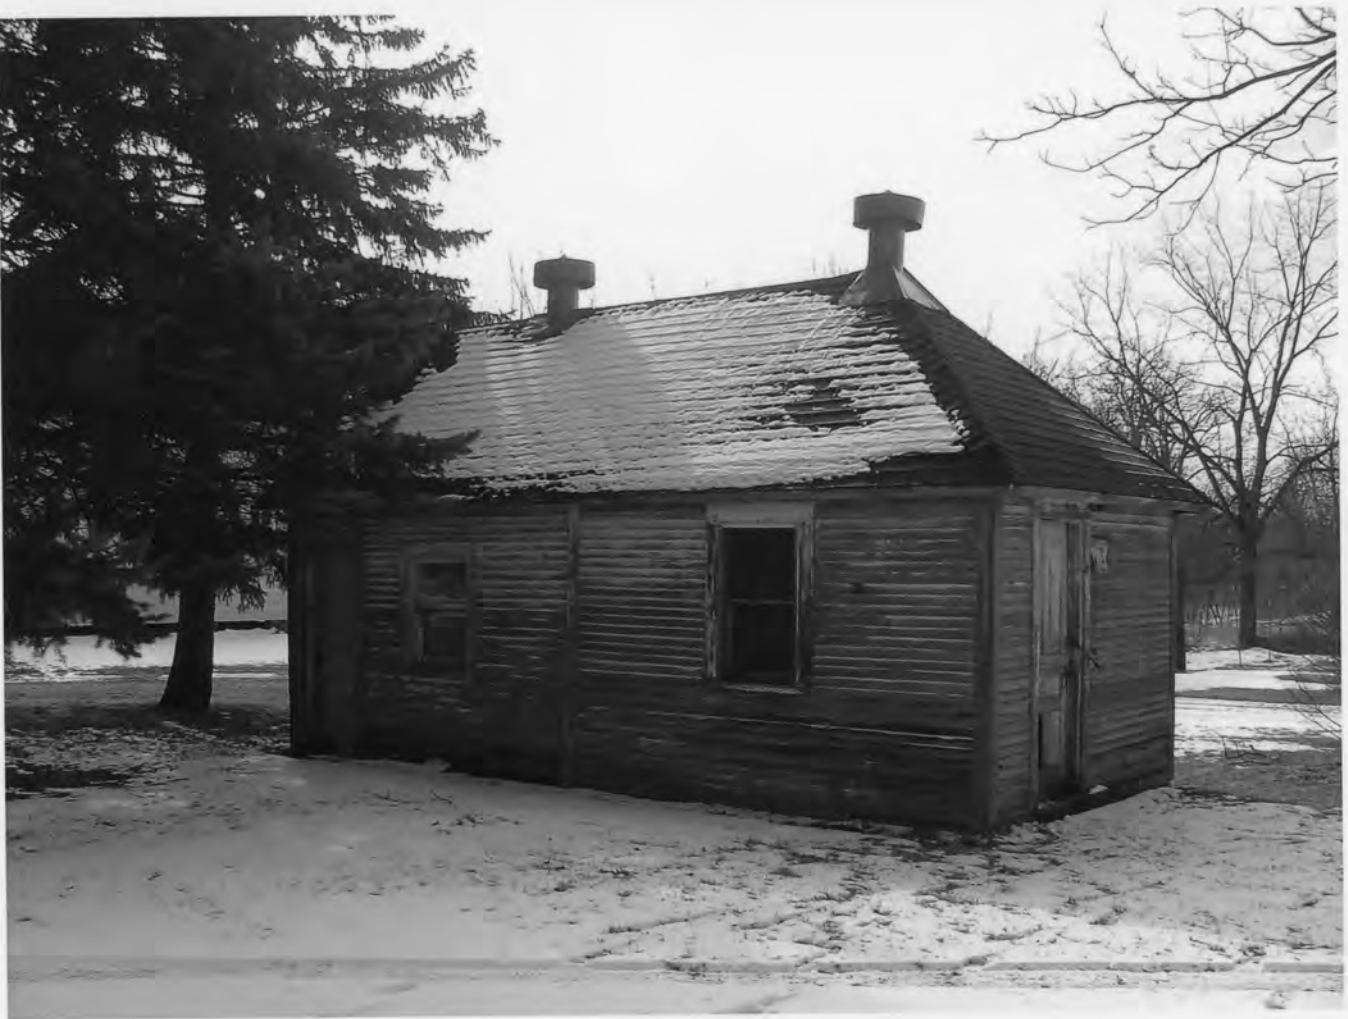
Morgan/Skinner/Boyd Homestead, Lake Co., IN #27

The old milk house (photo 27) is a rectangular wood framed structure constructed c. 1900. The walls are covered with narrow width shiplap siding. There are two entry doors into the structure, one on the east side of the north elevation and the other on the south end of the east elevation. The east elevation has two widely spaced windows, each opening into a separate room within the structure; this is repeated on the west elevation. There are no openings on the south elevation. The north elevation has a hipped roof and the south elevation is gabled ended. The roof is covered with asphalt shingles. Two ventilating fans sit on the ridge of the roof. The interior has wood, unfinished flooring and is in need of some repair. The interior is divided into two rooms with the northern most room being about one third of the length of the structure. This room appears to have been used as an office/workshop. The larger room at the south of the building was used for storage.

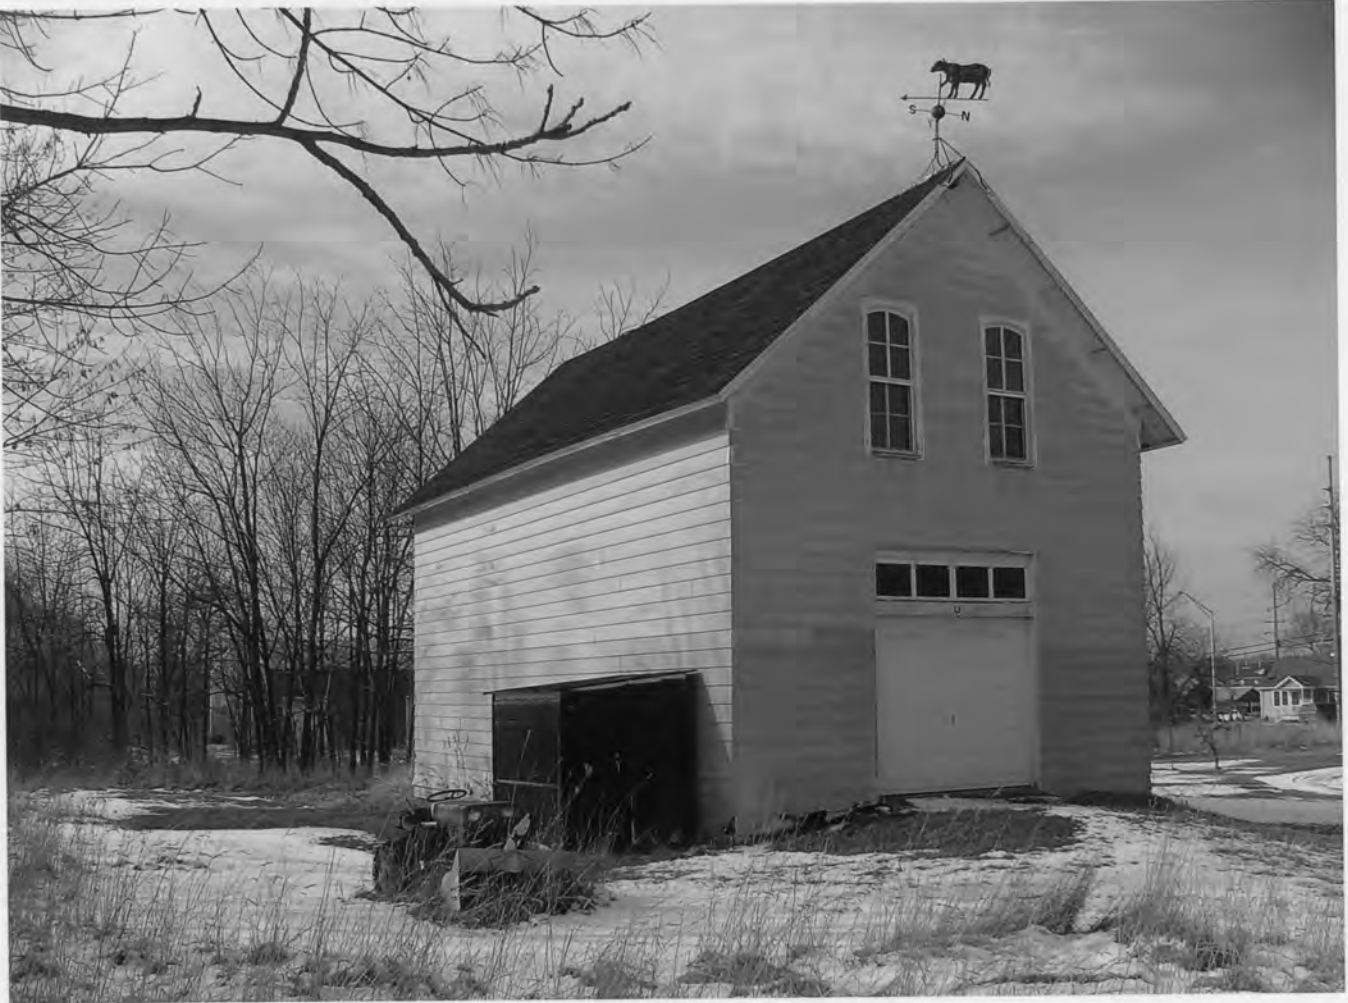
Morgan/Skinner/Boyd Homestead, Lake Co., IN #28

The granary (photo 28), c. 1877, is the largest building on the property and is oriented east to west. It is a gable end structure and is constructed like a transverse frame barn. It is covered with a modern vinyl siding. Large modern, multi-paneled roll up doors are centered on both the east and west elevations; the door on the east elevation has a fixed four light transom above it. Underneath the gable on both the east and west elevations are two wood double hung 2/2 segmental arched windows. There are no openings on the north and south elevations of the structure. The interior has an earthen floor. Along the south wall of the first floor of the interior are a series of wood bins that stored the grain. Along the north wall, in the eastern two-thirds of the structure is a storage room. A two landing stairwell occupies the northwest corner of the structure providing access to the loft. The loft is one large room with a floor is constructed of pine boards. The gabled roof is covered with asphalt shingles. A large weathervane/lightning rod sits at the east end of roof ridge and the spinner blade is a silhouette of a bull. This structure is in very good condition.

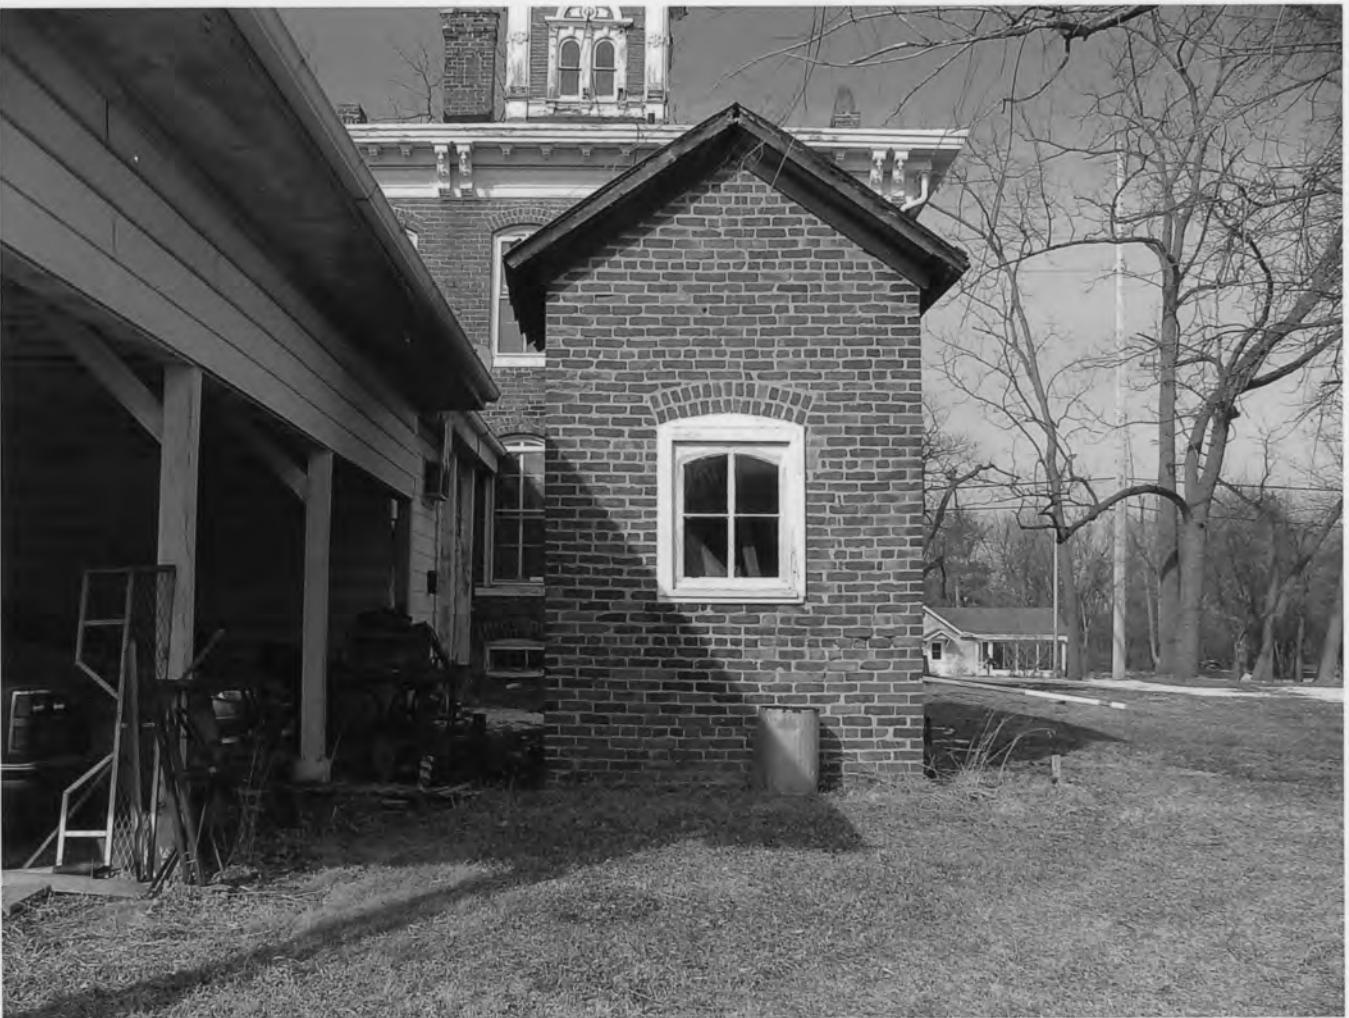
Morgan/Skinner/Boyd Homestead, Lake Co., IN #29

The pump house (photo 29), c. 1877, is constructed of the same brick as the main house. This tall structure is approximately eight foot square with a door centered on the north elevation facing

the house, near where the original rear door into the house was located. A small fixed 2/2 segmental arch window is centered in the south elevation; it has a wood sill and a segmental arch constructed using two rows of header brick. The interior of the structure is one room with a brick-lined well centered in the floor. The floor is constructed of pine boards and is in need of some repair. A gable end roof caps the structure and is covered with asphalt shingles. The exterior of the structure is in good condition, the interior floor needs replacing.
