HISTORIC PRESERVATION UNIT  
DEPARTMENT of CULTURE & HISTORY  
SCIENCE & CULTURE CENTER  
CHARLESTON, WEST VIRGINIA 25305

- NAME(S), historic/common: Walton, Wait, House (Downtown Parkersburg M.R.A.)
- LOCATION, street/road: 1232 Murdoch Ave.  
69-2  
TAX MAP city/town: Parkersburg, WV 26101  
LOT # (incorporated/~~unincorporated~~)
- USE/FUNCTION, present: vacant (public/private, restricted)  
original: residential
- OWNER/ADDRESS, present: Jean H. Brady & Elizabeth Wolfe Eddy (public/private)  
Trustees, 805 1/2 Market Street Parkersburg, W.Va. 26101  
original: Walton Wait
- PHOTO/SKETCH OF: 8112-R5-F26  
8201-R2-F26-30
- PLAN (include approx. dimensions):

Walton Wait House  
1232 Murdoch Ave.

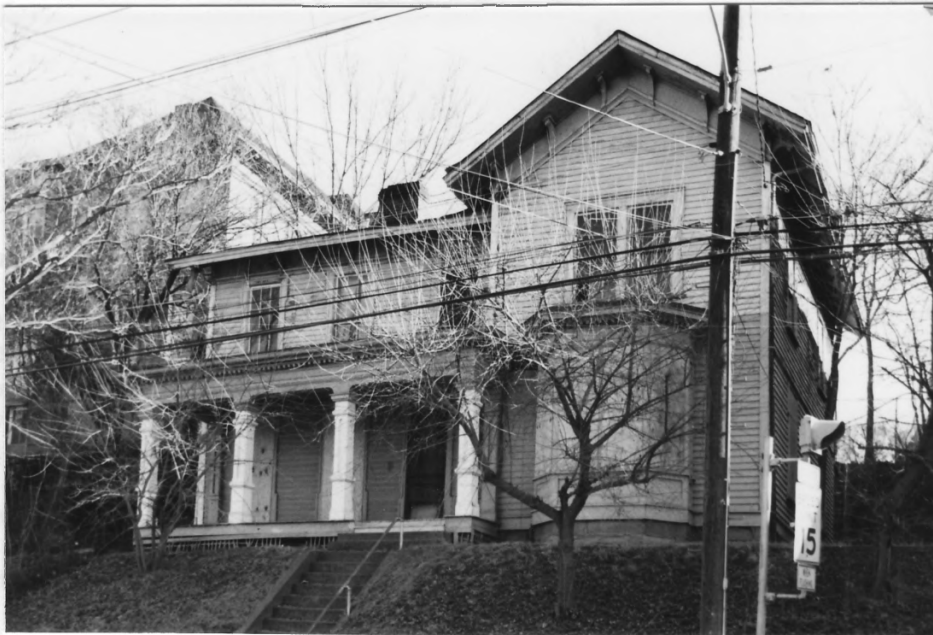
- LOCALE/ENVIRONMENT (map):
- ACREAGE (approx): 50' x 100'  
City Lot No. 69-2  
(See No. 2)

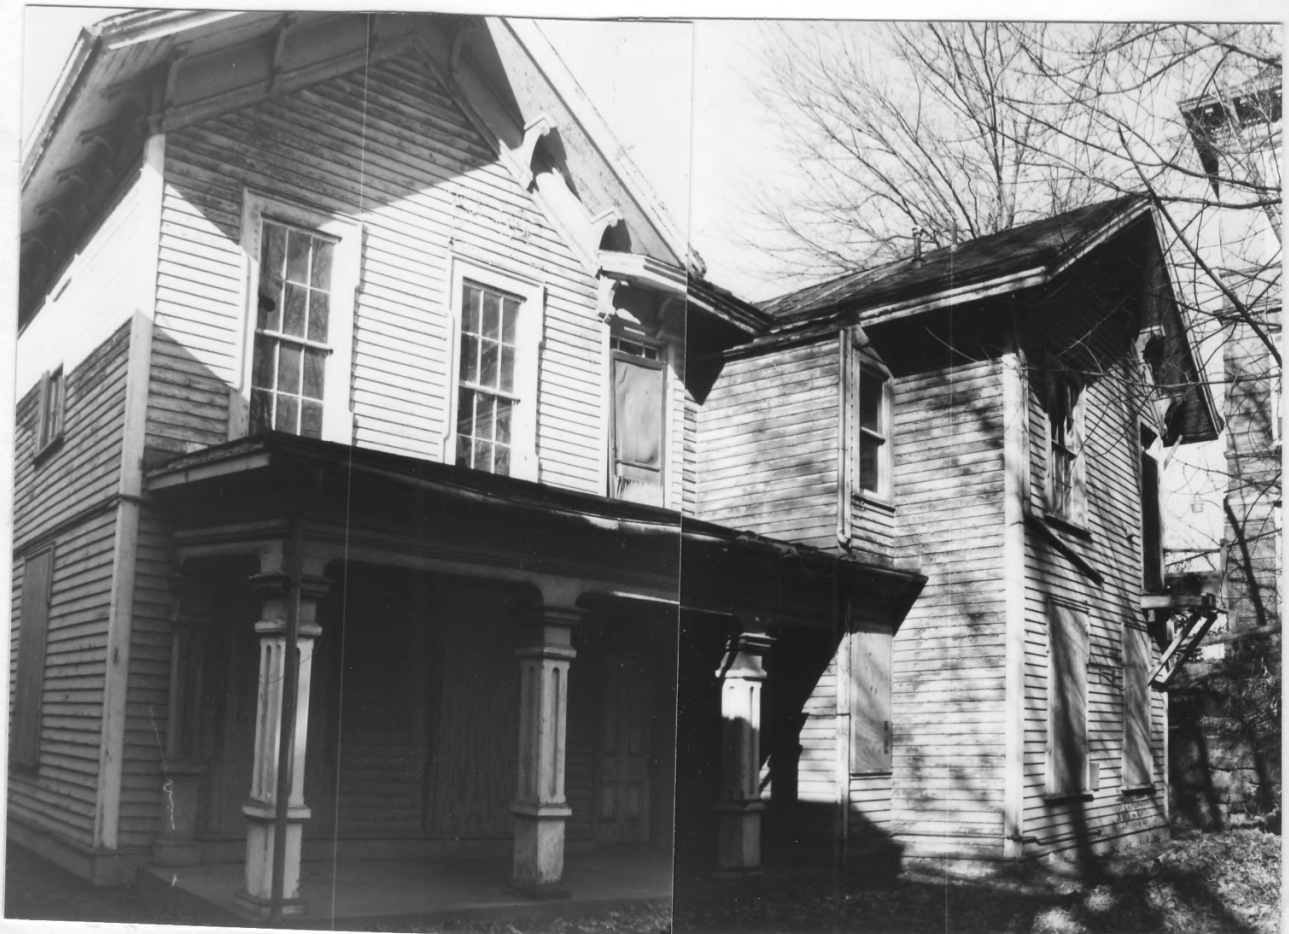
8201-R2-1003

Terraced high above busy Murdoch Avenue, this is a handsome and remarkably intact 2 story structure which illustrates the transition from the Greek Revival to the Italianate. When it was moved c. 1924, the house was not turned around; consequently, its orientation has changed and the former rear is now the front (W). Its gable roof, ridgepole running N-S, is intersected by a single gable on the W and 2 on the E; the widely overhanging eaves rest on brackets. There are 3 visible chimneys. The windows throughout are d/s (6/6), of full length on the 1st story, with fine architrave trim; a 3-sided bay projects from the W gable end. (In 1907, some of the windows were shuttered.)

The NW and SE corner porches match. Their deep, dentiled cornices rest on heavy, chamfered wooden posts. The 2 single doorways are transomed. A 3rd porch is barely visible on the N end of the house; it appears in the 1907 photo.

Exterior alterations apparent include an additional door to the right of the W door, removal of a balustrade from the W porch 2nd story, replacement of a 2nd story window with a door on the E, and addition of a 2 story infill in the ell of the E facade.
