National Register of Historic Places Registration Form

1. Name of Property		
historic name <u>Bowman, John and Ellen, House</u>	•	
other names/site number		
2. Location		
street & number 1719 NE Knott Street		not for publication
city or town Portland		
state Oregon code OR	county <u>Multnomah</u> code <u>051</u>	zip code <u>97212</u>

Bowman, John	and	Ellen,	House	
Name of Property

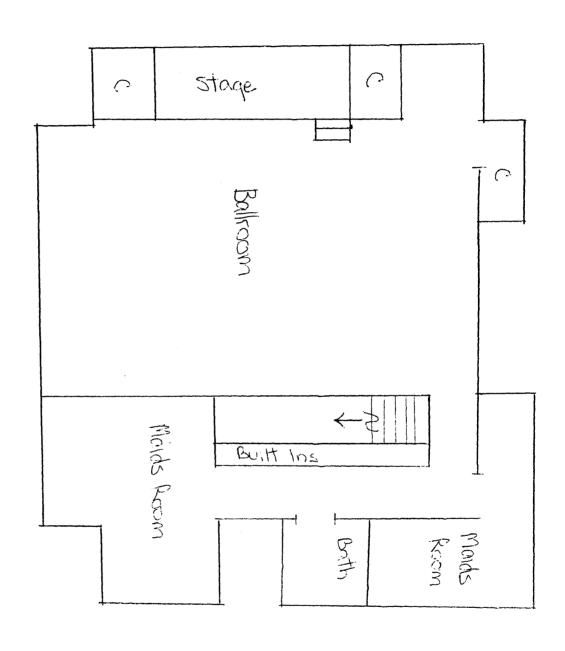
Bourman House 3xd Floor Not to Scale

The third floor of the house is divided into the ballroom and the servants quarters. The ballroom, occupying the western half of the third story, has a ribbon of casement window along the south wall, and a small stage on the west wall. The oak woodwork is stained dark.

The servants quarters have two bedrooms and a bathroom. The ceilings are sloped, matching the roof and dormer lines. Many windows, mostly casements located in dormers, provide plenty of natural light. The bathroom contains original fixtures. The hall has a large built-in cabinet.

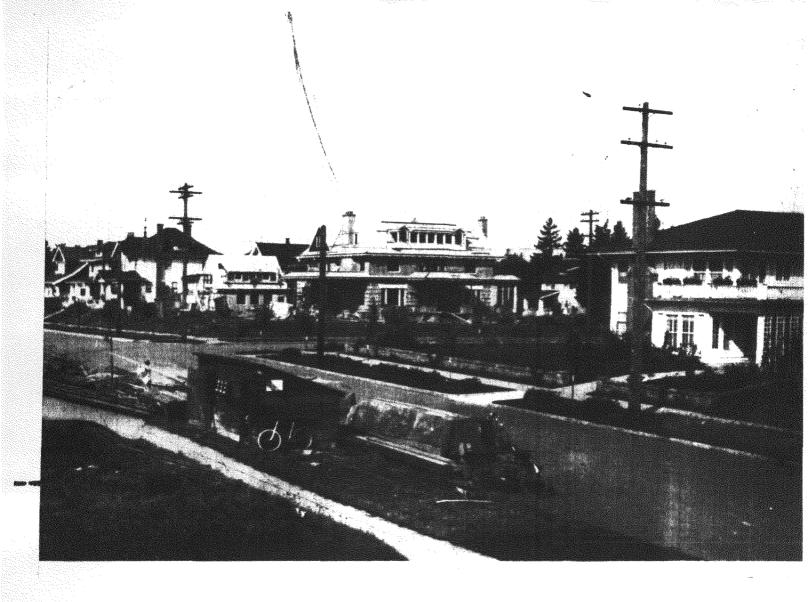
John L. Bowman House During construction 1915/1916 OHS Photo Collection

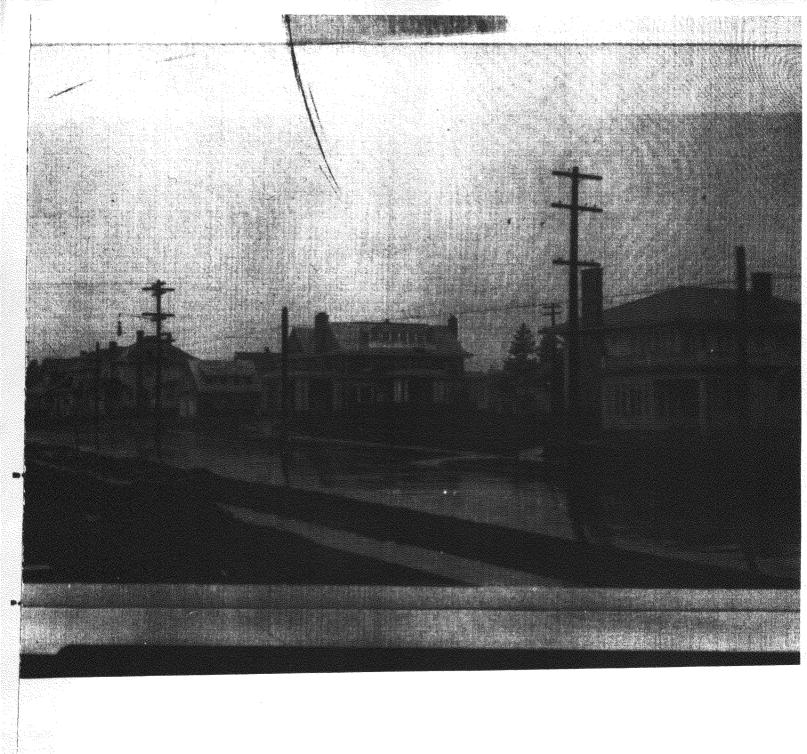
John L. Bowman House Just completed ca. 1916 OHS Photo Collection
