National Register of Historic Places  
Registration Form

historic name WEST HAVEN BAPTIST CHURCH

street & number 48 Book Road N/A not for publication

city or town West Haven N/A vicinity

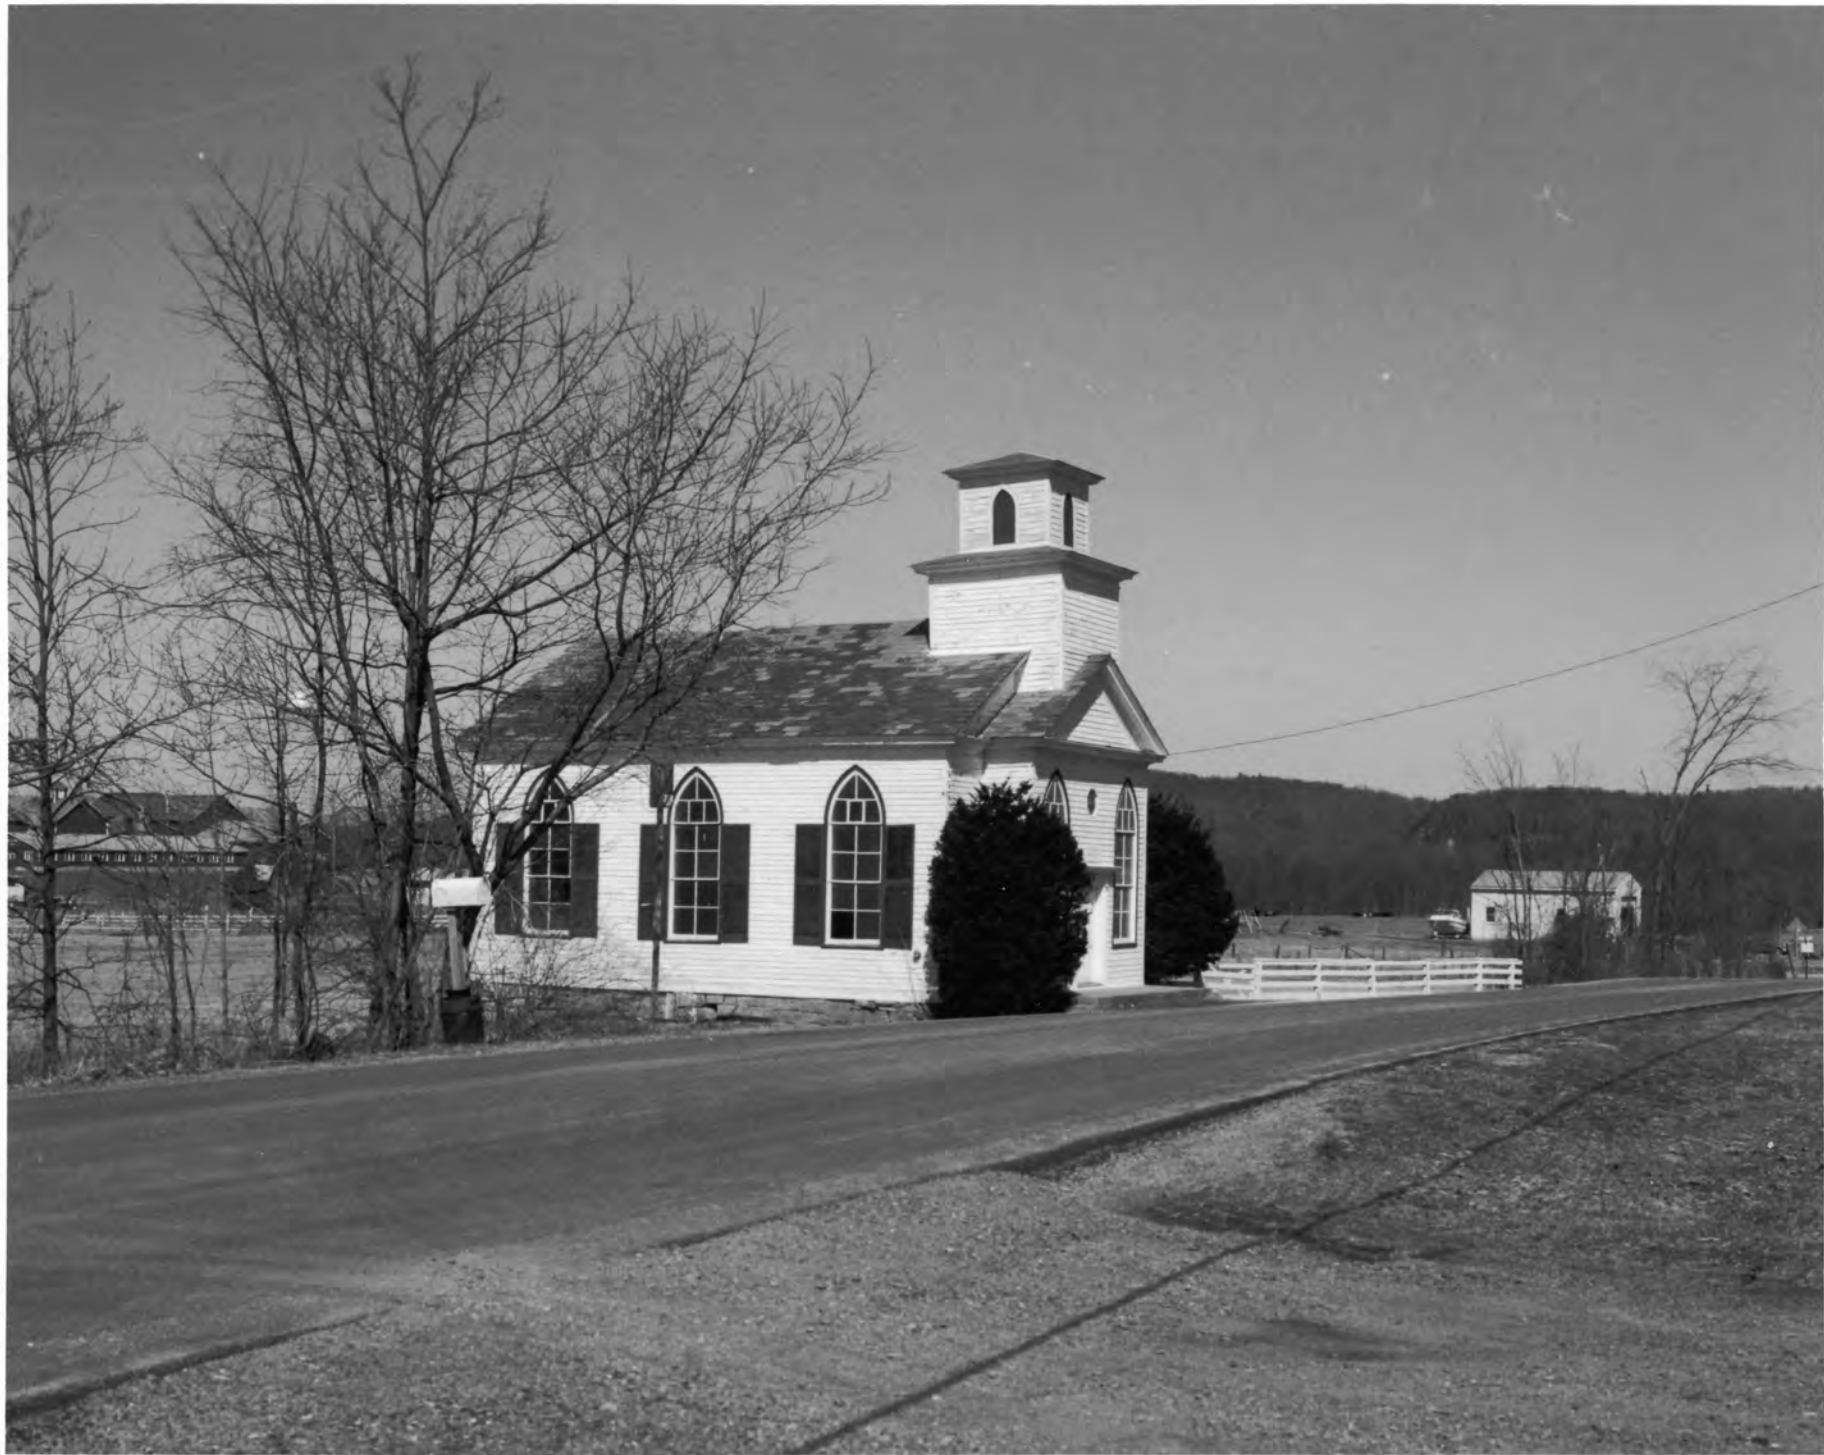
WEST HAVEN BAPTIST CHURCH  
WEST HAVEN, RUTLAND CO., VT.  
Photograph 1

Photograph 1  
Setting of church on west side of Book Road; view looking northwest.

The West Haven Baptist Church stands on the west side of Book Road, a short distance south of its intersection with Main Road at the center of the hamlet of West Haven. An open field surrounds the building and its small lot. A horizontal-board fence extends northeastward from the northeast front corner of the building to separate the front grounds from the adjacent field. The grounds slope gently downward from the paved road, landscaped only with cultivated lawn. Nearly concealing each front corner of the building, a coniferous tree pruned into a roughly cylindrical form rises almost to the height of the horizontal eaves.

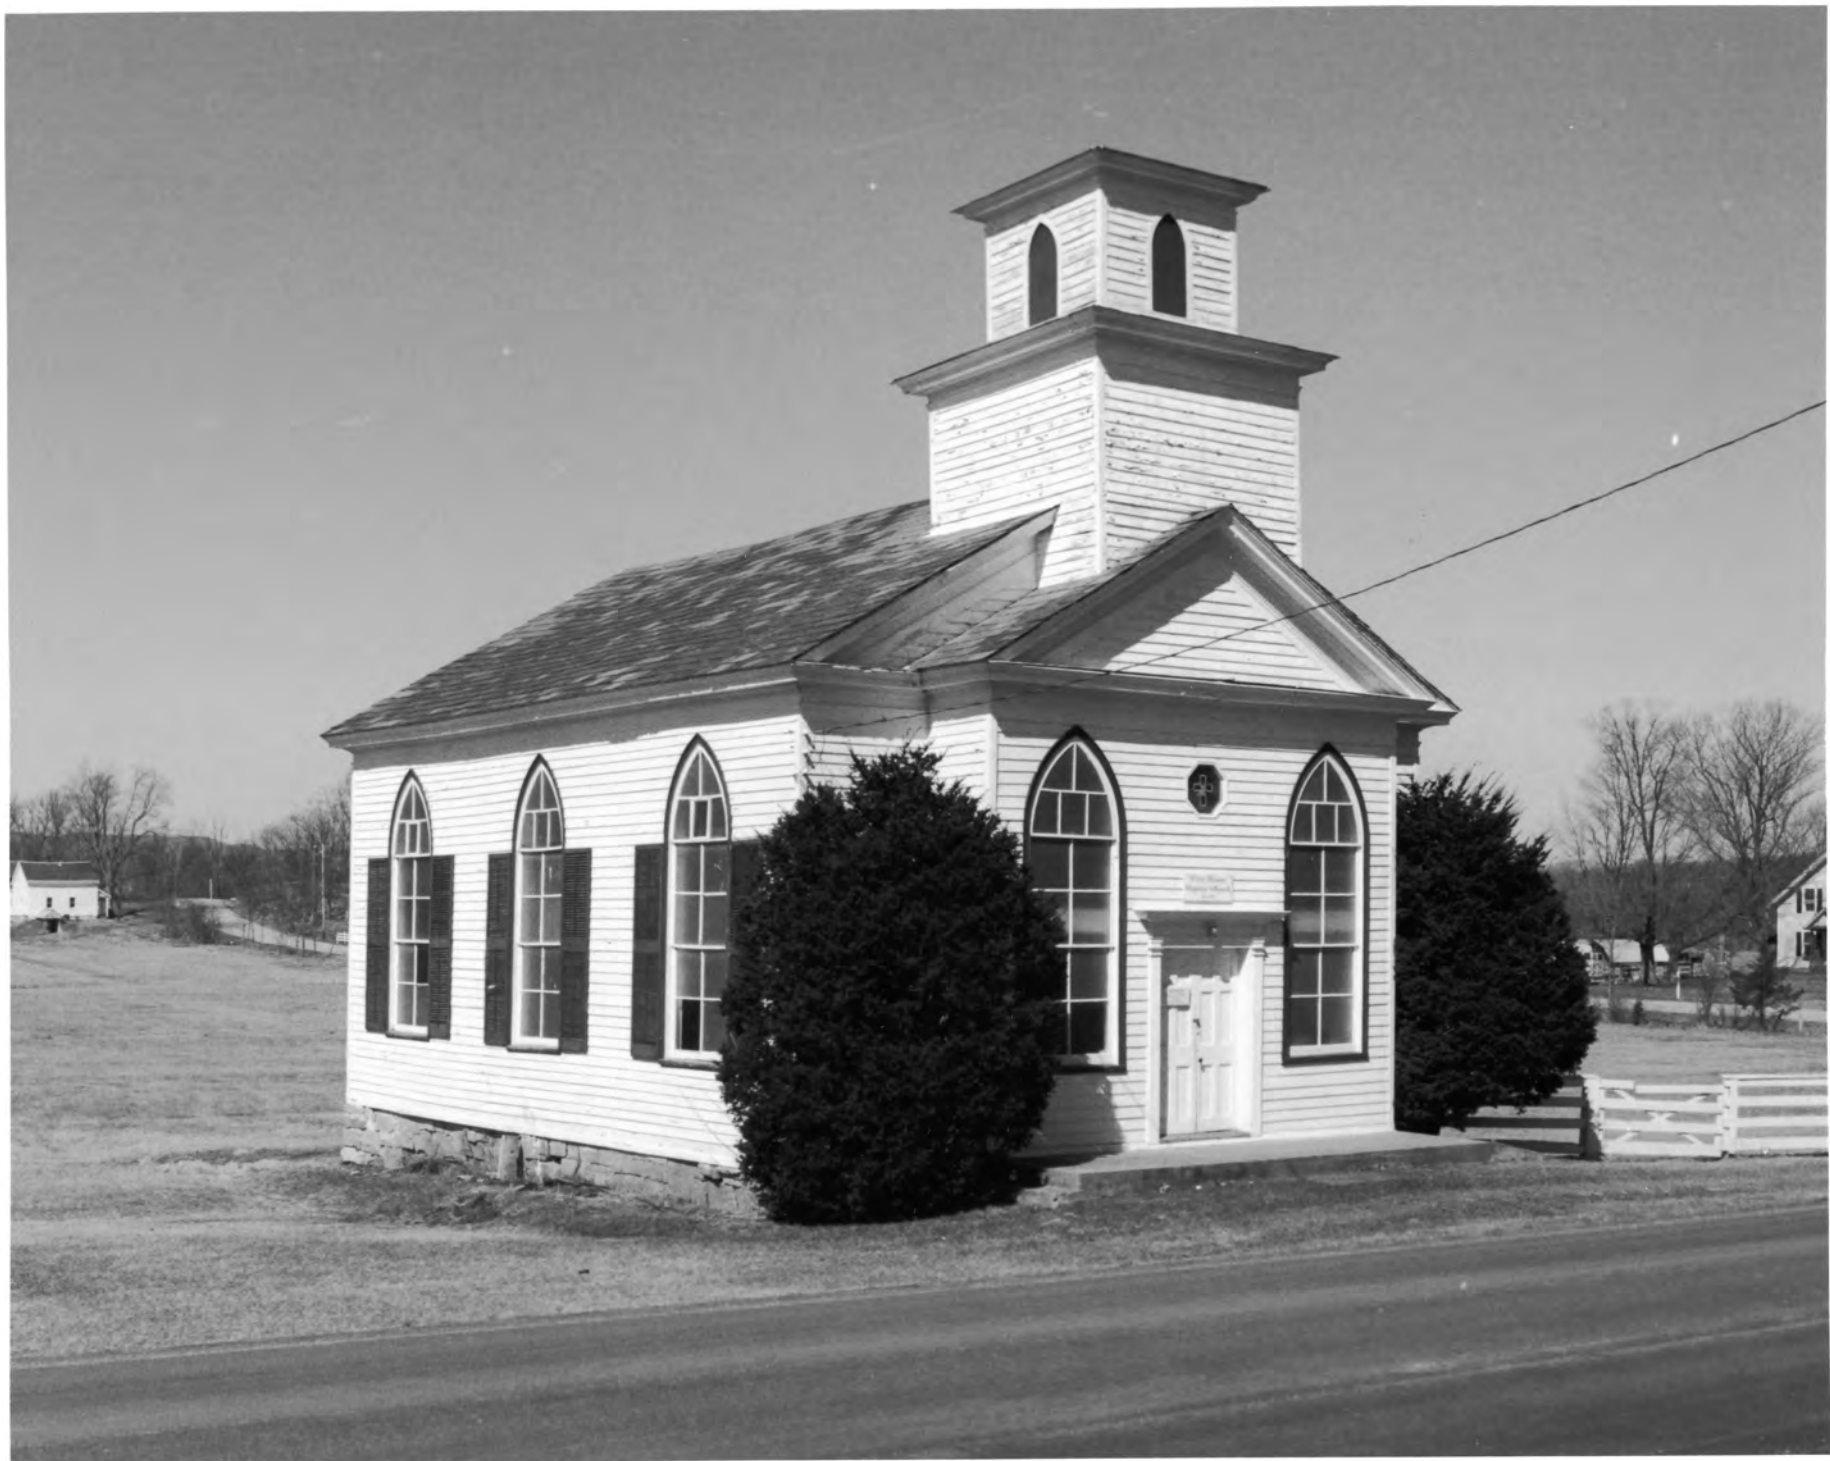
WEST HAVEN BAPTIST CHURCH  
WEST HAVEN, RUTLAND CO., VT.  
Photograph 2

Photograph 2  
South and east facades; view looking northwest.

The main (east) gable facade of the church presents a symmetrical arrangement dominated by the shallow pavilion with the central main entrance flanked closely by an overscale pointed-arch window on each side. An open concrete deck spans the pavilion only two steps above ground level, having replaced in 1982 an earlier wood counterpart.

The north and south eaves facades share nearly identical appearance. Three equally spaced bays fenestrate each facade, each bay having a pointed-arched window with sash matching those on the main (east) facade. The window treatment on these eaves facades differs only by the presence of hinged, louvered wood shutters corresponding to the height of the four-over-four sash below the pointed-arch sash. These are the remnants of shutters that existed historically to cover all window surfaces.

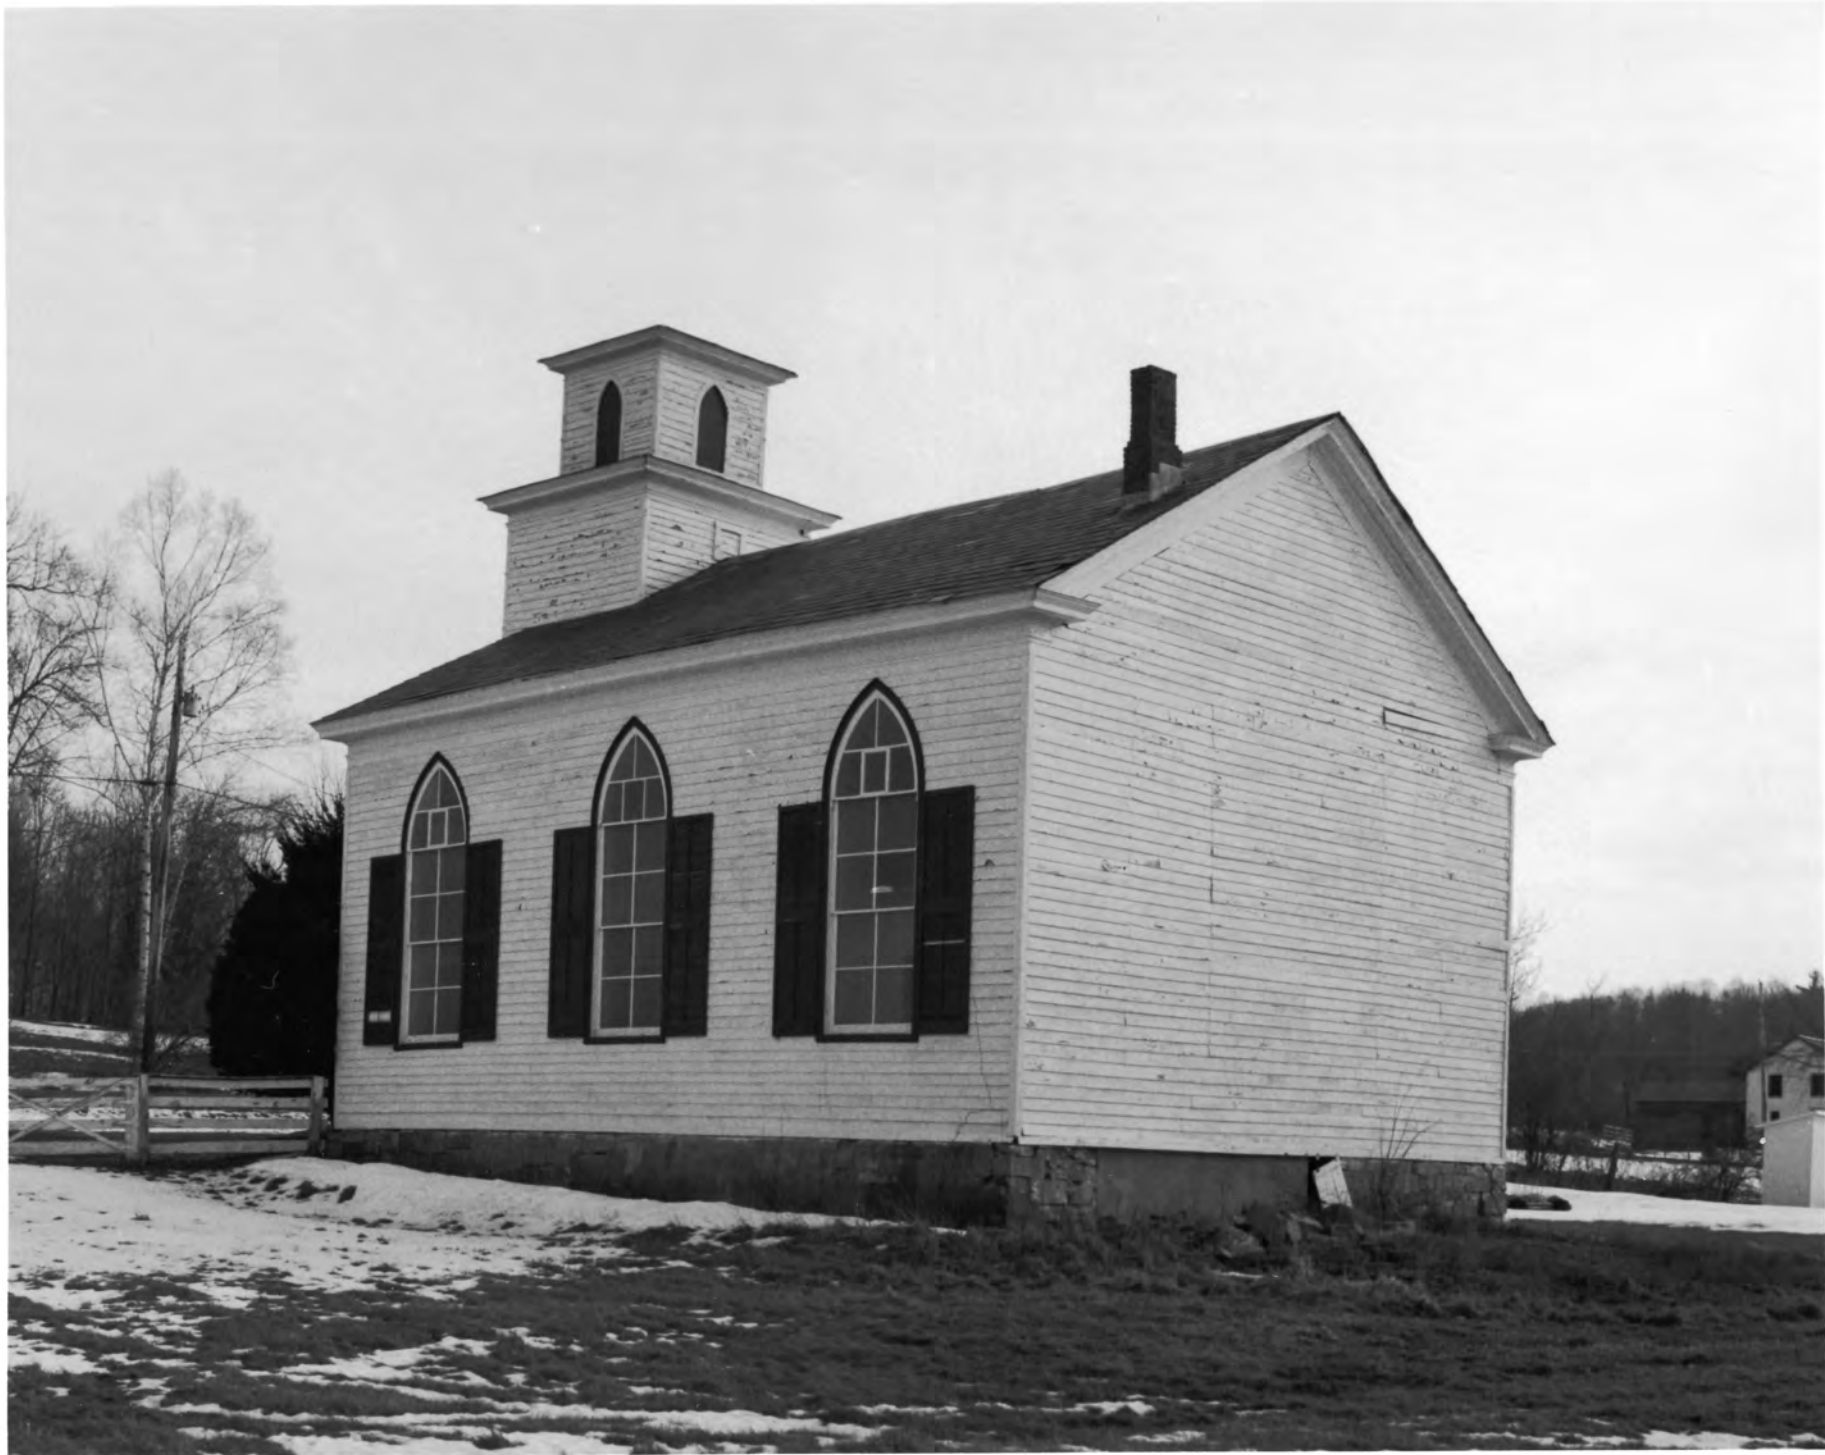
WEST HAVEN BAPTIST CHURCH  
WEST HAVEN, RUTLAND CO., VT.  
Photograph 4

Photograph 4  
North and west facades; view looking southeast.  
Date: January 2006

The rear (west) gable facade contrasts with the others by its present lack of openings. However, cuts in the clapboards indicate that two regularly spaced windows matching those elsewhere have been removed. Also, the gable displays only short cornice returns rather than a full pediment in the manner of the main facade.

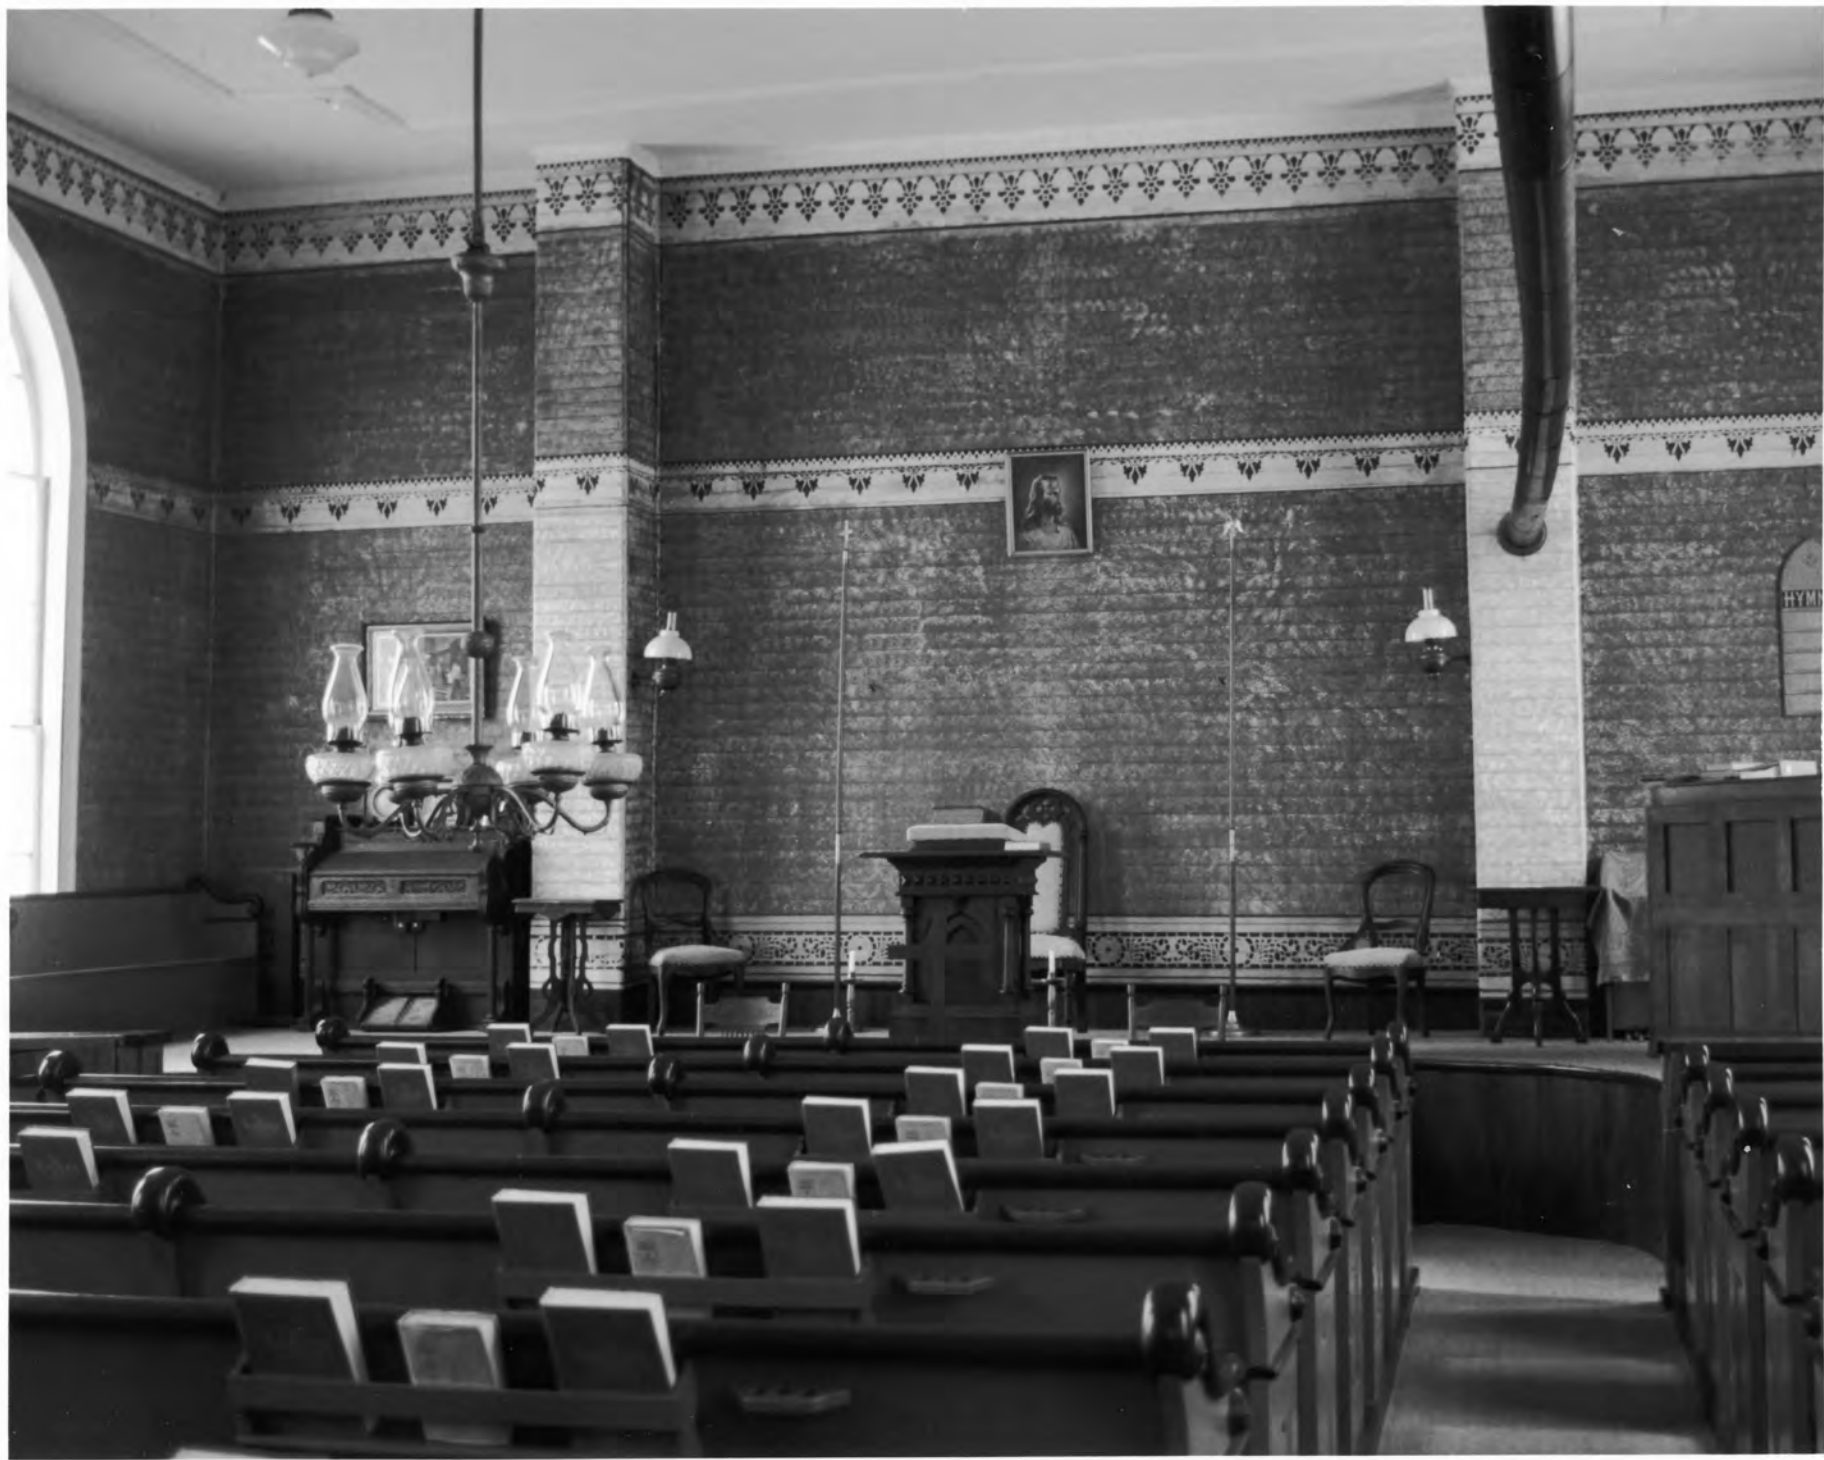
WEST HAVEN BAPTIST CHURCH  
WEST HAVEN, RUTLAND CO., VT.  
Photograph 5

Photograph 5  
Interior of auditorium; view looking west.

The present appearance of the auditorium reflects refurbishing done in 1871, 1886, and 1902. The wall surfaces are sheathed with beaded matched boards applied vertically below the thicker molded chair rail linking the window sills and horizontally above that level. Three decorative stenciled bands encircle the walls respectively at the levels of the chair rail, the imposts of the window arches, and just below the crown molding at the ceiling. The ceiling also is sheathed with matched boards, overlaid by a narrow paneled molding with bullseye corner blocks affixed a few feet inward from and paralleling the walls.

A dais spans the west end of the auditorium; its recessed-curve front has opposing flights of steps flanking a central lectern with pointed-arch blind panels and corner colonettes. Open pews with scrolled and paneled bench ends occupy most of the main floor. Suspended by a metal pole from the ceiling, a central chandelier of Victorian design incorporates six oil lamps. An electric light fixture with a "schoolhouse" circular glass globe hangs by a chain in each of the four ceiling quadrants.
