National Register of Historic Places Registration Form

Historic Name: Our Lady of Guadalupe Church
Other Names/Site Number: Nuestra Señora de Guadalupe, 5CN.489
Name of related multiple property listing: n/a

Street & Number: 6631-33 County Road 13
City or town: Conejos State: CO County: Conejos
Not for Publication: Vicinity:

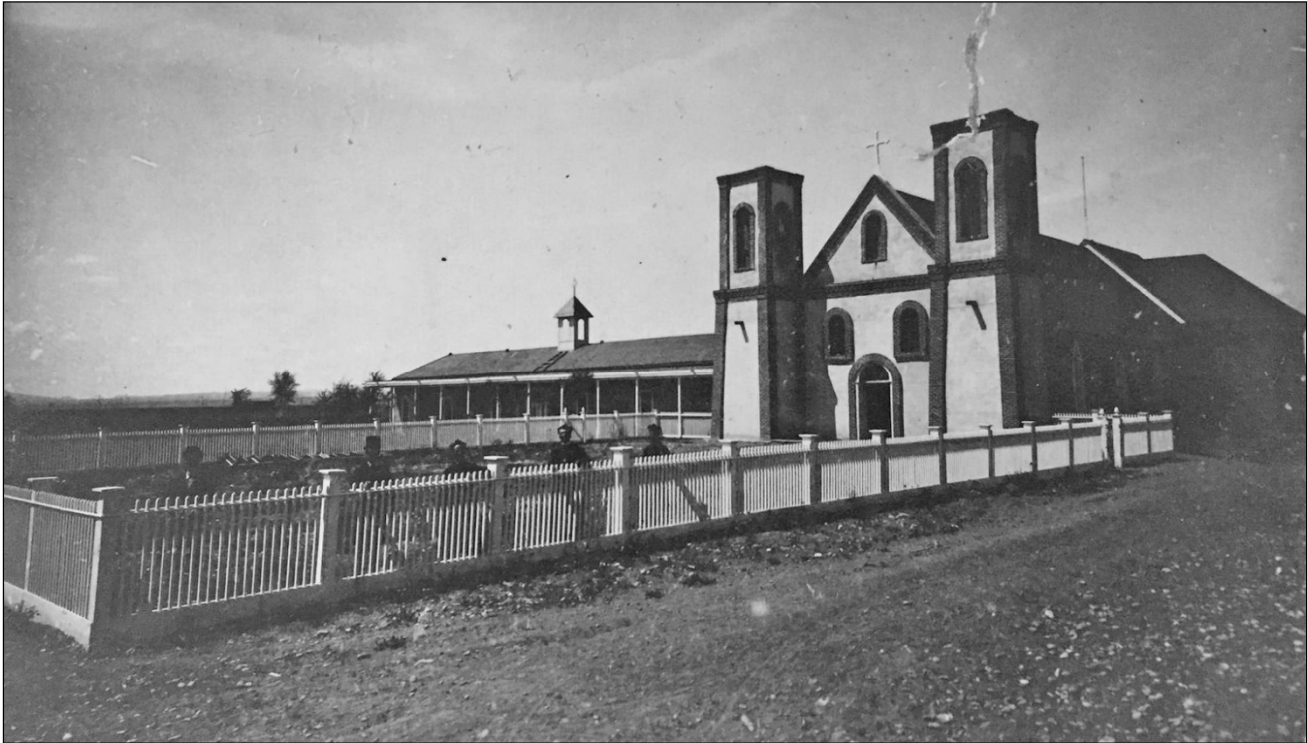
Figure 3. This pre-1904 southwest view shows priests standing inside a wood fence east of the church. The residence shown at the left adjoined the church on its south side. Courtesy of Special Collections Jesuitica, Regis University, Denver, Colorado.

The Jesuits took steps to improve the existing 1863 adobe church. In 1879 the front of the church was repaired and two 40' towers were constructed. The church received a new roof, fencing of the grounds, and twenty pews in 1881. Unfortunately, in 1886 and 1887 two walls of the church collapsed, requiring their rebuilding in 1888.³¹ The Sanborn fire insurance map for 1890 shows the church with a U-shaped "pastoral residence" attached to its south wall (see Figure 3).

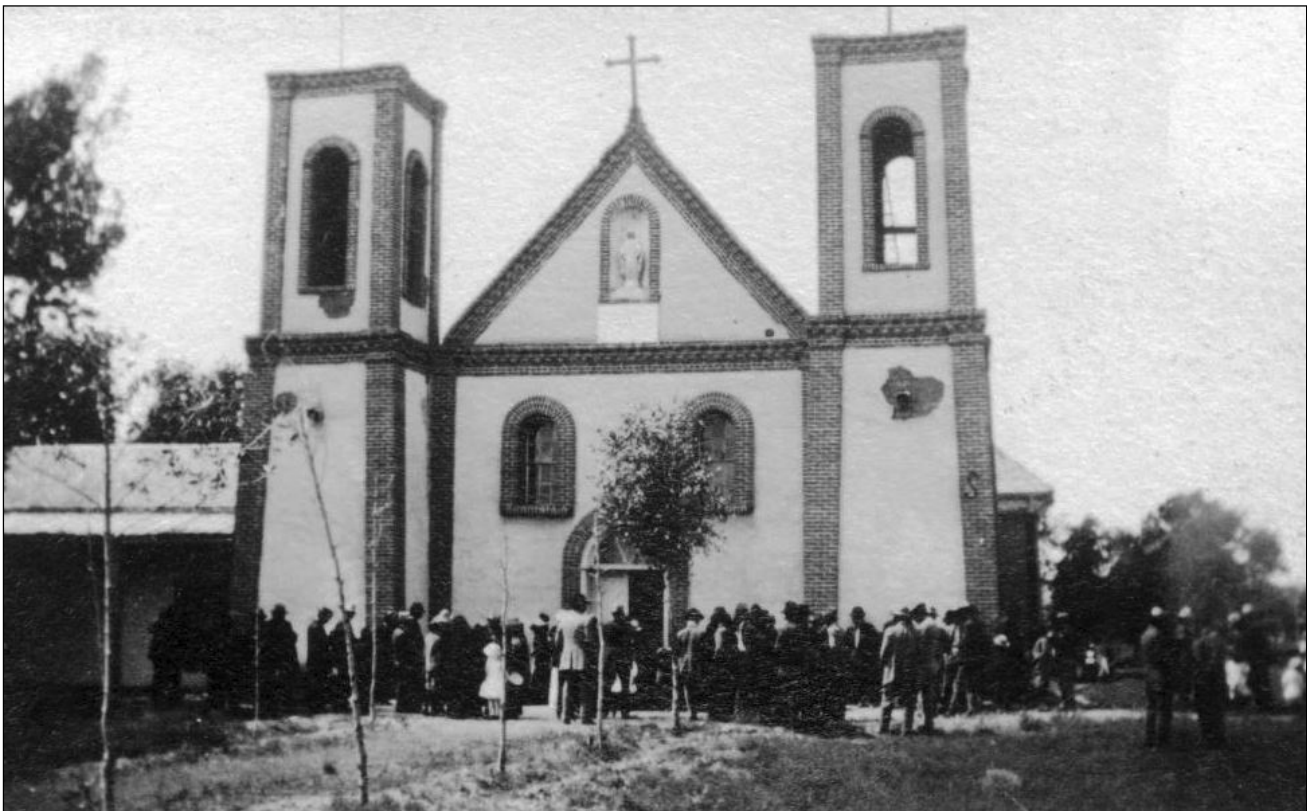
Figure 4. This 1911 view shows the front of the church. The niche in the gable holds a statue of the Blessed Virgin above a white dedicatory plaque placed in 1904. Courtesy of Stephen H. Hart Library and Research Center, History Colorado, Denver, Colorado.

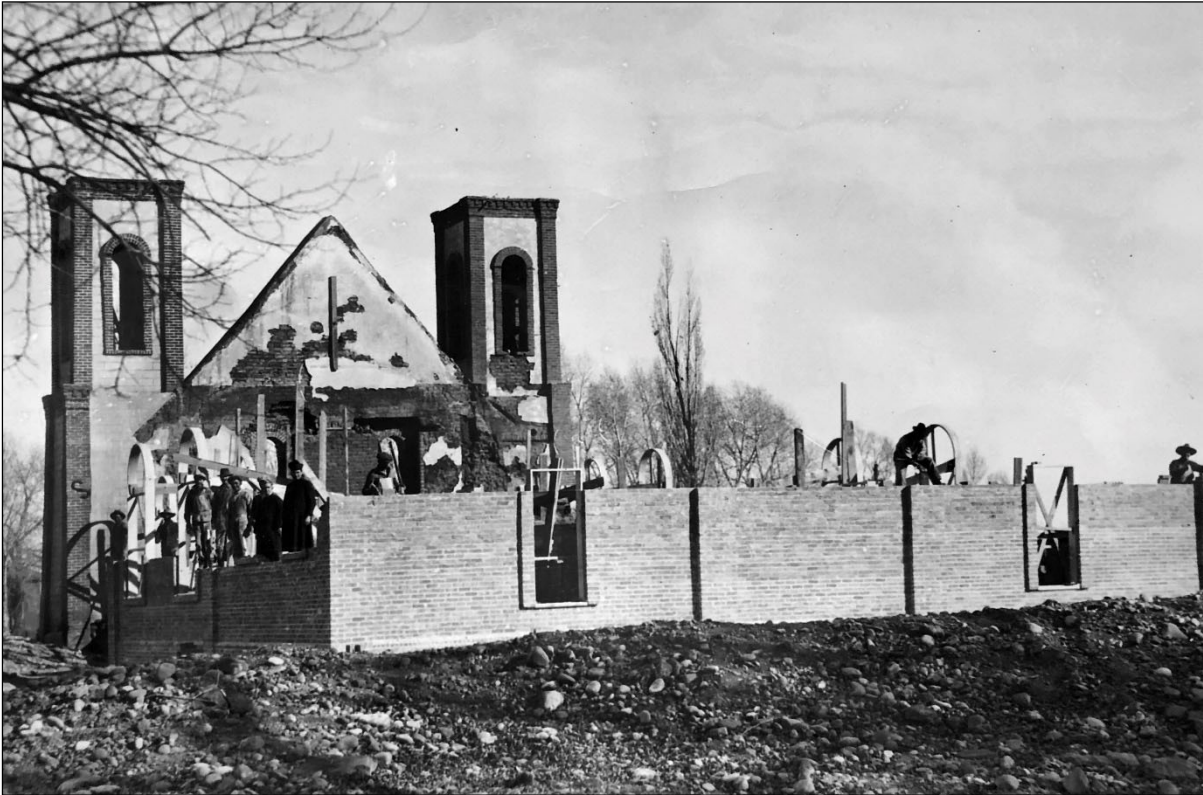
Figure 5. Following a devastating February 1926 fire that spared only the adobe towers and front wall, the church was rebuilt in 1926-27. Courtesy of Stephen H. Hart Library and Research Center, History Colorado, Denver, Colorado.

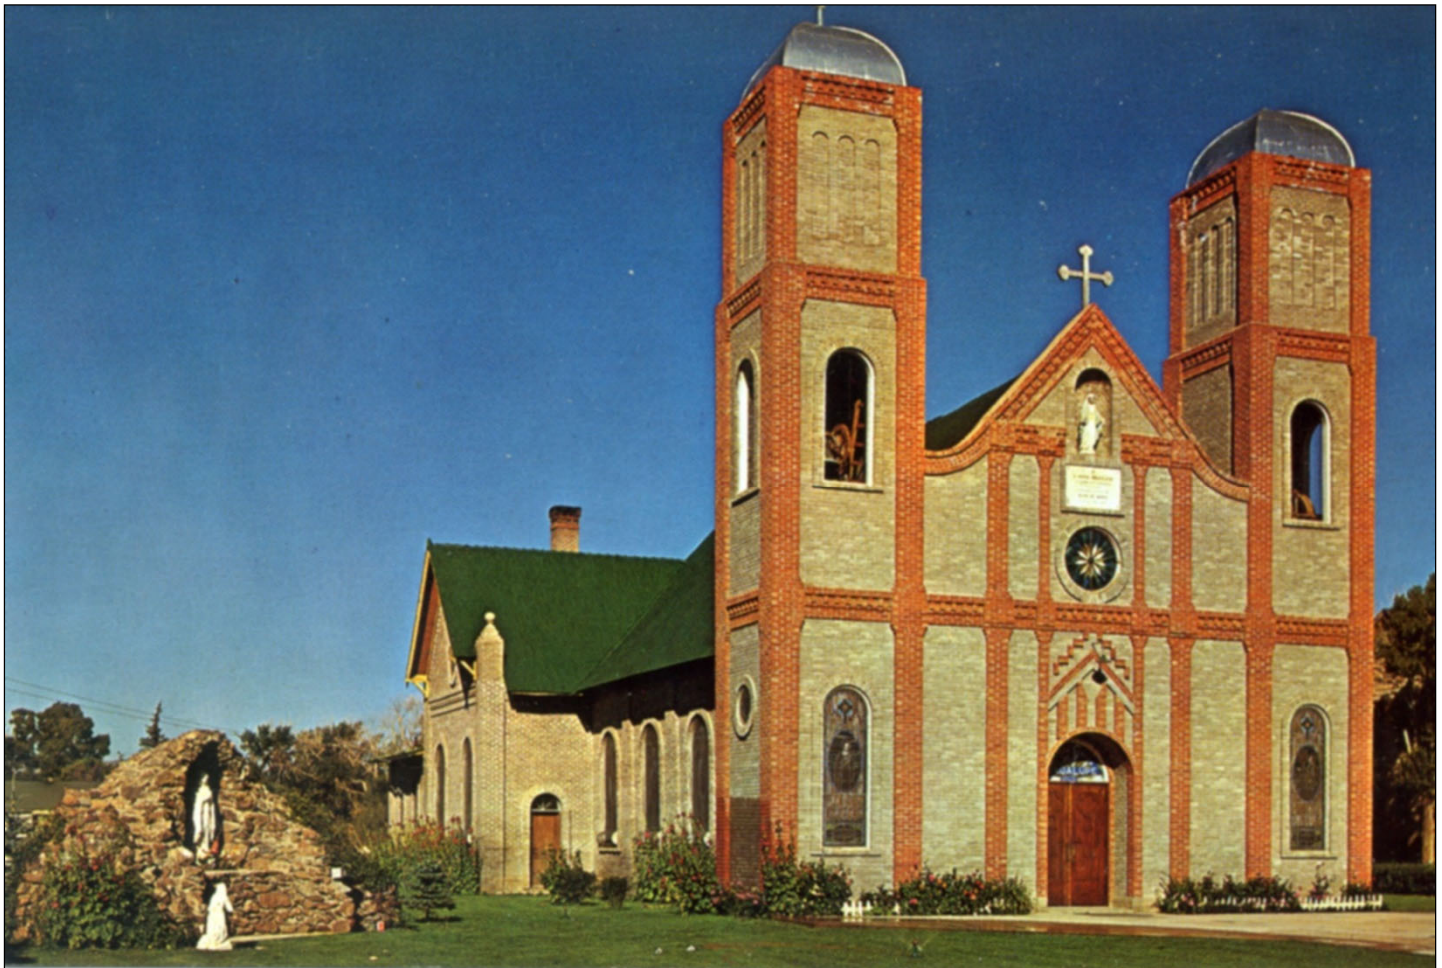
Figure 10. In 1948 the adobe towers and front were removed. The building was extended eastward one bay and the present concrete brick twin towers with aluminum domes constructed. The Lourdes Grotto at left was created in 1954. Courtesy of Thomas H. and R. Laurie Simmons, *Our Lady of Guadalupe*, ca. late 1950s-early 1960s, historic postcard collection, Denver, Colorado.

adding a new façade with twin towers. The new construction employed the same gray concrete brick used in the 1927 work. Monsignor Patrick C. Stauter praised the new towers: “Aluminum domes were added to the towers and with them the towers stood 56 feet high, making the building stand out on the landscape almost rivaling San Anton peak for eye-catching appeal” (see Figure 10).⁵¹ Parishioners donated funds for the domes, as well as four new stained-glass windows—two on the front and two on the north and south walls of the new bay. The project brought the seating capacity of the church to more than five hundred persons.⁵²

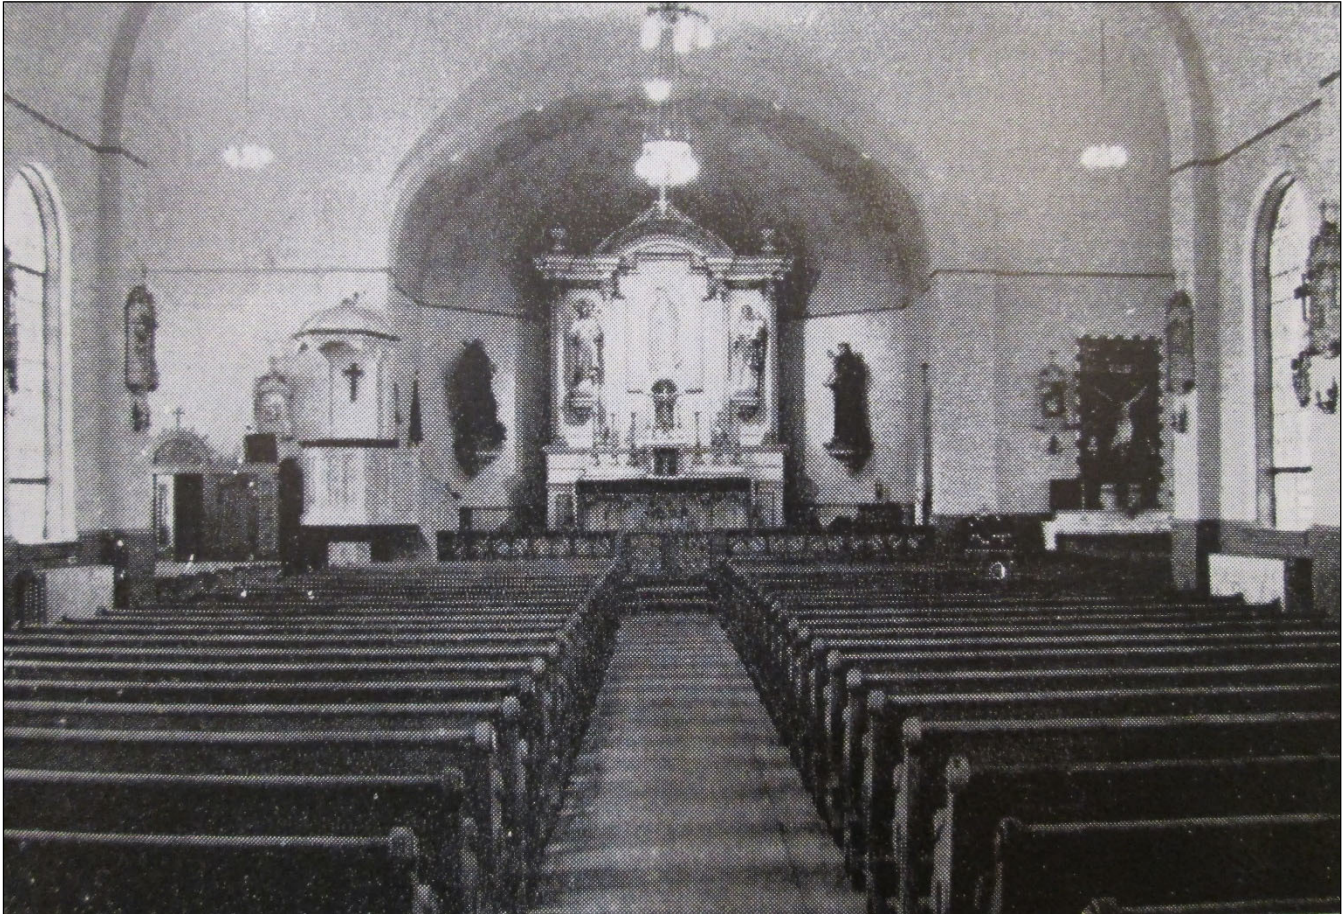
Figure 11. The view shows the altar area from the center aisle ca. 1957-58 view. Father Francis Colom, C.R., photographer, in Stauter, *Our Lady of Guadalupe, Conejos, Colorado* (1997), 19.

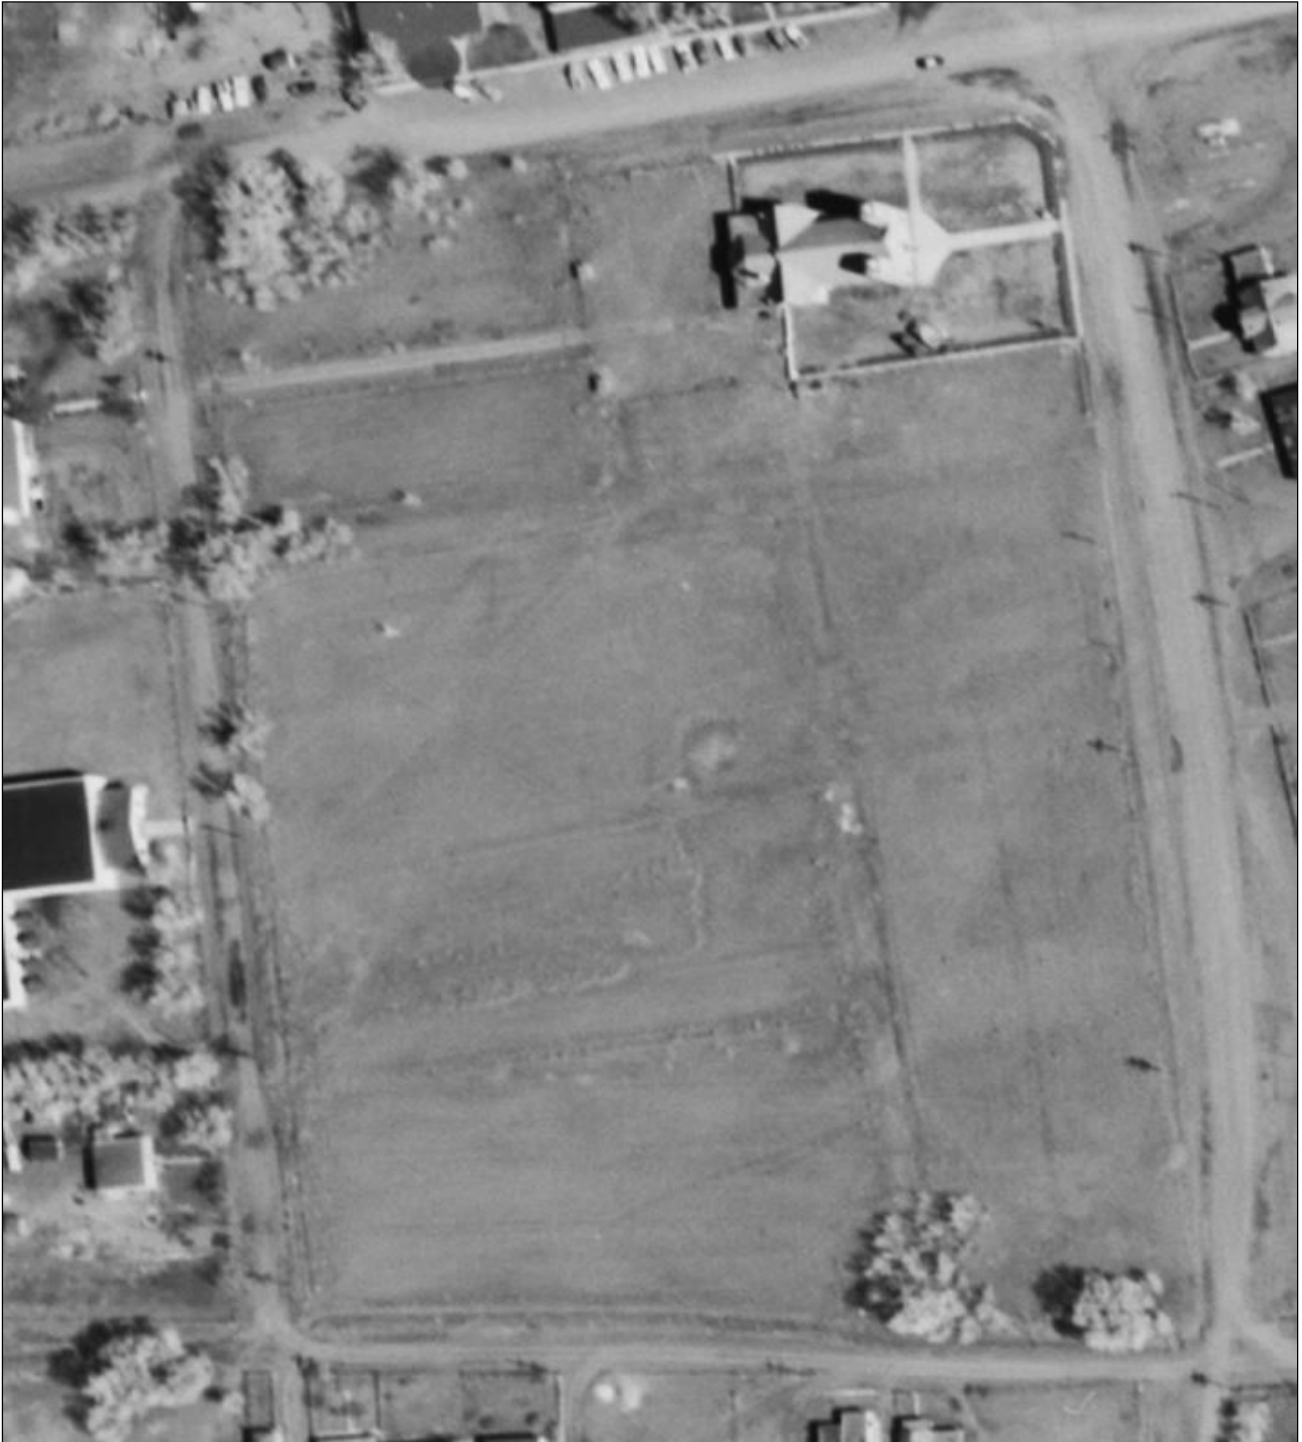
Figure 12. This 1965 aerial photograph shows the undeveloped nature of the block containing the church at that time. The church, shrine, historical marker, and wellhouse in the northeast corner were the only extant resources. Aerial photograph H-5600 GS-VBBI, 30 April 1965. Courtesy of Colorado School of Mines/U.S. Geological Survey.

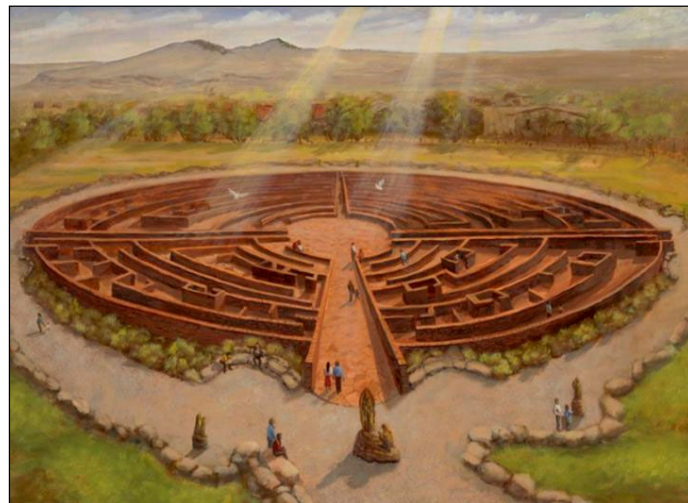
Figure 14. The Santuario de los Pobladores is a labyrinth, with an outdoor altar and sculptures, planned for the southern portion of the nominated area. Courtesy of El Santuario de los Pobladores, Our Lady of Guadalupe Parish, www.ologp.com, 18 March 2018.

The planned Santuario de los Pobladores, dedicated to the Mysteries of the Rosary, is to be located in the south-central part of the block (see Figure 14). A full-scale hay bale mock-up of the proposed labyrinth was installed at the site in recent years to illustrate its proposed scale, which has since been removed.¹⁵ As of the writing of this nomination, the location is currently marked by a 145'-circle covered with gray gravel; a large mound of gray gravel and earth are present along the west edge of the parcel. Construction of the foundation is expected to begin late summer 2018.¹⁶
