National Register of Historic Places Registration Form

historic name Camp (1) Misty Mount Historic District
other names/site number

Name of related multiple property listing: ECW Architecture at Catoctin Mountain Park

Camp (1) Misty Mount Historic
District, Frederick County
Maryland

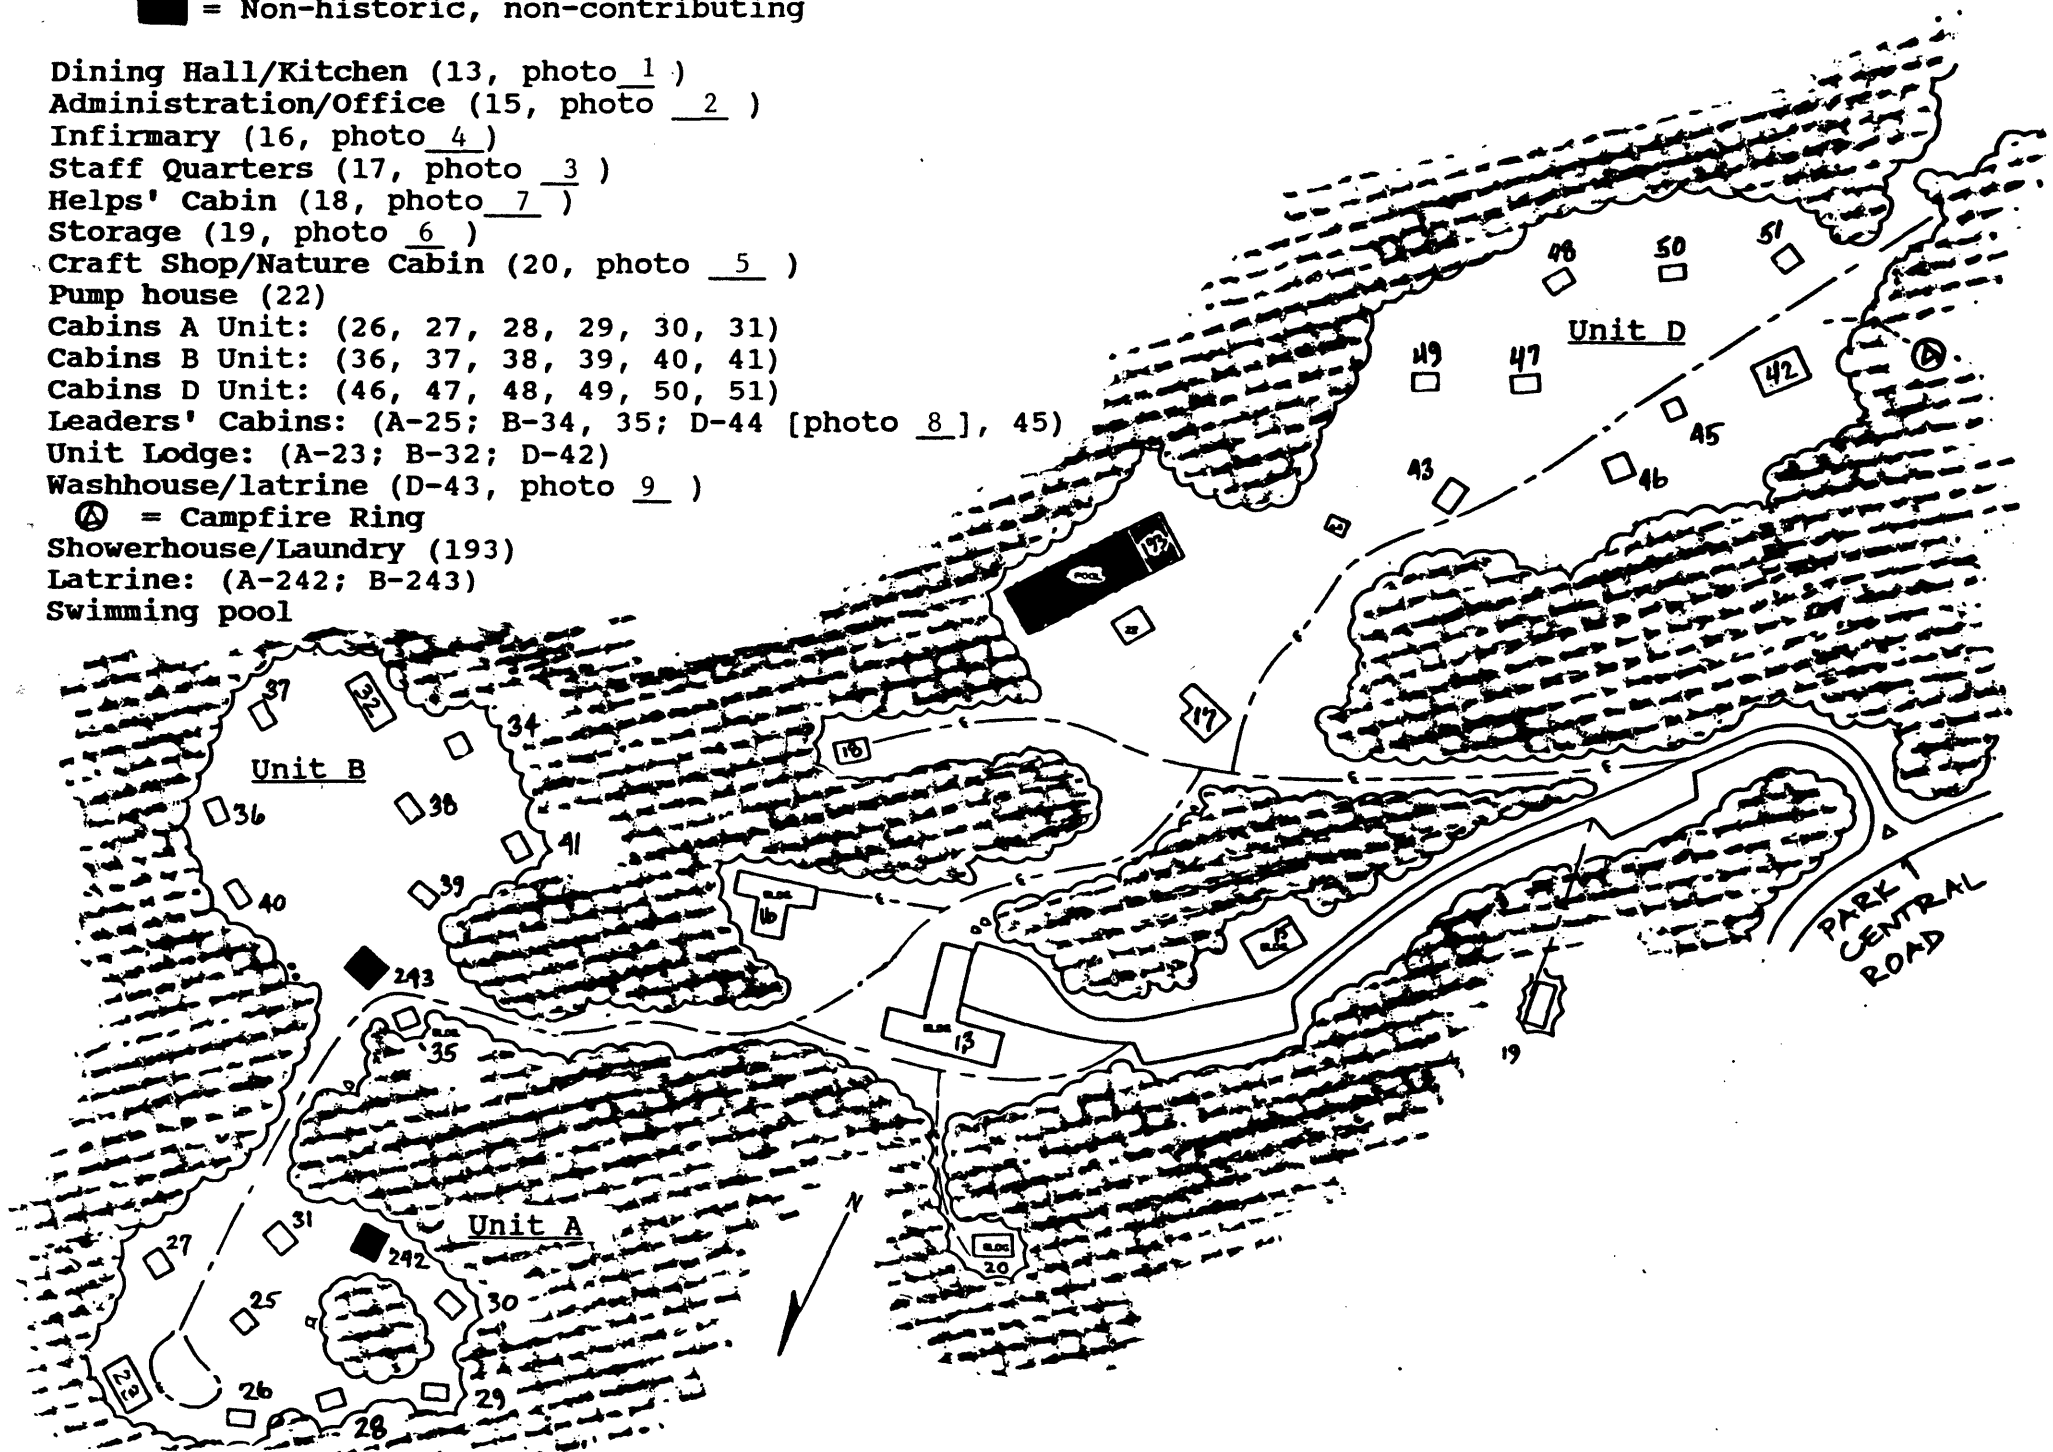
MAP: 3A

CAMP (1) MISTY MOUNT HISTORIC DISTRICT

■ = Non-historic, non-contributing

Dining Hall/Kitchen (13, photo 1)

Administration/Office (15, photo 2)

Infirmary (16, photo 4)

Staff Quarters (17, photo 3)

Helps' Cabin (18, photo 7)

Storage (19, photo 6)

Craft Shop/Nature Cabin (20, photo 5)

Pump house (22)

Cabins A Unit: (26, 27, 28, 29, 30, 31)

Cabins B Unit: (36, 37, 38, 39, 40, 41)

Cabins D Unit: (46, 47, 48, 49, 50, 51)

Leaders' Cabins: (A-25; B-34, 35; D-44 [photo 8], 45)

Unit Lodge: (A-23; B-32; D-42)

Washhouse/latrine (D-43, photo 9)

⊙ = Campfire Ring

Showerhouse/Laundry (193)

Latrine: (A-242; B-243)

Swimming pool
