INDIVIDUAL DATA SHEET

Property Name Stack Barn Property Owner Jerry Haskins
Location Hwy. 94 Spur, vic. Monte Ne Address Route 1, Box 755
Construction Date 1901 Survey No. 0941 Rogers, AR

Stack Barn (Benton County MRA)
Benton County
ARKANSAS

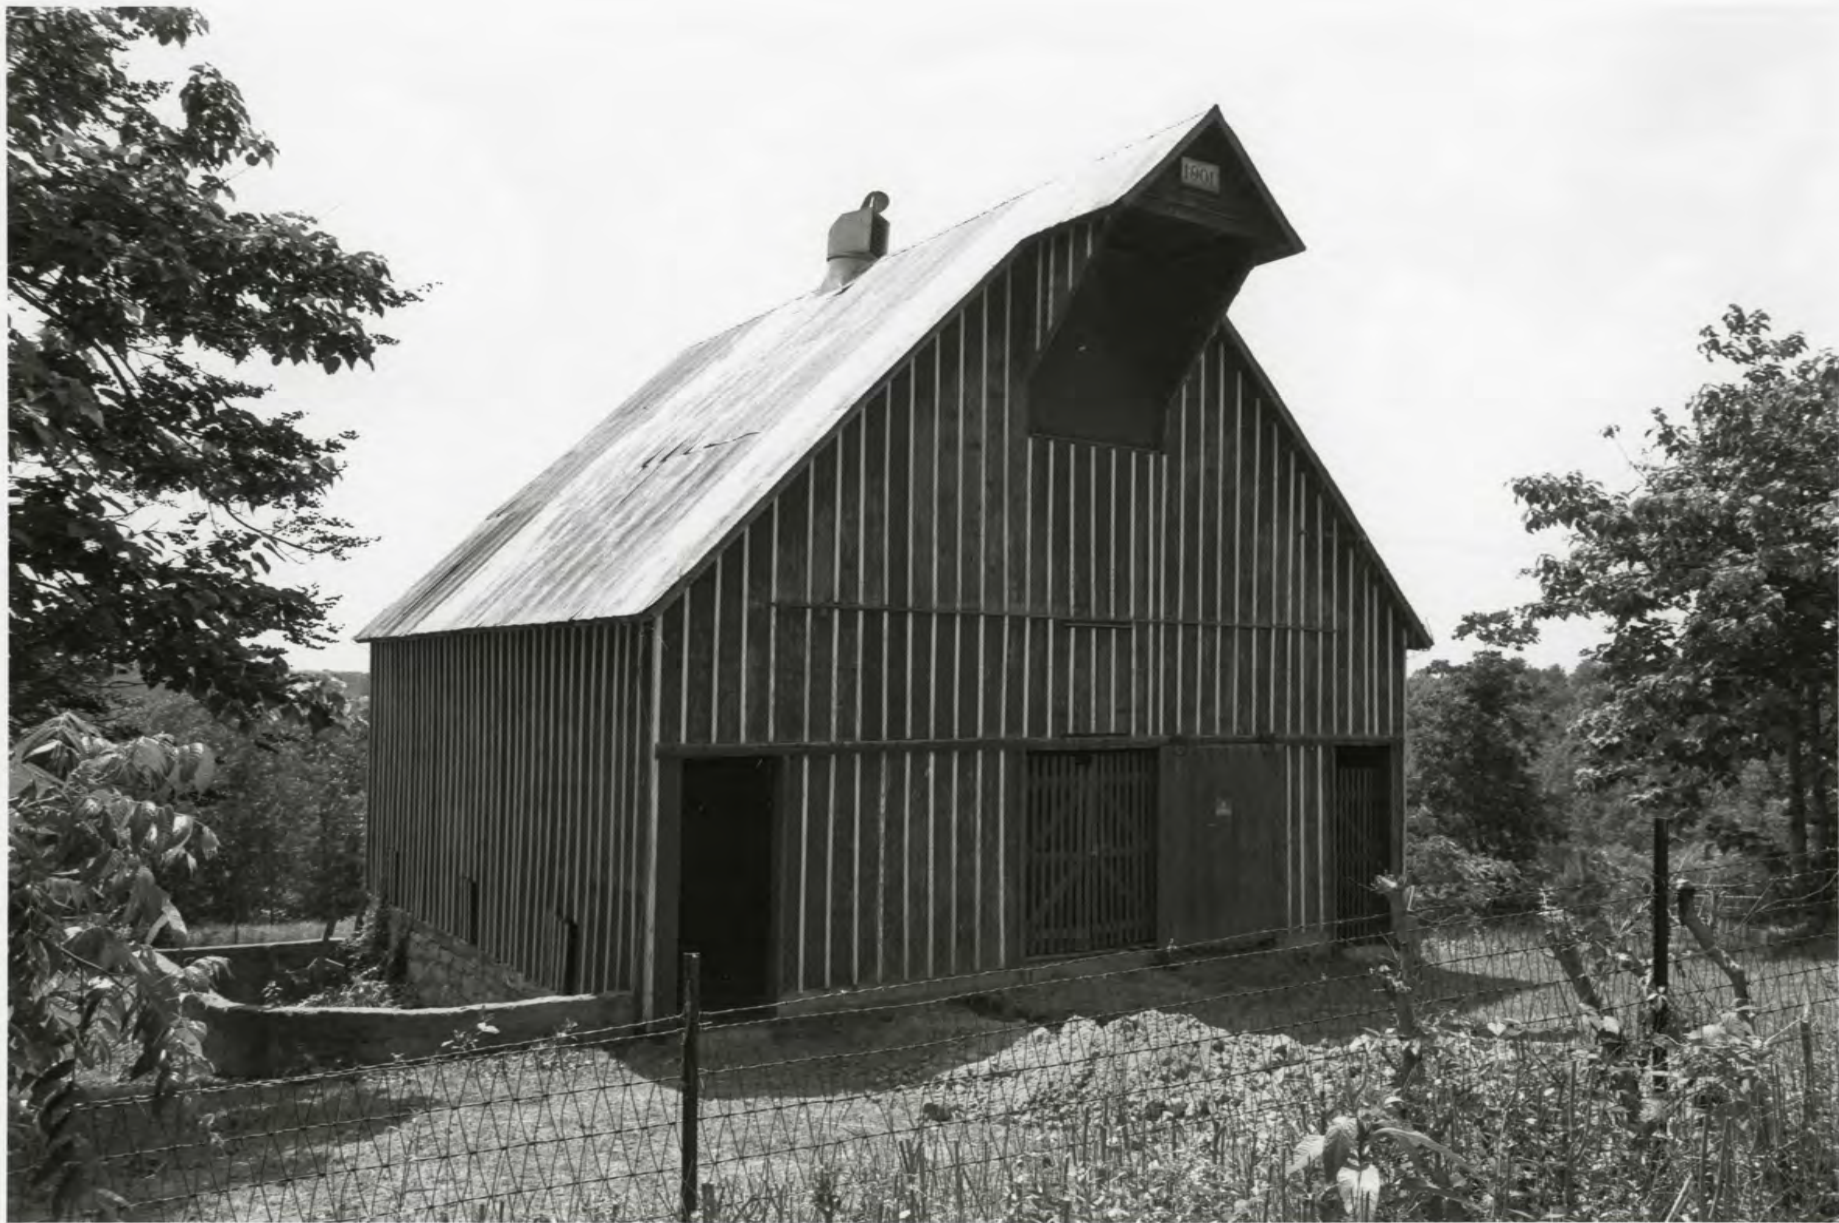
No. 39

The Stack Barn is an unusual amalgam of features typical in barn types in Pennsylvania and in the south central states. Its gable roof is sheathed with sheets of tin and features a hay hood with triangular sideboards. A small wooden plaque dated 1901 is displayed in the gabled hood. A large metal vent, centrally fixed, is a later addition to the roof ridge.

The barn plan resembles the midwestern three-portal barn, which was the standard farm structure in the south central United States in the late nineteenth and early twentieth centuries. An expanded version of the transverse crib plan, feed cribs and open stalls flank a central drive or hallway which is closed on the rear elevation. The plan is expanded by adding enclosed side drives. Double sliding doors close the drive and single sliding doors close the side portals on the front elevation, which faces northeast. Three top-hinged doors, designed for ventilation or forking hay or feed, open in the southeast elevation, while two similar doors open on each of the northwest and southwest elevations. The southeast, or rear, elevation, which rises to approximately six feet in height on the continuous footing of native stone, resembles the German bank barn, common in Pennsylvania and the northeast and middle states. Because of the raised rear elevation, the barn

was necessarily floored, an unusual feature in Arkansas where earth floors were the rule. Board and batten siding covers the barn. Continuous concrete footings, which probably housed additional side sheds or drives, flank the two side elevations.

~~Haskins~~ Dur-Stack Barn - 0941D
Vic. Monte Ne
Benton County MRA
