KENTUCKY HISTORIC RESOURCES INVENTORY

Site No. 42-24

1. Historic Name(s) <u>John Allen house</u>		22. ADD/County <u>Bluegrass / Woodford</u>	
Original Owner <u>John Allen</u>		23. U.S.G.S. Quadrant (15'/75') <u>Range 4-5</u> G.I.S. Mod. <input type="checkbox"/>

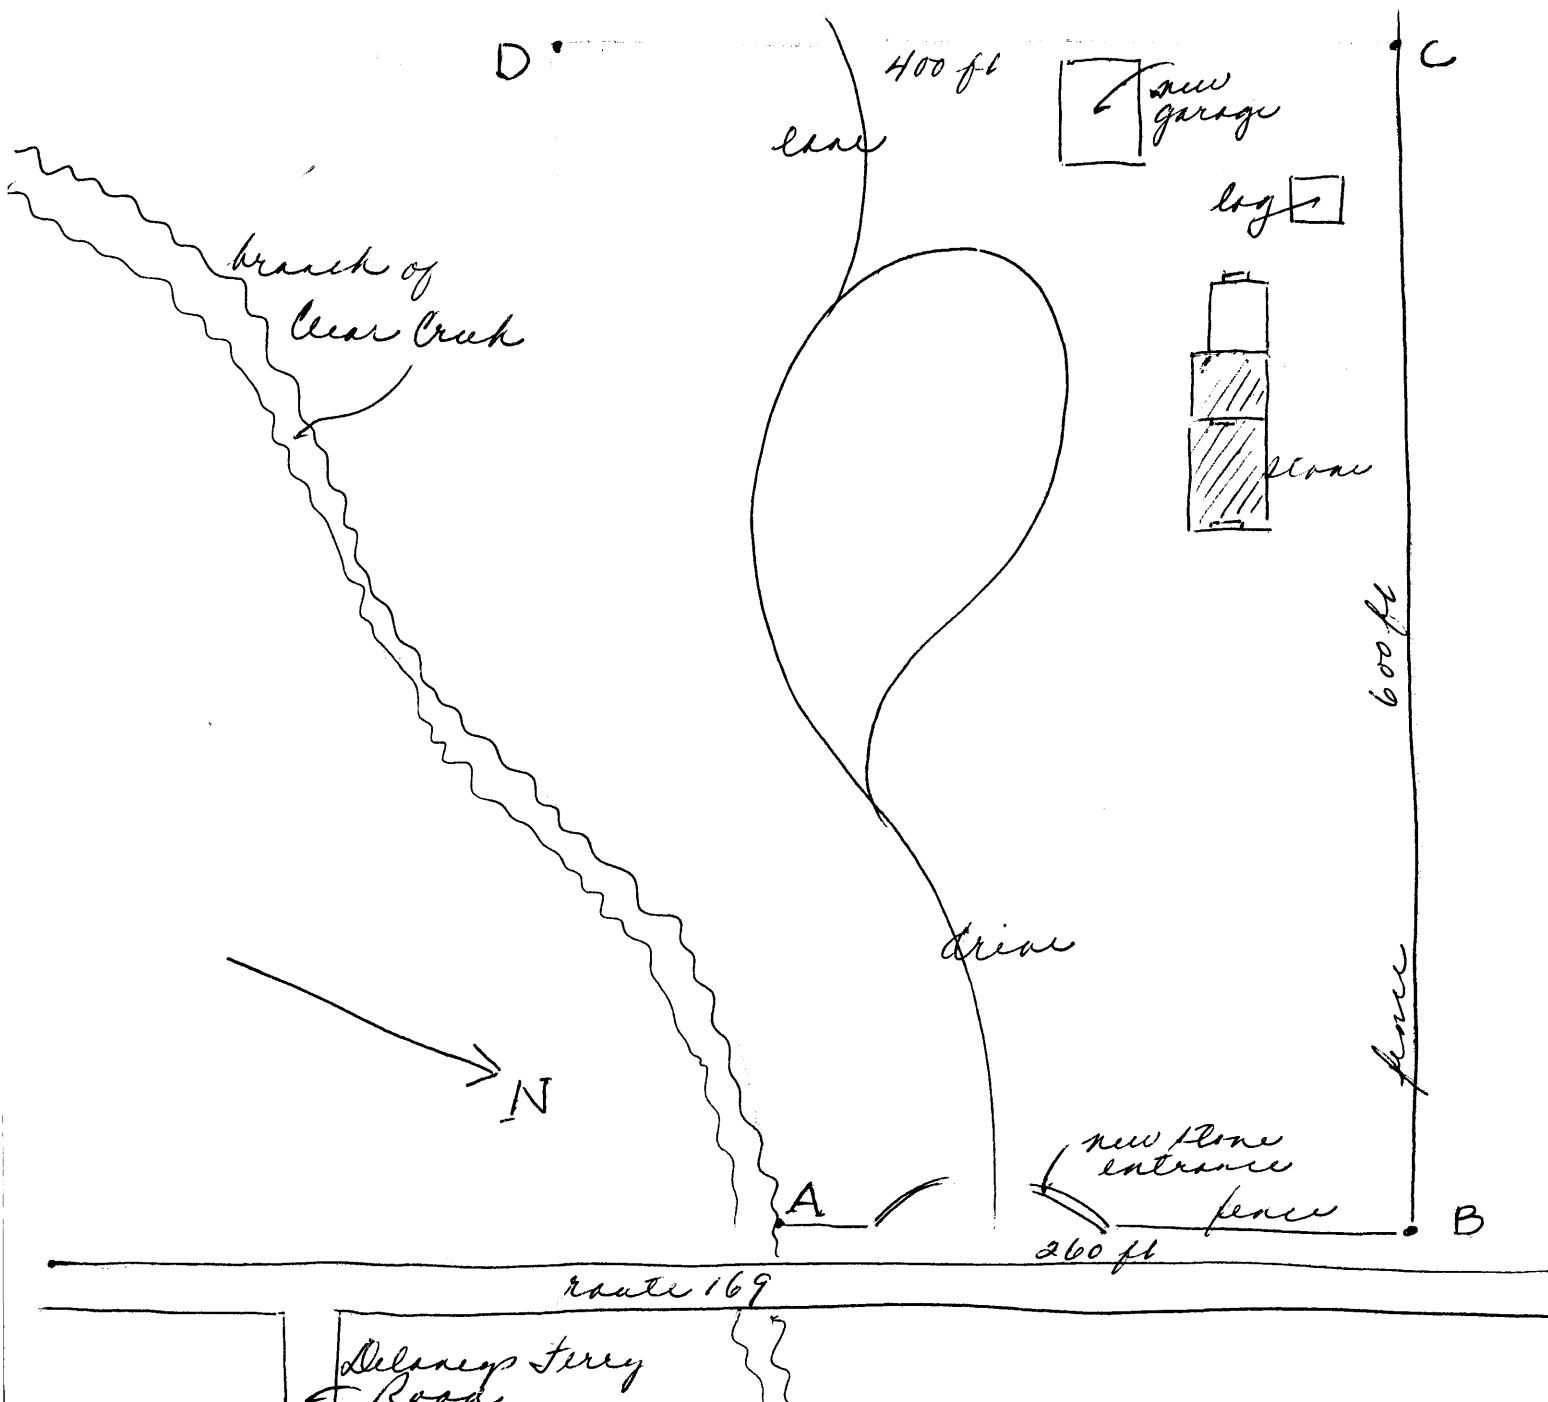
SKETCH MAP OF SITE SHOWING BOUNDARIES AND KEY BUILDINGS AND FEATURES WITH NORTH ARROW.

Beginning at A where the creek branch goes under the road (169) thence N along road to the fence at B 260 ft, thence with fence W 600 ft to C, thence S 400 ft perpendicular to fence & outside garage to D, thence E parallel to B-C fence to creek bank & with creek to the beginning, containing the house, log building and garage. about 4 acres
