**NATIONAL REGISTER OF HISTORIC PLACES
REGISTRATION FORM**

historic name: Snowbound Mine

Survey Map
Snowbound Mine

SKETCH MAP FOR
SNOWBOUND MINE

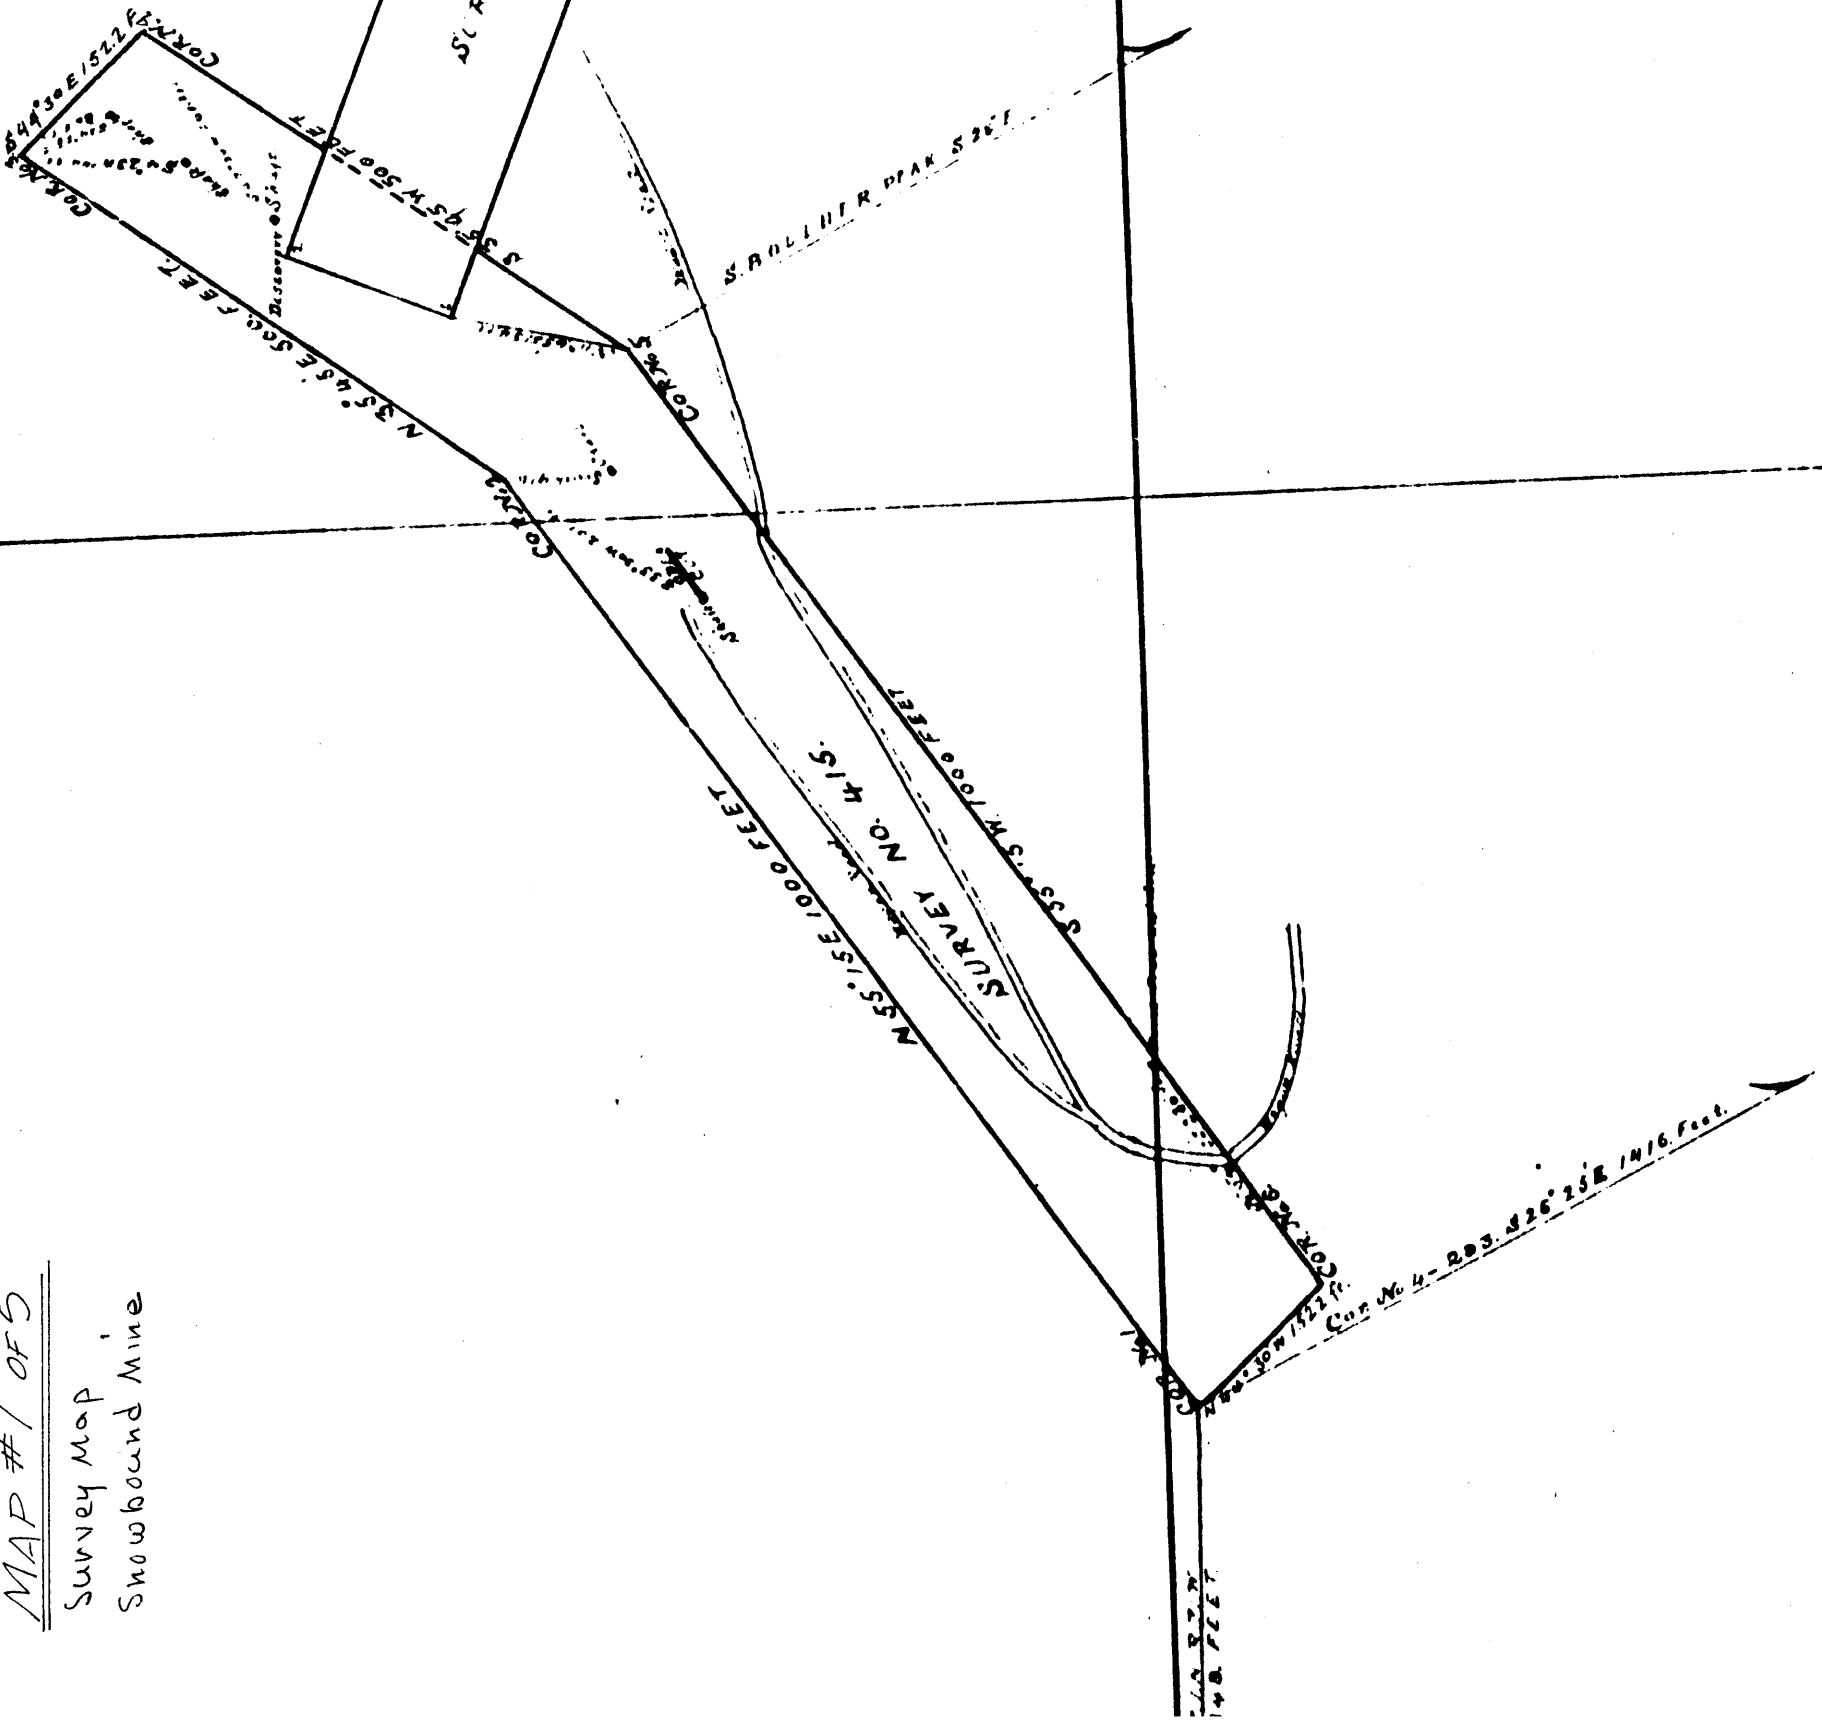
MAP #1 OF 5

Containing 4.88 Acres

Scale of 200 Feet to an Inch.

BOUNDARIES.		
No. of Course.	COURSE.	Distance in feet.
1	N 55° 15' E	1000
2	N 35° 45' E	500
3	S 44° 30' E	152.2
4	S 35° 45' W	500
5	S 55° 15' W	1000
6	N 44° 30' W	152.2

See map #1

The site boundaries follow the boundaries of claim #415 and include the buildings that were built during the Snowbound's greatest period of significance, the mine dump which is an integral part of the physical and historical background of the mine. The area of surrounding land which characterizes the mountain setting typical of tunneled metal mines.

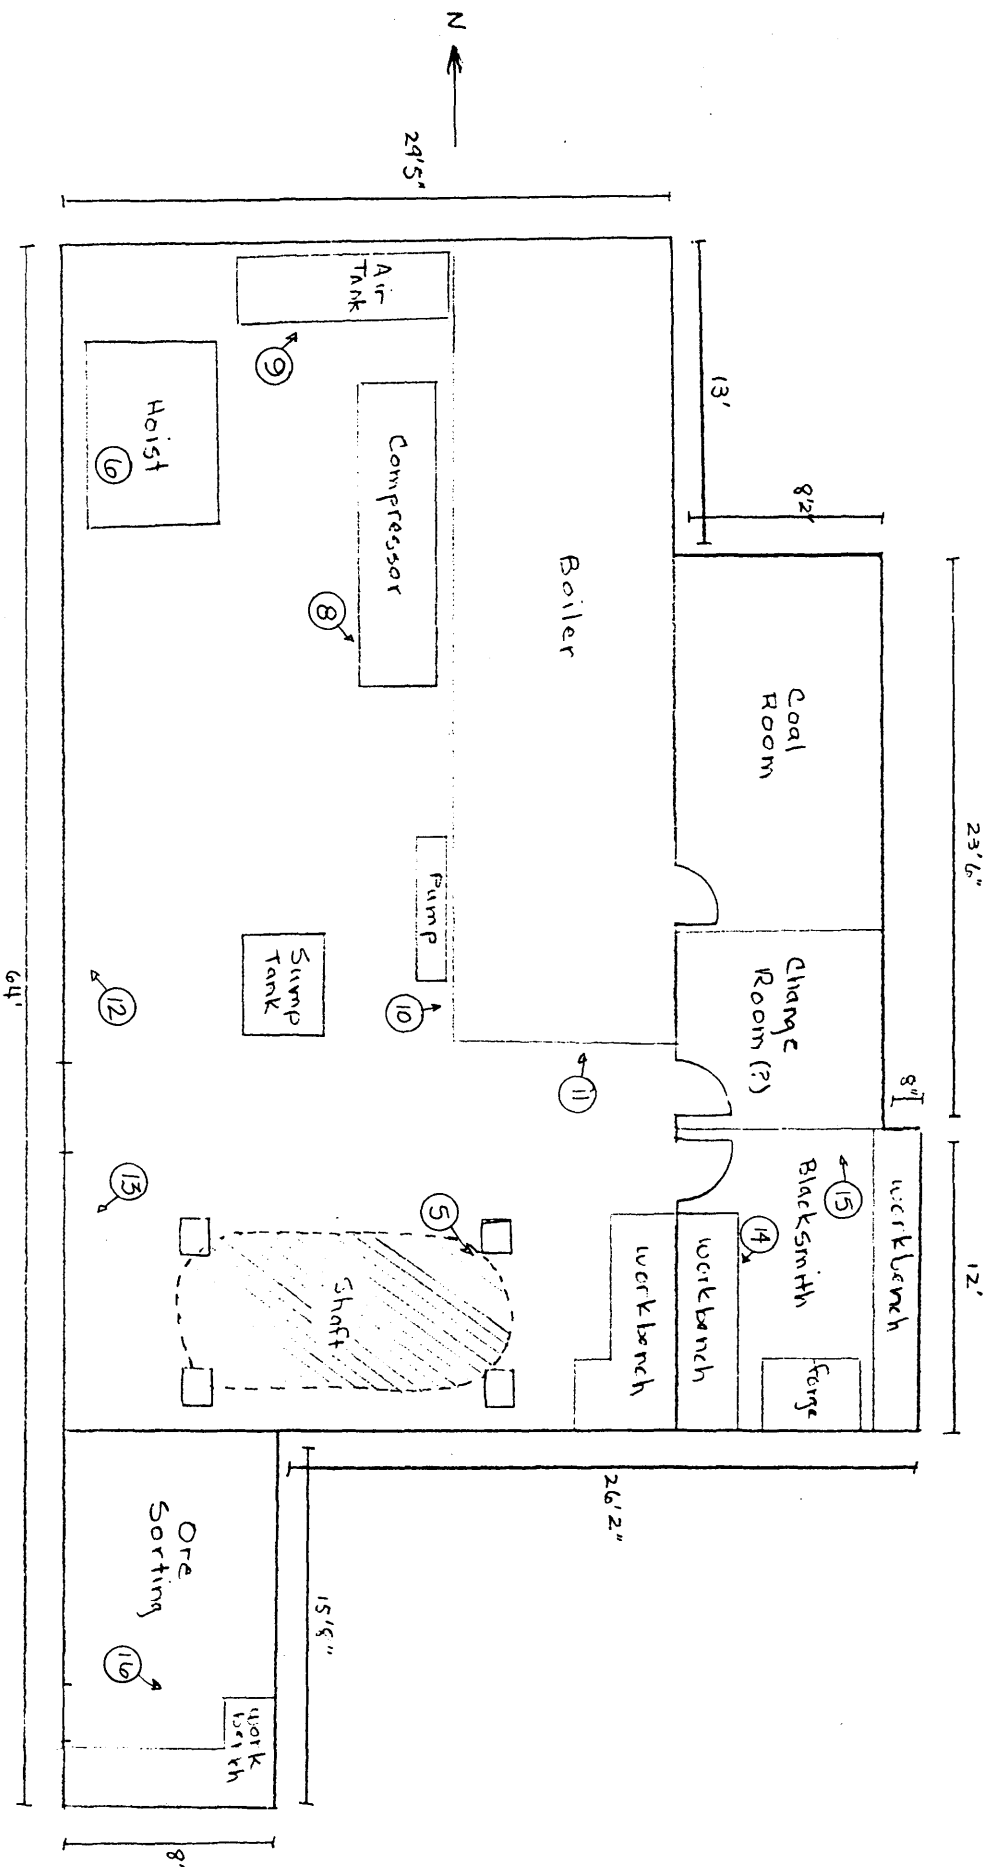
Snowbound Mine
Shaft house (NUMBER 1)

() - PHOTOGRAPH NUMBERS

The shafthouse, built in 1917, has a modified T plan and measures 64 feet long by 30 feet wide with one entrance on the west side of the building. (photo #1) The building is sided with one by eight inch horizontal fir planks which were once covered with tarpaper held in place by narrow wood strips. The tarpaper is gone but the wood strips are still visible. The roof is gabled and steeply pitched with a cross-gable section at the south end of the building (top of the T) which contains the head frame and hoist. The roof of both sections has corrugated metal sheets laid with the rake of the roof. On the north section there are one-by-one wood strips or fastening ribs at the seams. (photo #1 & #2) At the southeast corner is the blacksmith shop entered through the shafthouse. It is a one story ell with a shed roof sheathed in corrugated metal. The exterior has a combination of rolled metal panels, and horizontal and vertical board facing. (photo #3 - the steam whistle is visible in the photo on the right side of the main roof.)

At the south end of the building (top of the T) there is a tall opening from the shaft house and tracks leading across the ore dump (photo #4 & #27). At the southwest corner is the assay/ore sorting office faced in lumber and a corrugated metal shed roof. This ell is entered from the exterior door on the west side of the building.

Inside the shafthouse, the shaft is located five feet to the right of the door. The shaft was originally developed to 226 feet but is now caved in about 35 feet down. The hole is four feet by eight feet on the surface. The mine shaft contains four levels, the deepest at 215 feet. It was cribbed from top to bottom with three by six and three by eight timbers, but none of the cribbing is visible from the surface of the shaft today.
