KENTUCKY HISTORIC RESOURCES
Individual Inventory Form

Resource # 114
Shelby County

1. Name of Resource: Rice House

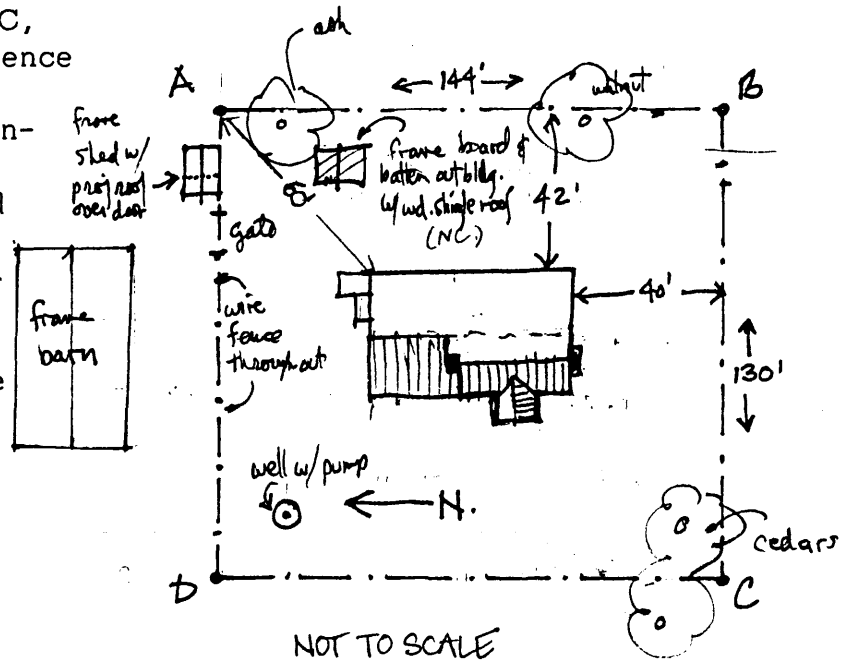
Site Plan (and boundary description and justification for N.R. sites):

Beginning at A, south along a fence 144' to B, thence west 130' along a fence to C, thence north 144' along a fence to D, thence east 130' along a fence to the point of origin. The boundaries were chosen to encompass the house and its domestic-related space and outbuilding as defined by fences and trees separating it from surrounding fields. Included is one non-contributing outbuilding.

Point A is the intersection of two fences in the northeastern corner of the yard and is 60 feet northeast of the northeastern corner of the dwelling.

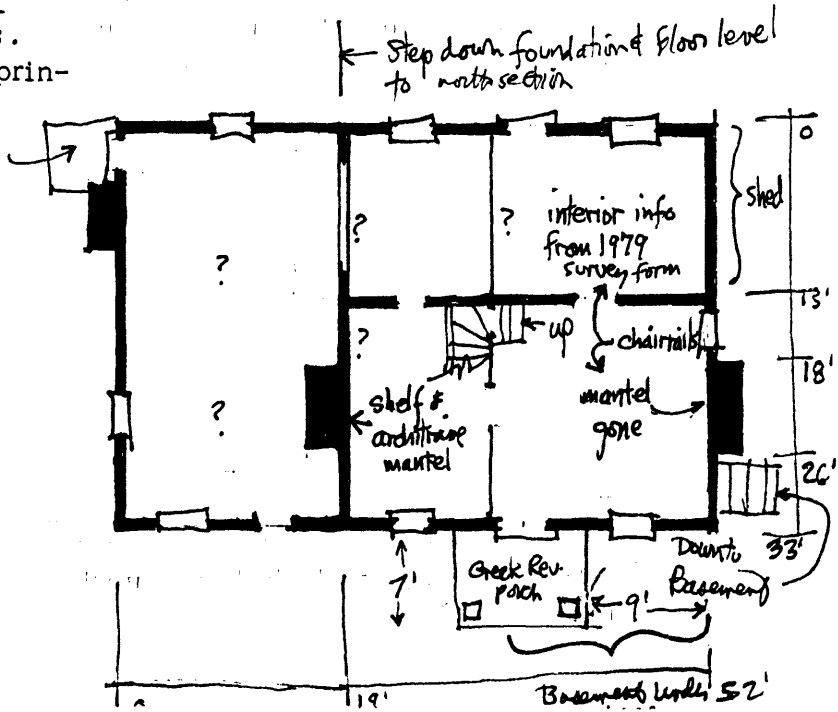
Description and House Plan:

1 1/2-story frame 3-bay hall-parlor (two-room) house with early additions on north and east, all incorporating mud infilling between timbers. Main section has beaded siding on west (principal) front, altered windows, original box cornice, added Greek Revival porch over central entry bay with square columns, heavy entablature, and pediment. External stone chimney at each end flanked by casements on south. Interior features chairrail and an enclosed stair rising from the larger room through the smaller. Mantel survives in smaller room (shelf and architrave) with federal detailing.

Shed-roofed frame section mirrors plan and fenestration to east. May be original. Both sections have tapered rake boards, and east section has beaded weatherboards on the east wall. A north section, also of mud-infilled timber, adds a room to both south sections, under one wide gabled roof. A stone chimney stands at the north end of the north room, partially demolished. May represent a hall-parlor house with a one-room north extension, soon enlarged by the addition of a lean-to across the back, at which time the roof of the north room united with that of the rear addition.
