KENTUCKY HISTORIC RESOURCES **Individual Inventory Form**

Resource	# SH 227			
SHELBY	County

Resource # SH-227

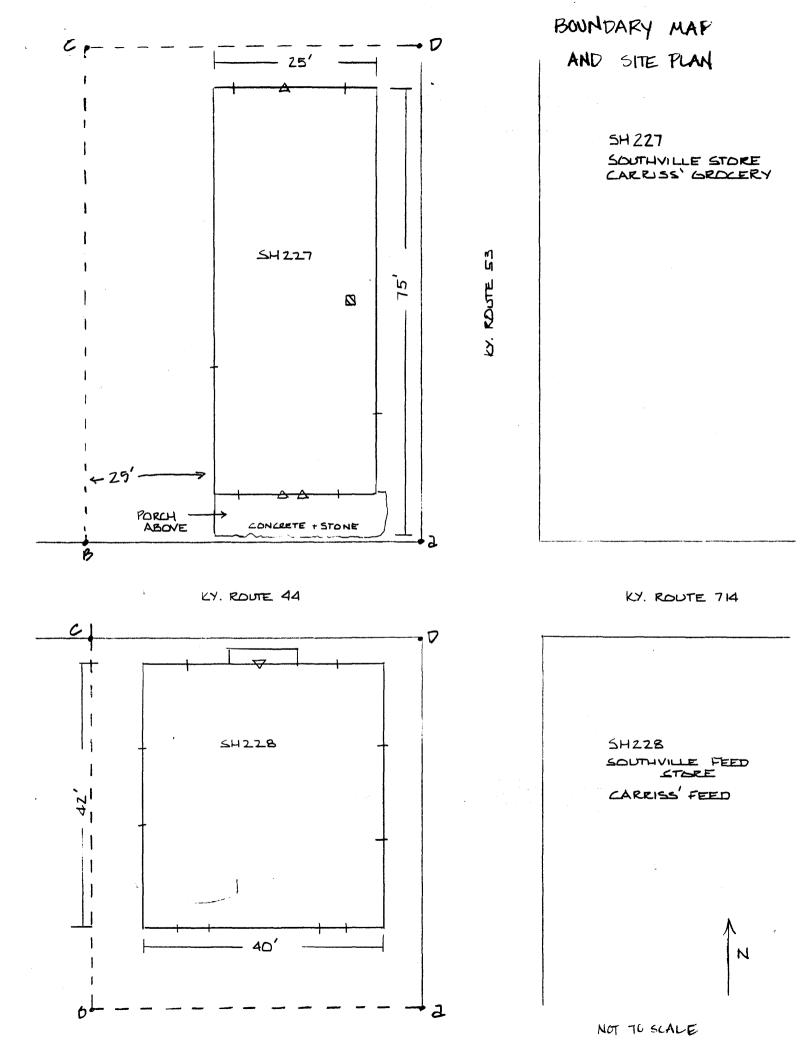
45. Description and House Plan:

The building presents a rather generic appearance: one main, rectangulr room; gable roof with metal clad porch suspended from the front gable end by guy lines; an elevated, stone front loading dock/porch; four-over-four sash windows; a recessed central front entry and clapboard siding. Overall, the building measures 25' by 75'. The interior, old, if not original, has a wood floor, kitchen grill, a couple of tables and shelves, both free standing and built in. The property contains one contributing building.
