**National Register of Historic Places
Registration Form**

historic name Union Park Historic District
other names/site number

**Union Park Historic District
Leavenworth County, Kansas**

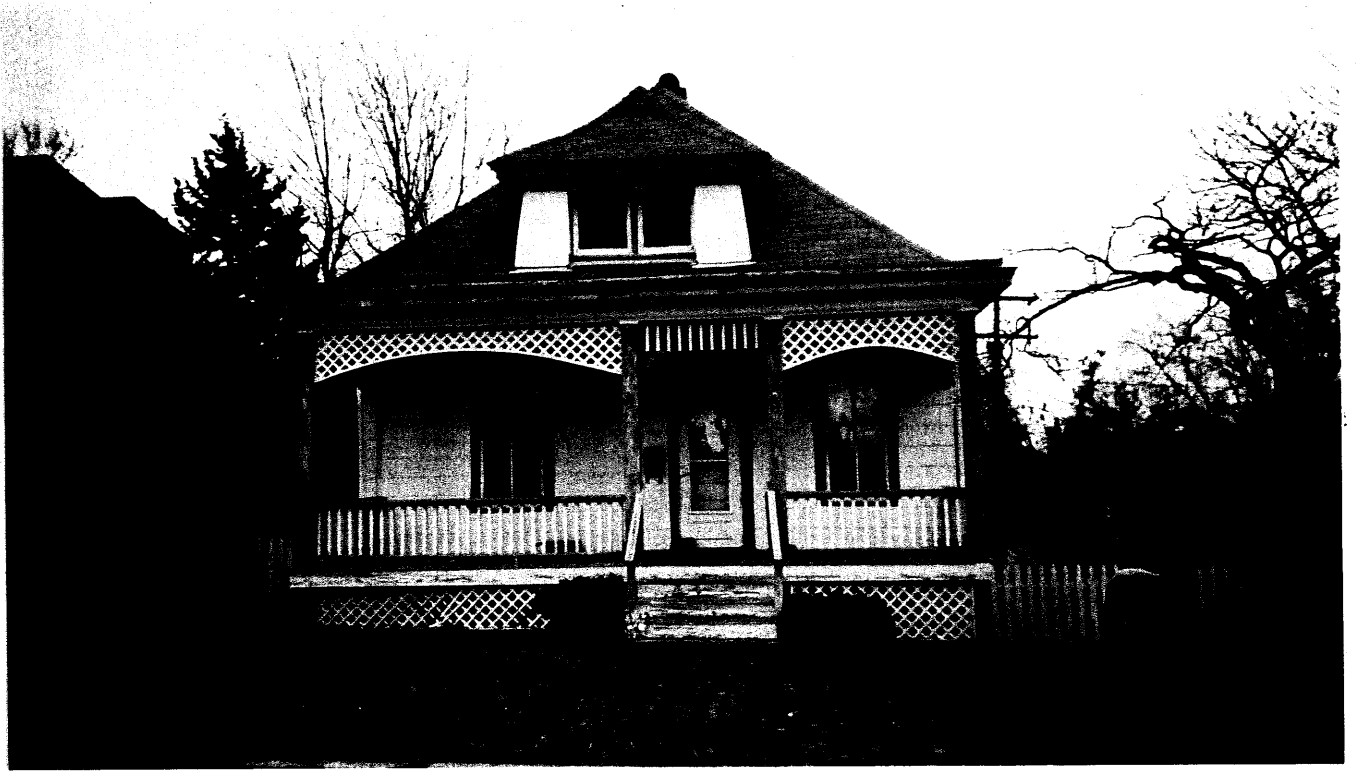
Before removal of ~~the~~ non-historic siding

The references to 807 S. Seventh St. (ca 1900) on pages 7.3 and 7.10 are, hereby, amended to indicate that the building contributes to the significance of the historic district due to the removal of asbestos shingles and verification that the historic wooden lap siding remains in good condition.

The SHPO staff supports certification of the house at 807 S. 7th as a contributing element of the Union Park neighborhood since the asbestos siding has been removed and other non-historic elements such as the porch lattice have also been removed. The original siding is in fair condition and the house retains its overall historic appearance. It appears to contribute to the Union Park District as a later addition at the turn of the 20th century as part of the move from Victorian styles to the Craftsman influence.
