National Register of Historic Places  
Registration Form

historic name Hickman House

street & number 3568 Mt. Holly Road

city or town Camden

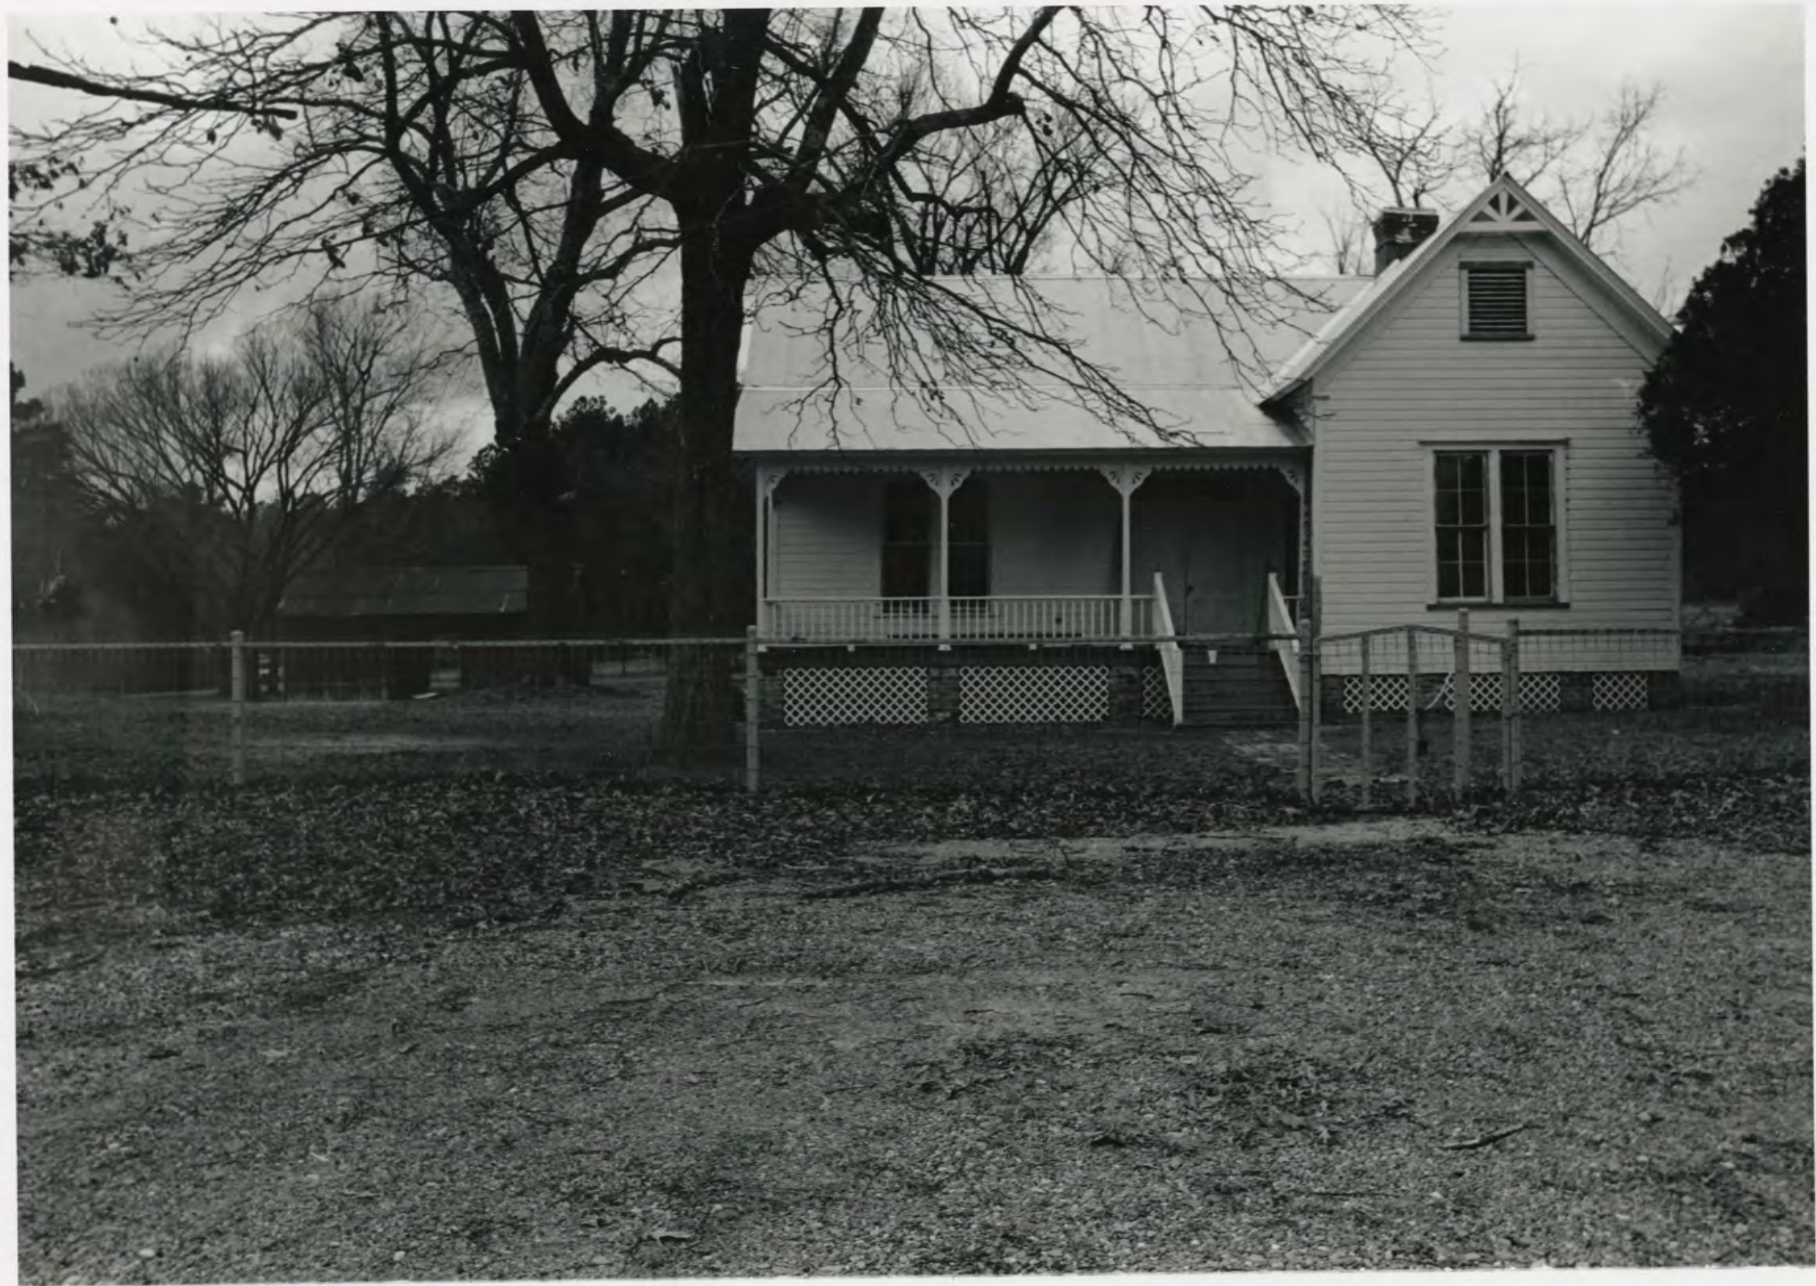
1. Hickman House
2. Ouachita County, AR
3. Sarah Jampole
4. January 15, 2005
5. Arkansas Historic Preservation Program
6. East facade, looking west
7. #1

The house faces east and is approximately 150 feet from Mount Holly Road. The far right bay of the house presents a front facing gable with a simple fretwork sunburst in the peak, as well as an attic vent. Front fenestration consists of two pairs of windows, one pair under the gable and one pair opening to the porch. Both pairs of windows are wood-frame, four-over-four, double hung.

There are two entrances on this elevation. The main entrance, leading into the hall, has double four-panel doors topped by a fixed transom, and faces east. The other faces south and enters into the living room, which is the far left bay of the east elevation.

The front porch railing is very simple, with square balusters with a rounded top rail to shed water. Folk Victorian details include the chamfered porch posts and simple sawn fretwork, including a scalloped border with sawn fretwork spandrels at posts and corners. The deteriorated wooden porch floor has recently been replaced with treated pine flooring. A shed roof shelters the three-quarter length front porch.

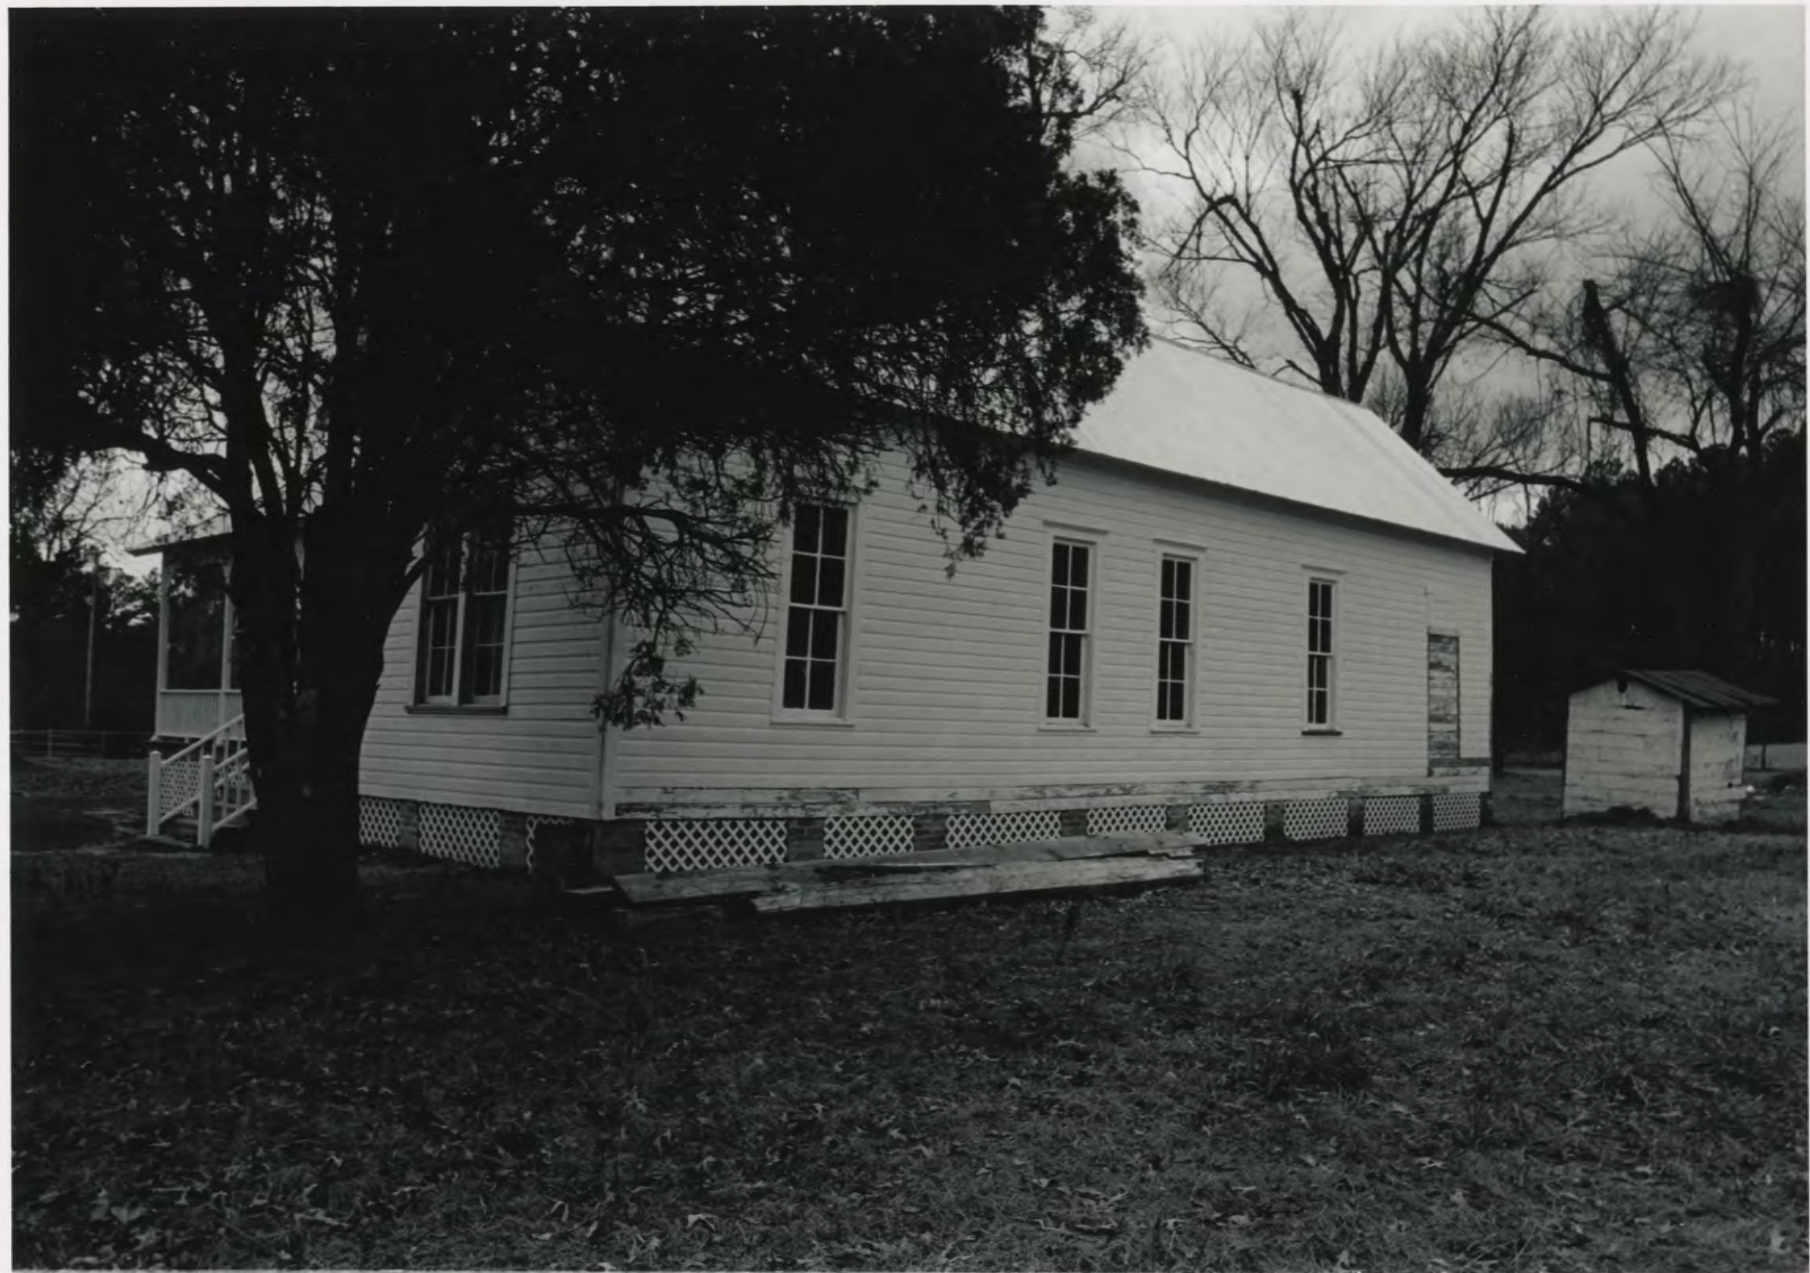
1. Hickman House
2. Ouachita County, AR
3. Sarah Jampole
4. January 15, 2005
5. Arkansas Historic Preservation Program
6. East elevation & north façade, looking  
south west
7. #2

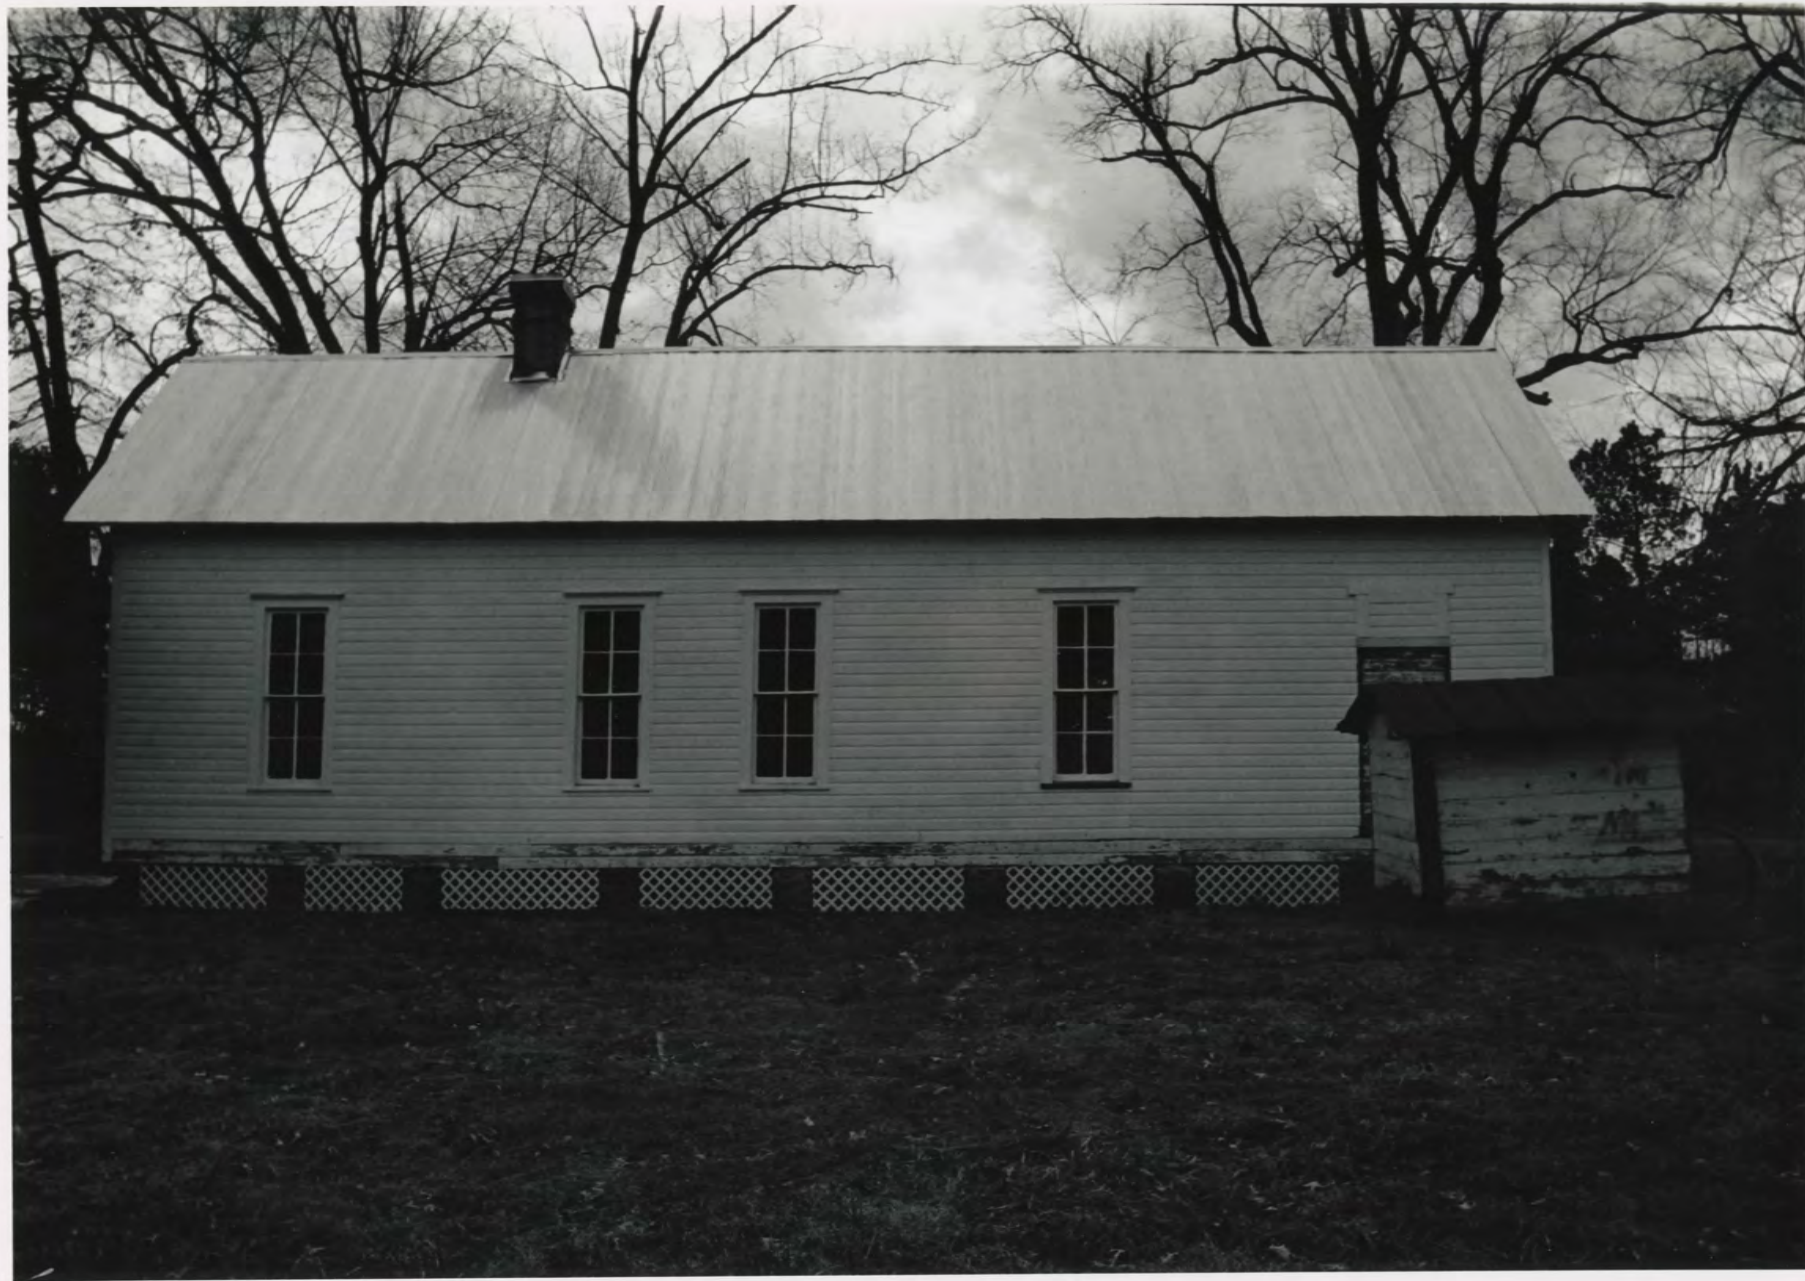
1. Hickman House
2. Cochise County, Ariz
3. Sarah Jampole
4. January 15, 2005
5. Arkansas Historic Preservation Program
6. North facade looking south
7. #3

The north elevation presents the longest expanse, fenestrated by a ribbon of four large four-over-four, double hung, wood frame windows. The two windows at either end of this elevation are spaced further apart from the two interior windows, which are no more than two feet from each other. At the far right end is a closed-in doorway which once led to a breezeway connecting the kitchen (rear room) to the original well house, which is no longer extant, but has been replaced with a newer well house.

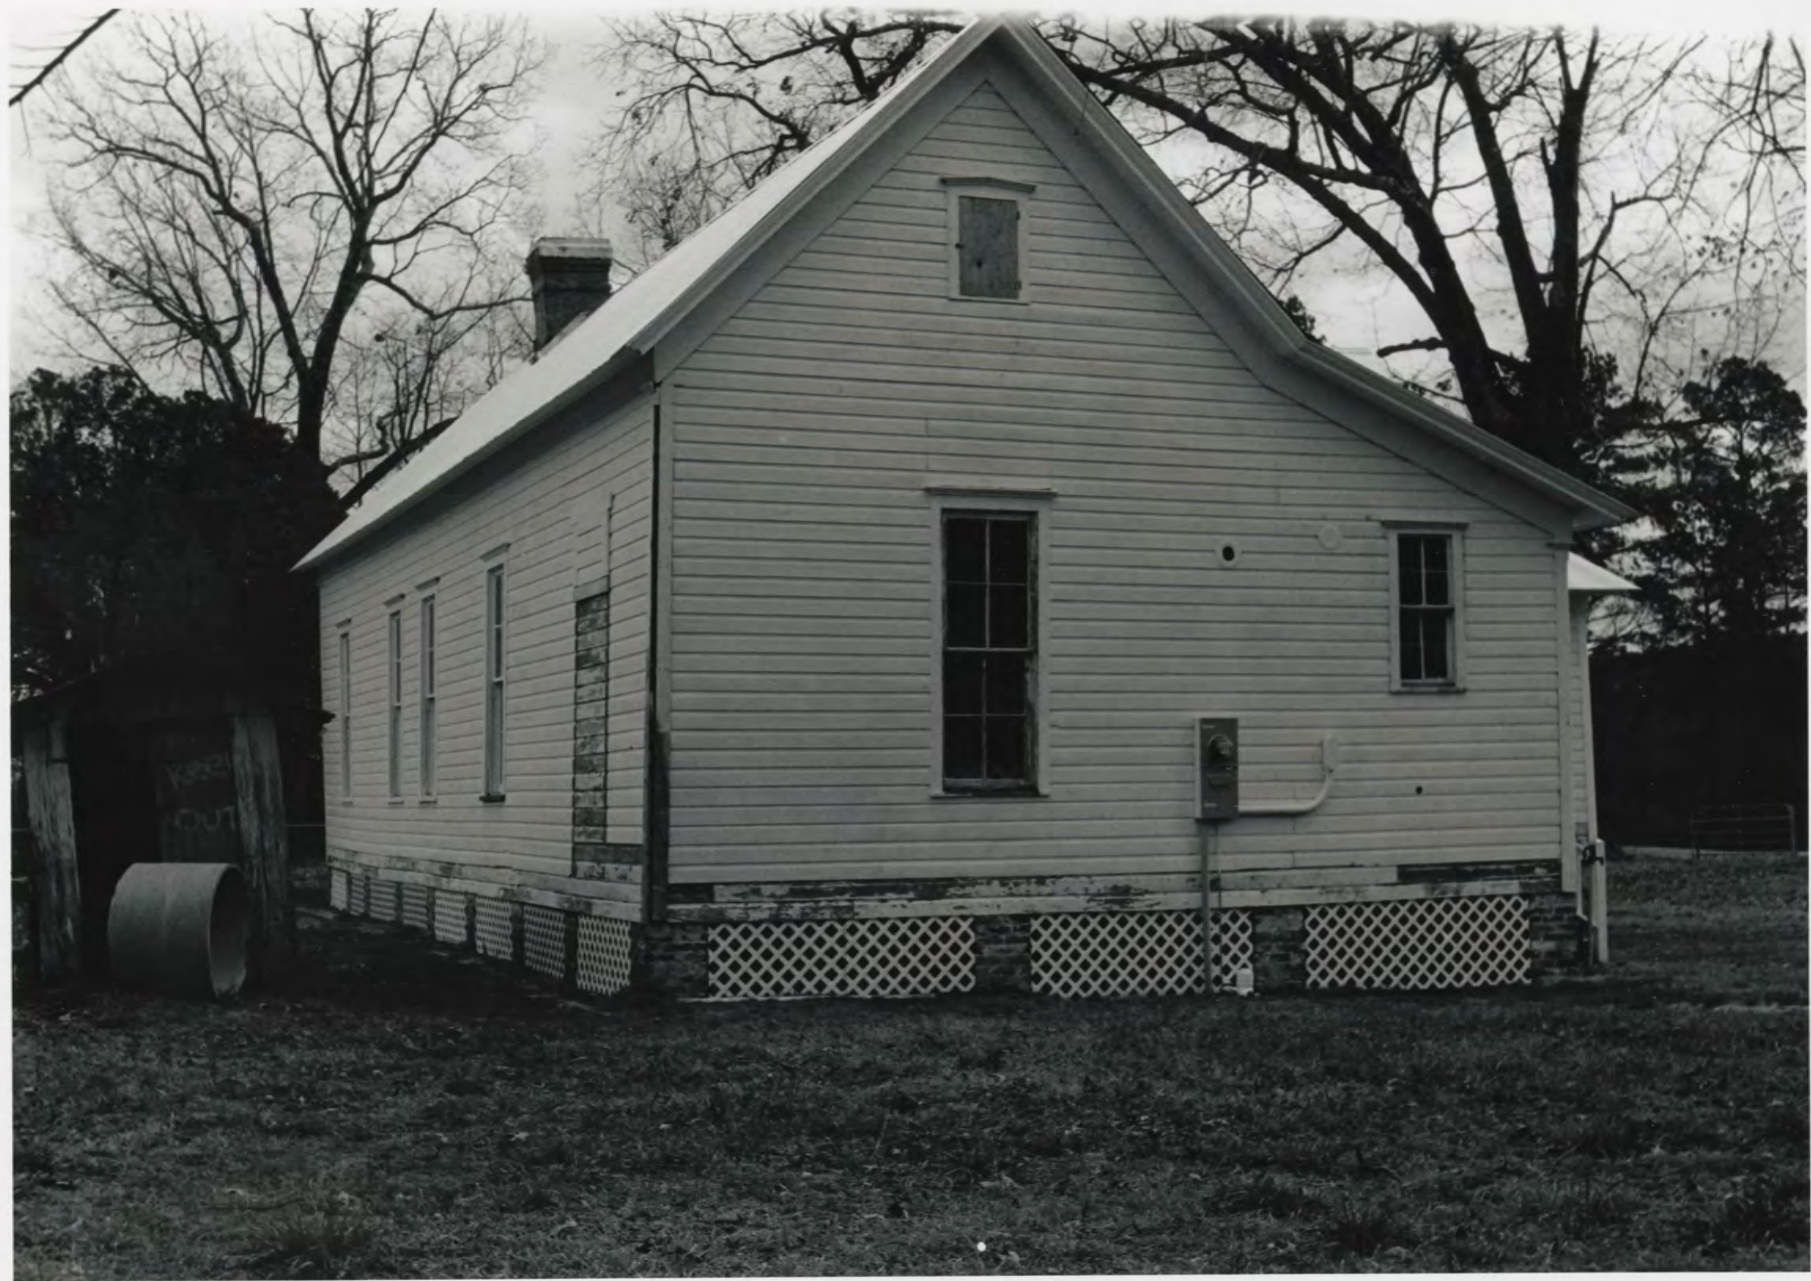
1. Hickman House
2. Osage County
3. Sarah Jampole
4. January 15, 2005
5. Arkansas Historic Preservation Program
6. North elevation & partial west facade,  
looking south east.
7. #4

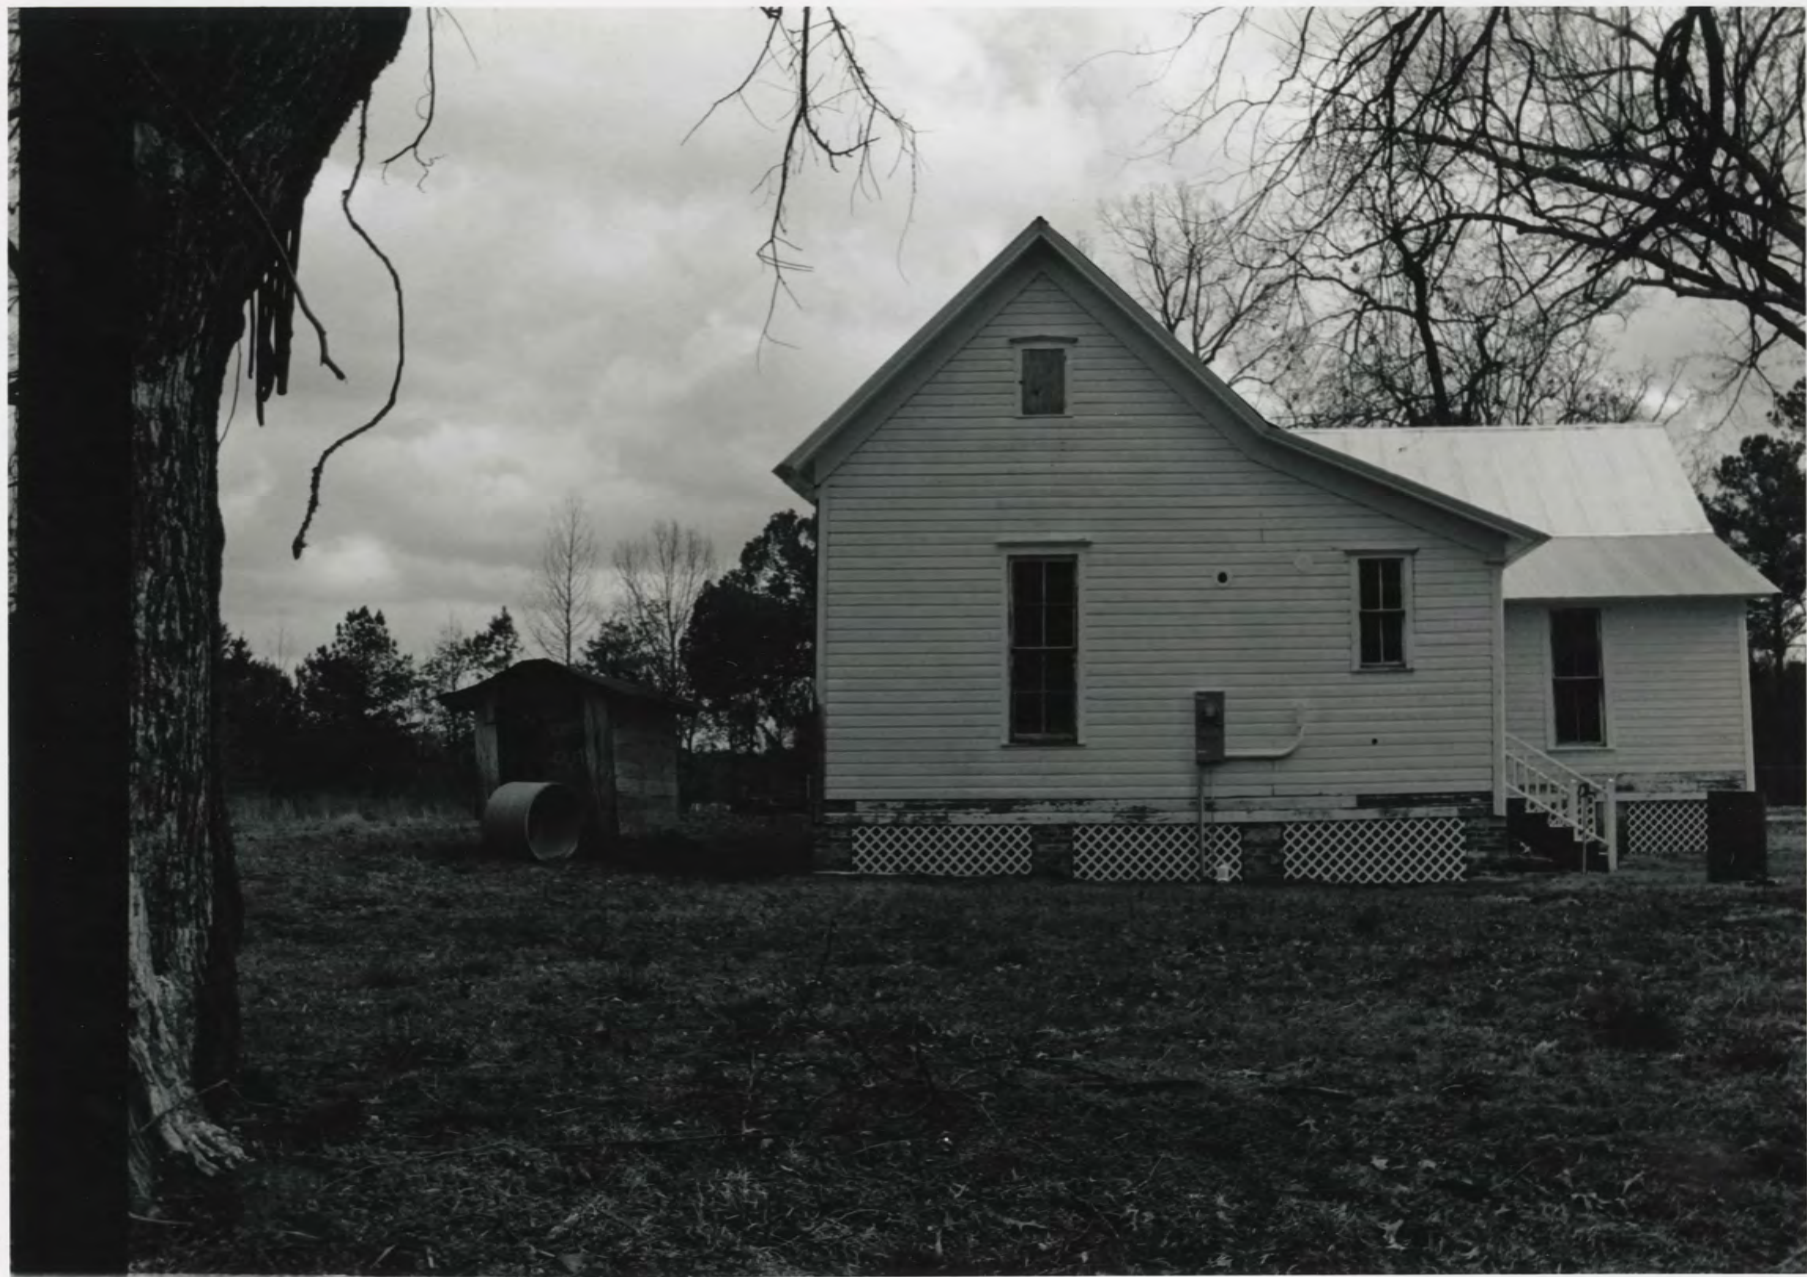
1. Hickman House
2. Ouachita County, AR
3. Sarah Jampole
4. January 15, 2005
5. Arkansas Historic Preservation Program
6. West facade, looking east.
7. #15

The far left bay of the west elevation of the house, the rear, has one large four-over-four window looking into the kitchen, and one small four-over-four window looking into the small room at the end of the side porch. A small attic vent is visible, though boarded up, at the gable peak in this bay. The cross gable (a continuation of the front facing gable) has a roof break over the side porch. The far right bay of this elevation is pierced by one wood frame, double-hung, four-over-four window that is similar to most of the others in the house, and looks into a bedroom.

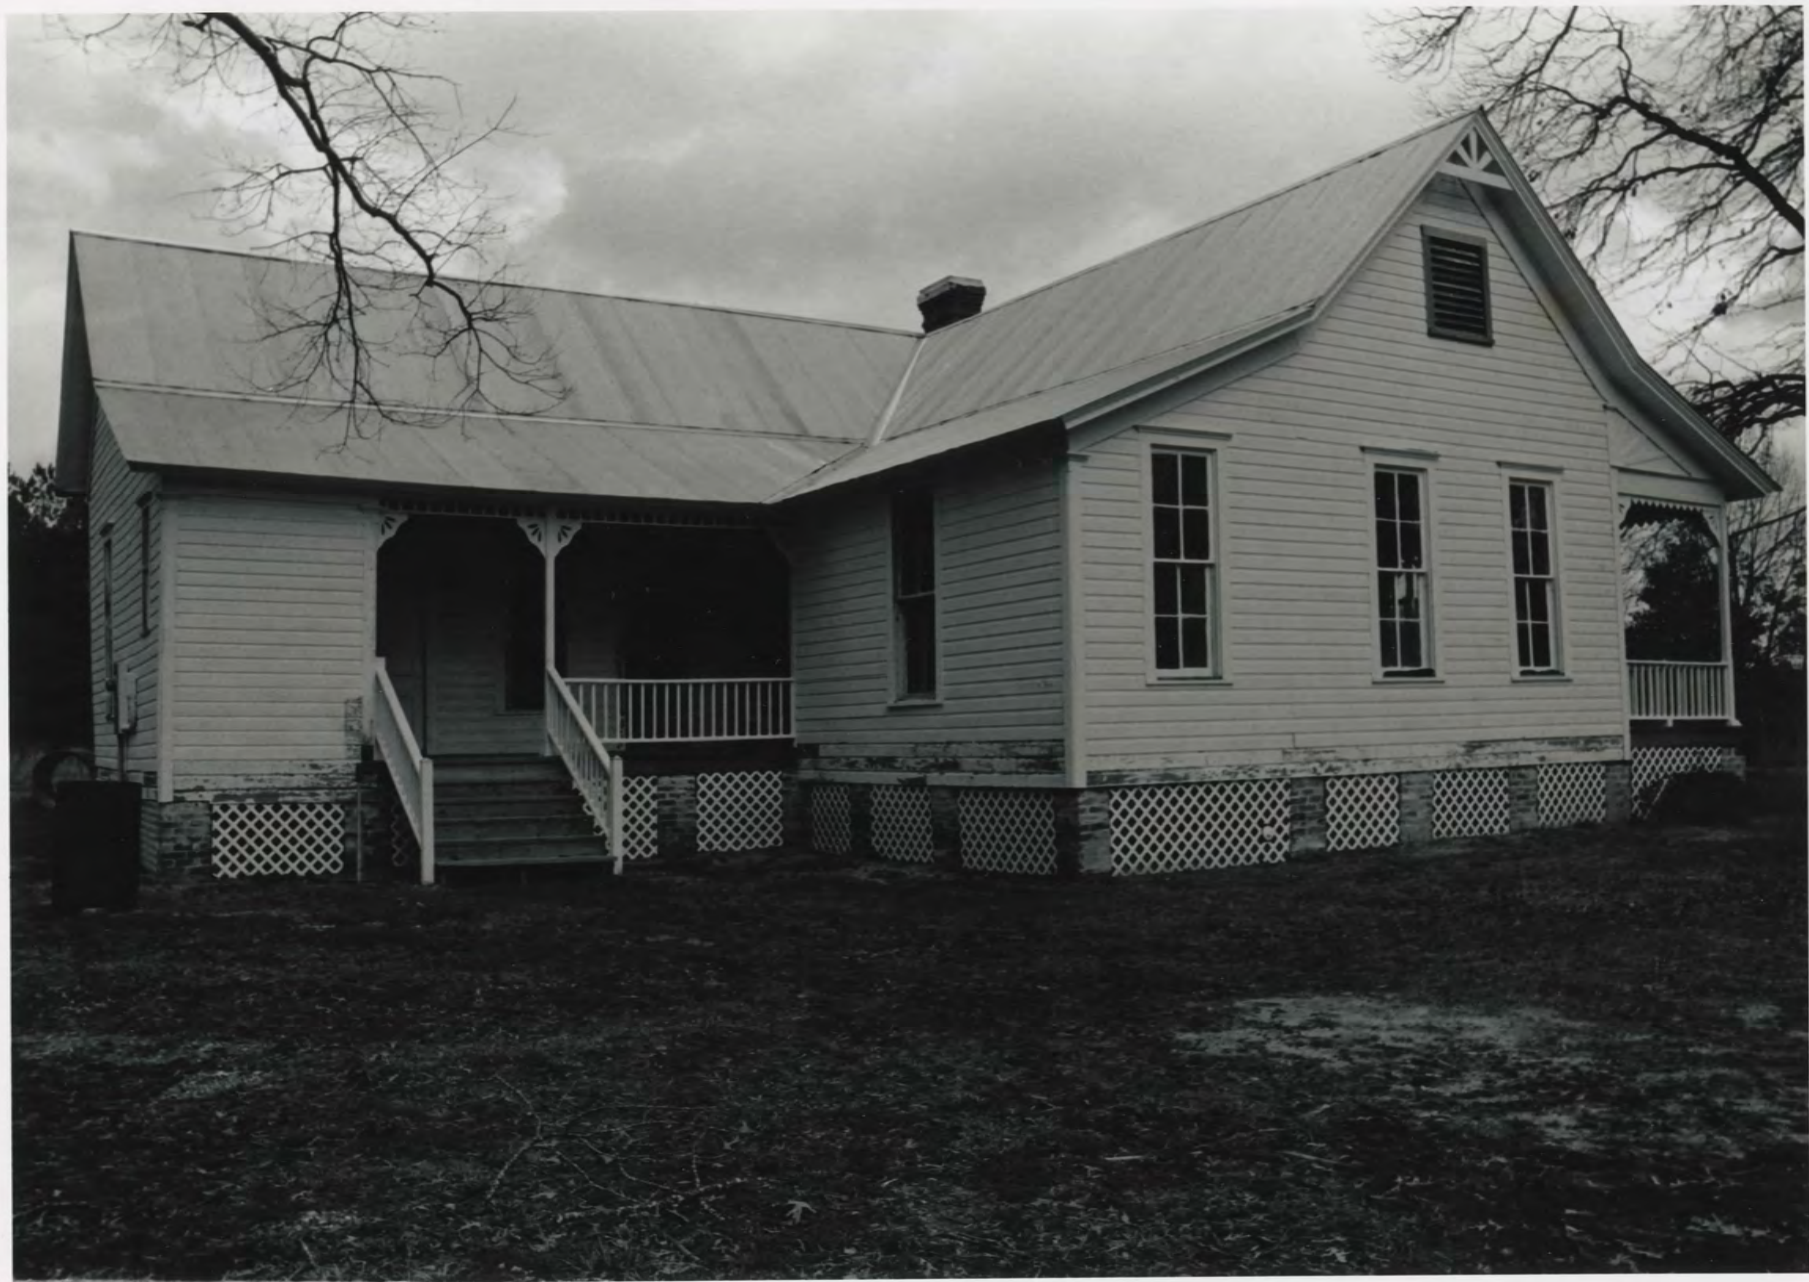
1. Hickman House
2. Ouachita County, AR
3. ~~Sarah Jampde~~ Sarah Jampde
4. January 15, 2005
5. Arkansas Historic Preservation Program
6. West elevation & south facade, looking  
northeast
7. #6

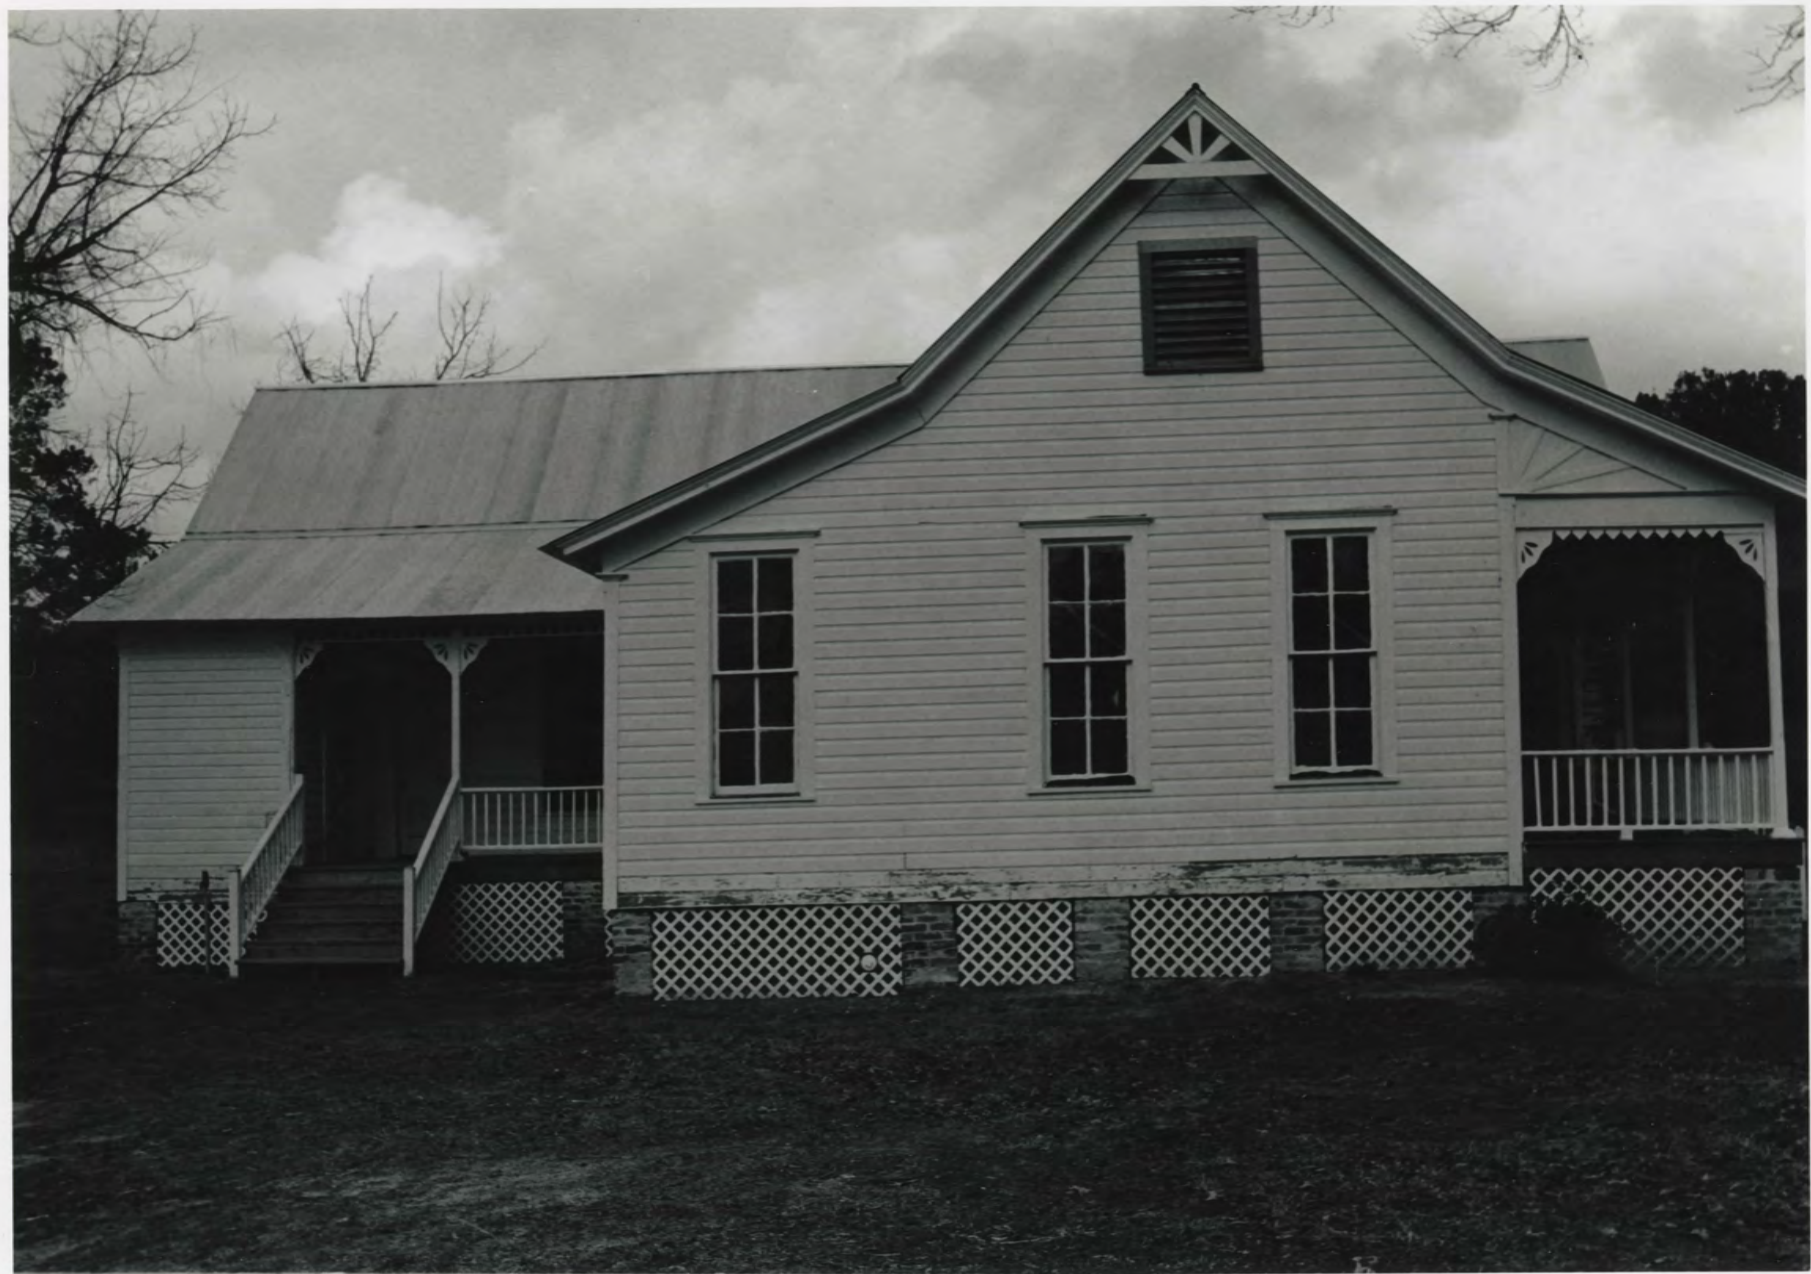
1. Hickman House
2. Ouachita County, AR
3. Sarah Jampole
4. January 15, 2005
5. Arkansas Historic Preservation Program
6. South facade, looking North
7. #7

The south elevation presents the most complex façade. The roof over the right bay breaks at both the front and rear of the bay—the front over the front porch and the rear over a small room behind the south bedroom.

On the far left side of the left bay of this elevation, is a series of five steps leading to the porch. Once on the porch and under the cover of the shed roof, one door is situated directly to the left, leading into the bathroom, and another door is situated straight ahead, leading into the kitchen. To the right of this door is a window opening, which at the time of the architectural survey in January 2005, did not have a window in place, but appears to be in keeping with the other windows in the house in regard to size and shape of the opening itself. To the right of this window opening is another door, which leads into the third room (the dining room) of the north side of the house. Directly to the right of this door is another window opening that, as with the previous window opening, did not have a window in place at the time of the January 2005 survey, but seems to be in keeping with the size and shape of the windows in the rest of the house.

The right bay of this elevation is fenestrated by three windows, which are all wood frame, double-hung, and four-over-four. The first, far left, of these three windows is located on the southwest corner of the elevation, while the next two windows are slightly more centrally-located, and grouped closer together. The grouping of these two windows appears to mirror the grouping of the two interior windows on the north elevation. The far right side of the bay is the side of the front porch. The peak of the cross gable is visible on this façade, and as is the case with the front gable, is punctuated with a fretwork sunburst and an attic vent. There is a matching fretwork sunburst under the side of the porch roof, with decorative corner post topped by a capital.

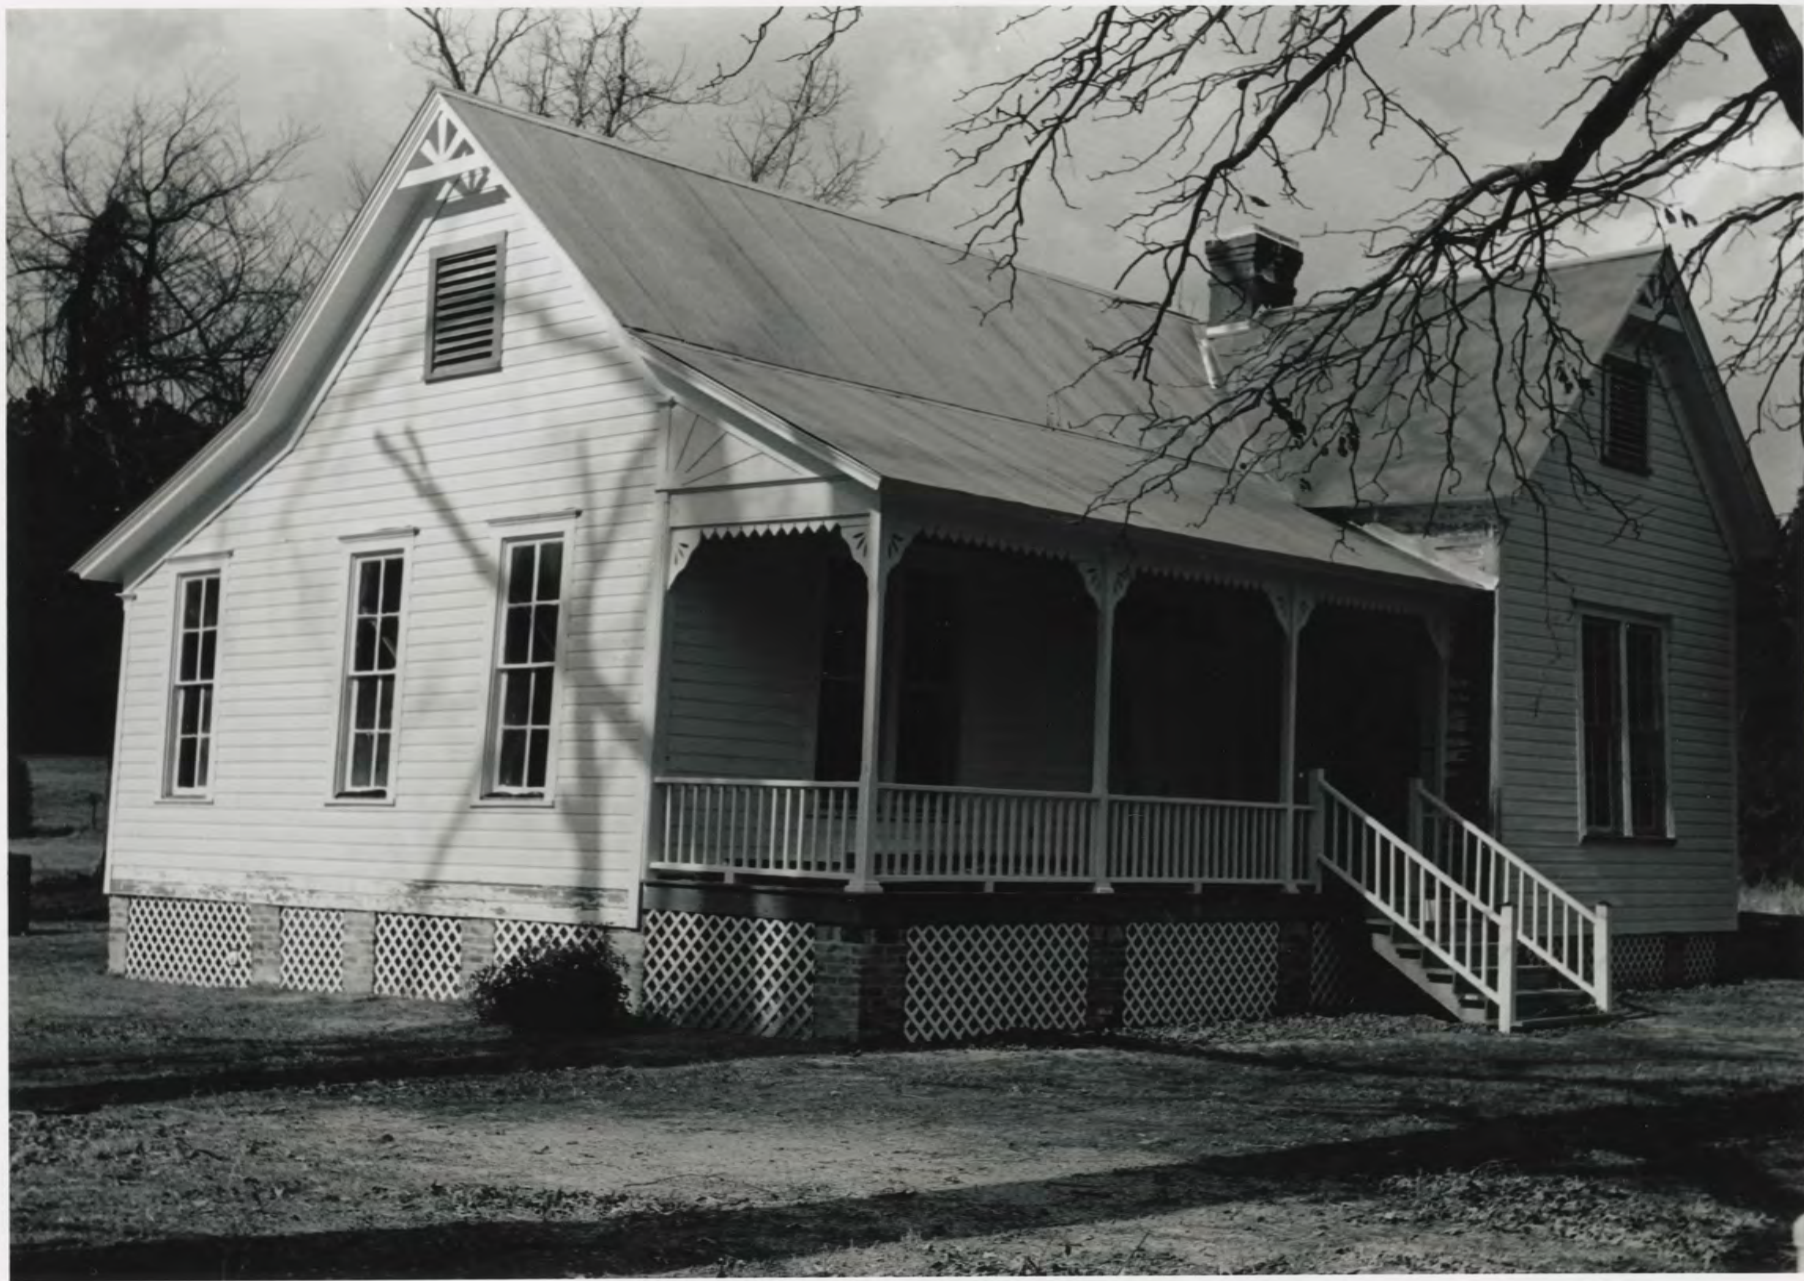
1. Hickman House
2. Ouachita County, AR
3. Sarah Jampole
4. January 15, 2005
5. Arkansas Historic Preservation Program
6. South elevation; west facade, looking  
northwest
7. #8

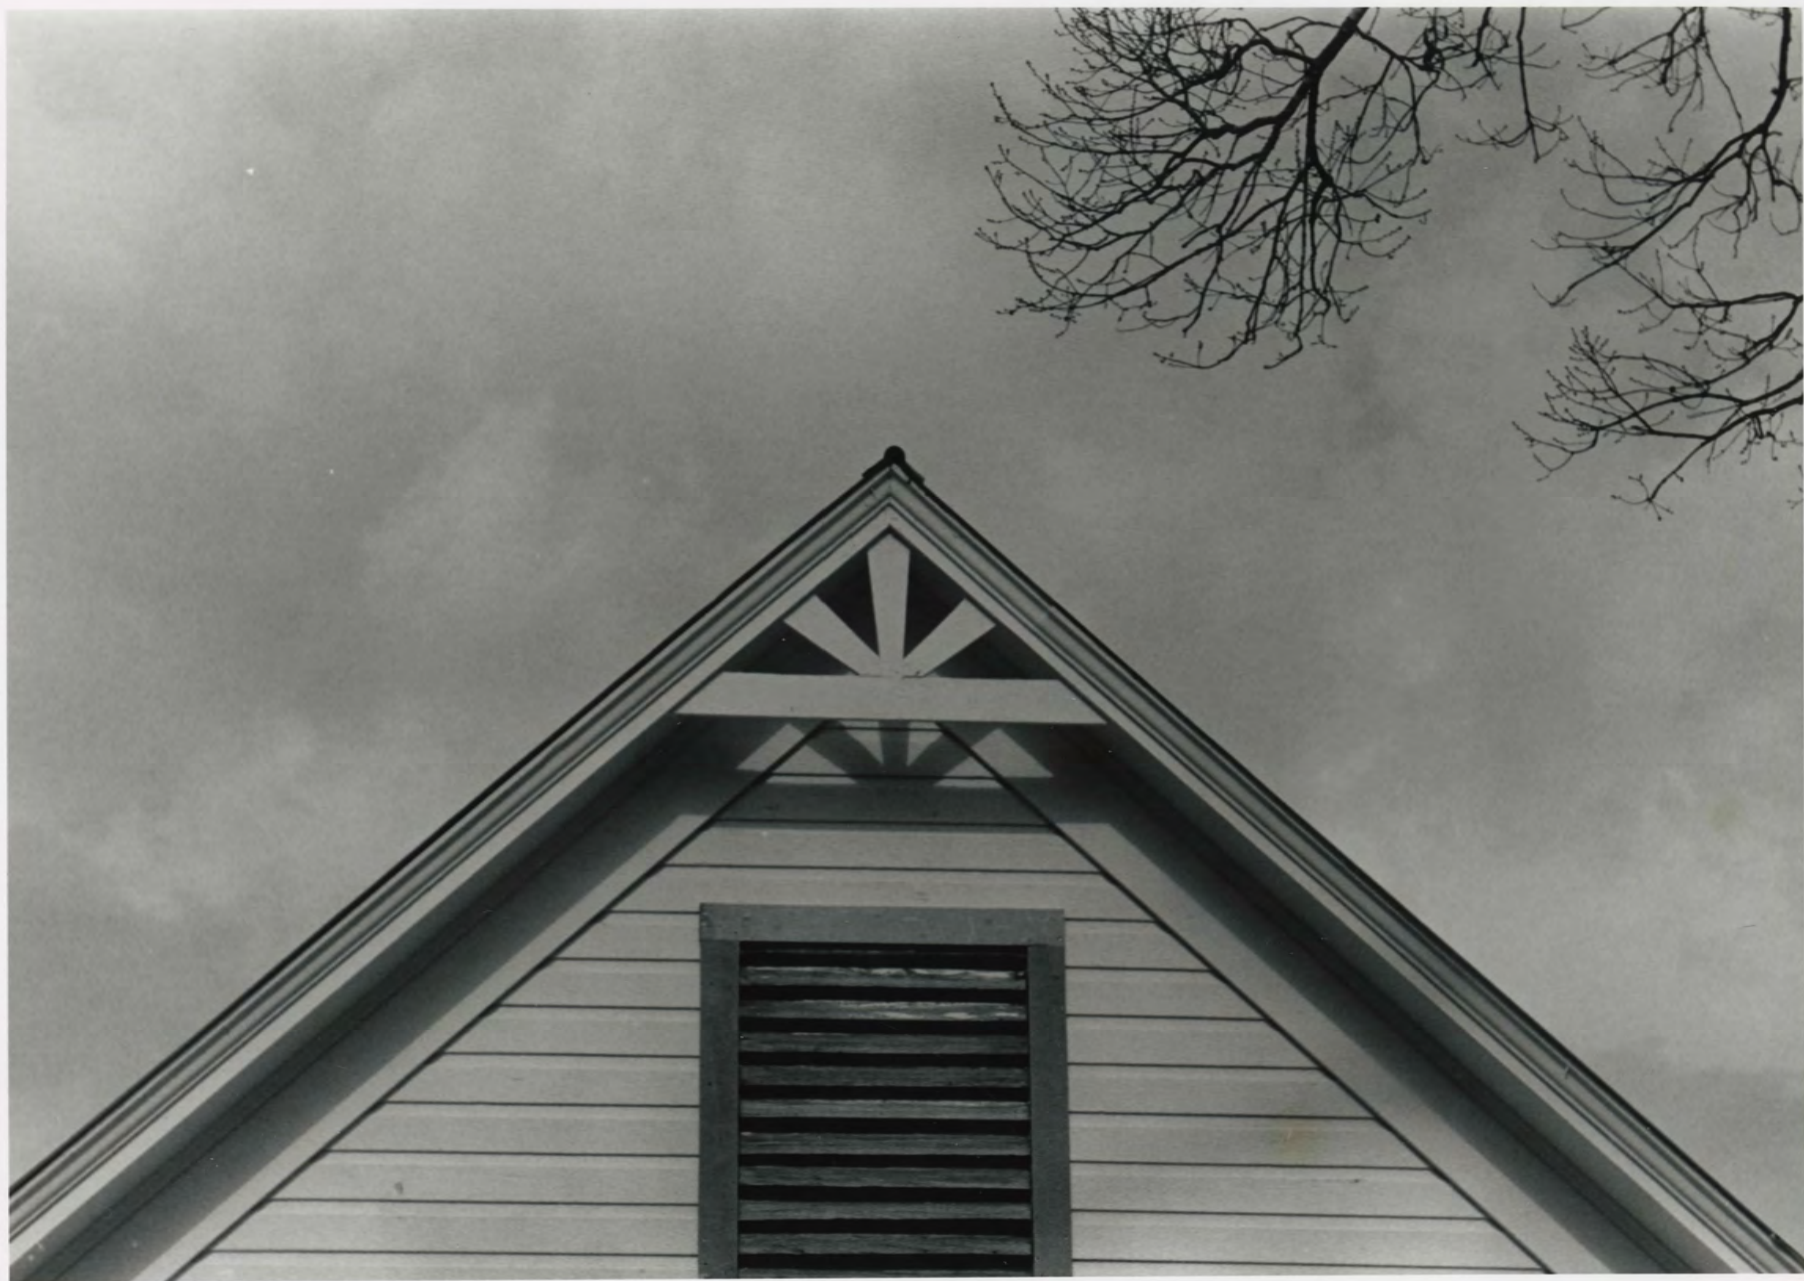
1. Hickman House
2. Ouachita County, AR
3. Sarah Jampole
4. January 15, 2005
5. Arkansas Historic Preservation Program
6. Gable Peak detail, south elevation looking  
west
7. HQ

Folk Victorian marks are seen in porch details such as chamfered wood posts with simple sawn fretwork and ornamentation. Similar details are found in the gables.
