National Register of Historic Places  
Registration Form

historic name Hickman House

street & number 3568 Mt. Holly Road

city or town Camden

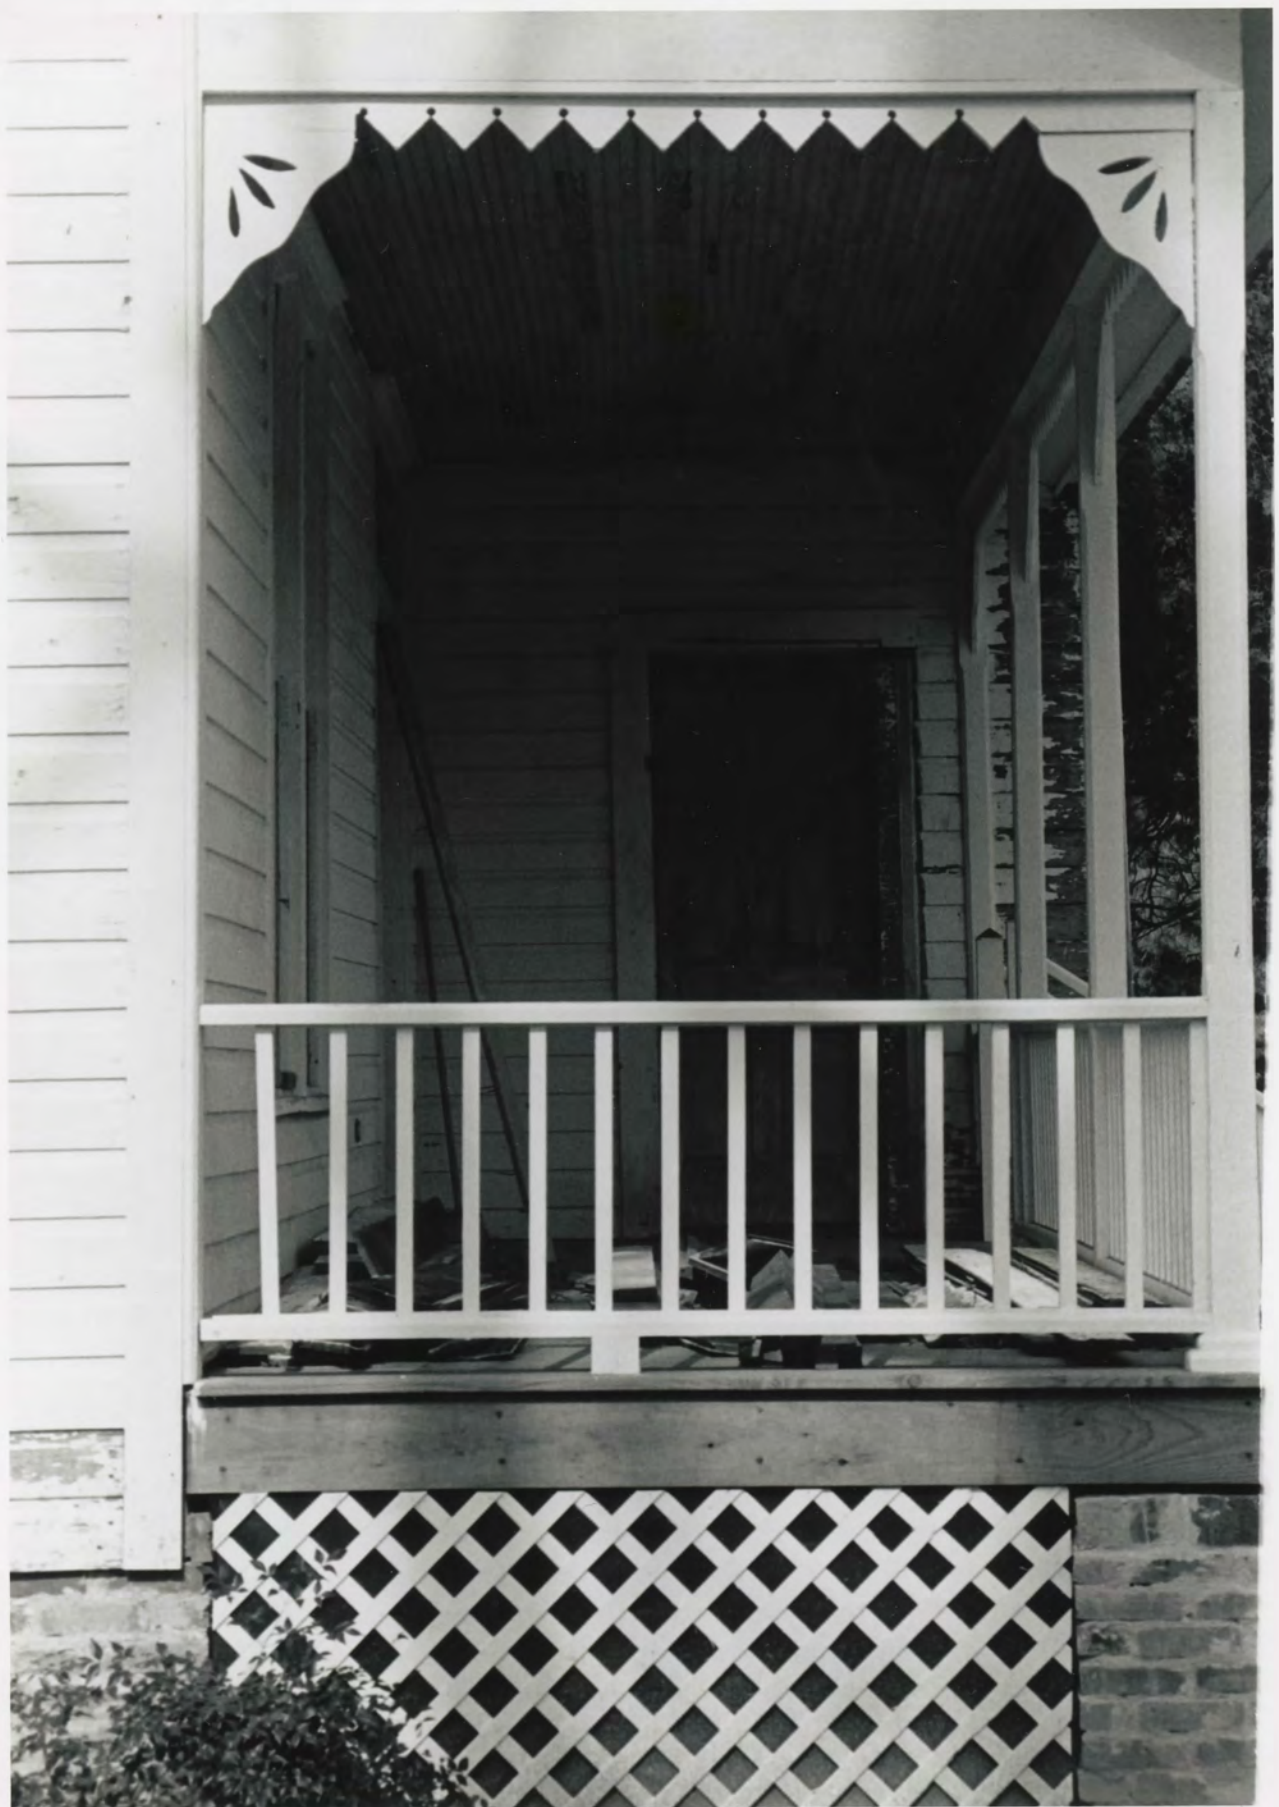
1. Hickman House
2. Ouachita County, AR
3. Sarah Jampelle
4. January 15, 2005
5. Arkansas Historic Preservation Program
6. Porch detailing, east porch, looking north
7. #10

The front porch railing is very simple, with square balusters with a rounded top rail to shed water. Folk Victorian details include the chamfered porch posts and simple sawn fretwork, including a scalloped border with sawn fretwork spandrels at posts and corners. The deteriorated wooden porch floor has recently been replaced with treated pine flooring. A shed roof shelters the three-quarter length front porch.

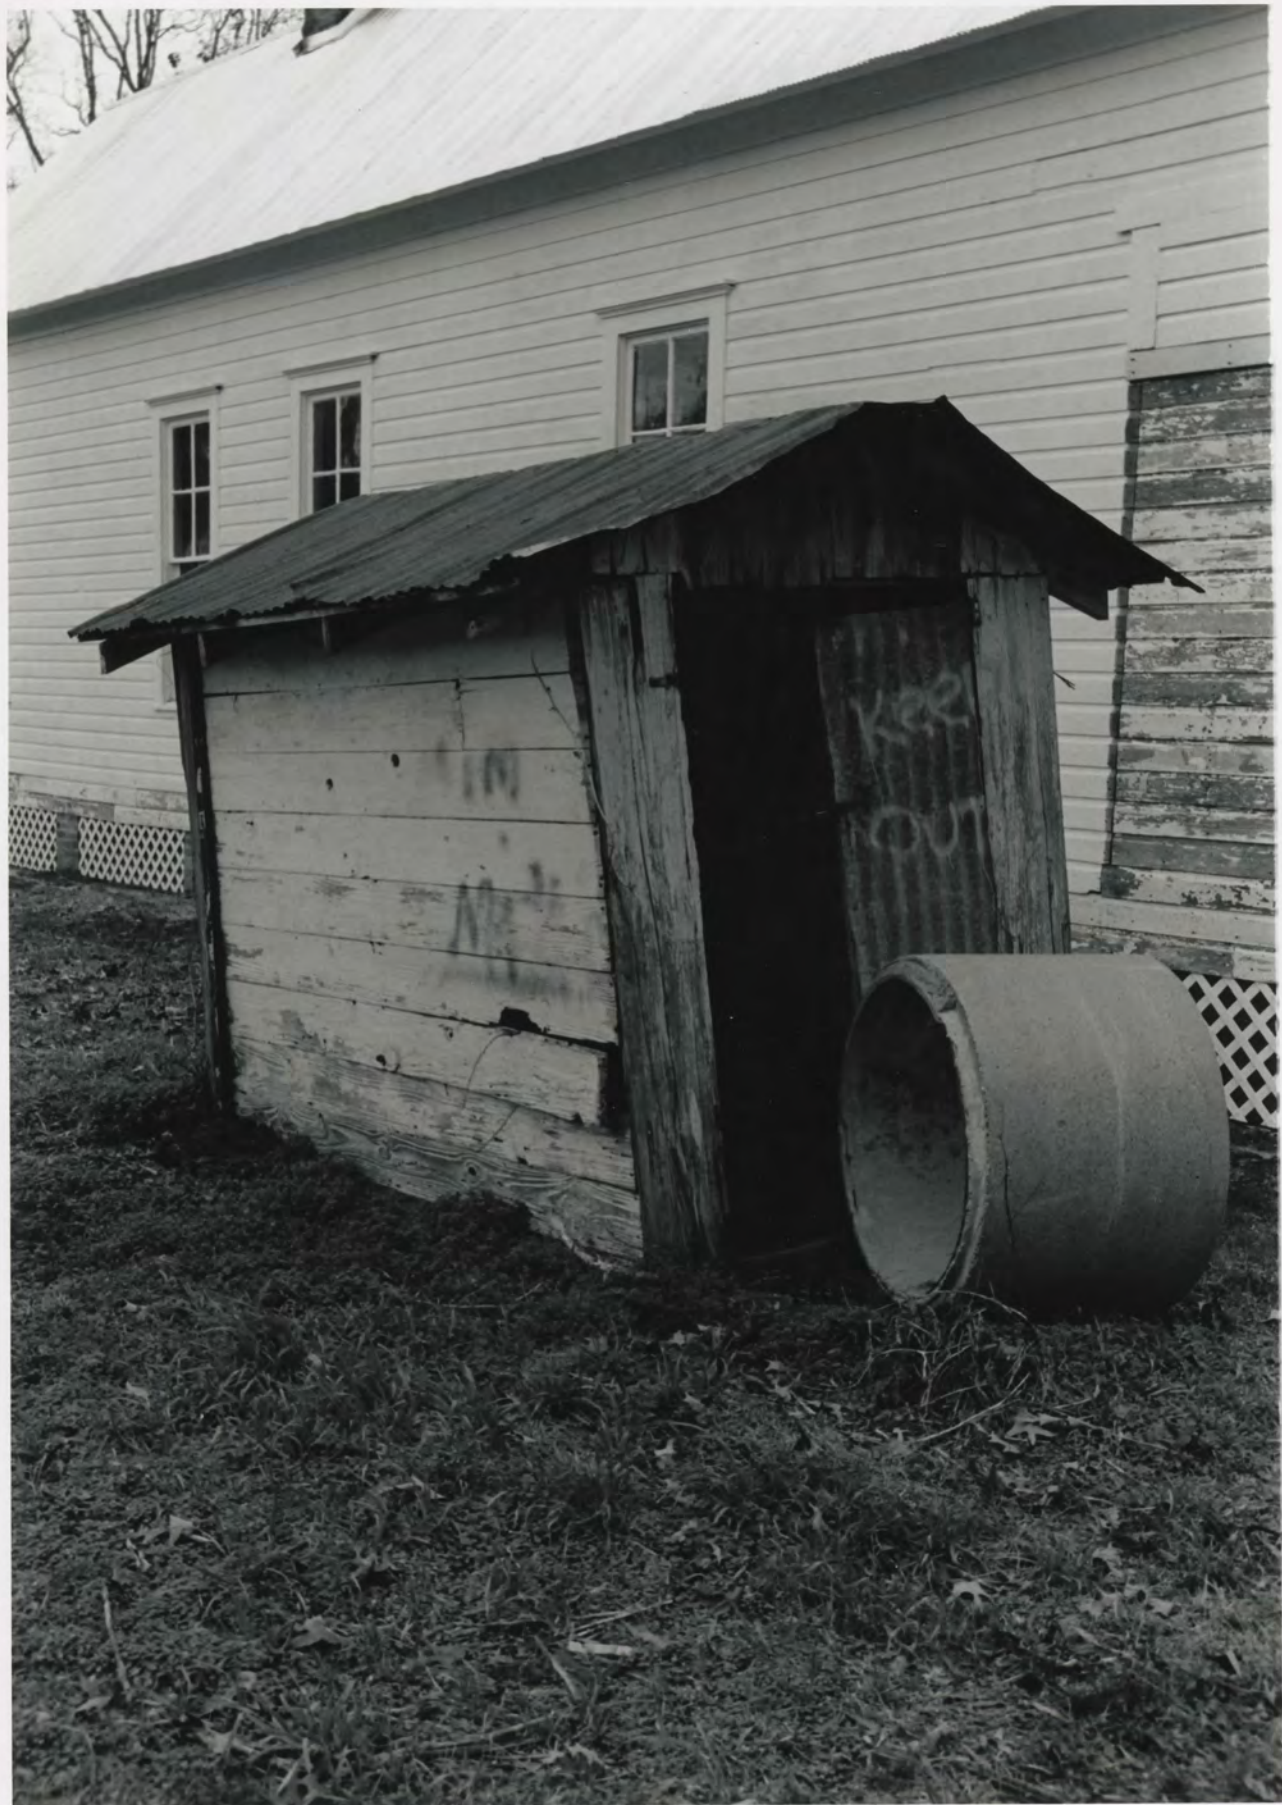
1. Hickman House
2. Ouachita County, AR
3. Sarah Jampok
4. January 15, 2005
5. Arkansas Historic Preservation Program
6. Well house, looking Southeast.
7. #11

The small, non-contributing well house is a simple wood frame structure, with horizontal board wall covering. Capped with a metal roof, an improvised corrugated metal door is marked with the words "Keep Out."

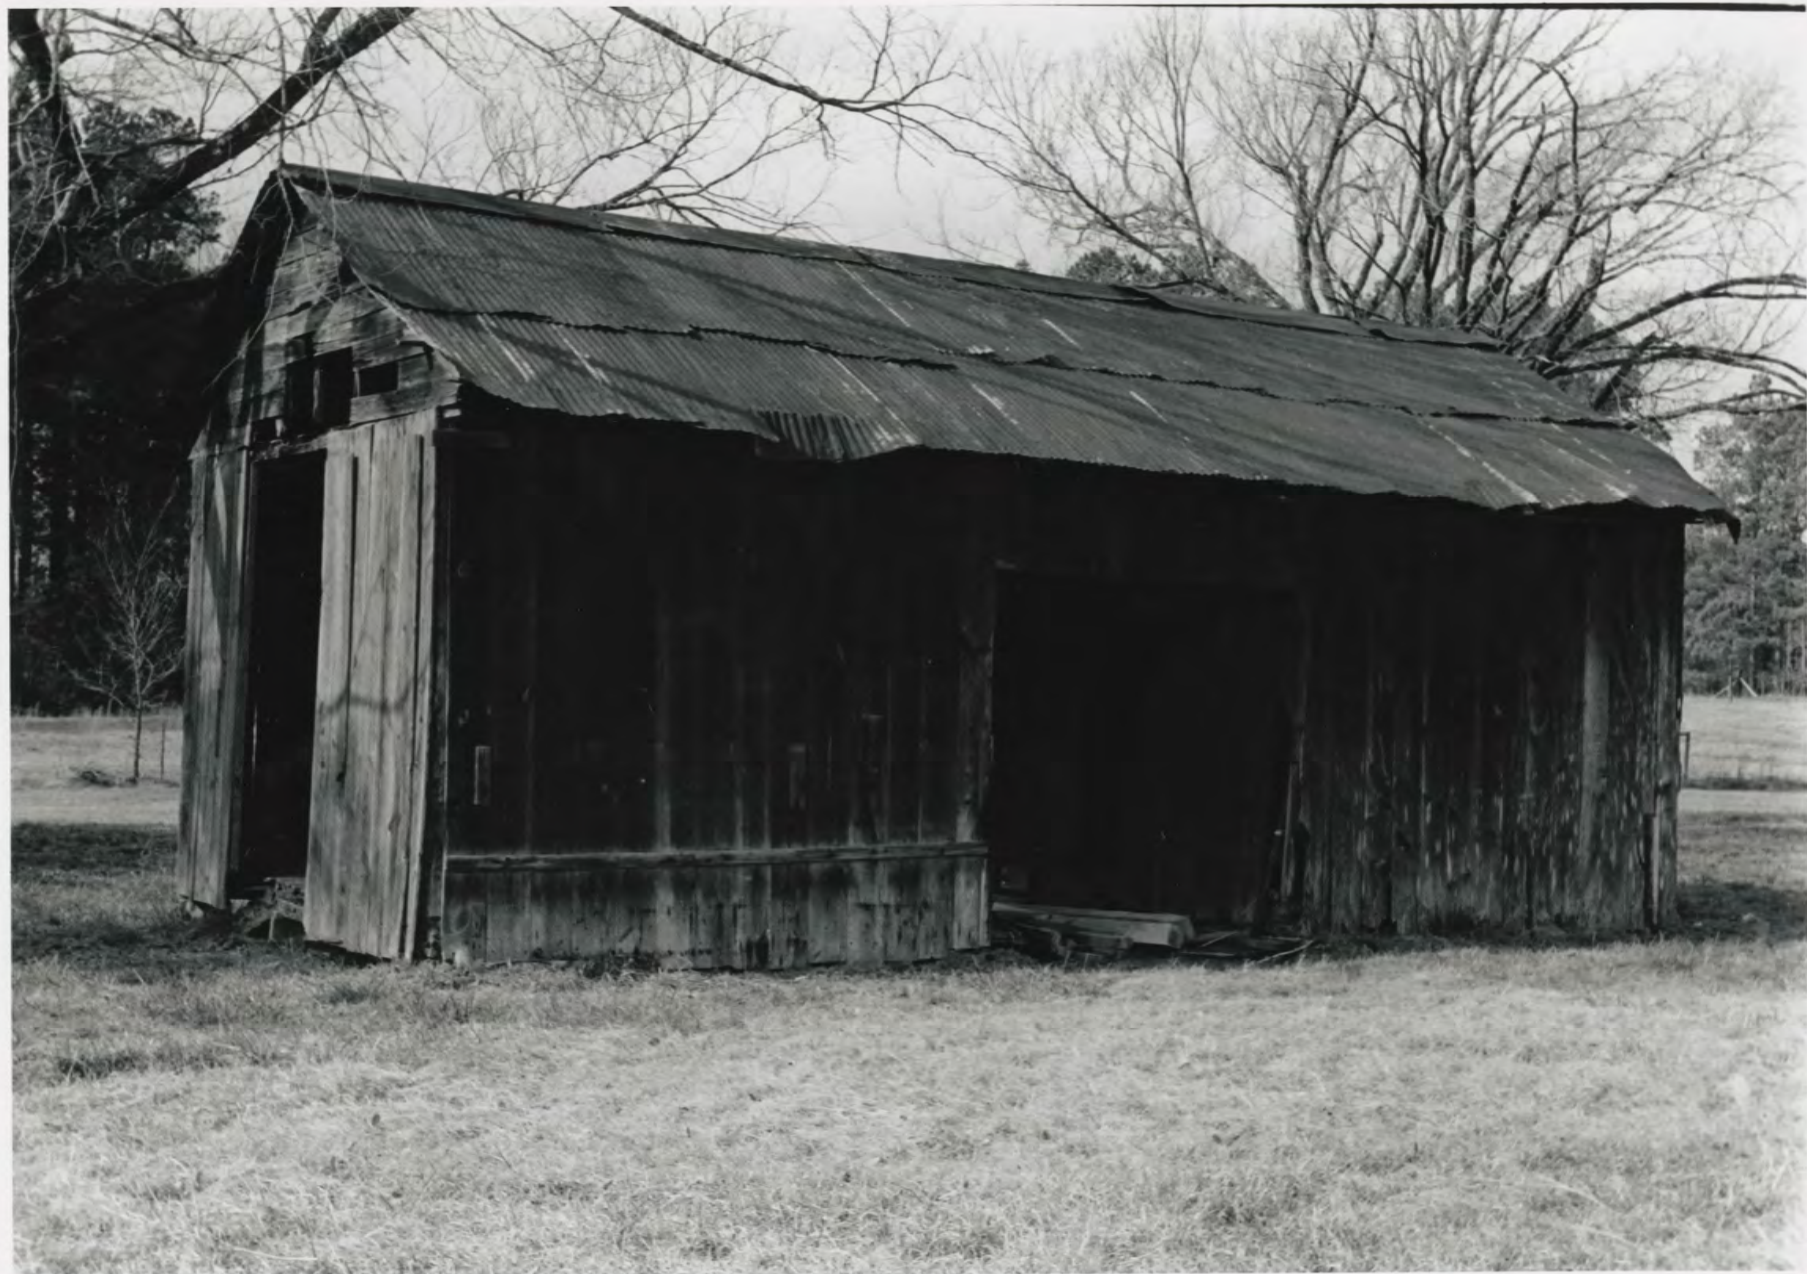
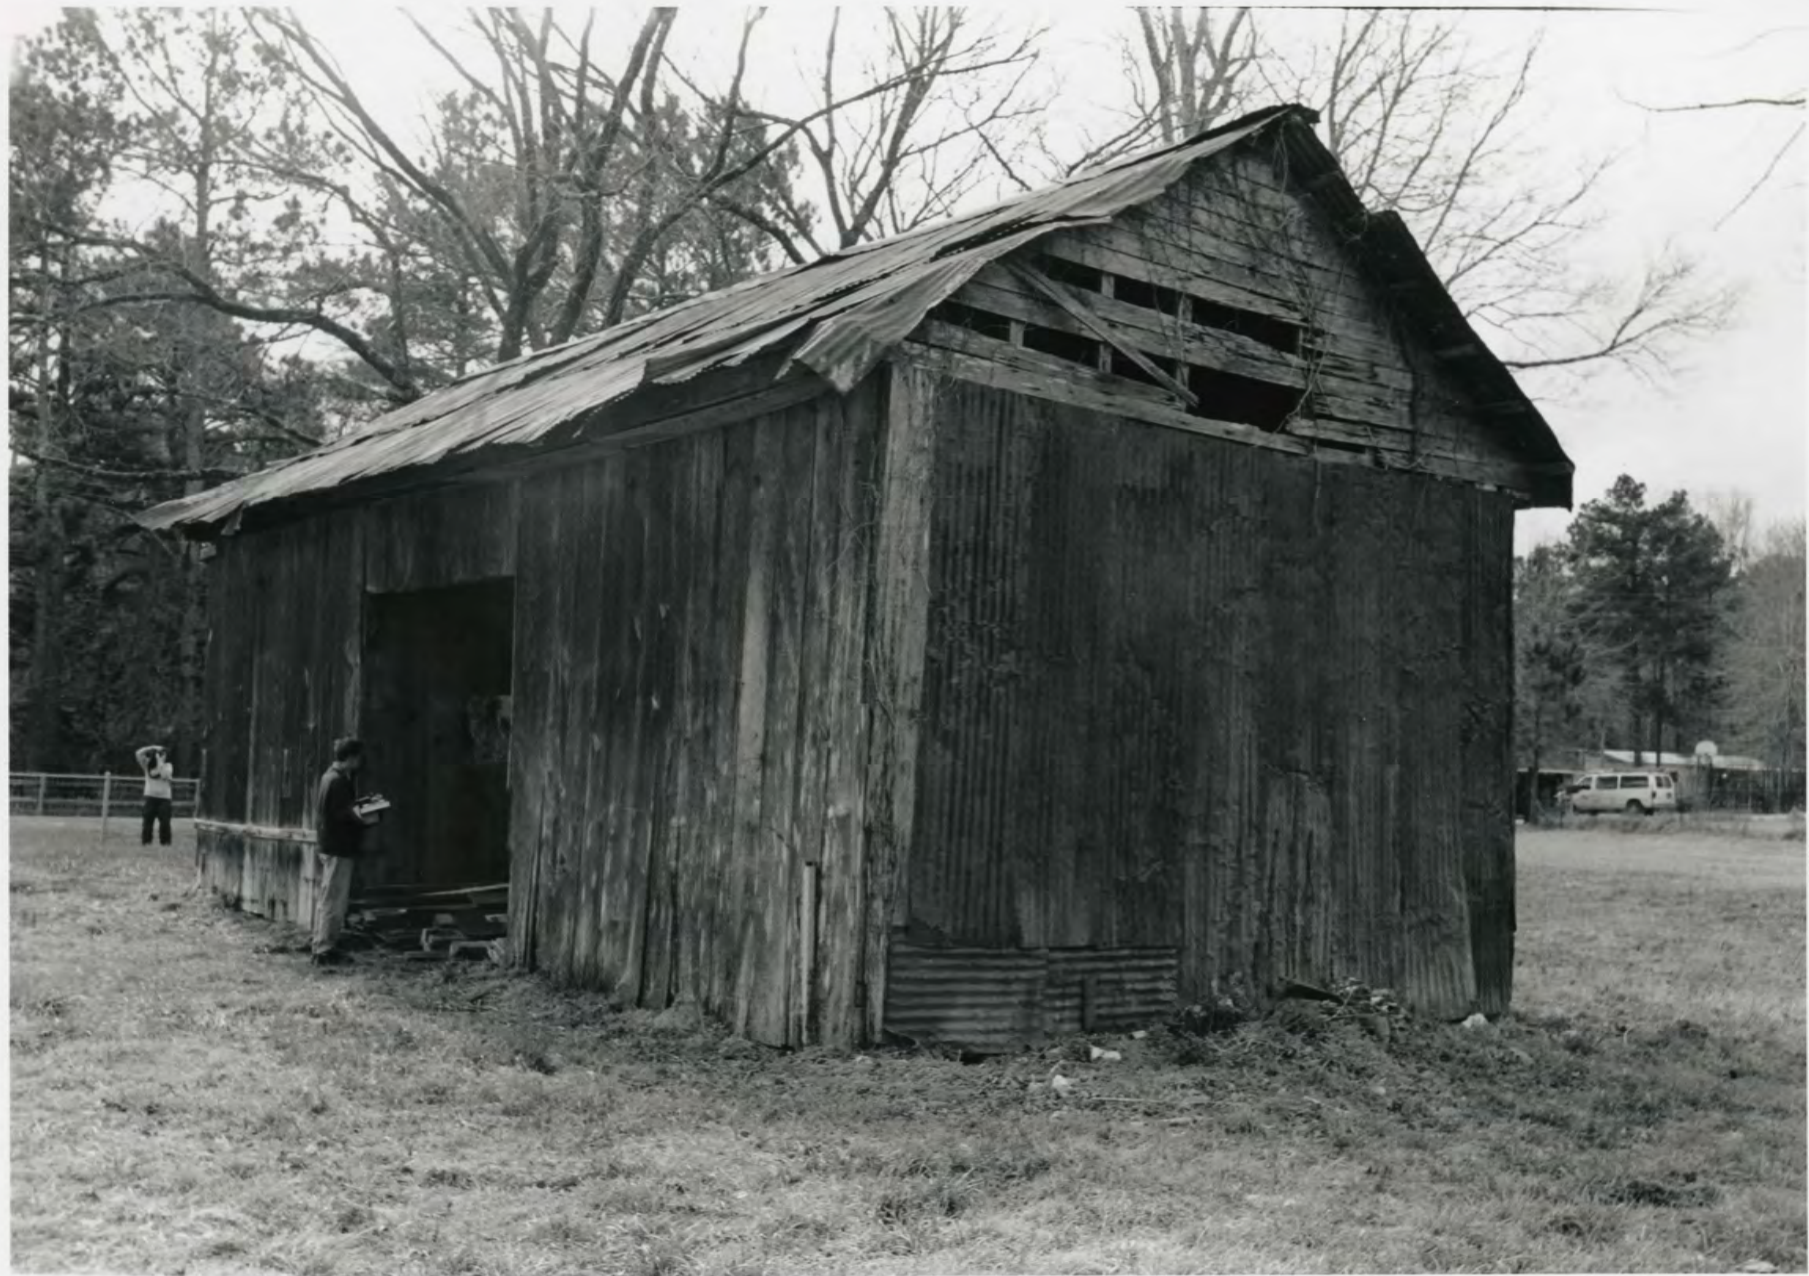
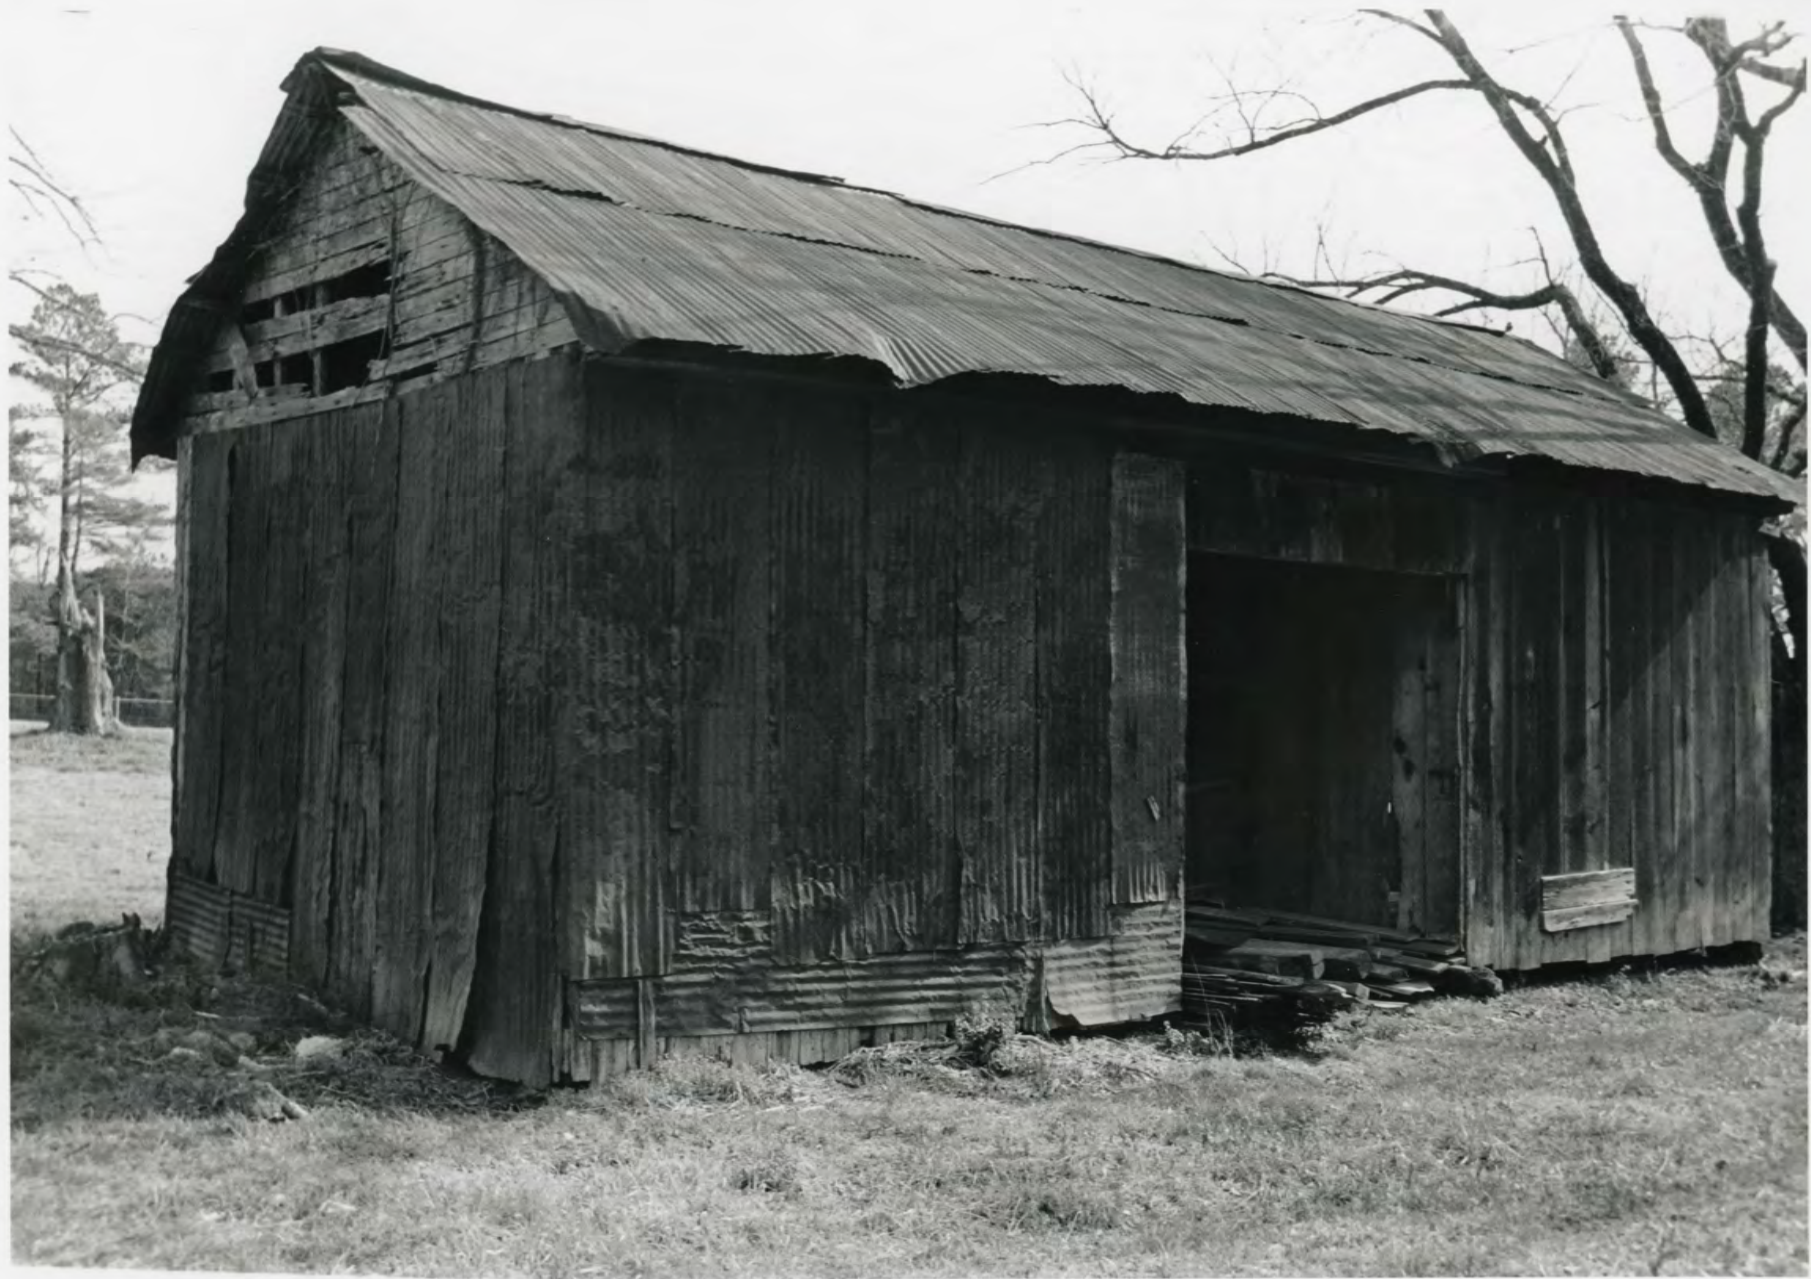
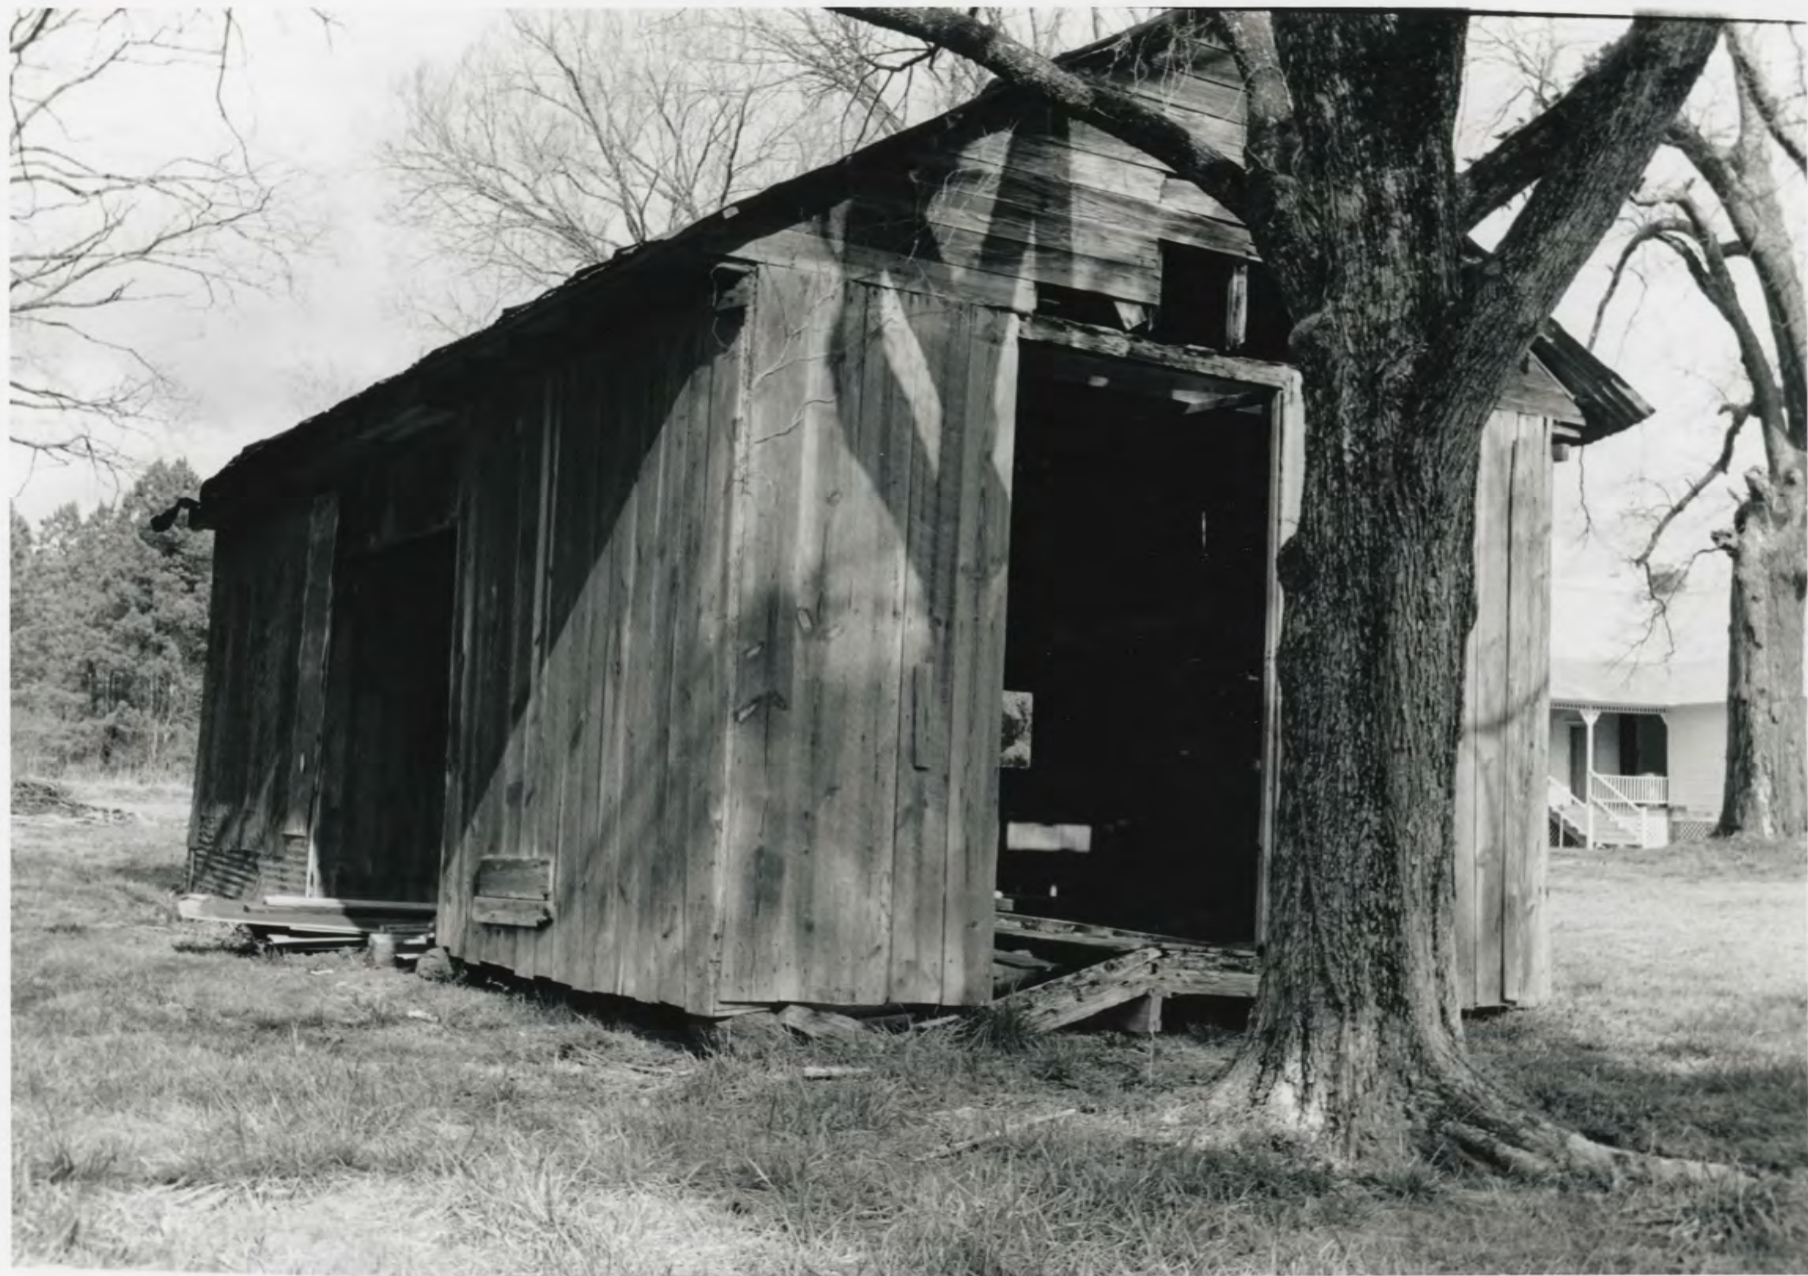
1. Hickman House
2. Ouachita County, AR
3. Sarah Jampole
4. January 15, 2005
5. Arkansas Historic Preservation Program
6. Barn, south elevation & east facade, looking  
Northwest
7. #12

1. Hickman House
2. Ouachita County, AR
3. Sarah Jumper
4. January 15, 2005
5. Arkansas Historic Preservation Program
6. East elevation, north facade, looking southward  
Barn
7. #13

1. Hickman House
2. Ouachita County, AR
3. Sarah Jampole
4. January 15, 2005
5. Arkansas Historic Preservation Program
6. North elevation & west facade, looking south-  
east  
Bern
7. #14

1. Hickman House
2. Ouachita County, AR
3. Sarah Jumper
4. January 15, 2005
5. Arkansas Historic Preservation Program
6. West elevation; south facade, looking  
NEARNEAS  
Barn
7. #15

The rough plank barn is located 150 feet southwest of the house. It is an end gabled, double-pen structure with a corrugated metal roof. The "dogtrot" is earth-floored, but the "rooms" have raised wooden floors such as would be needed for a corn crib or other structure intended for food storage. Old timers recall onetime sheds along the south and east wall. The dogtrot runs east to west, with no fenestration or door openings on both the east and west elevations. No opening is evident on the north elevation, while the south elevation provides an opening into the south pen of the barn. This opening, however, is not intentional, as it appears to have been created by deterioration over time. The main, intended, access into the north and south pens, is located under the dogtrot. The north pen is accessed by a single, centrally-located door, as is the south pen. The small window is located just to the left of the door leading into the south pen.
