National Register of Historic Places Registration Form

historic name Hayden Co-Operative Elevator Company

street & number 198 East Lincoln Avenue

city or town Hayden

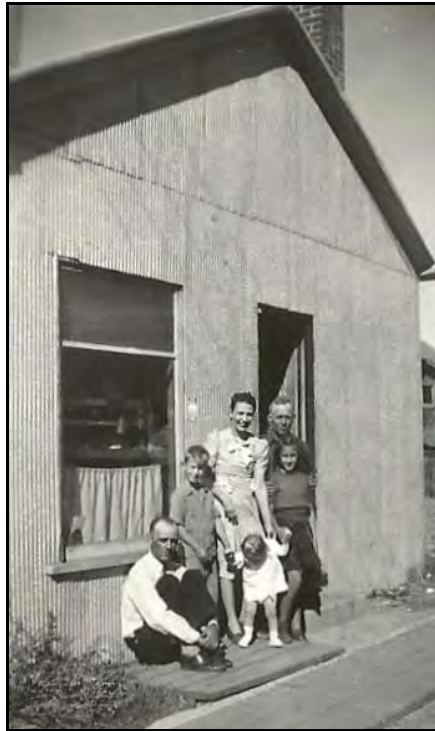
Figure 001-b

Grandbouche family in front of 1917 grain elevator scale house and sales office, 1942. Left to right: unknown, Gordon Grandbouche, Elva Grandbouche, Steve Grandbouche, Lester Grandbouche, and Elva Grandbouche.

The 1917 grain elevator originally had a hand-operated balance scale (figure 001 – seen through 1917 scale house and sales office window at left of photo) with an exterior deck located directly in front of the 1917 scale house and sales office and about 20' in length. This scale was upgraded to the current electronic scale, a Fairbanks-Morse Spring-less, in 1953 (photo 019). Located immediately to the south of the 1952 scale house and sales office, the current exterior concrete deck is 50' in length and can hold a capacity of up to 95,000 lbs (photo 020, figure 003). Trucks loaded with grain drove onto the exterior concrete deck headed east, weighed, drove around through the drive-through dump headed west from the east entrance, dumped their grain, then drove out the west end and circled back to the deck in an eastward direction to weigh a second time. The Fairbanks-Morse Spring-less scale placed in the bay window of the 1952 scale house and sales office, has two faces that can be read by the farmer through the picture window and by the grain elevator manager inside the scale house (photos 007 and 019). The Fairbanks Company has manufactured scales since 1830 when Thaddeus Fairbanks designed and patented his first scale. In 1916, Charles H. Morse, a Fairbanks employee, acquired control of the company. In addition to the manufacturing and distributing of scales, the Fairbanks-Morse company also produced diesel engines, electric engines, and pumps for industrial use. In 1958, Fairbanks-Morse merged with Penn-Texas and was renamed Fairbanks-Whitney.⁴

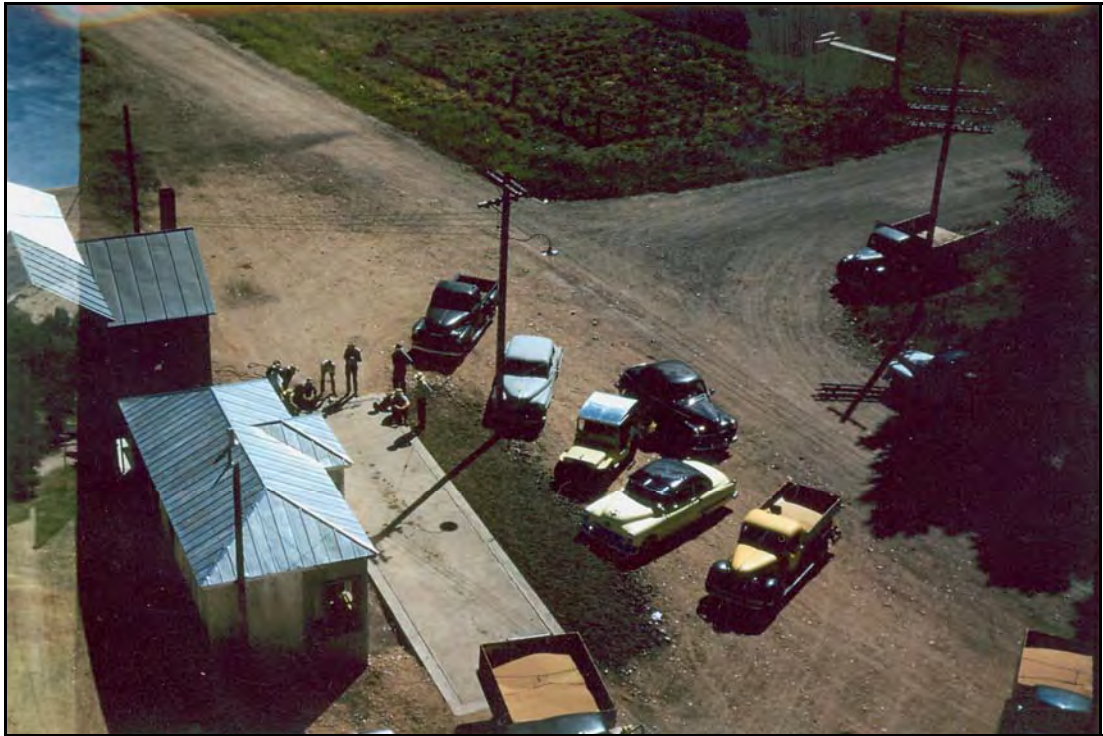
Figure 003

View of scale house and sales office and exterior concrete deck, circa 1953. (Courtesy: Tammie Delaney personal files, Hayden, CO)

Electronic Scale and Concrete Deck, 1953 (photos 007, 019 and 020, figures 001 and 003)

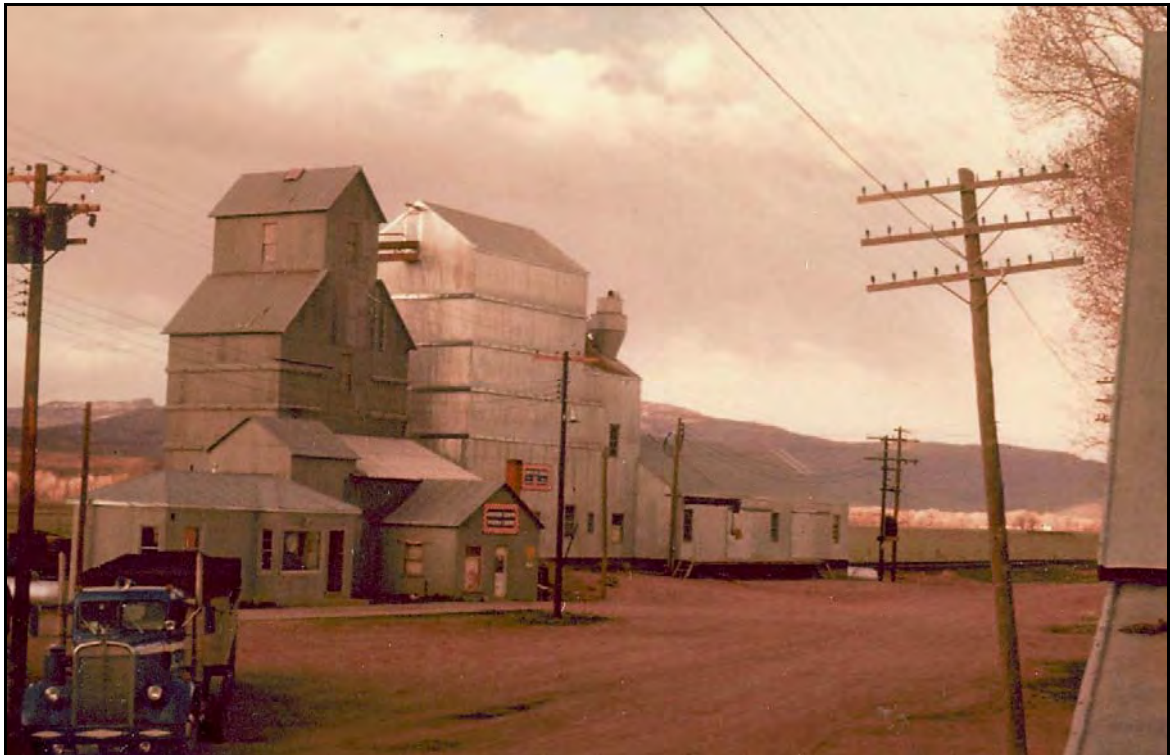
Figure 004

Hayden Grain Elevator shortly after construction of the pellet mill and half of the processing plant, camera facing northeast, circa 1955. (Courtesy: Tammie Delaney personal files, Hayden, CO)

Main Grain Elevator Complex, 1917, 1952, 1955-56, 1974-circa 1995 (photos 001-014; figures 001, 003 and 004)

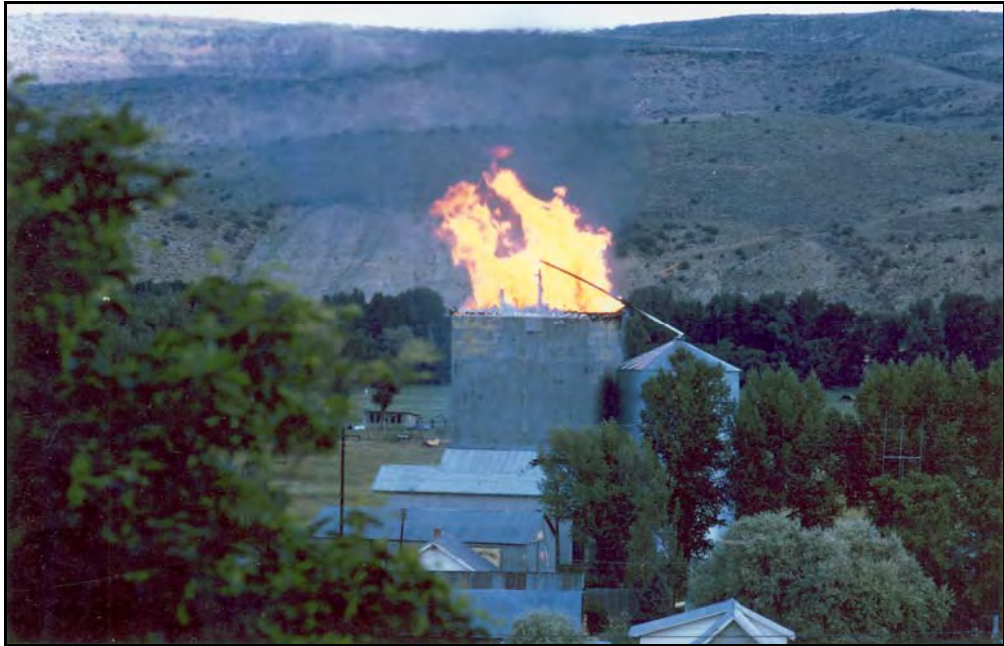
Figure 005

Fire at circa 1950 grain elevator, camera facing north, August 1972. (Courtesy: Tammie Delaney personal files, Hayden, CO)

Grain Storage Bin and Elevator Complex, 1968-73 (photos 015 and 016, figures 002, 005 and 006)

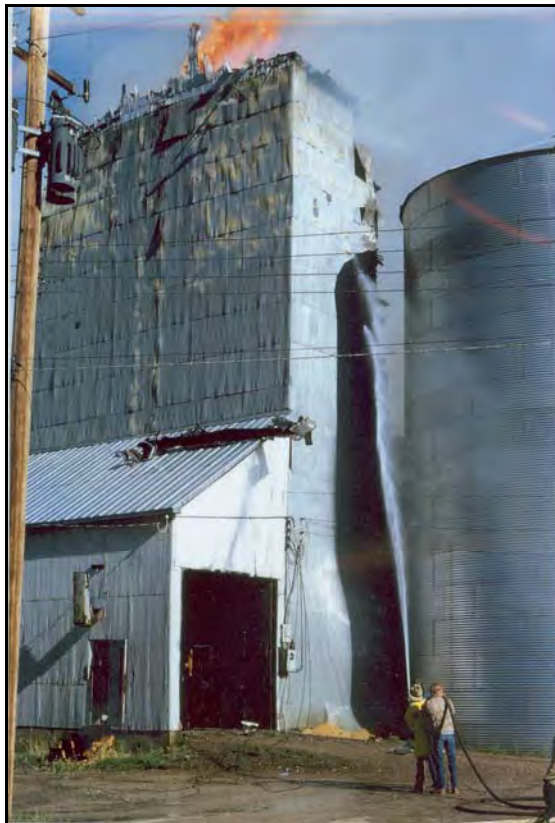
Figure 006

Fire at circa 1950 grain elevator, camera facing northwest, August 1972. (Courtesy: Tammie Delaney personal files, Hayden, CO)
