# National Register of Historic Places Continuation Sheet

Property Name: Brownsville City Hall and Market House

1. Name of Property	DECE VIE
Historic Name: Brownsville City Hall and Market House Other name/site number: City Market House, Brownsville City Hall Name of related multiple property listing: NA	AUG 1 6 2019

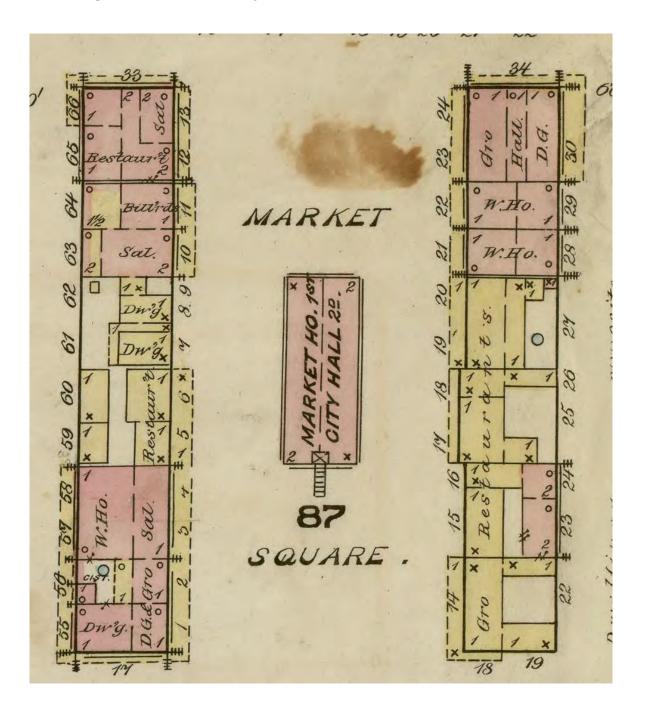
1877. The earliest Sanborn map features Market Square in the configuration that was in place after the Hurricane of 1867, with the second floor quite diminished from the original 1852 design. A hipped roof of moderate height had replaced the full Border Brick-style upper walls and parapet. Access by a precarious wooden stairway to the City Hall chambers remained up until the 1912 remodeling.

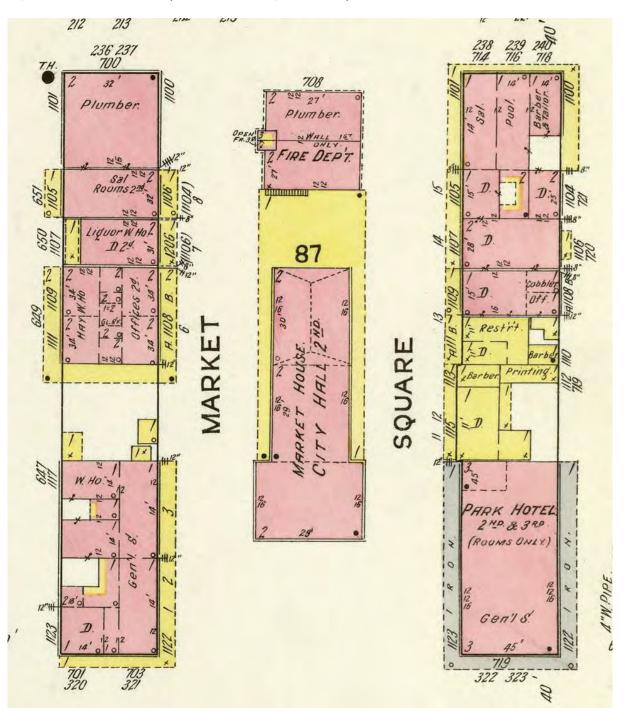
1914. Dramatic change as a result of the 1912 Mayor Kowalski re-make, which started with the 1908 construction of the firehouse at the north end and culminated with a substantial build-out of a complete second floor, plus an expansion of city offices on the south end. Concerning the firehouse, The noted occupant of the north half of that bottom plant conflicts somewhat with oral tradition in that, for a brief period it was apparently occupied by a "plumber", then it was a restaurant (The Texas Lunch, 1914-1997).

The Market House was expanded with the construction of a freestanding, two-story brick fire department building in 1908-09, and then with the reconstruction and expansion of the 1852 building in 1911-12 under architect-builder A. Goldammer. The building housed professional fire-fighting staff, but not any fire-fighting vehicles.<sup>14</sup> The west half of the building's ground-floor space, abutting E. 11th Street, was a commercial lease space. The 1914 Sanborn map

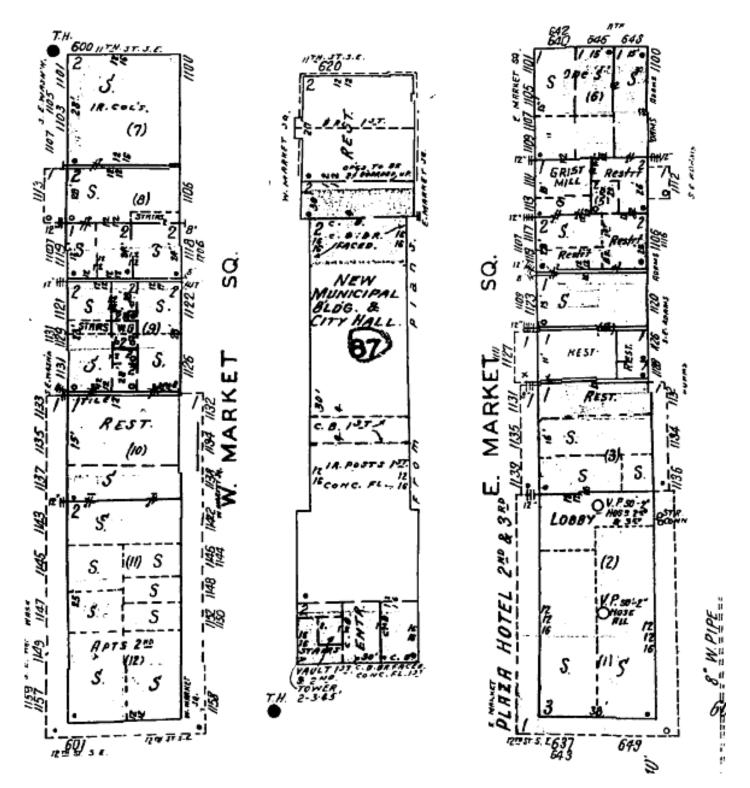
# 1930-1957

Same as current footprint Note the enclosed stairwells (in blue), constructed in 1949.

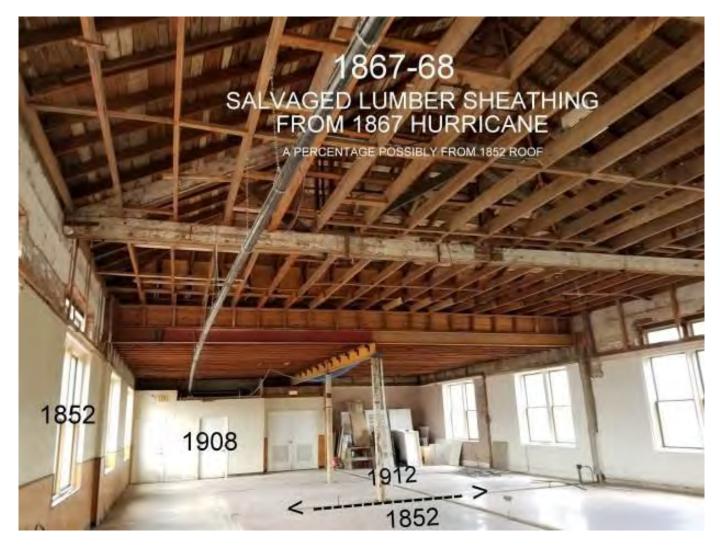
Selective interior demolition of 2018. A rare opportunity to observe the successive stages of structural composition

No structural alterations have been applied from the time of the 1949 re-make/addition to present. The selective demolition that was undertaken was sensitive to original hard wall preservation. Interestingly enough, with the subceiling having been removed during this phase of the restoration process, the original roof construction is clearly exposed and reveals an interesting account of piecemeal lumber and beam usage that stems back to the 1851 period of original construction. The plank sheathing of the roof section over the Market Hall is especially interesting, in its mosaic composition of lumber that was obviously salvaged from the Great Hurricane of 1867. The rafter beams are

astounding in their magnitude. The same is true with the various locations which openly reveal masonry appointments. One can clearly observe the timelines of the four distinct construction eras (1850, 1867, 1912, 1949).
