Embassy Building No. 10/D.C. Dept. of Recreation

Headquarters

Washington, D.C.

Embassy Building No. 10/D.C. Dept. of Recreation
Headquarters
Washington, D.C.

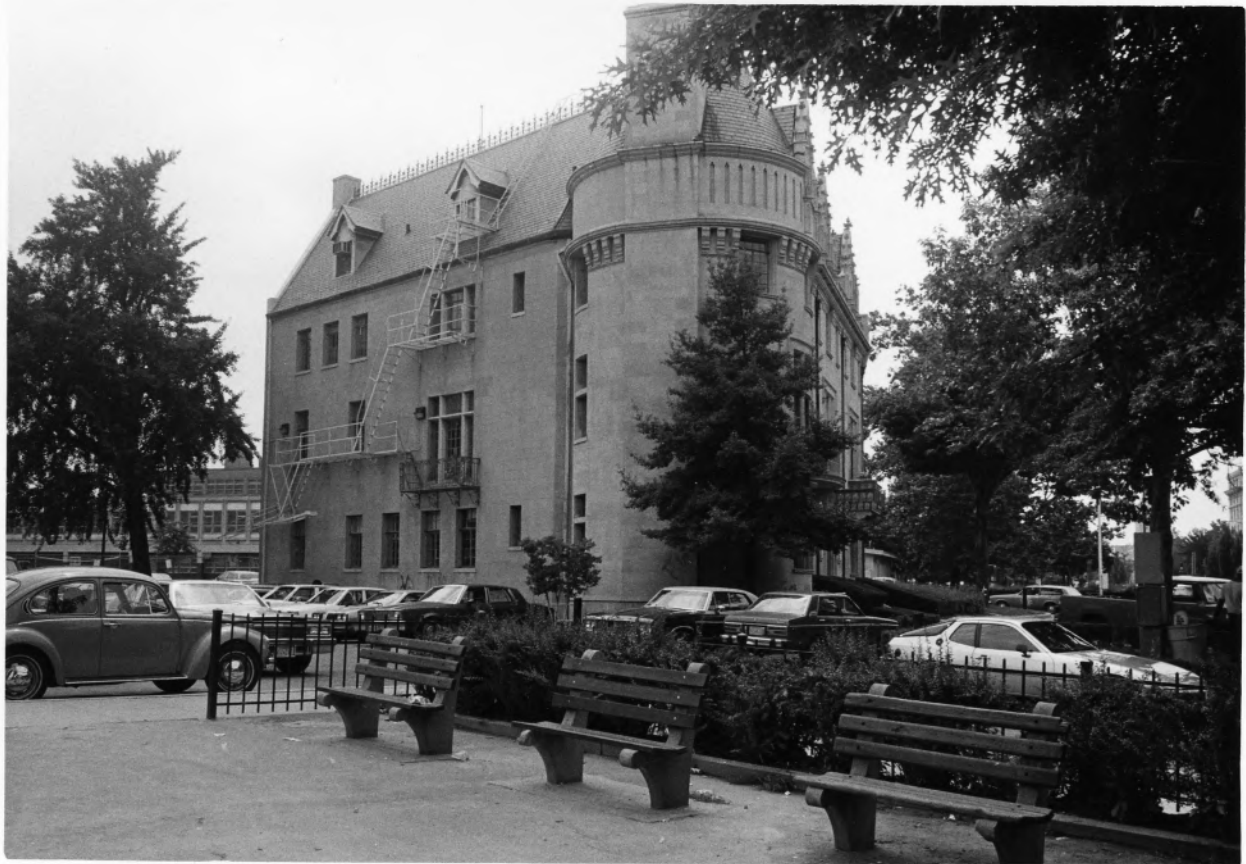
3 of 7

View facing south; door formerly between last 2 windows
on first floor has been filled in.

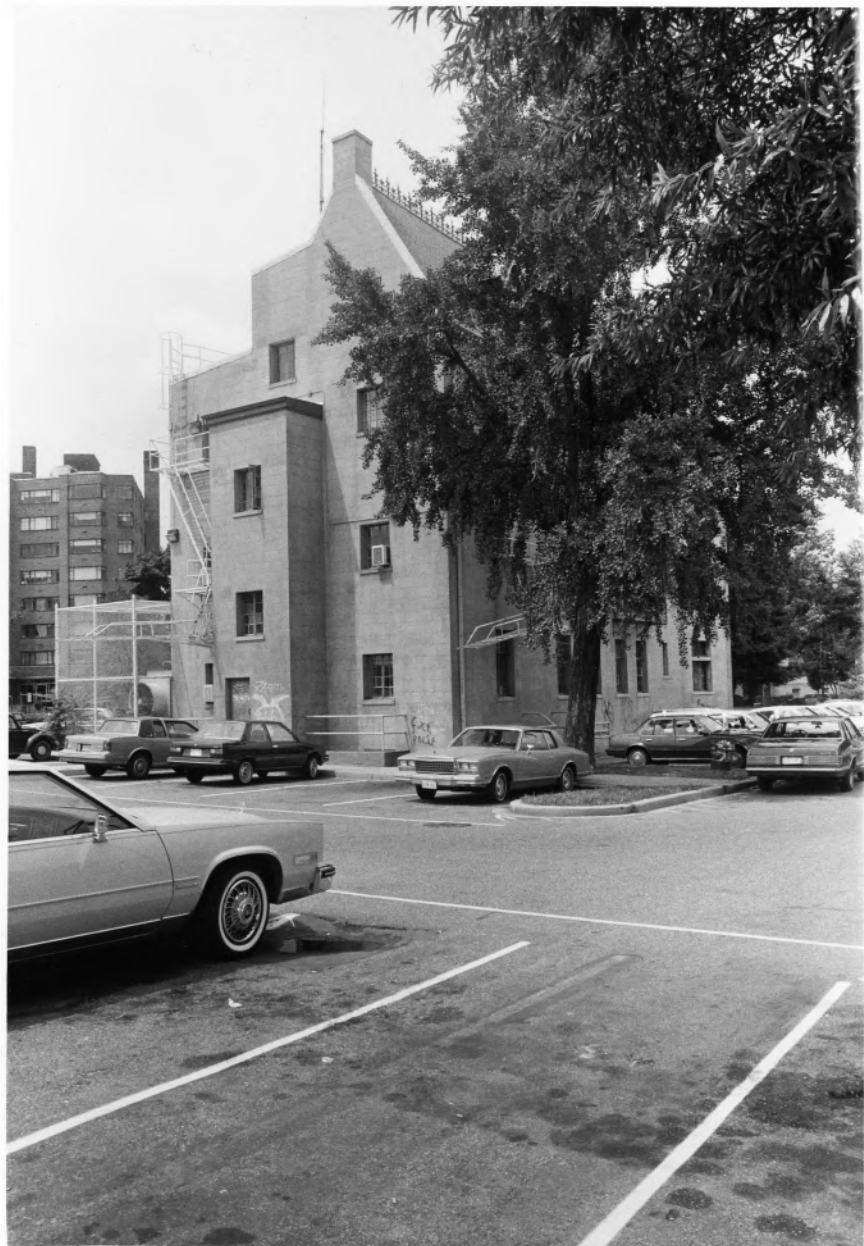
4 of 7

View facing west; note iron pipe railing on north
exterior wall leading to now-filled in doorway.

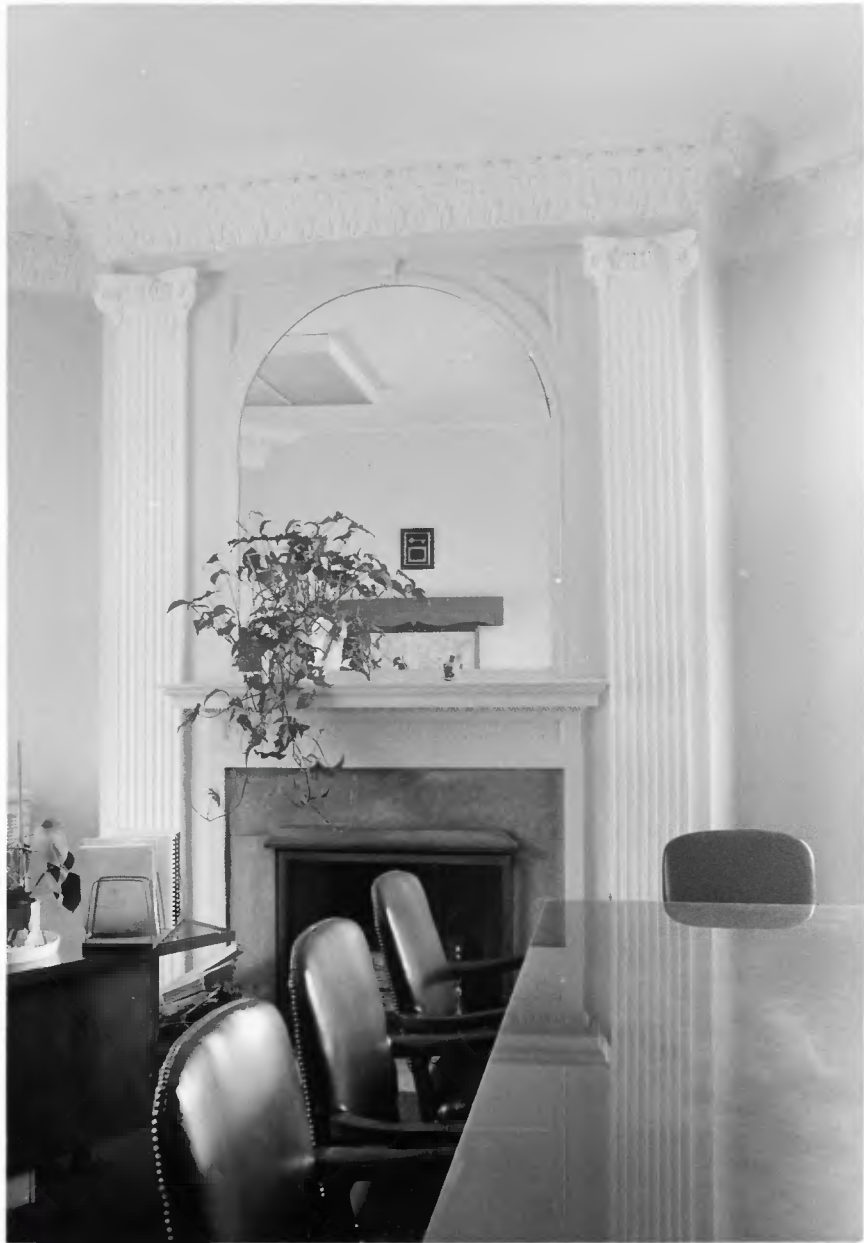
6 of 7

View facing north of office, 2nd floor, showing
decorative plaster molding and treatment of
fireplace.

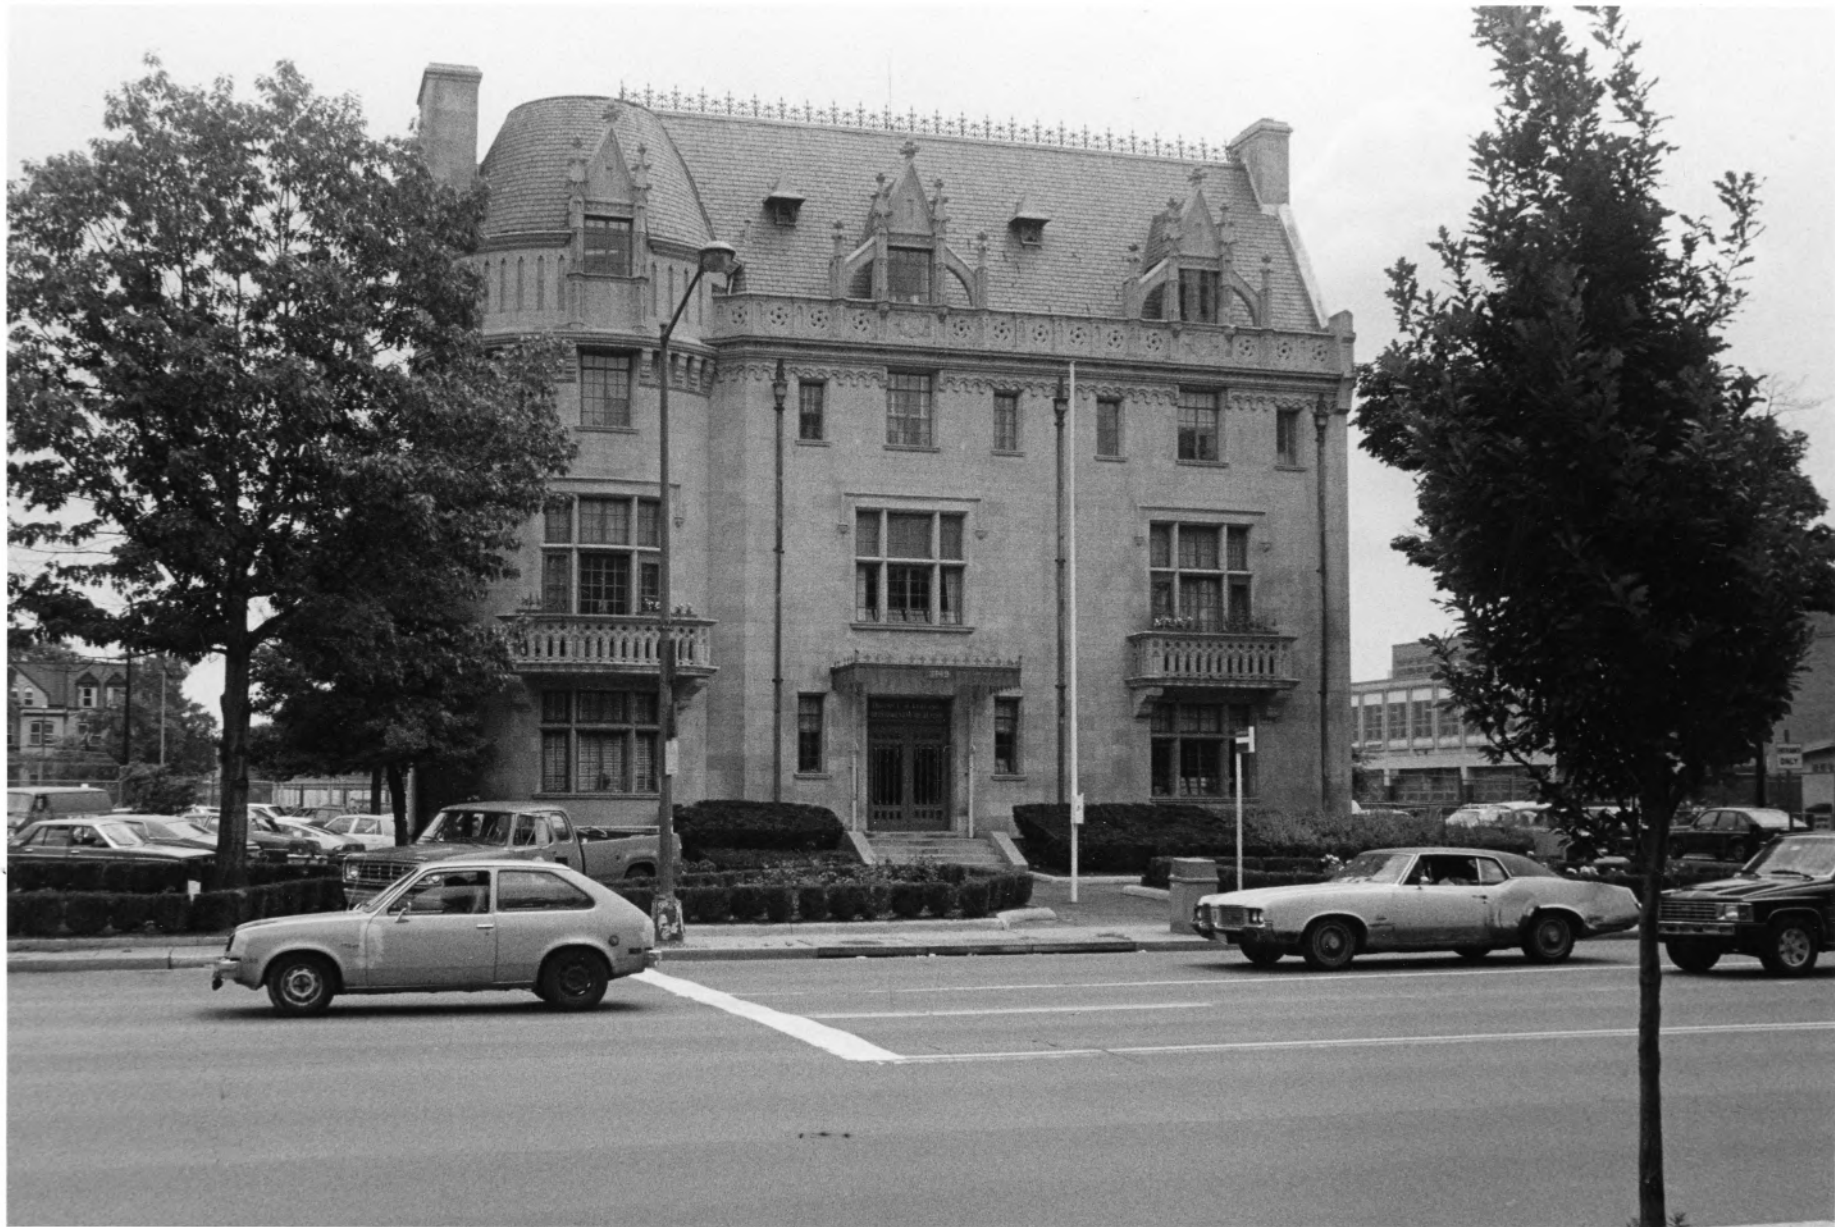
Facade, facing northeast, D.C.
Department of Recreation
Headquarters, 3149 16th Street,
N.W., Washington, D.C., 1985

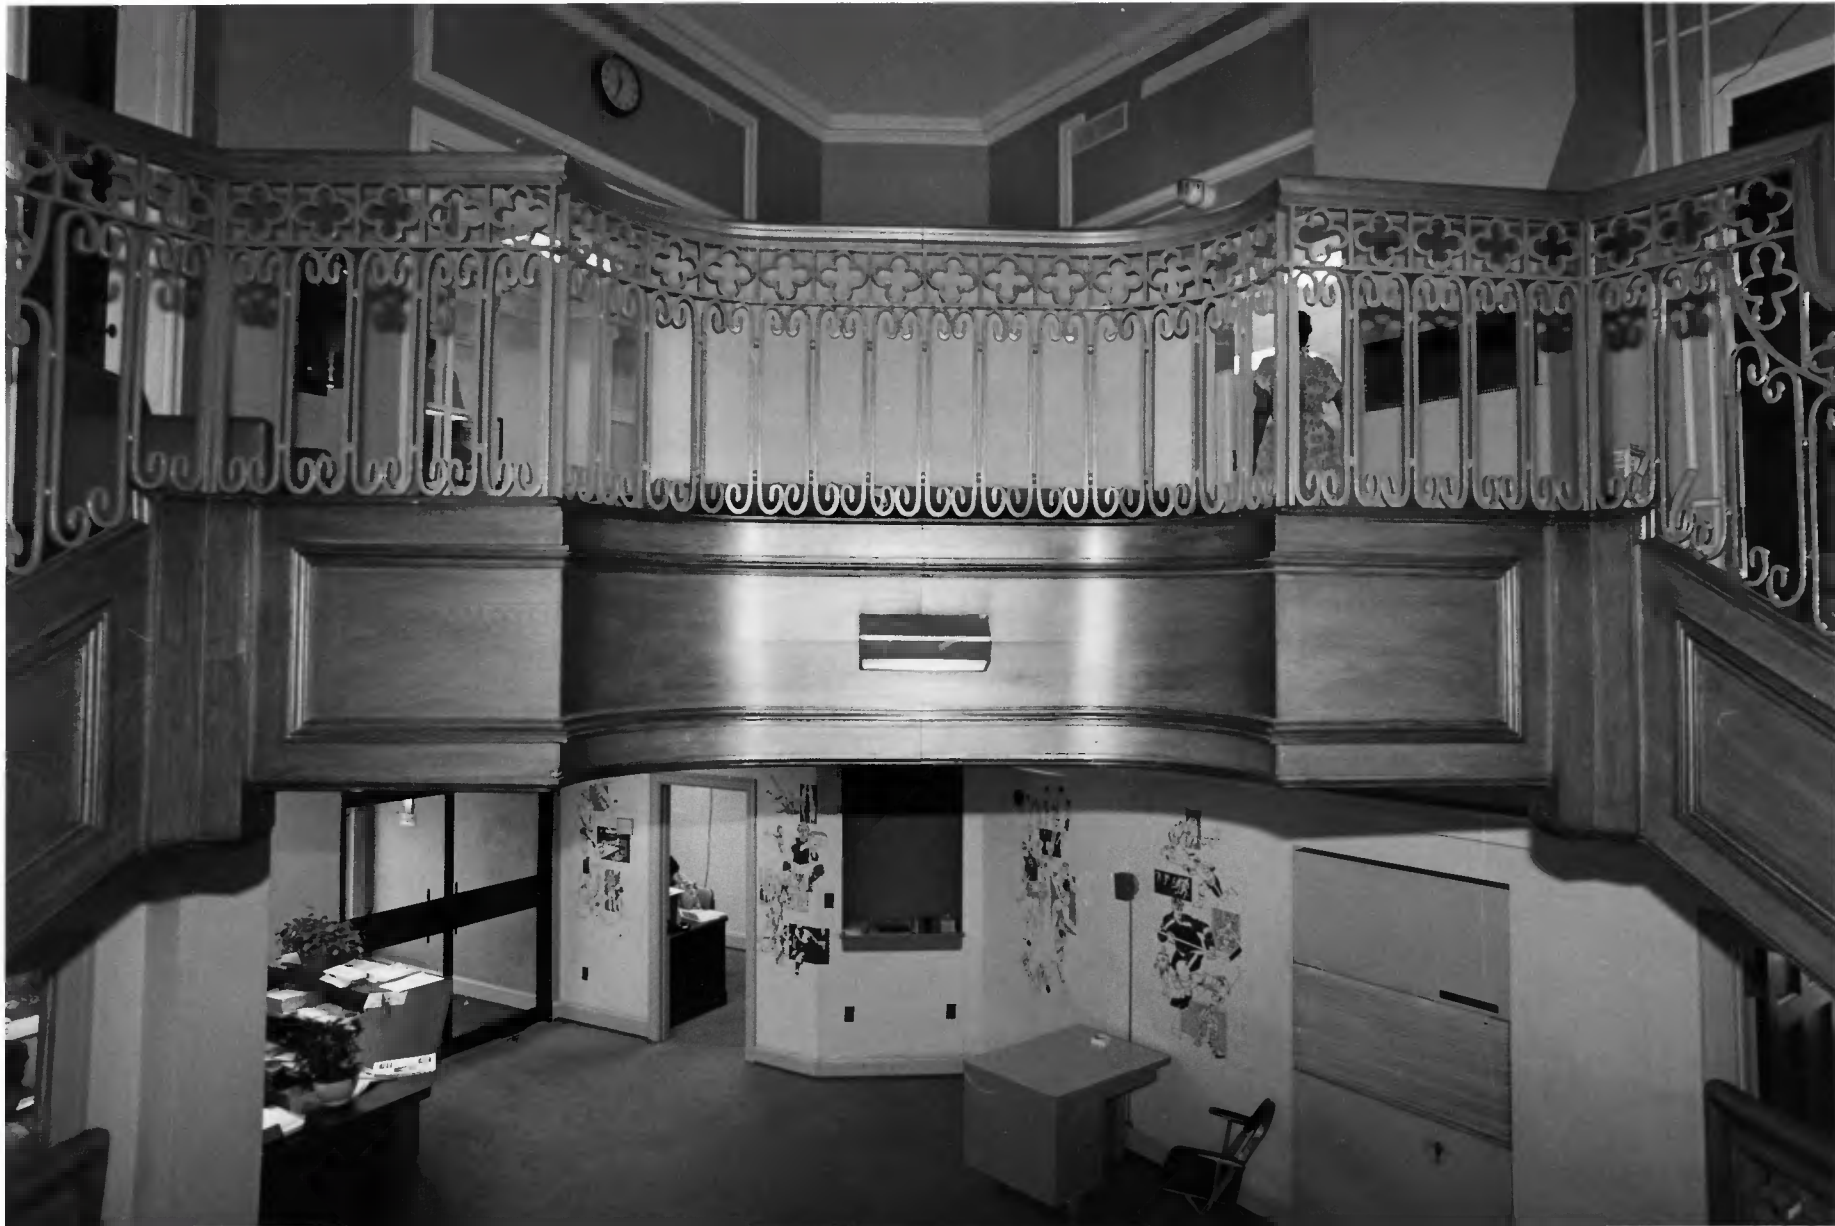
Decorative stair balustrade with
quatrefoil, D.C. Department of
Recreation, 3149 16th Street,
N.W. Washington, D.C., 1985

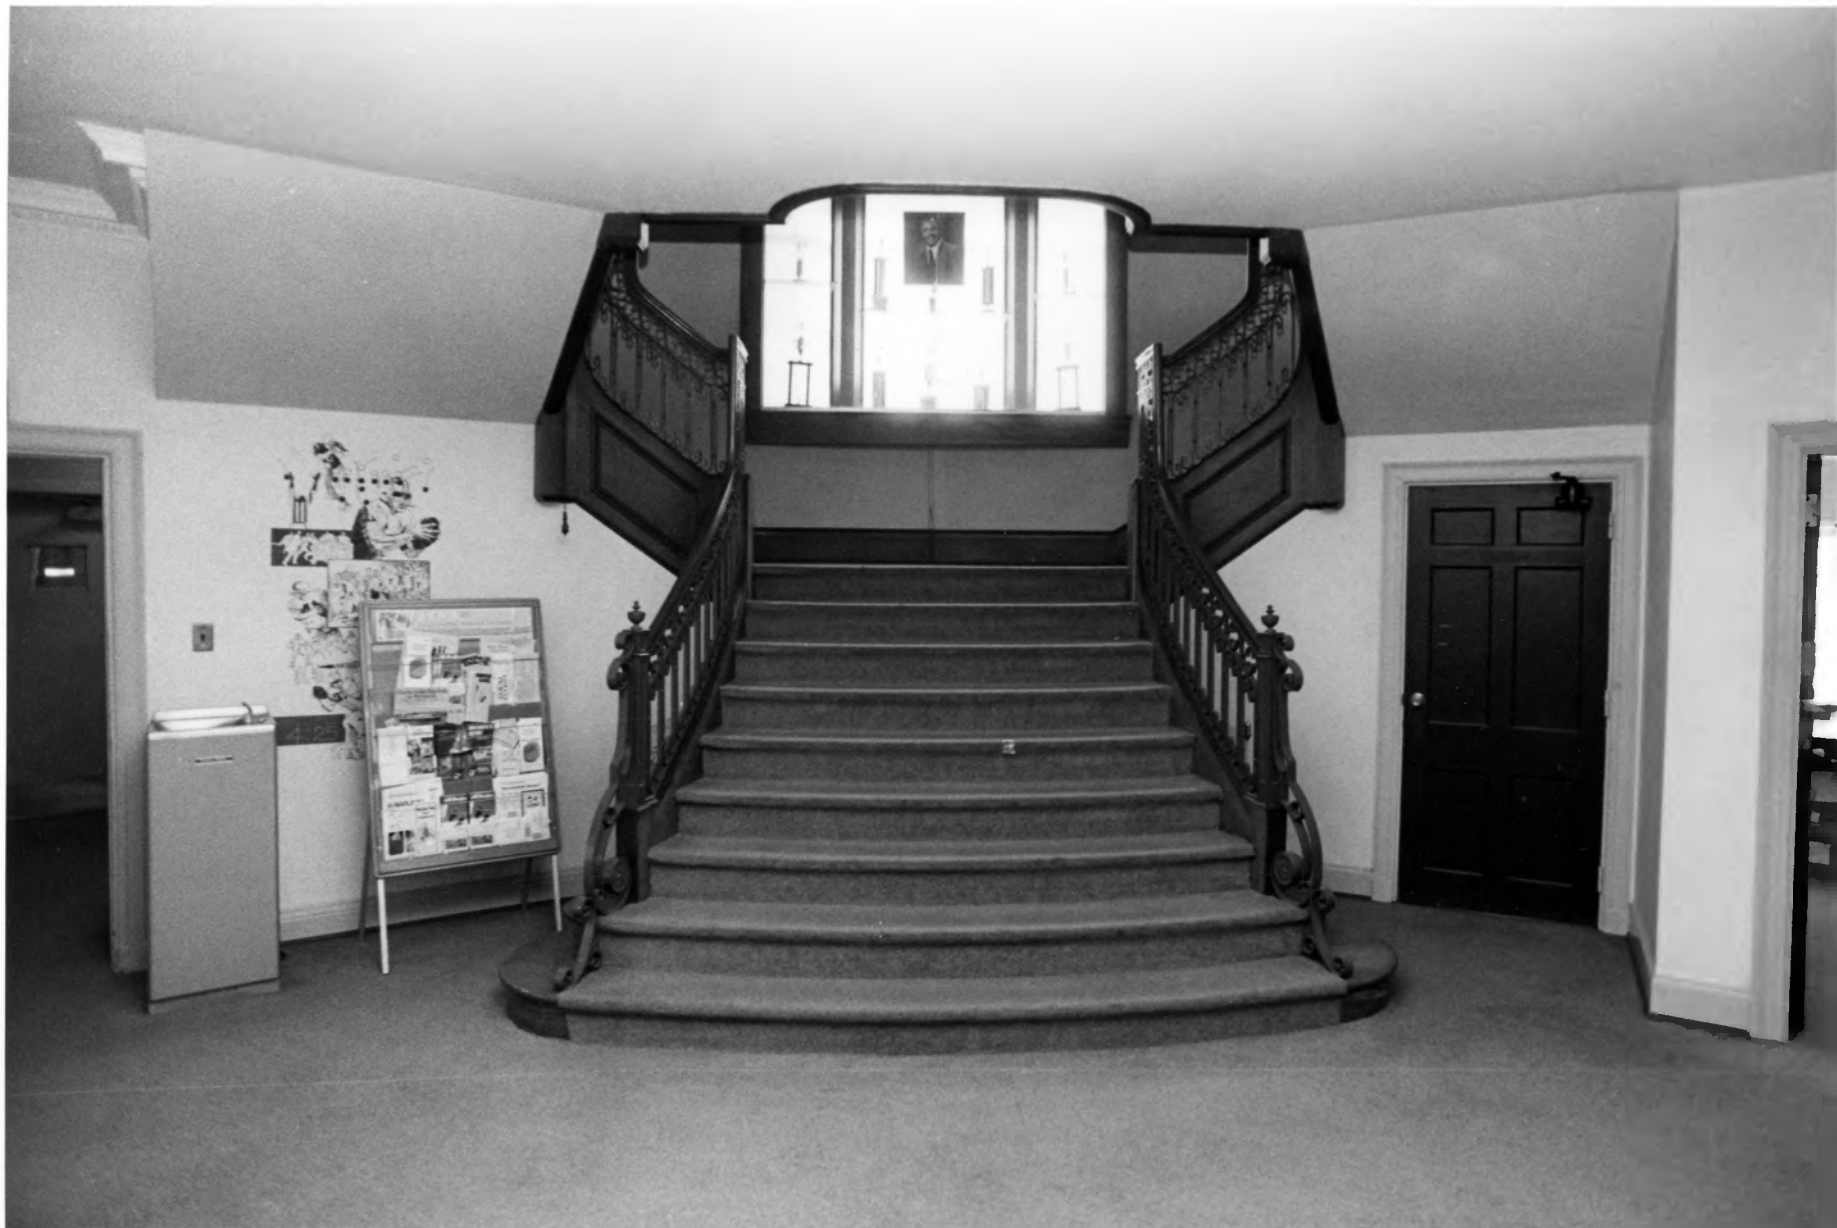
Curved entrance stairway with decorative balustrade, D.C. Department of Recreation 3149 16th Street, N.W., Washington, D.C., 1985.

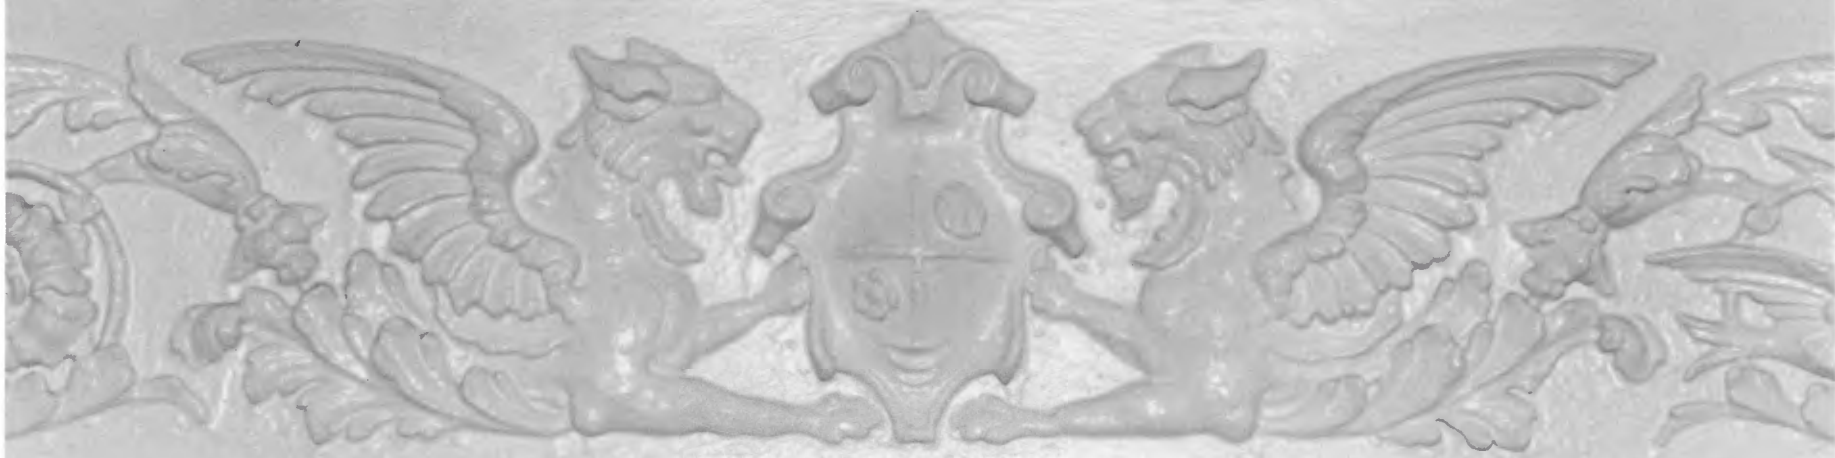
Faux coat of arms with griffins
attopped by egg and dart molding,
first floor front left office
fireplace, D.C. Department of
Recreation.

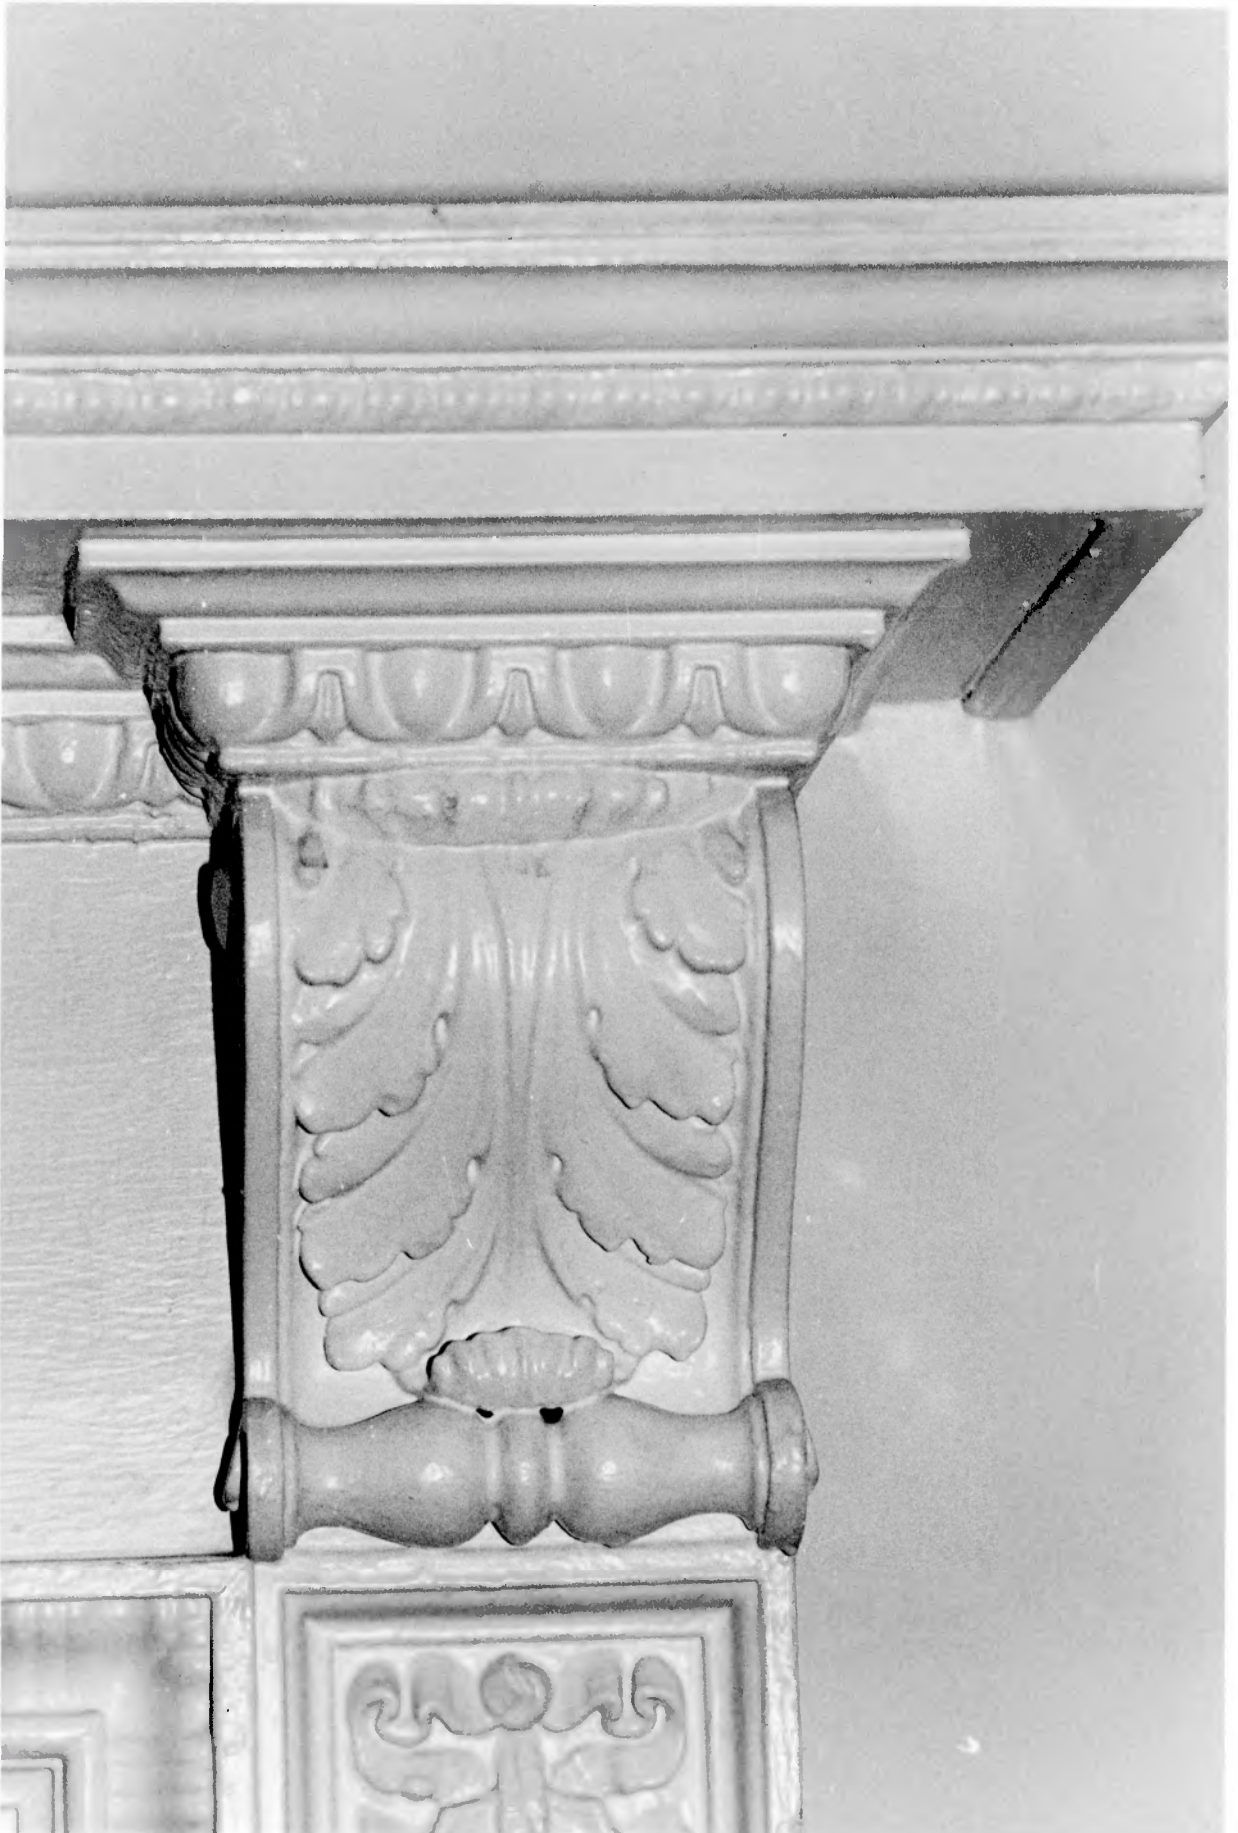
Decorative bracket with acanthus leaf and egg and dart molding, mantel with bead and reel molding, first floor front left office fireplace, D.C. Department of Recreation, 3149 16th Street, N.W., Washington, D.C., 1985.

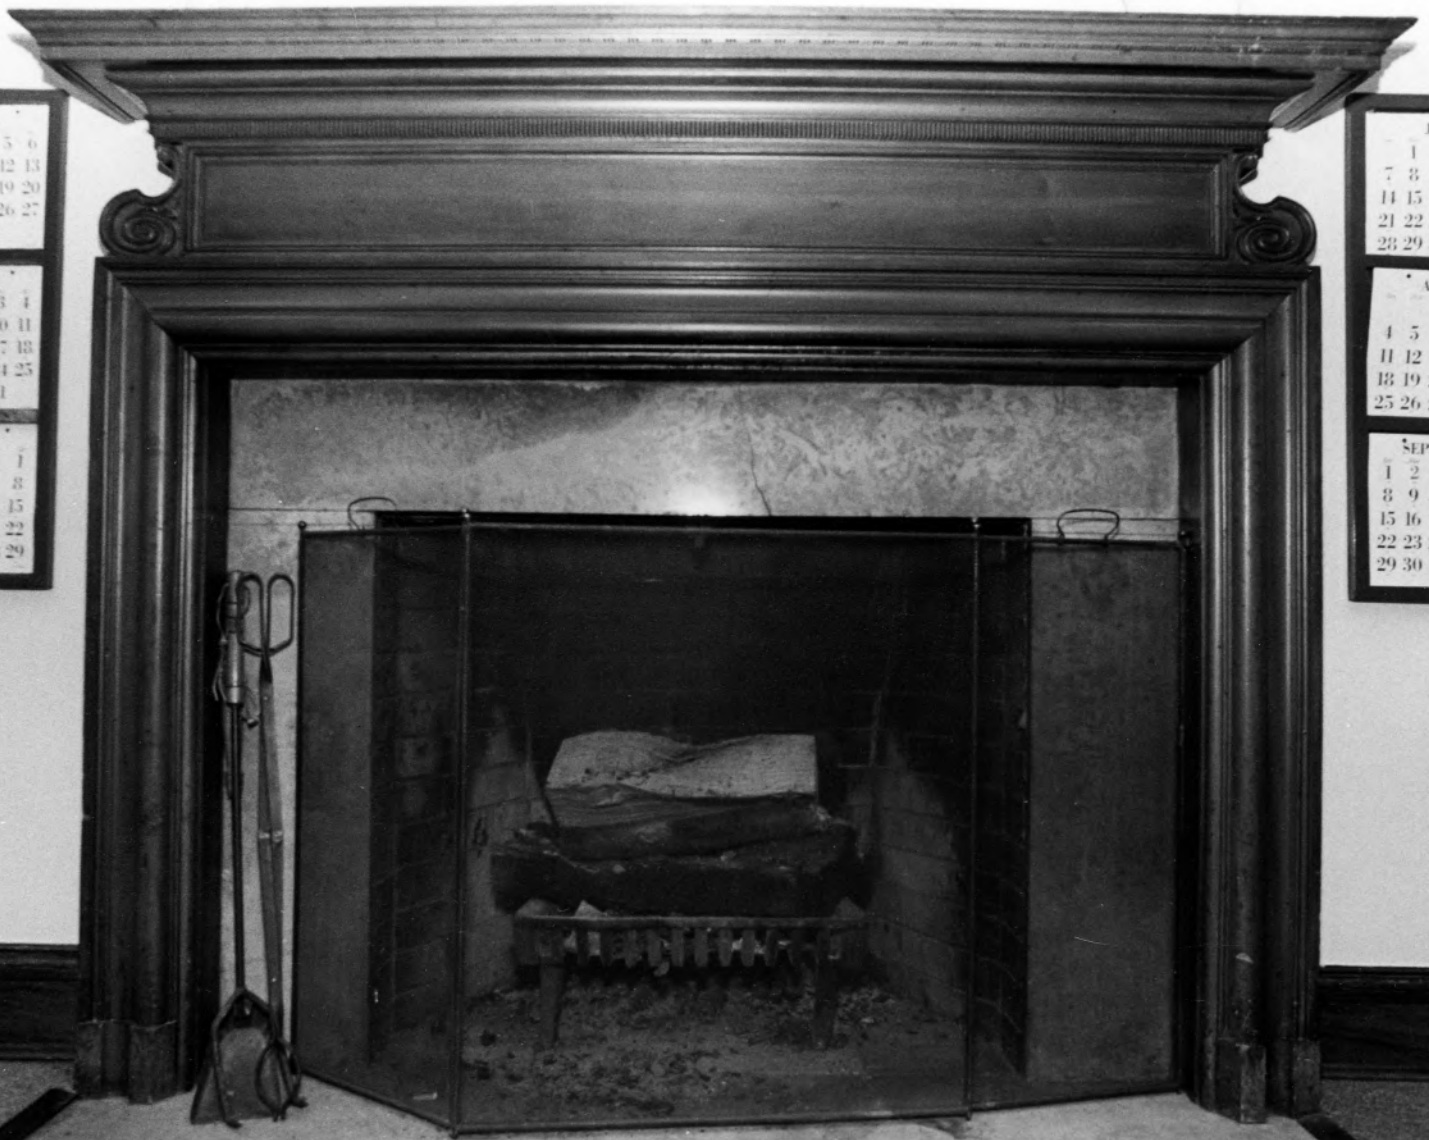
Mantelpiece, First floor, front
elevation, D.C. Department of
Recreation, 3149 16th St., N.W.
Washington, D.C., 1985.

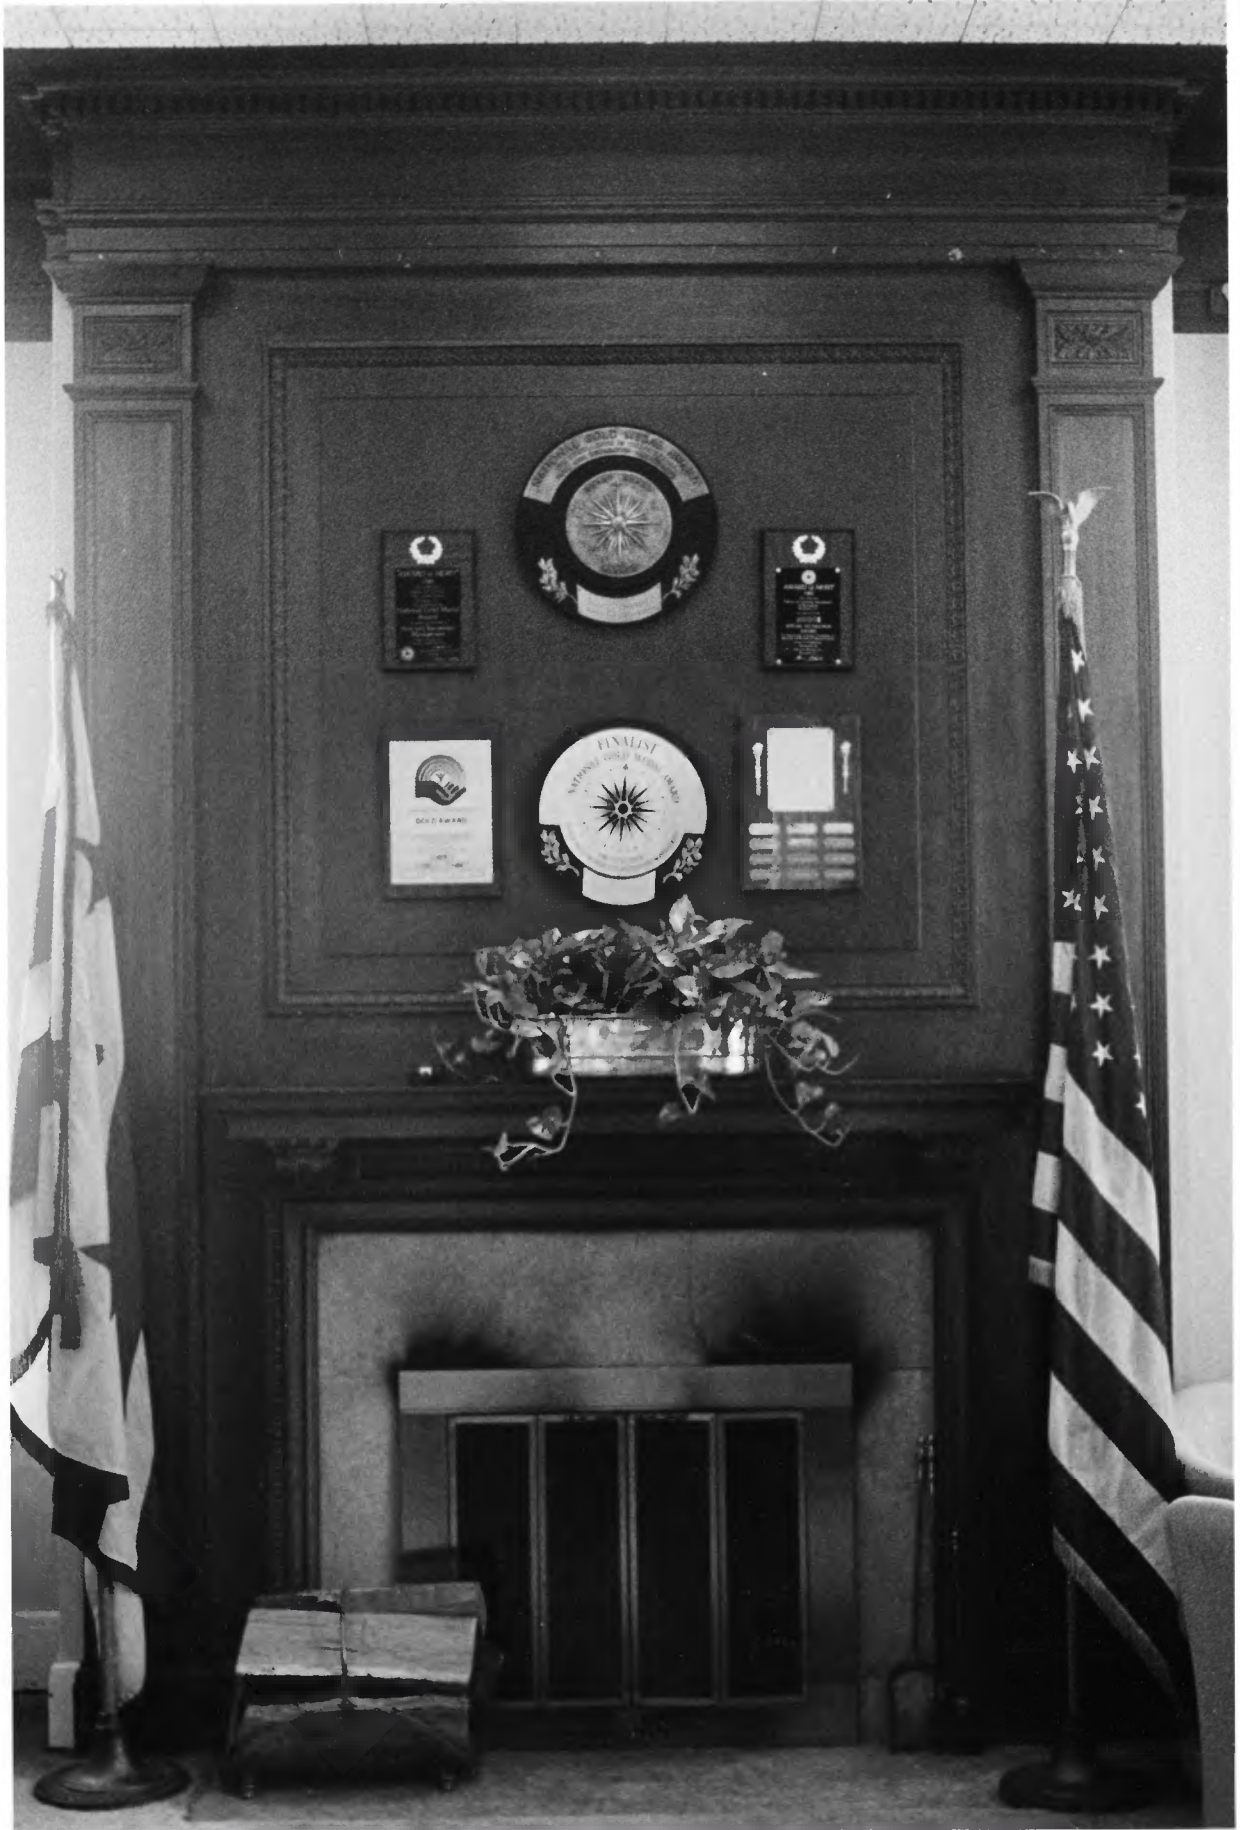
Details of fireplace, front
left second story office,
D.C. Department of Recreation
Headquarters, 3149 16th Street,
N.W., Washington, D.C., 1985
