National Register of Historic Places Registration Form

historic name Holland-Thompson Property

other names/site number Thompson House / 5GF.4774

city or town Carbondale

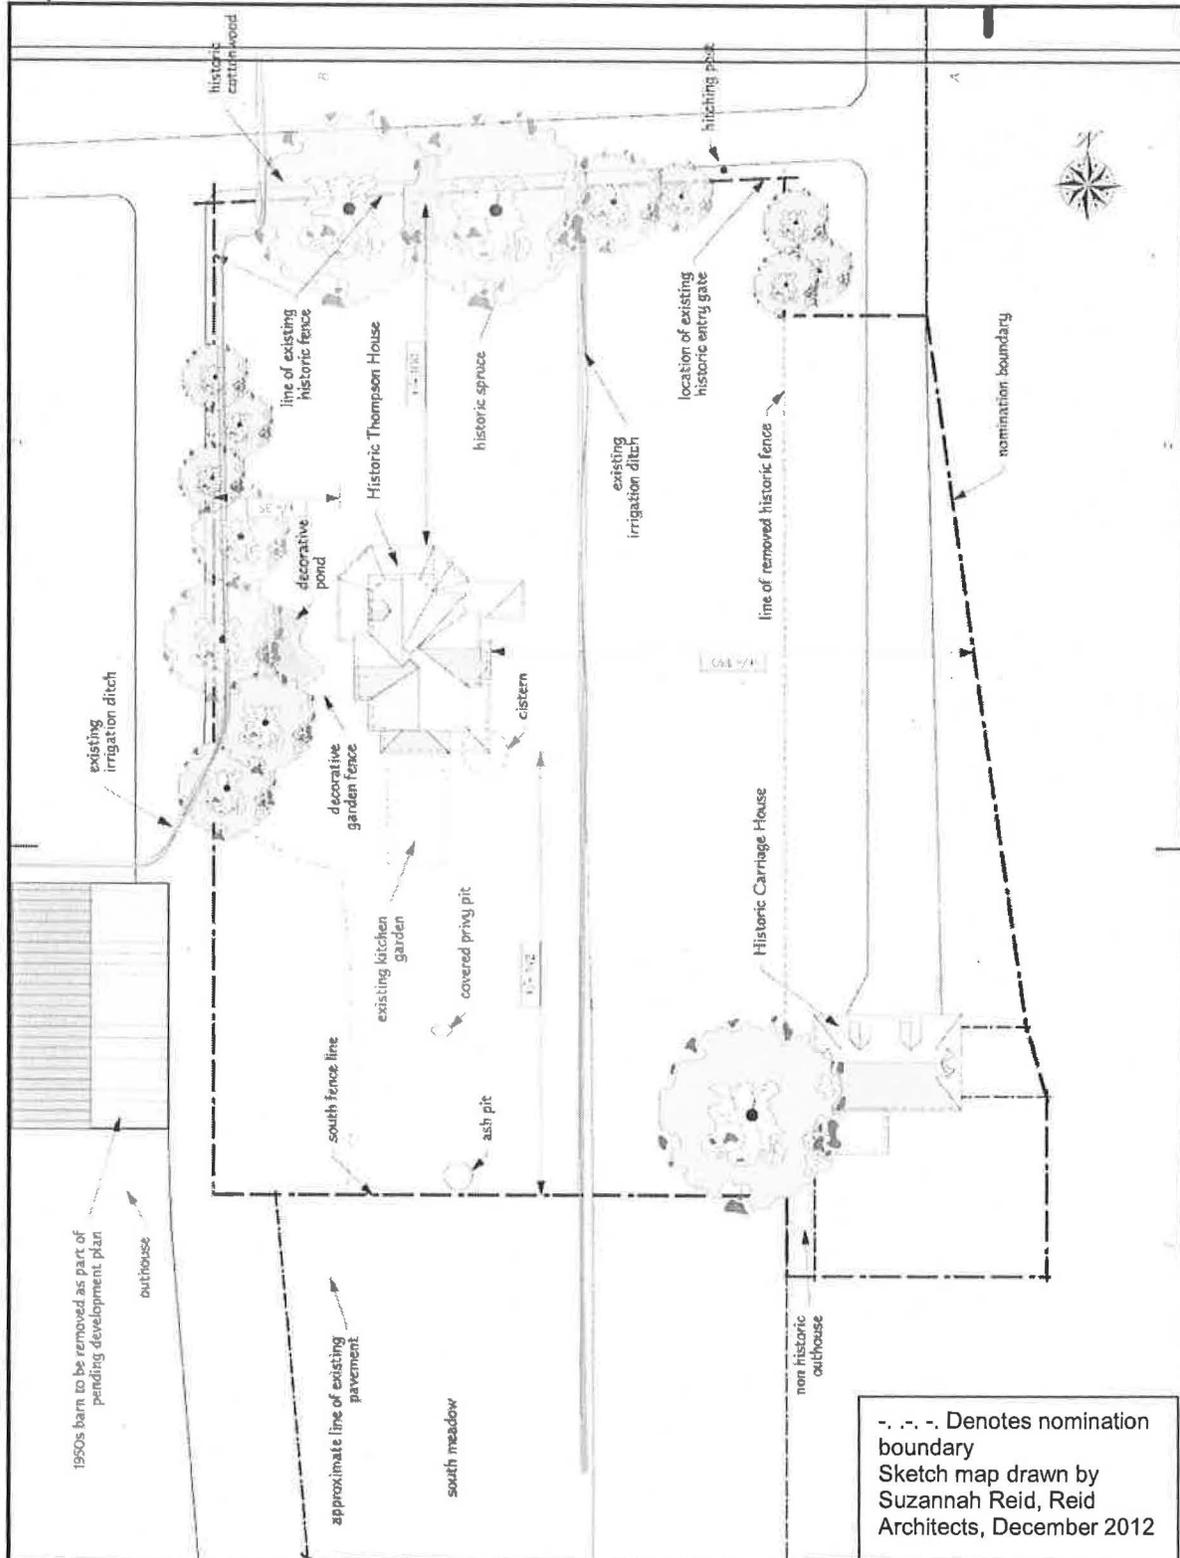
Sketch Map

The main house sits on a flat site, at the west side of a large manicured lawn. The lawn is approximately one acre and is bounded by gravel roads on the north, east and west sides. A circa 1990s wood plank fence defines the south edge. An additional one-half acre of wild grasses lies on the far side of the south fence line and abuts a residential street. A paved parking area exists to the southwest of the house, which connects to a paved lane that now accesses the property.

A concrete beehive shaped incinerator, or ash pit, is located along the south fence line at the rear of the house. Directly behind the back of the main house is a historic kitchen garden, measuring approximately 15' x 12'. Also, a covered privy pit exists between the back of the main house and the ash pit; while manicured lawn covers the pit covering, a small depression exists denoting the location of the pit. The west side yard has been decorated with a historic shallow pool and several garden structures, all dating to circa 1910 - 1920. The shallow pool is fed by a 3" wood pipe that is part of the original irrigation and domestic water system on the property.

The carriage house sits at the end of the gravel road bounding the east side of the yard. A historic wrought-iron fence encloses the north and west sides of the yard, the east fence line having been removed in the mid-twentieth century. The original gate is located on the northeast corner of the property is an original hitching post. The adjacent lots are sparsely developed in a typical rural pattern. Access to the property from the north side is from State Highway 133 and off a residential street on the south side. The surrounding large lots are in turn surrounded by denser residential development that was subdivided from the original ranch acreage in 1970.

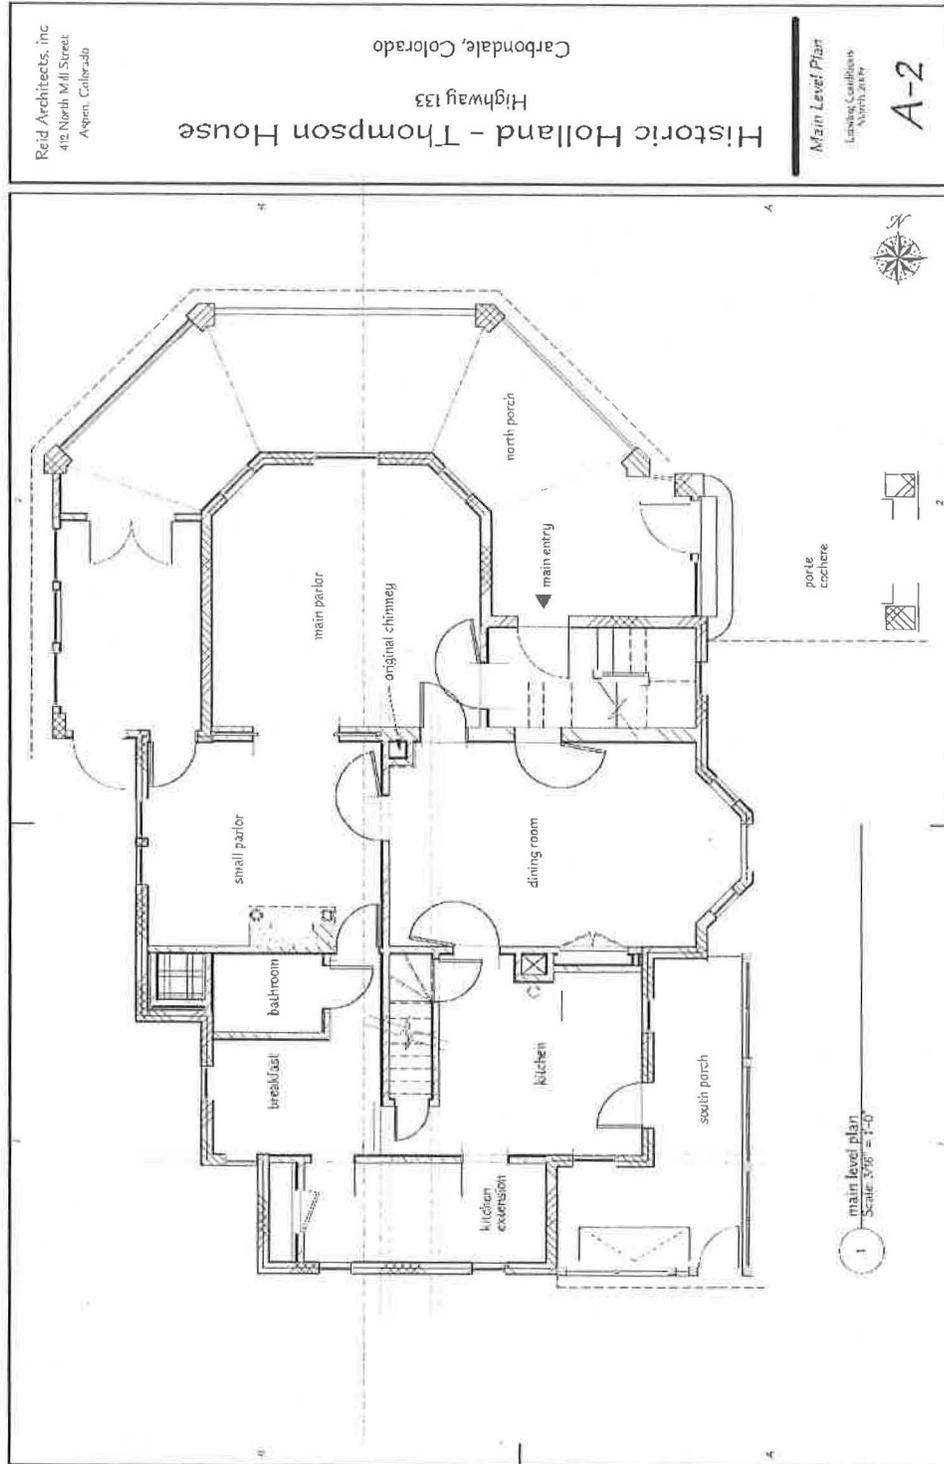
House Sketch – Main Floor

Interior: The interior of the Holland-Thompson main house reflects its external geometry. The main level is a series of three main rooms, one in each of the volumes defined by the roof form, and two rooms sharing the rear wing. The small entry hall is located on the northeast corner, within the side wing gable volume. The main level rooms are connected directly; each room connected to its adjacent room by doorways. The front porch is enclosed, creating an additional sitting room and an enclosed entry area. A smaller sitting area is located on the west side of the porch and is separated from the main porch area by a dividing wall with a French door.

In plan, the main level is 58' long north to south, and 38' wide, not including the porte cochère. The house is 1,285 sq. ft. on the main level plus 600 sq. ft. of enclosed porches. The upper level is 1,285 sq. ft. with an additional 37 sq. ft. of enclosed porch.

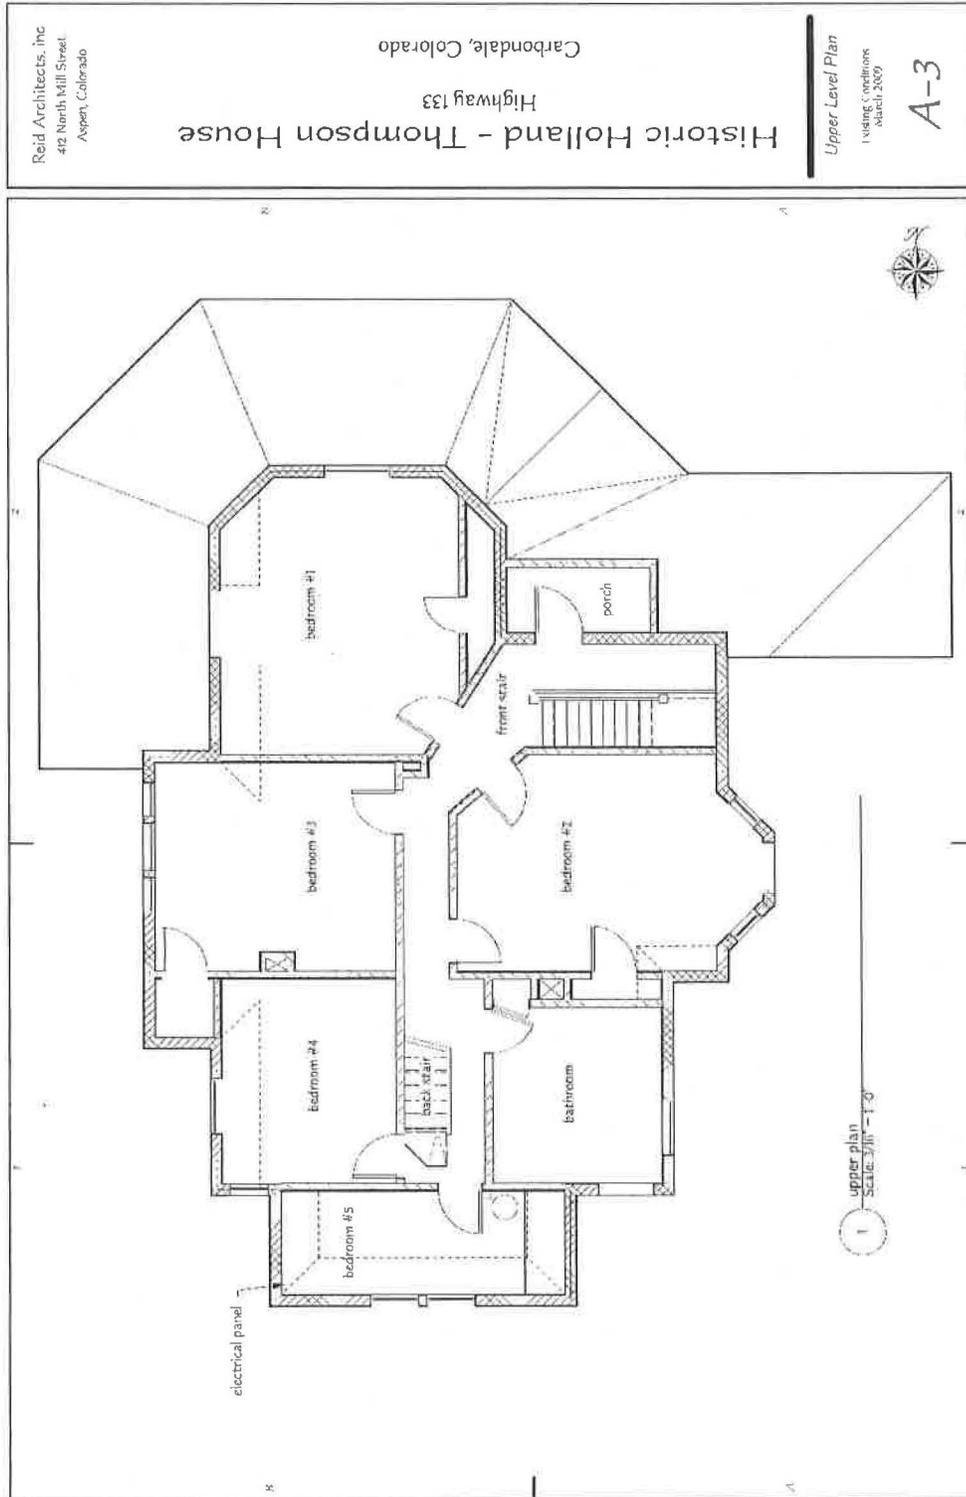
House Sketch – Second Floor

The upper level consists of five bedrooms and one bathroom, divided similarly to the lower level rooms. A narrow central hallway connects the front stair hall to the rear of the house and the bedrooms and bath open off the hall. The service stairs connect to the hallway at the south side of the house and run down to the kitchen. The upstairs bathroom occupies the space directly above the main kitchen. It has a historic pedestal sink, claw foot tub, foot basin and toilet. A floor grate

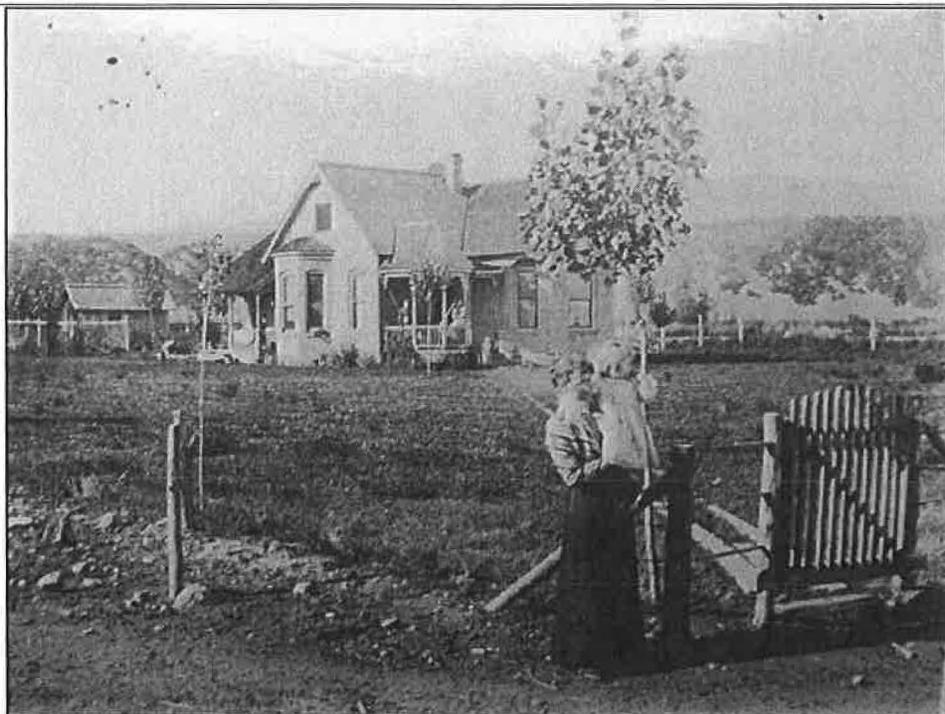
View of the Holland-Thompson main house looking southwest, circa 1886.

The corner at the front of the photo is the same corner as seen in 2012 photo # 17 of 17

discernible. An early photograph (figure 1) shows the front-gable bay, the side wing with a bay on the southeast and the back porch. A steep hipped-roof porch is located in the ell created by the side wing and front gable. The porch has delicate turned posts, brackets and a low picket railing. The high ridge of the main roof is also visible.

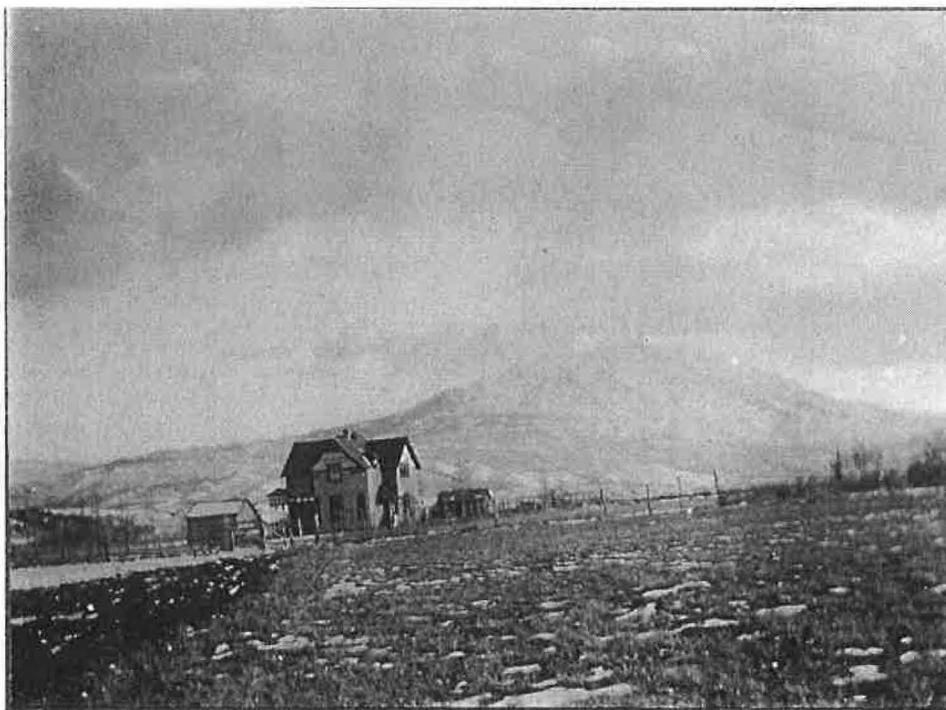
Figure 2

View of the Holland Thompson House, circa 1900, looking southeast.

This view shows the house with the second story and a decorative porch, called the intermediate porch in the narrative.

The intermediate porch is shown in a photograph of the house taken after the second level was added. This porch is highly decorative with a shed roof extending off the north side of the side wing, at the entry door, and a cone-shaped roof over a circular area of porch that is disengaged from the brick wall. The porch has a decorative frieze, spindle, posts and brackets. Its proportions are extremely delicate relative to the brick house.

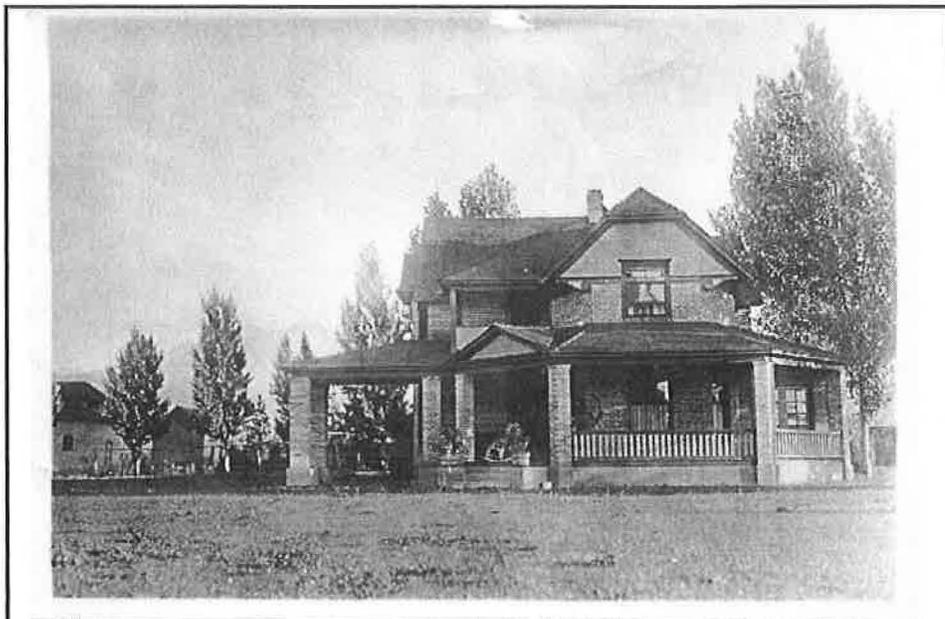
The front porch and the porte cochere have been added.

The Carriage House is at the far left.

The third historic photo (figure 3) shows the current north porch with its brick piers, hipped roof and porte cochère. This photo also shows the carriage house located on the southeast corner of the lot. In this photo the entrance to the porch is on the forty-five degree angled section facing northeast. A wide concrete stair accesses the porch and a low pitched gable protects the entrance. The final photo shows the house in its current condition, with the glass enclosure of the main porch.

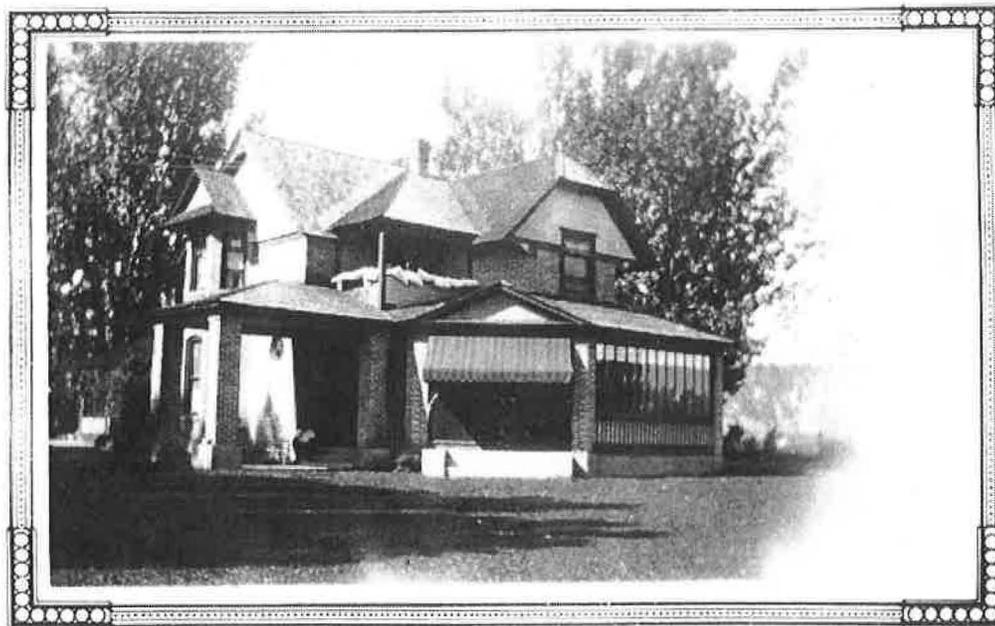
Figure 4

View of the Holland-Thompson main house looking southwest from the northeast corner of the house, main entrance, circa 1939.

Glass panels have been added to the main porch.
