National Register of Historic Places Registration Form

historic name Hansen Bridge

other names/site number Pearl Street Bridge, Downie River Bridge, Scott's Bridge, Bailey's Bridge, Bridge 13C0003

Low-side steel truss bridge

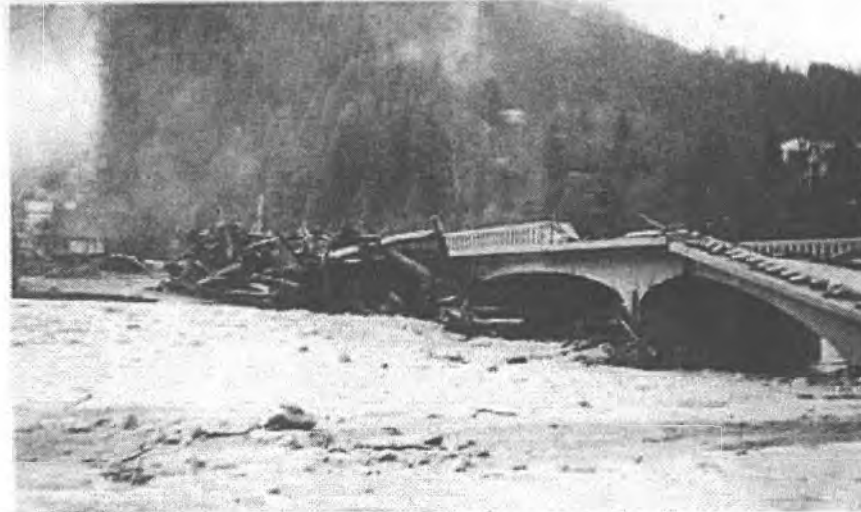
Figure 2. Historic photo of damaged highway bridge, 1937

Remains of Highway Bridge

On December 10, 1937, major storms sent a torrent of water through Downieville via both rivers. Nearly ten years had passed since the last high water, and an enormous amount of debris was swept into the river by the storm. State highway crews, aware of the storm's danger, stood by to clear debris from the bridges, but as the river rose to the point where the highway bridge's arches were underwater, clearing debris became impossible. The storm passed mostly under the Hospital Bridge and damaged the footings of the Hansen Bridge. The Highway 49 concrete arch bridge, unlike the truss bridges, had several pillars that extended into the river, and once road crews could no longer reach the bridge, debris

collected on the piers and blocked the passage of water through the arches. The temporary dam brought the water level high enough to send the river through the streets of Downieville, lifting homes from their foundations and sending them floating downstream. The highway bridge could not withstand the pressure of the water and debris for long, and collapsed after approximately 30 minutes. The catastrophic break-through of water and debris caused more damage to the buildings of Downieville, and utterly destroyed the two wooden bridges downstream from the highway bridge, the Jersey and Durgan Bridges.

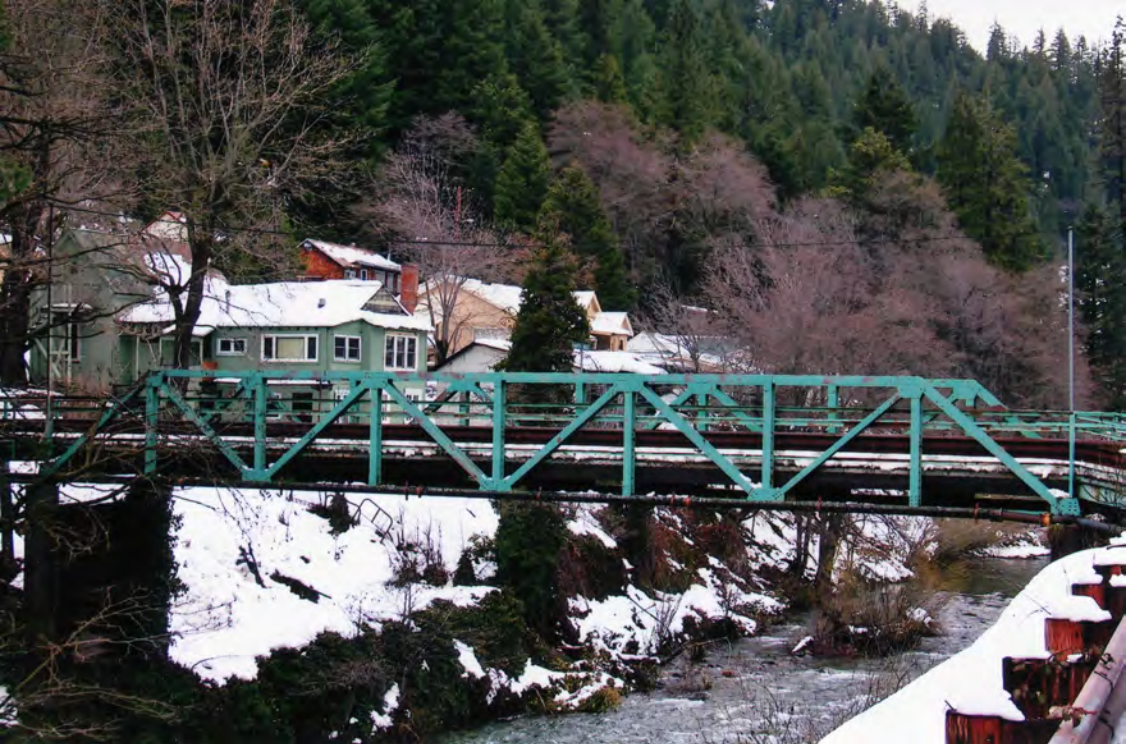
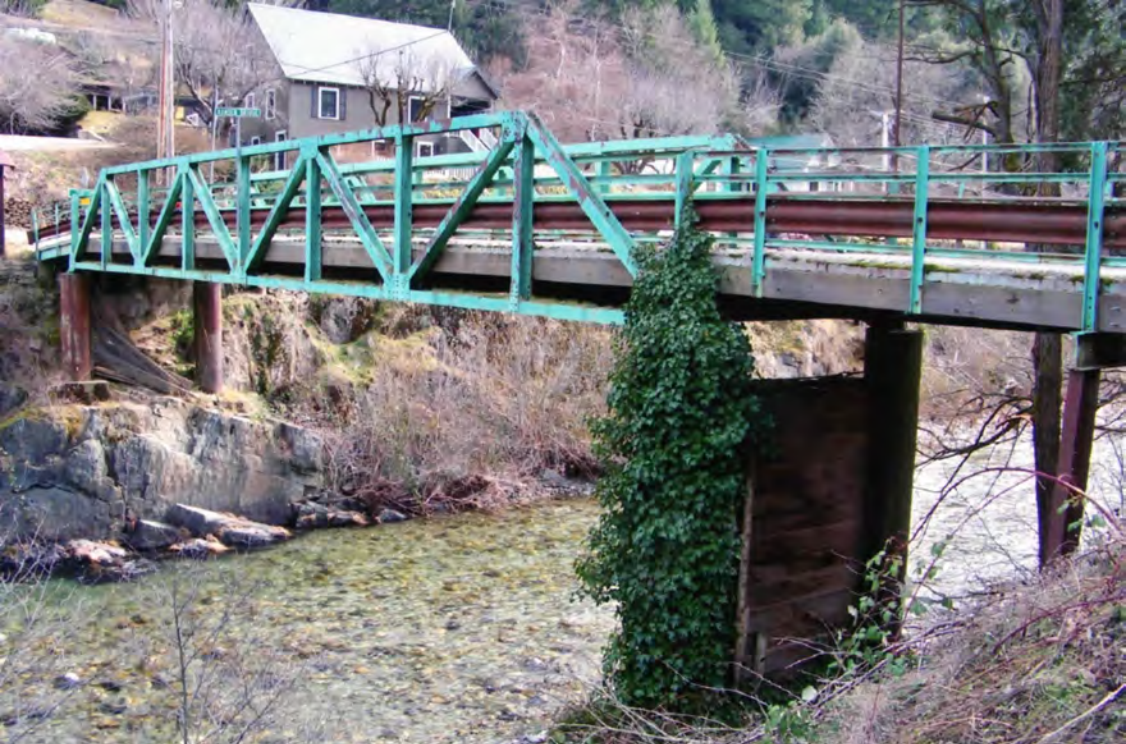
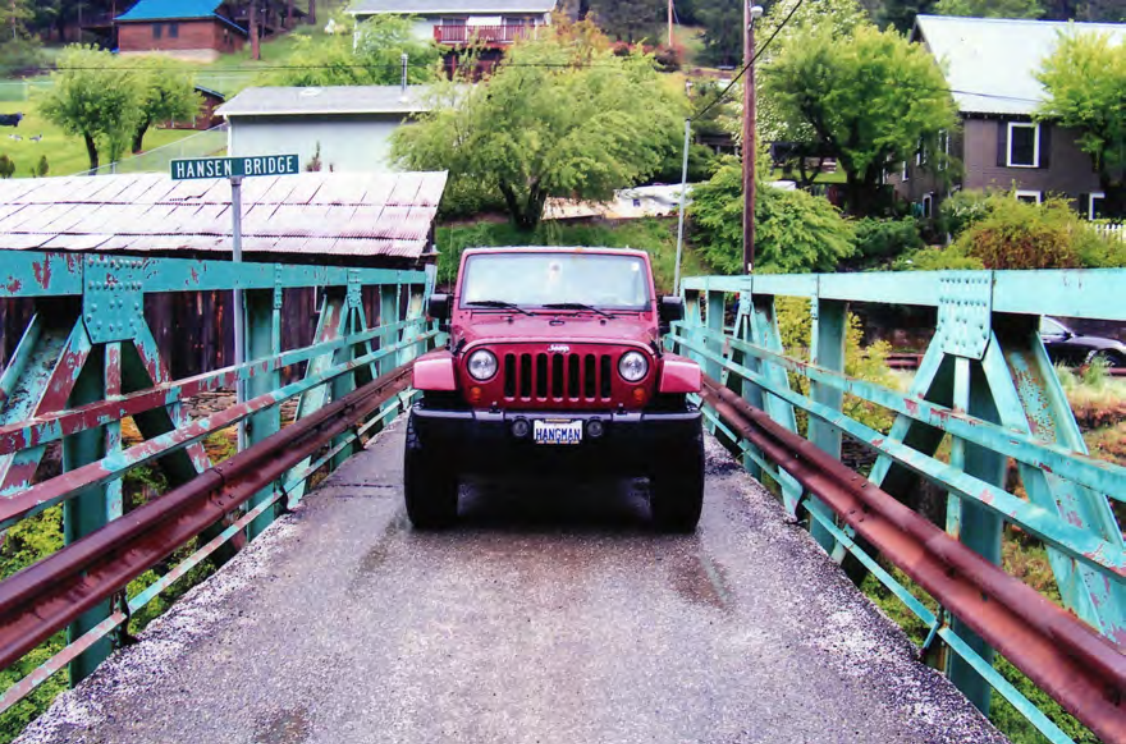
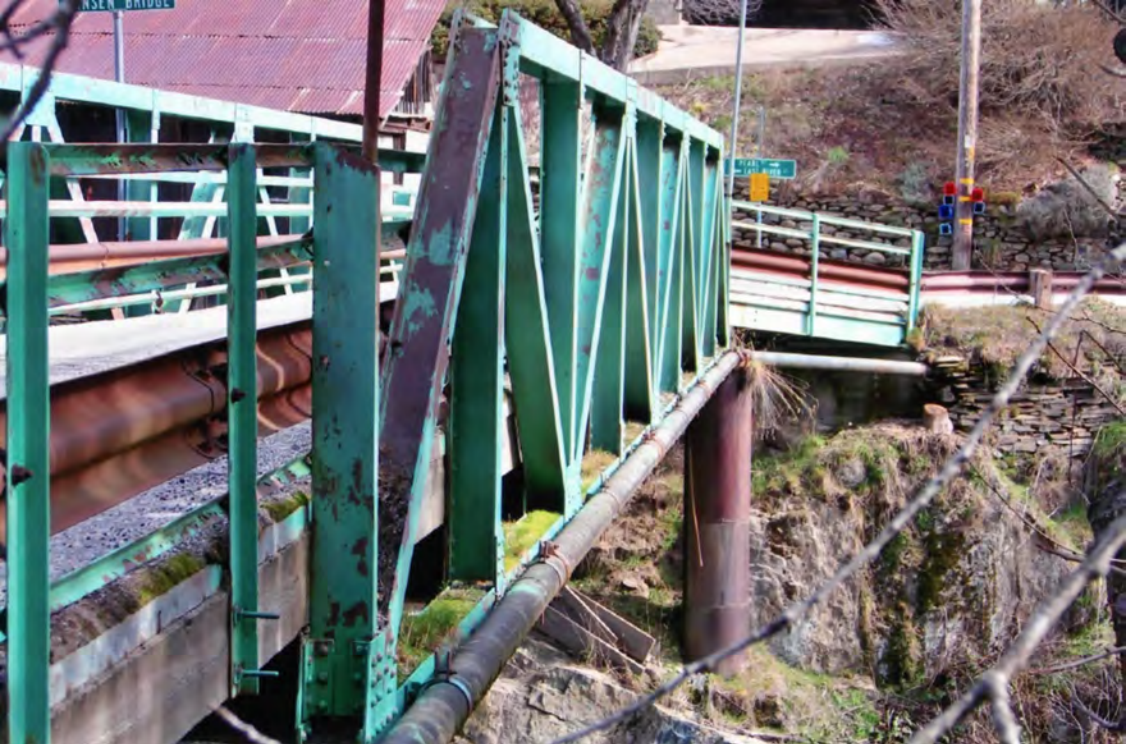
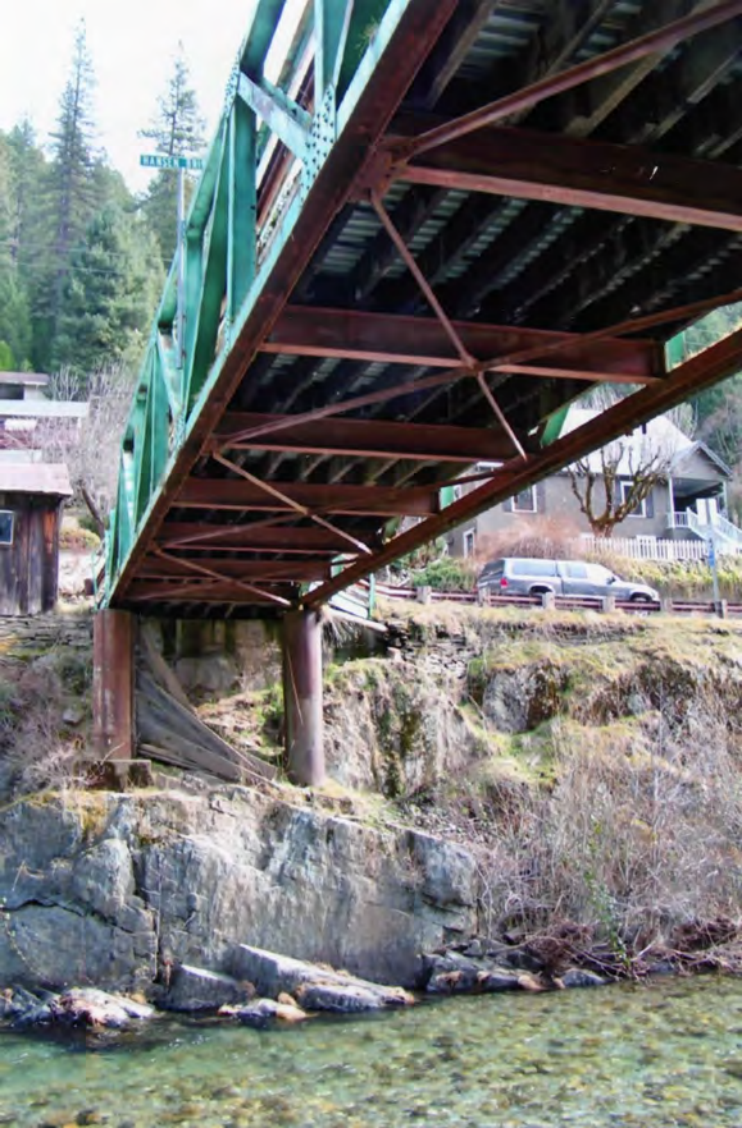
1. Hansen Bridge, camera facing east
2. Hansen Bridge, camera facing northeast, showing bridge support piers
3. Hansen Bridge, showing bridge surface and roadway
4. Hansen Bridge, camera facing south, showing detail of chords, end posts and water pipe
5. Hansen Bridge, view of underside of bridge showing wooden bridge stringers, steel bottom laterals, lower chord and bracing

The Hansen Bridge is a Pratt pony truss steel bridge 80 feet long and 12 feet 4 inches wide, running east-west across the Downie River. The bridge trusses are constructed of steel I-beams secured by riveted steel plates. Steel guardrails extend beyond the edges of the pony truss on either side of the bridge, with a rolled sheet metal safety railing below the steel guardrails. The roadway deck is supported on wooden stringers running the entire length of the bridge, topped with corrugated metal and an asphalt road surface. The bridge is supported by two concrete pilings on each end, resting on concrete footings, with wooden boards between each piling. The boards on the western side appear to have partially collapsed but are still present. Steel struts from the canyon wall to the bridge are located on the eastern side of the bridge behind the pilings. A water pipe runs along the northern edge of the bridge. The remains of a granite retaining wall, possibly from an earlier bridge, are present on the northern side of the western bridge abutment.
