United States Department of the Interior
National Park Service
National Register of Historic Places Registration Form

Historic Name: Glen Rose Downtown Historic District
Other name/site number: N/A
Name of related multiple property listing: N/A

Street & number: Properties surrounding courthouse square, bound by Vernon, Walnut, Bernard, & Elm; 100 block, 201, & 205 SW Barnard St.
City or town: Glen Rose State: Texas County: Somervell
Not for publication: Vicinity:

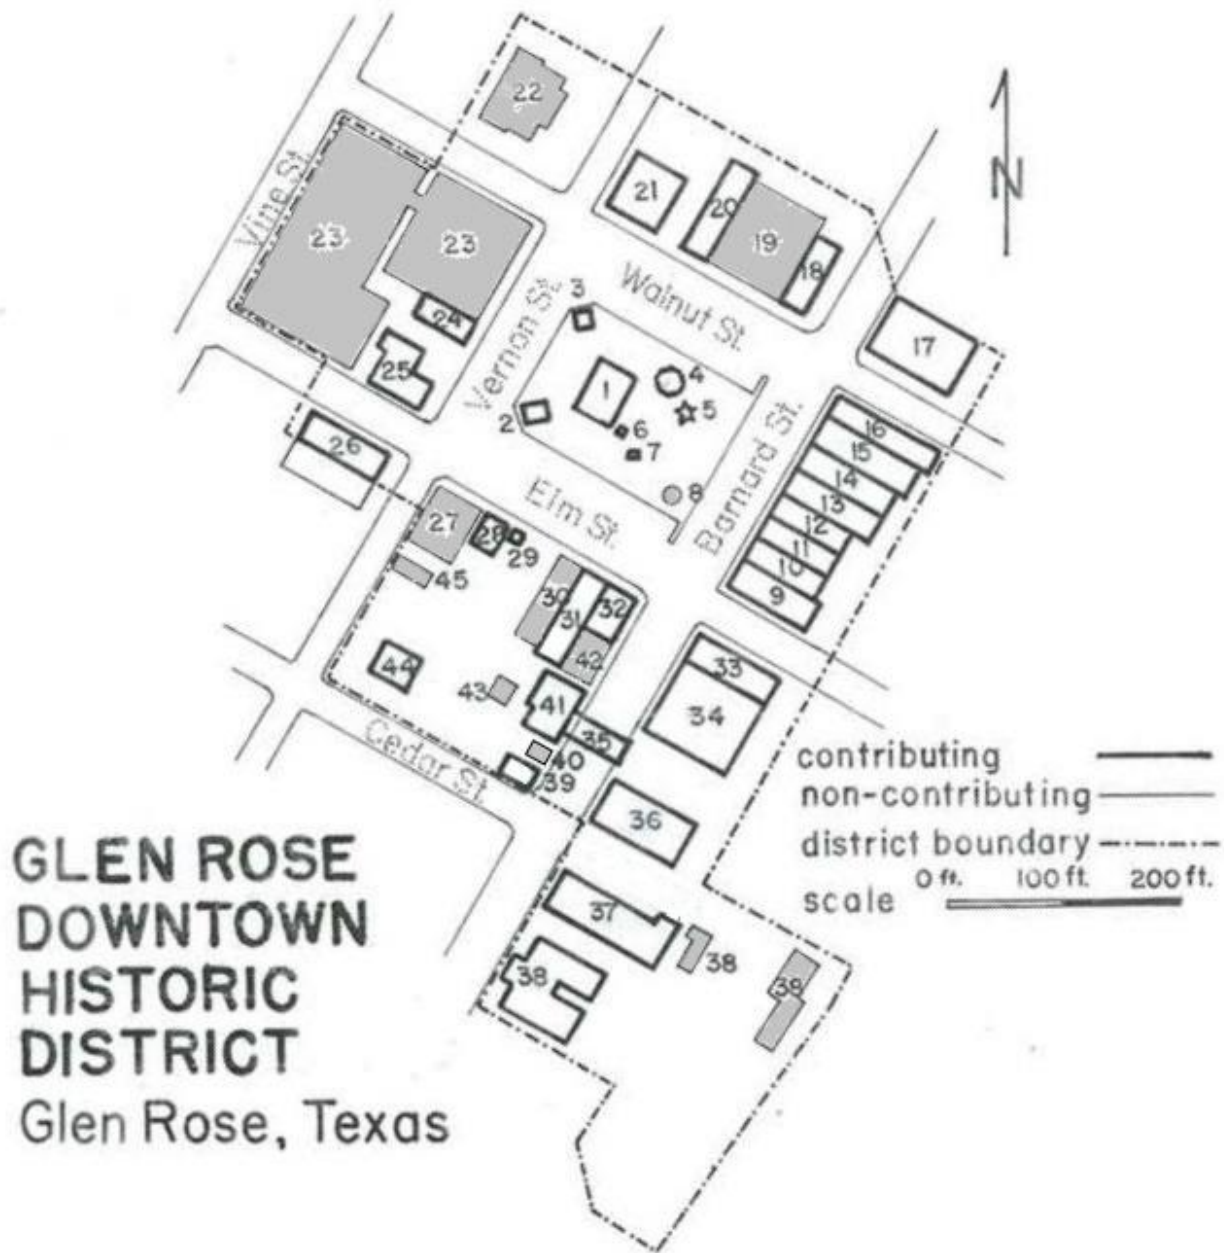
Map 4: Sketch map depicts contributing and noncontributing properties within the district. The identification numbers correspond to those used in the Inventory Table on Pages 10-12.

Noncontributing properties are shaded gray.

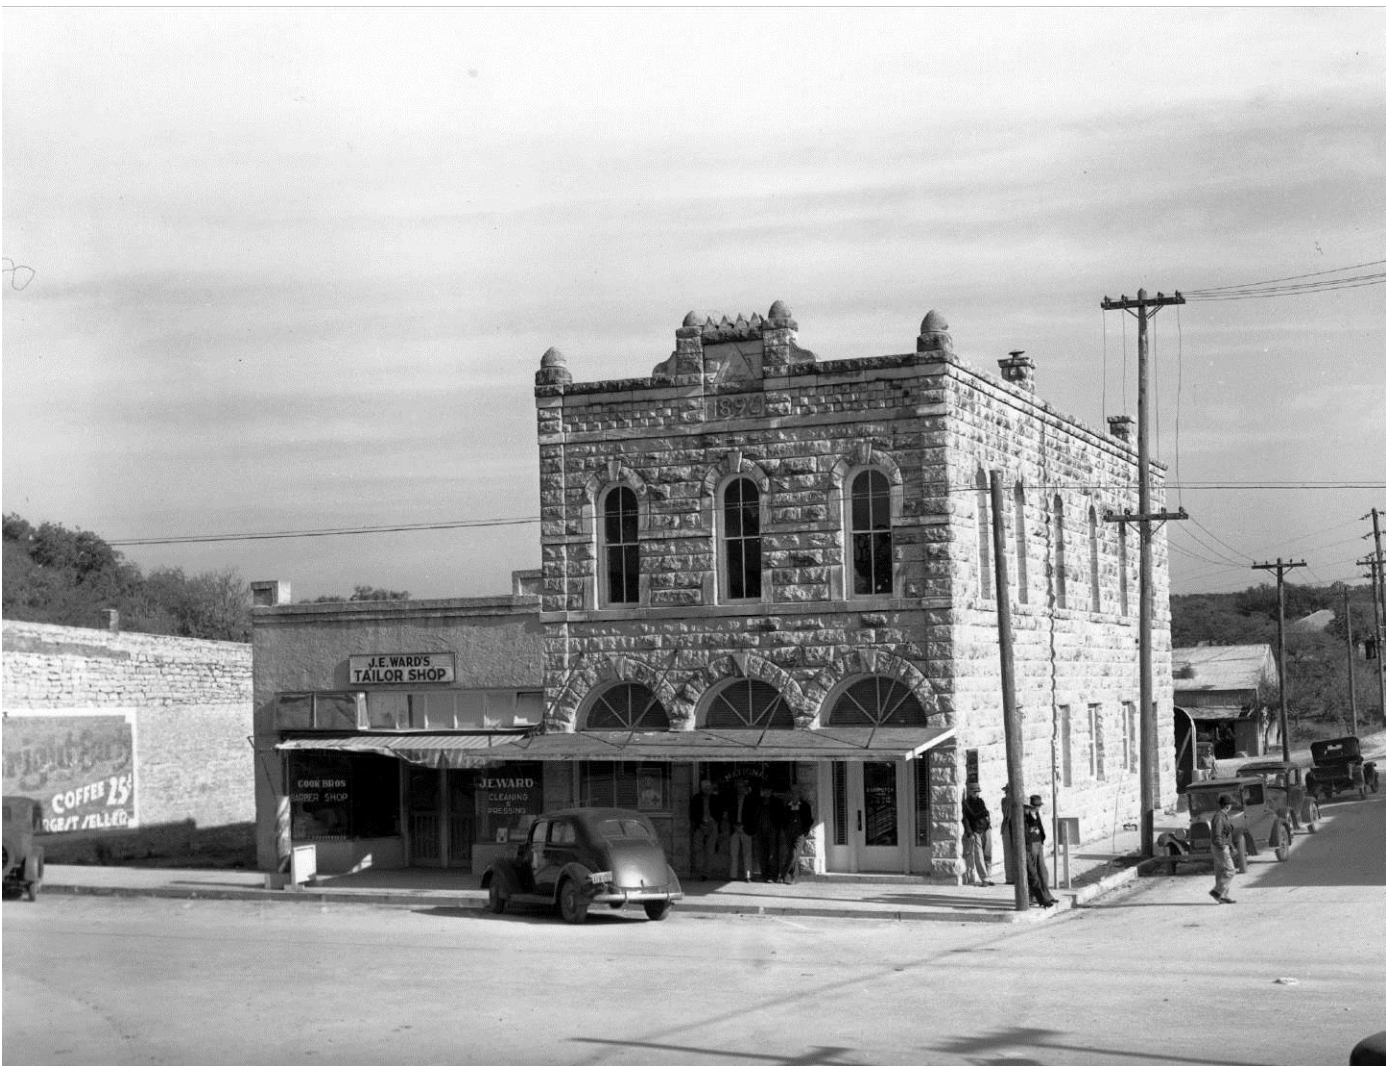
Historic Photo 8

Humphrey Saloon and Sadler's Drug Store, Glen Rose, Texas, November 1939.

Southeast from the intersection of Northeast Barnard Street with West Elm Street to the front of the A.H. Humphrey Saloon (First National Bank, 100 Northeast Barnard Street) and Saddler's Drug Store Building (J.E. Ward's Tailor Shop, 102-104 Northeast Barnard Street), Glen Rose, Texas, in November 1939. Photograph by Russell Lee courtesy of Farm Security Administration/Office of War Information Collection, image LC-USF34-034710-D [P&P], Library of Congress, Washington, D.C.

The Sadler's Drug Store Building is a masonry One-part Commercial Block with three bays constructed from locally quarried limestone. It measures 22 feet across and 70 feet 1 inch long, with a flat roof that tapers toward the rear for drainage. The front originally had two free-standing stone piers supporting the upper facade, but by the 1930s they had been replaced with iron pipe supports. At this time plate glass display windows with cuprous molding and a recessed double-door entry were installed. During this renovation a row of rectangular transom windows were put in place above the entry and display area. During most of its history the building had a variety of wooden and corrugated galvanized sheet steel awnings, most of the time the outer edge being suspended from the wall on iron rod supports though at times also stabilized with iron pipe uprights. Historic photographs show that these awnings frequently covered the transom windows, making them less effective as sources of interior natural lighting than they might otherwise have been. These transoms currently are covered with a stucco-like material. At the time of this study, the building has a visually compatible fabric-covered awning that is wall-mounted on a steel framework. The Sadler's Drug Store Building shares side walls with its two adjoining structures. Its ashlar limestone rear wall with three different visible varieties of mortar has a central single doorway with historic wooden framing and a sash window on either side that have been enclosed. There is a rain gutter across the rear with downspouts on each side.

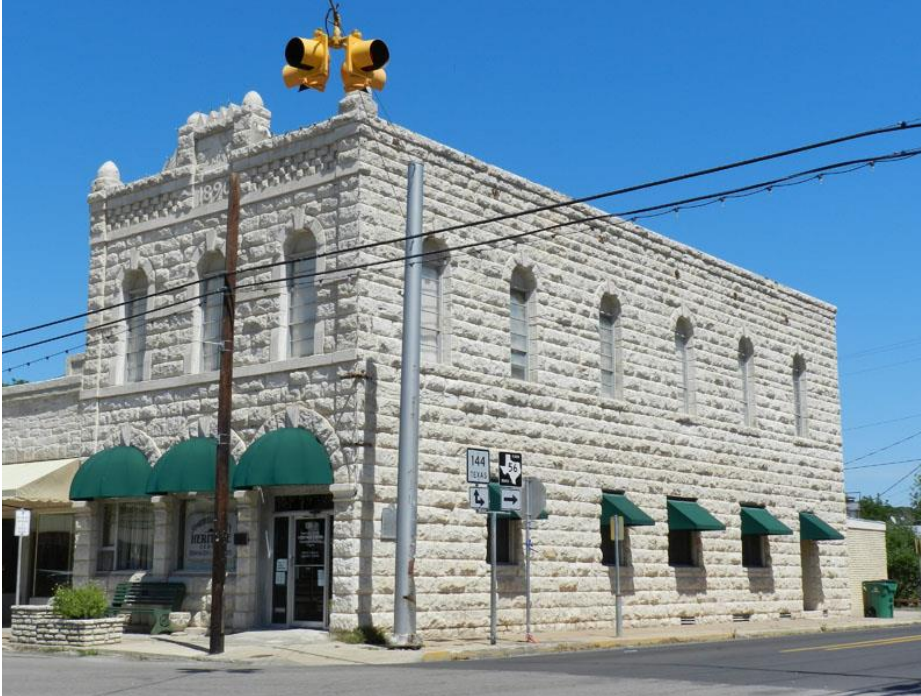
Photo 2: Property # 9 (Contributing)

A.P. Humphrey Saloon (currently Somervell County Heritage Center), 100 N.E. Barnard Street
Oblique view of facade and southwest side
Camera facing: East

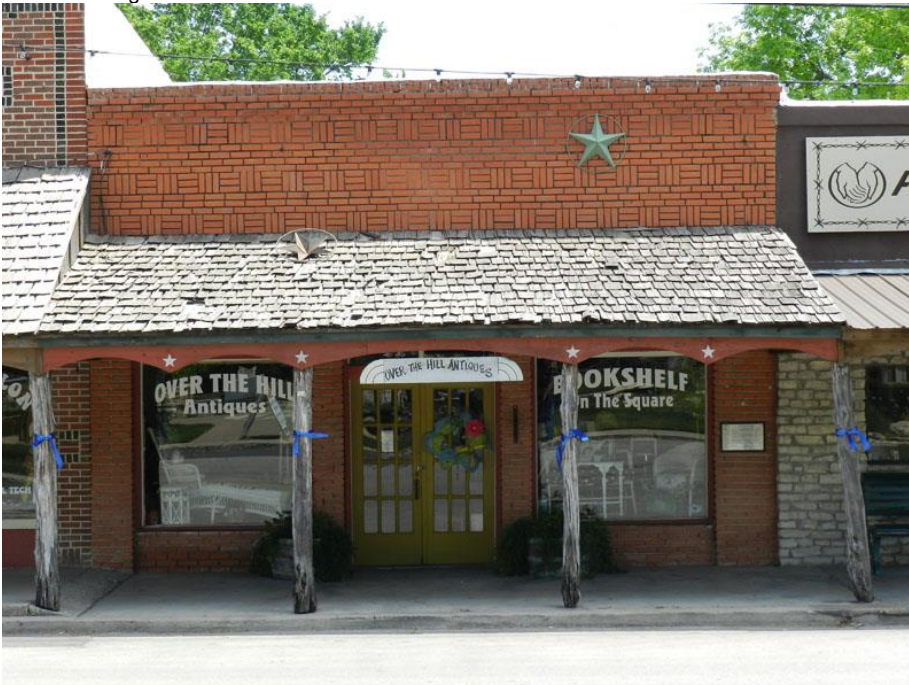
Photo 3: Property # 12 (Contributing)

Don Hill's Variety Store Building (currently Over the Hill Antiques and Bookshelf on the Square), 108 N.E. Barnard St.
Northwest elevation
Camera facing: Southeast

The commercial building at 108 Northeast Barnard Street was one of four adjacent Glen Rose structures that burned in a fire in late 1926. Charles W. Hill rebuilt the building in 1927 on the site where he and then his daughter and son-in-law, Lillie Hill Campbell and Clarence Campbell, had operated a general store. Then son Don C. Hill purchased the property from his sister, and for almost five decades Don and his wife, Vivian Hill, operated a variety store there. The store became a particular attraction for local children. Local resident Dorothy Gibbs remembered from her girlhood during the 1930s, that she and others went to Don Hill's for merchandise ranging from toys to candies. From her child's perspective, Gibbs felt that "He had everything in the world." After Don and Vivian Hill closed out their business enterprise in the mid-

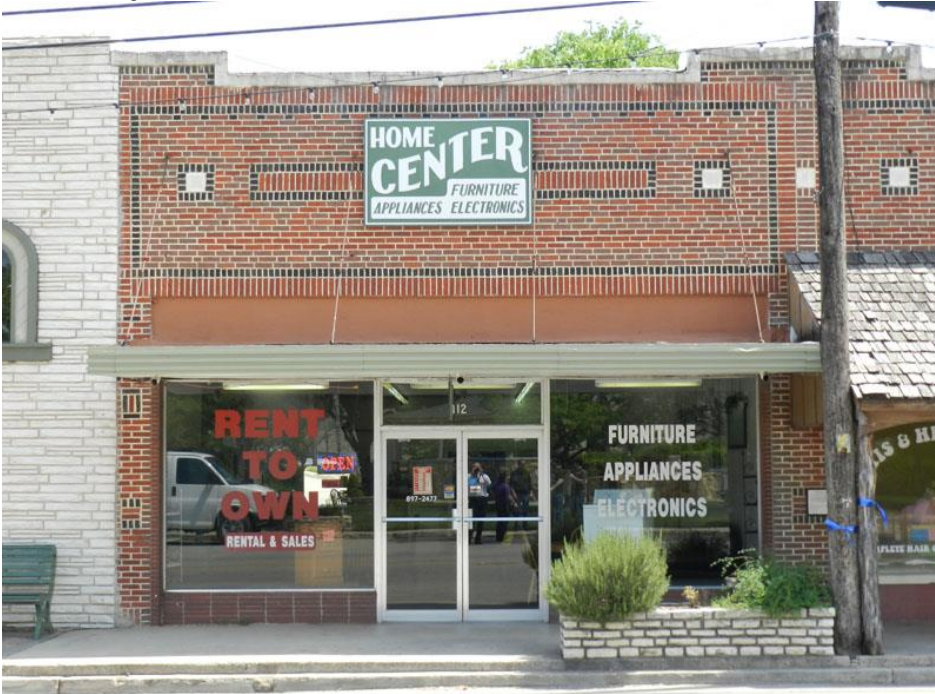
Photo 4: Property # 14 (Contributing)

Gresham and Company Dry Goods Building Southwest Half (currently The Barnyard Antiques and Decor), 112 N.E. Barnard St.
Northwest elevation
Camera facing: Southeast

The Gresham and Company Dry Goods Building Southwest Half stands on the site of the 1883 wooden building that formerly housed the E.H. Martin Saloon. After the voters of Glen Rose voted to prohibit the sale of alcoholic liquors in 1899, the saloon closed, and within a comparatively short time Harriet Abby Gresham expanded her late husband's pre-existing dry goods store next-door at 114 Northeast Barnard Street into the adjacent building at 112 Northeast Barnard. The building housed the southwest half of Gresham's at 112 Northeast Barnard until it burned in the fire in late 1926 that destroyed three other businesses on the southeast side of the courthouse store. The Gresham family rebuilt at the same site concurrent with reconstruction next-door at 110 Northeast Barnard Street. This collaboration led to the two buildings sharing the same decorative brick facade. Gresham and Company continued to run its dry goods business in the building into the 1980s. After that time the building provided space for other commercial enterprises including the Blue Bonnet Cafe. In 2012 the interior of the building was renovated for commercial use. This work included removing a modern lowered ceiling that exposed the fully intact pressed metal ceiling installed in 1927. Plaster repair at this time also temporarily revealed a bricked-up double-door-sized opening toward the rear that formerly connected the two halves of the Gresham and Company dry goods store. Currently The Barnyard Antiques and Decor occupies the location.

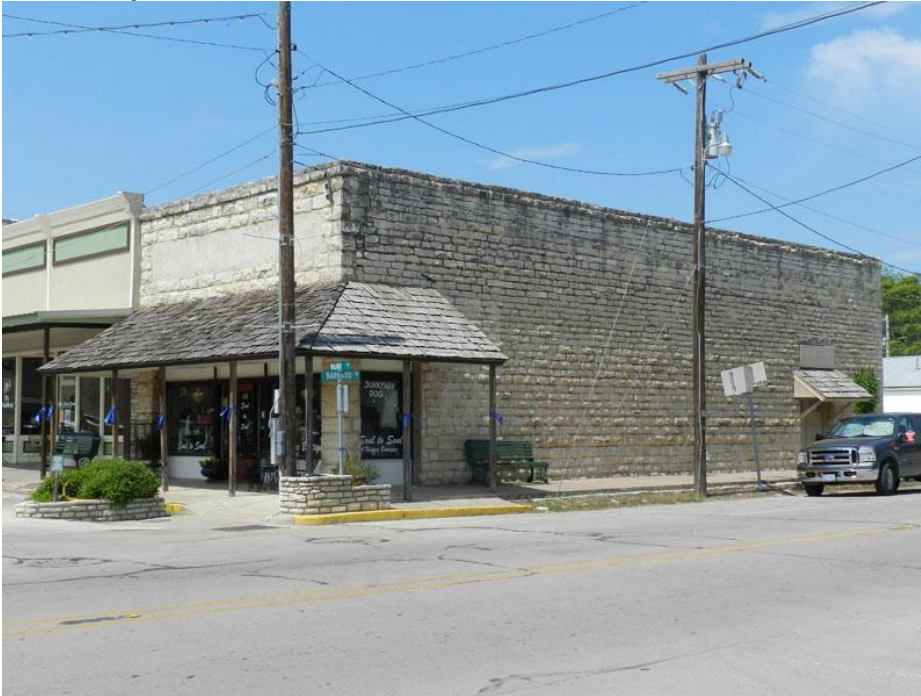
Photo 6: Property # 18 (Contributing)

Bryan's Dry Goods Building (currently The Barnyard Antiques and Decor), 100 W. Walnut St.
Oblique view of facade and southeast side
Camera facing: Northwest

The Bryan's Dry Goods Building is an ashlar limestone three-bay One-part Commercial Block located on the corner of Northwest Barnard Street with West Walnut Street fronting onto the Somervell Courthouse Square. The rectangular building, which measures 25 feet 10 inches wide and 69 feet 7 inches long, has a flat roof that drains toward its rear. The front of the three-bay building has a flush single-door entry with side lights flanked by plate-glass display windows. In the past the building had a wooden and corrugated galvanized sheet awning across its front. At some date after 1987 a replacement wooden awning with square lumber posts and a shake shingle covering was installed on the front and on the southwestern end of the Barnard Street side to shade display windows and to provide shelter for pedestrians from inclement weather. Locally quarried ashlar limestone stonework in the building is laid in regular courses, with larger blocks in the lower courses and with a coping stones in the parapet. Stonework was carefully executed, with mortar joints that were struck and with the stones comprising the corners being smoothed to give the edges a sharp appearance. For its early years the upper portion of the facade uniformly had an ashlar surface, but sometime after 1940 a rectangular panel was smoothed and plastered in order to be painted with the business name. The side of the building facing Northeast Barnard Street has a single plate-glass display window at the front and a double-doorway entrance near the rear. This opening as recently as the 1950s had taller doors and a transom, but the transom was enclosed, shorter doors were installed, and a shed-style canopy with shake shingle covering was installed above to provide shelter. The southern corner of the building has a free-standing limestone pilaster that allows there to be a plate-glass display window that faces the busy Northeast Barnard Street. Along this southeast side of the building is a concrete sidewalk that is edged in rectangular pieces of limestone, the last remaining visible limestone curbs in the downtown commercial district. Near the cornice on the side are holes and iron studs for former electric service insulators. The limestone rear of the building, covered with protective cementacious stucco, has a boarded up single-door entry on the right and shows evidence to the left of two former sash windows that have been enclosed with masonry.

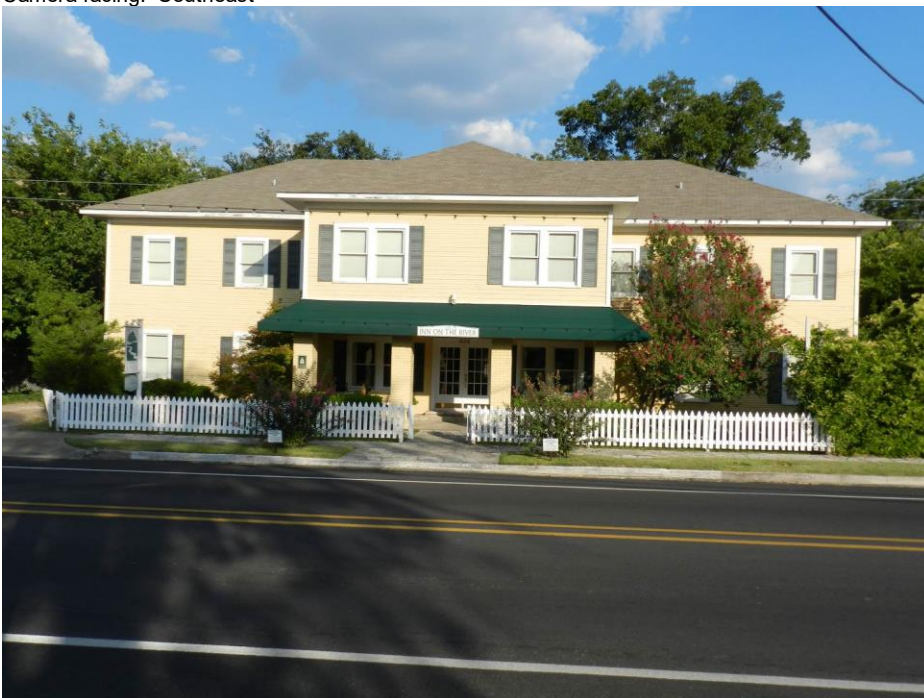
Photo 11: Property # 38 (Contributing)

Snyder Sanitarium (currently Inn on the River), 205 S.W. Barnard St.
Northeast elevation
Camera facing: Southeast

The Snyder Sanitarium, constructed in 1919 as a health facility, is a two-story Craftsman style wood frame building with a U-shaped plan. Constructed on a pier-and-beam foundation, the wooden structure was erected by the Williams Lumber Company for local healer George P. Snyder. It was designed to provide thirty-five rooms for patients plus treatment and support areas. Originally a separate building housed a kitchen and dining room. The sanitarium measures 80 feet 5 inches across and each of the two wings are 62 feet 4 inches long. The two-story wood-frame building has beveled wooden siding, much of it remaining from original construction (protected for many years beneath now-removed asbestos siding). On both floors the building has large one-over-one wooden sash windows to facilitate ventilation during the years before air conditioning. The exterior is painted a pale pastel yellow with grey-painted shutters. The hipped roof is covered with grey composition shingles. Four square brick posts support a 29-foot 6-inch-long front porch with a hipped roof. Beneath is a double-door entry with each door having twelve fixed panes of glass. After the Snyder Sanitarium ceased to serve medical needs of health seekers, the structure was converted to become a large bed-and-breakfast business. At that time a new dining room was added to the side of the southwest wing. Also during the 1980s and 1990s, two modern supporting wooden outbuildings were erected on the grounds closer to the Paluxy River to serve hospitality functions. These subsidiary buildings, with no historical connections to the sanitarium, measure 95 feet 7 inches by 27 feet 5 inches and 44 feet 2 inches by 21 feet 2 inches, and are painted, trimmed, and roofed similarly to the historic structure.

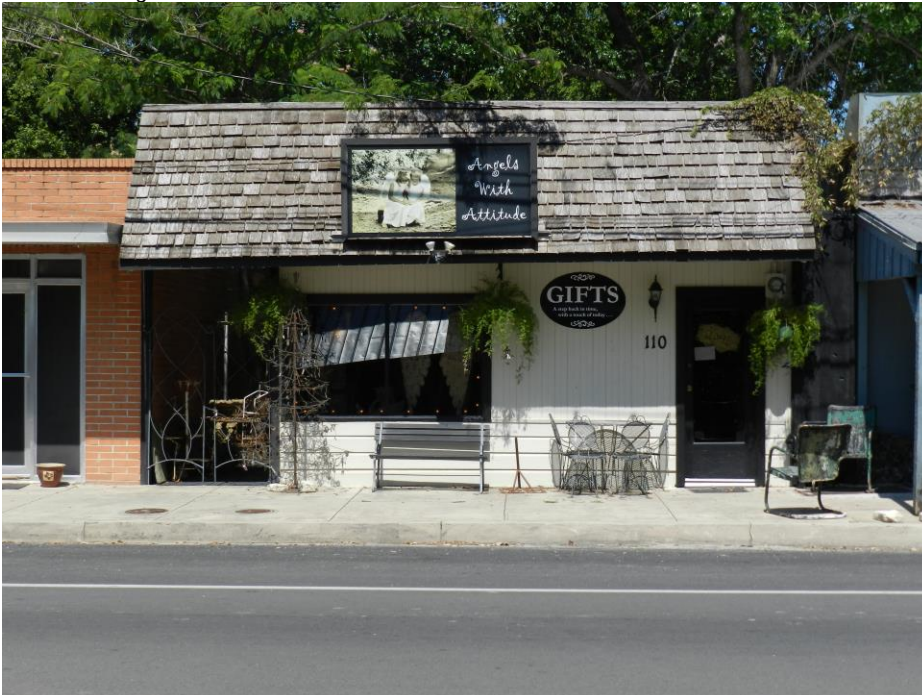
Photo 13: Property # 40 (Noncontributing)

Ernst Insurance Building (currently Angels with Attitude), 110 S.W. Barnard St.
Southwest elevation
Camera Facing: Northwest

siding. The exterior is painted a cream color trimmed in dark brown. Like the adjacent Vogue Beauty Shop (Property #39), the Ernst Insurance Building fronts on a solid foundation at the side of the street, but its rear is supported on vertical concrete piers set in a concrete footings in the bed of Connell Branch. Although the Ernst Insurance Building lies about 2 feet from its adjacent Miles Building (Property #41), there is a wider 4-foot 8-inch gap between it and the Vogue Beauty Shop (Property #39) on the other side. In this space an open deck on wooden supports has been laid so that one can walk between the two buildings to a larger diagonal deck built onto the rear of the former insurance building. The current occupant of the commercial building uses this open deck area for displaying yard furniture and outdoor decor items that can be exposed to the elements.
